**MEMS Reliability Alliance**  
Technical Report No. 37-01

**UNRELEASED POLYSILICON BEAM FAILURE**

Russell A. Lawton, Gisela Lin, Joanne Wellman  
Jet Propulsion Laboratory  
August 4, 2000

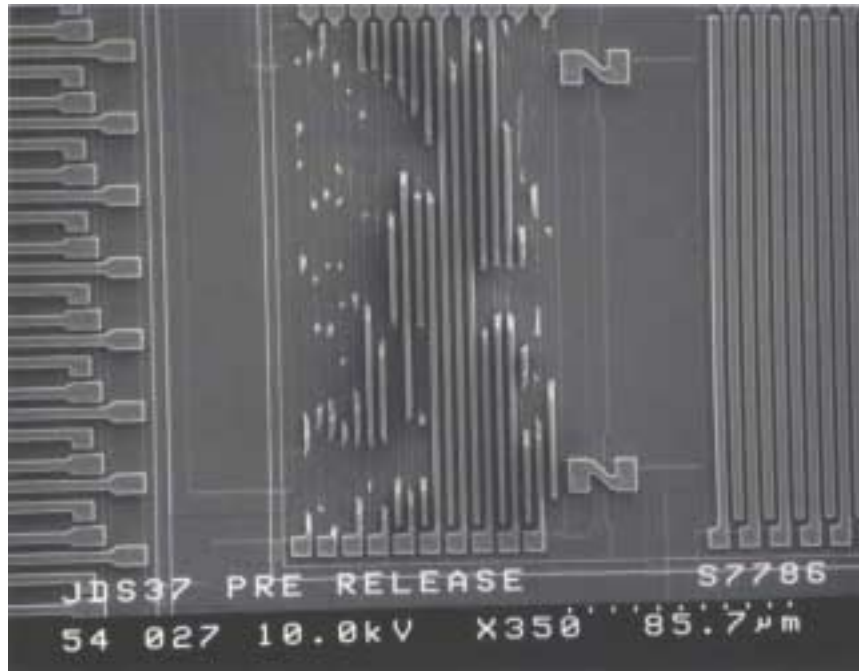
It was found that the poly2/poly1  $2\mu\text{m}$  wide beams did not survive wafer dicing. As shown in Figures 4 - 7, the damage was extensive to this array. The cause of failure is presumably the pressure of the water jets in the dicing saw. The dicing cuts were made perpendicular to the

beams. Thus, the force due to the water jets is perpendicular to the beam as affects the entire length of the beam. Damage occurred only on the  $2\mu\text{m}$  wide poly2/poly1 beams. As shown in Figure 4,  $4\mu\text{m}$  wide beams survived in tact. All poly1 beams survived due to the protective oxide 2 layer that covered them (these die were not released, so all oxides were still present).

Figure 4. SEM photo of beam array, top view. As shown,  $2\mu\text{m}$  wide poly2/poly1 beams (center) were damaged during wafer dicing.  $4\mu\text{m}$  wide poly2/poly1 beams (right) were not damaged.

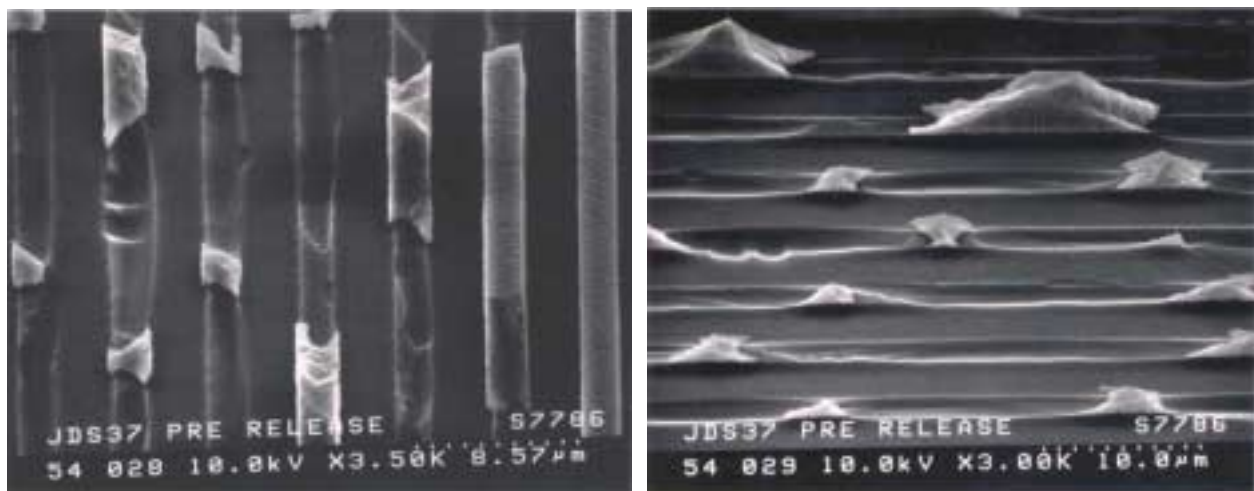
Figure 5. Perspective views of the damaged area. During wafer dicing the poly2 broke off from the poly1 sheet beneath, leaving behind an indentation. The remaining poly2 appears brighter in color.

Based on the data gathered from Figures 4 - 7, it appears that the adhesion of poly2 to poly1 is strong, such that when the poly2 portion of the beam is exposed to excessive force, a portion of the poly1 is broken off with it (hence the indentation). The amount of force that caused the failure can be estimated by the following equation:

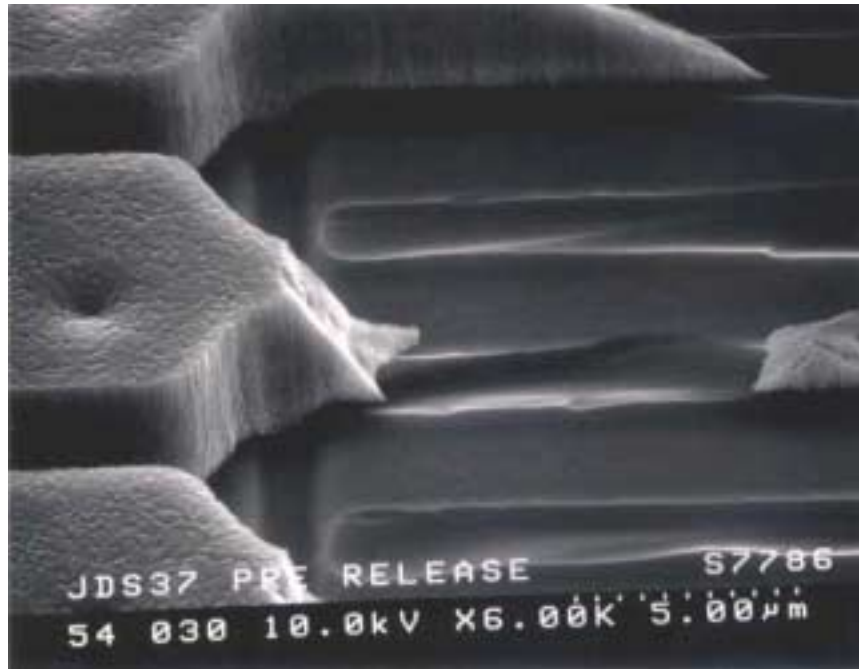
*Figure 6. Close-up perspective view of the poly2 portion of the beam anchor, and indentations after beam damage. The indentations appear smooth and well defined.*

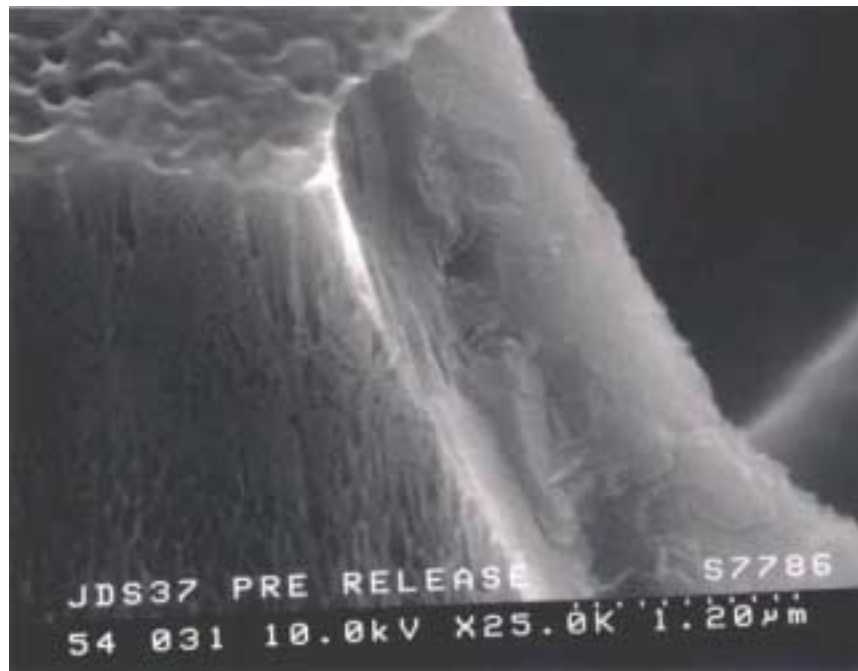
*Figure 7. Close-up of the anchor portion of the center beam in Figure 6. The remaining poly2 portion of this beam shows relatively smooth surfaces and microcracking.*

It should be noted that prior to the wafer dicing, all beams underwent a 20 minute ultrasound bath to clean any photoresist residue off the chips. Although under the optical microscope, the beams looked intact afterwards, none of the beams were inspected for microcracks. It is possible that microcracks may have been initiated in the  $2\mu\text{m}$  wide poly2/poly1 beams during the ultrasound bath, which propagated during wafer dicing until failure. Further studies will need to be performed to confirm whether microcracks were formed.
