Environmental Test Laboratory

HESSI Spacecraft Incident - March 21, 2000

Terry C. Fisher

June 2001

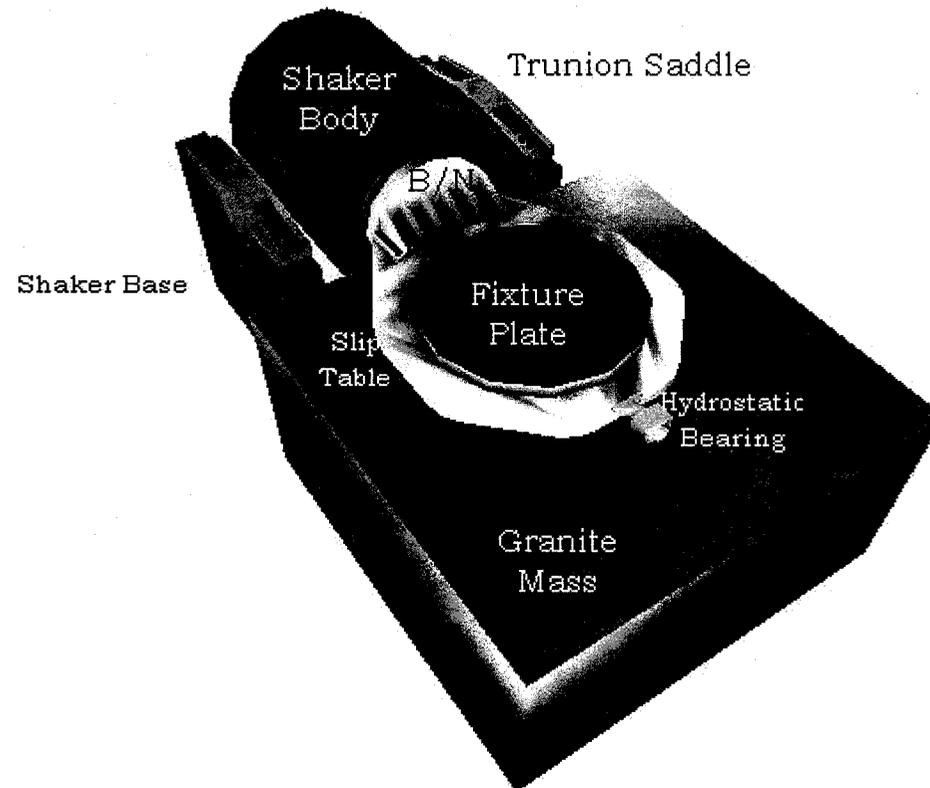
HESSI Test Set up

- The HESSI Spacecraft was mounted on the Environmental Test Laboratory (ETL) Ling A-249 shaker slip-table for vibration testing
- During the sine burst test the shaker and spacecraft were driven at a higher level than programmed
- Cause of the HESSI Over Test
 - Slip table misalignment
 - Broken trunion bearing
 - Inadequate self-check resulting in a poor transfer function estimate

Root Cause: Stiction caused by misalignment of the shaker and slip table was the root cause of this mishap.

- **Contributing Factors (Continued):**
 - The shaker, a Ling A-249, shifted in its support cradle after being coupled to the slip table in preparation for this test. The shift resulted in a misalignment that brought one area of the slip plate into contact with the granite reaction mass creating a much larger frictional drag than normal.
 - *Recommendation:* Refurbish or replace the Ling Model A-249 shaker.
