SMT SOLDER JOINT RELIABILITY/WORKMANSHIP ENVIRONMENTAL
TEST RESULTS CORRELATION FOR LCC ASSEMBLIES

Reza Ghaffarian, Ph.D.
Jet Propulsion Laboratory
California Institute of Technology
Pasadena, CA

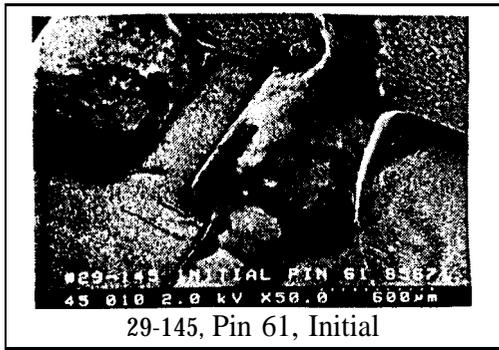
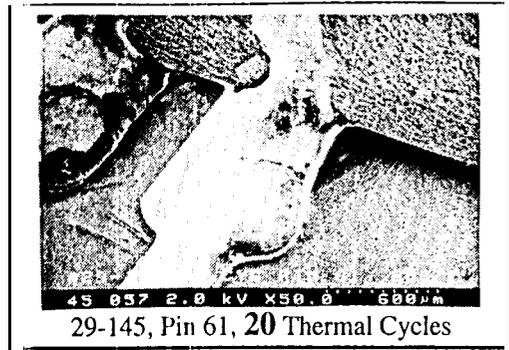
FIGURE 4. SEM Photos of Crack Propagation for 68-Pin Leadless Chip Carrier

At JPL, the conventional pass/fail criterion relies on visual inspection at 10x to 50x magnifications. For leaded parts, once cracking is observed, more than an one order of magnitude additional cycles are required before the failure. For leadless assemblies this is not the case. The cracks usually initiate inside the joint, at the corner underneath the part, and propagate outward. Figure 4 illustrates SEM photos of a corner solder joint of a 68-pin LCC assembly from initial to final failure showing damage propagation with cycles. For this particular test assembly, cracks were not observed until 47 cycles. Complete cracking and failure occurred after 71 cycles.

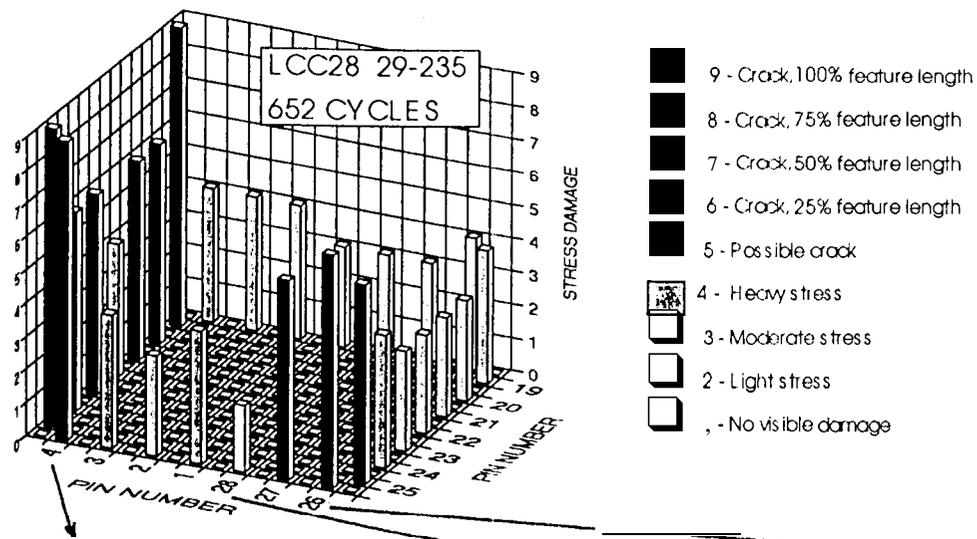
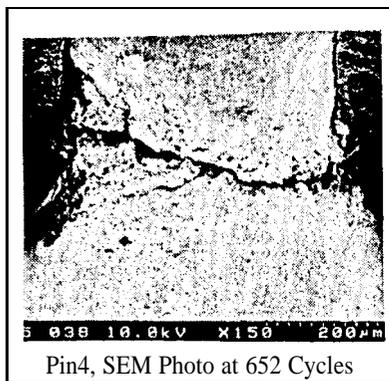
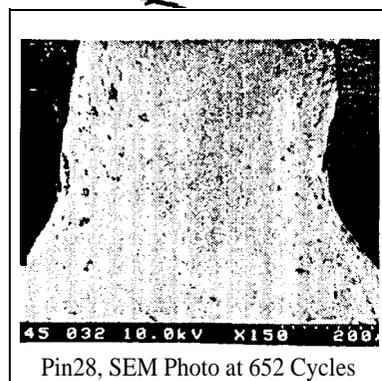
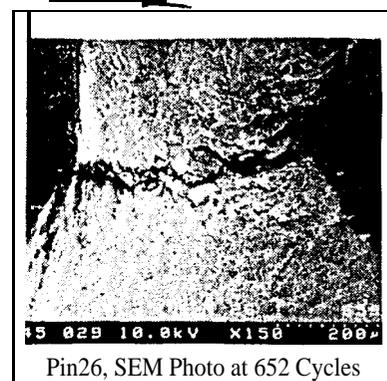
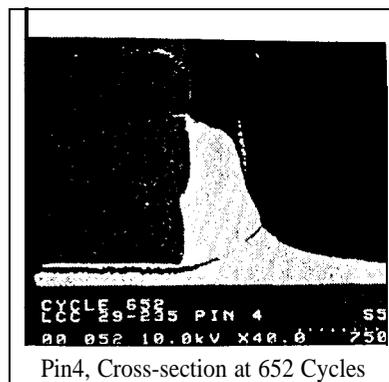
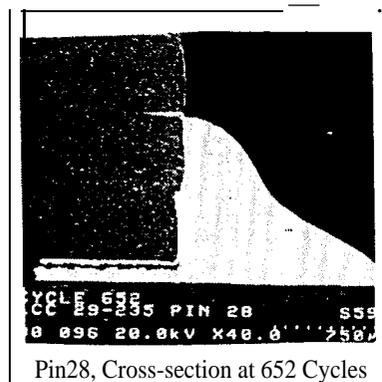
FIGURE 5. Plot of Ranking Solder Joint Damage Levels by Visual Inspection. SEM and Cross-sectional Photos for solder joints with different damage levels

Figures 5 illustrates the use of this type of plot for the 28-pin LCC assembly with the 29-235 serial number. This sample failed after 652 thermal cycles as detected by the Anatech[®]. The X and Y axes depict the pin locations of the part. The Z (vertical) axis depicts a qualitative relative value assigned to various levels of stress, from 1 (no visible damage) through 9 (100% feature length crack, dark bars

The solder joints at one side of the assembly received considerably more damage than did the opposite side. Apparent damages also increase as moving away from center and are maximum at the corner solder joints. The results confirm the assumption generally made in theoretical modeling that the corner joints with the maximum Distance from Neutral Point (DNP), should typically fail first

Visual inspection results need to be verified by SEM and cross-sectional microscopy in order to gain confidence in data for analysis and crack propagation mapping. For comparison, SEM and cross-sectional micrographs for the selective leads with increasing damage levels are also shown (Figure 5). It appears that even though inspector does not access to the inner of solder joints that crack initiates, if they are trained, they will possess ability to provide inspection results that correlate well with cross-sectional micrograph results. To be effective in Qualification Inspection, the QA inspector need to be trained in inspection procedures and to be provided with a well categorized list of observable damages and correlation to inner solder joint characteristics and relationship to life cycles.

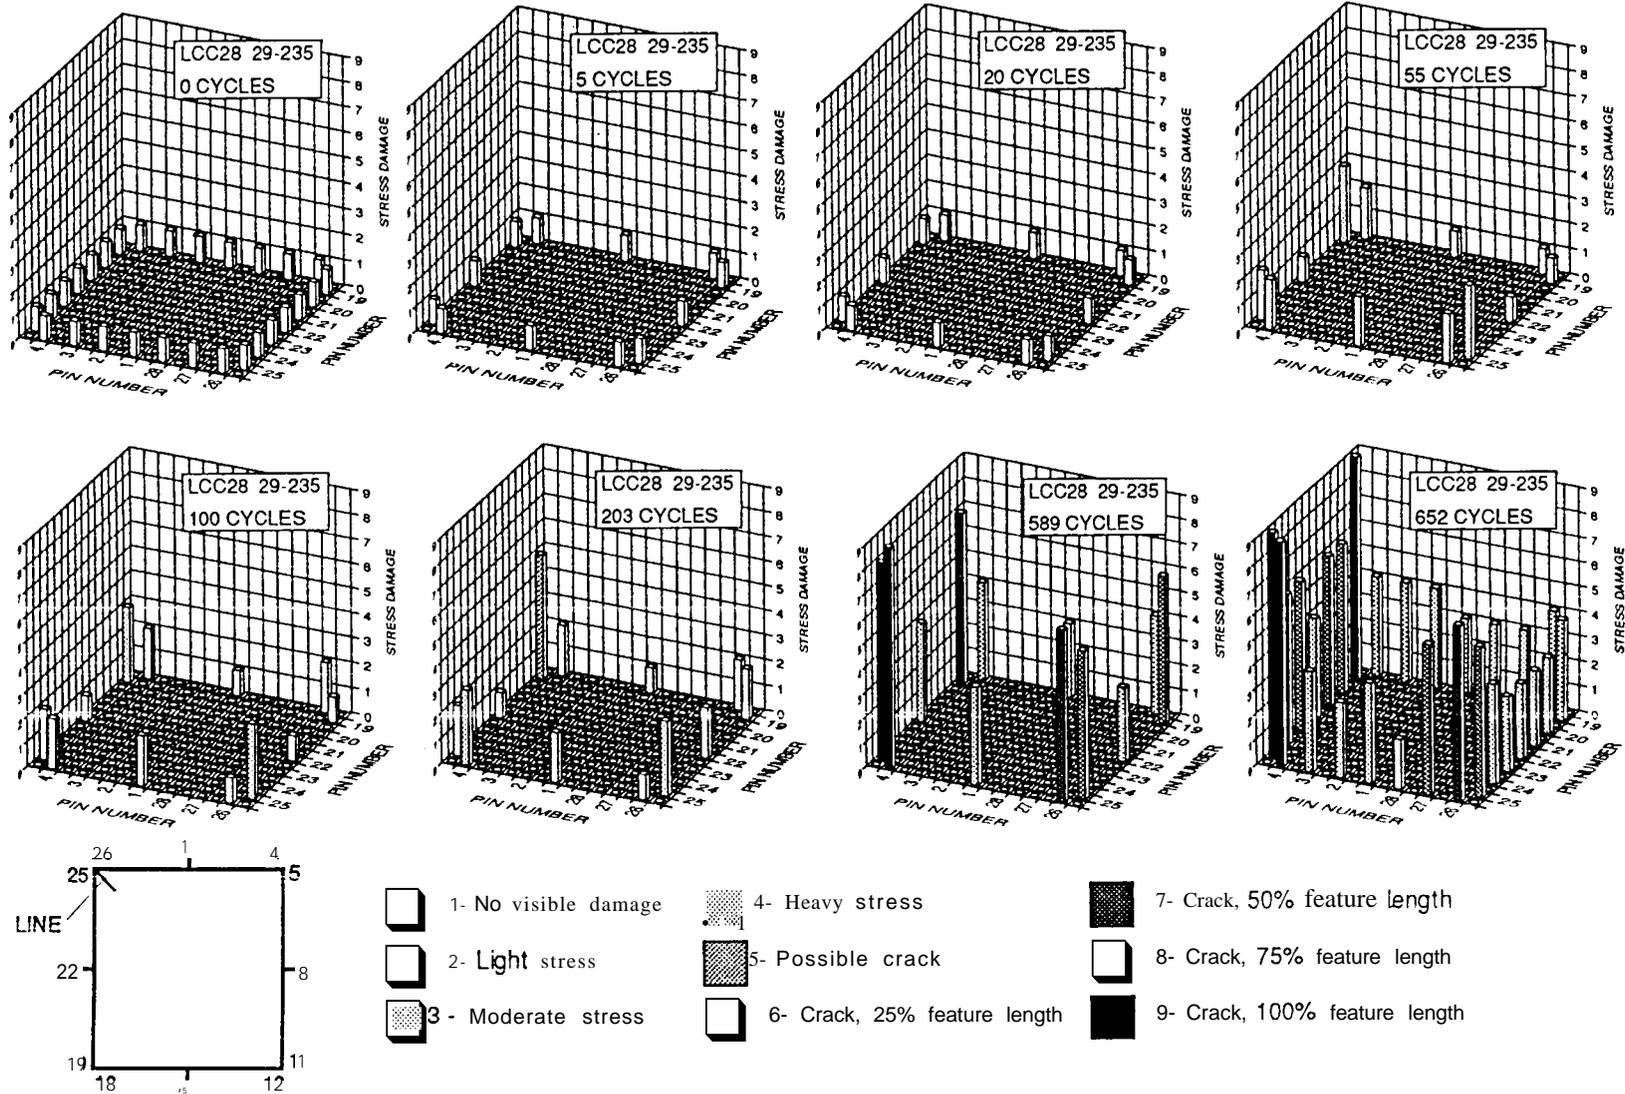
FIGURE 6. Cycling Stress and Crack Propagation for 28-Pin LCCC

Visual inspection results, proven to correlate well with SEM and cross-sectional evaluation, were used for crack propagation mapping during thermal cycling. The progress of crack propagation over time are graphed using data visualization technique developed (Figure 5). Figure 6 shows plots of data with thermal cycle for 29-235 assembly, a 28-pin LCC on FR-4. Eight inspections were performed on all 28-pin assemblies, but due to quantity of the assemblies and number of leads to inspect, during cycling inspections only the corner and center leads on each side were inspected. Full inspection similar to those after manufacturing were performed when failure detected by Anatech®.

The first visible indication of stress occurred between the 20th and 55th cycles, mainly in three corner solder joints. One of the lead was further damaged and showed signs of possible cracking at 203rd inspection cycles, {Unfortunately no inspections were performed between 203 and 589, when (apparently) much damaging activities occurred, The corner pin 4 showed almost full cracking at 589th cycles. This pin showed 100% cracking at the last inspection (652 cycles) performed after failure detection by Anatech®.

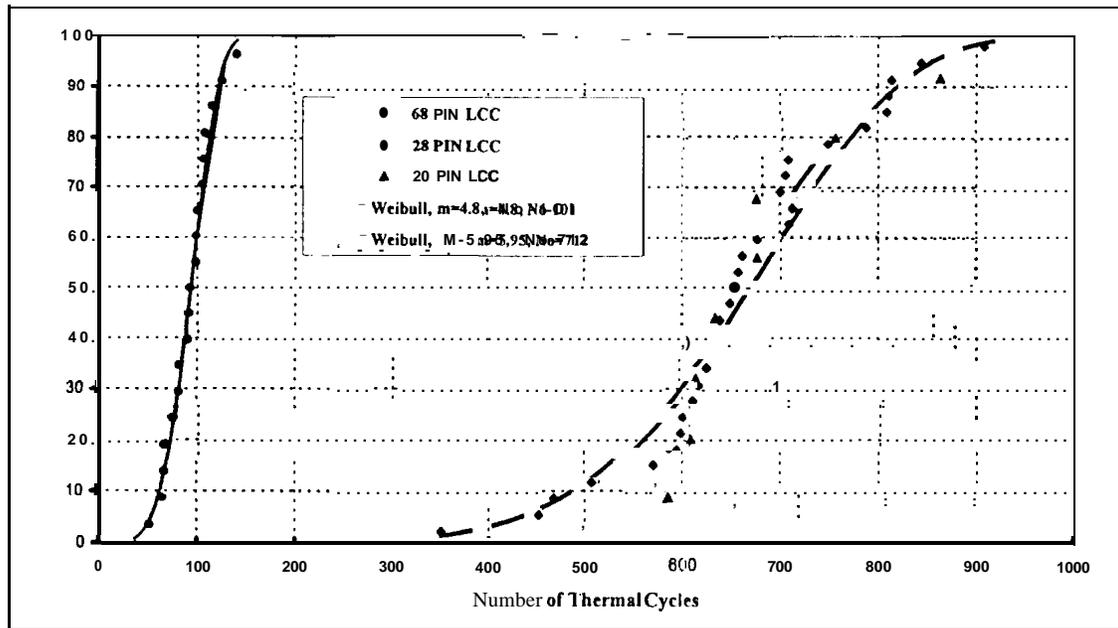
FIGURE 7. Cumulative Failure Distribution Plots for LCC Assemblies

Figure 7 shows cycles to failure for 68-, 28-, and 20-pin LCC assemblies. Failures were detected by Anatech[®] and verified by visual inspection. The failure distribution percentiles were approximated using median plotting, position, $F_i = (i-0.3)/(n+0.4)$. As expected, there was a large spread in cycles to failure because of variance in solder joint volume, quality and location. The first failure for the 68-pin LCCs was detected at 53 cycles while the last sample failed after 139 with 93 average cycles. 28-pin LCCs failed at much higher cycles in the range of 352 to 908 with 660 average cycles. The 20-pin cycles to failure were in the same range as for those of 28-pins and failed within 573 to 863 averaging 674 cycles.

If only DNPs are considered, the 20-pin LCCs should have failed at higher cycles. Cycles to failure is directly proportional to DNP. However, cycles to failure also inversely depends on the effective solder fillet height. As listed in Table 1, solder fillet height is lower for 20-pin (.021), which is lower than that for 28-pin (.033) LCC. The difference in part size could have been off-set by the difference in the fillet height.

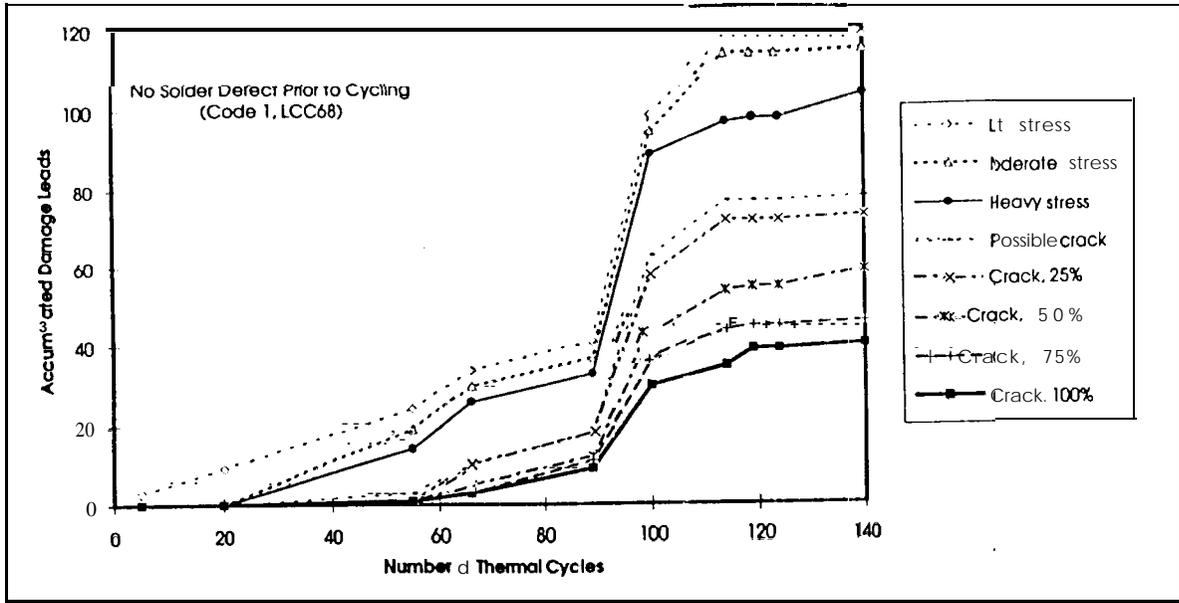
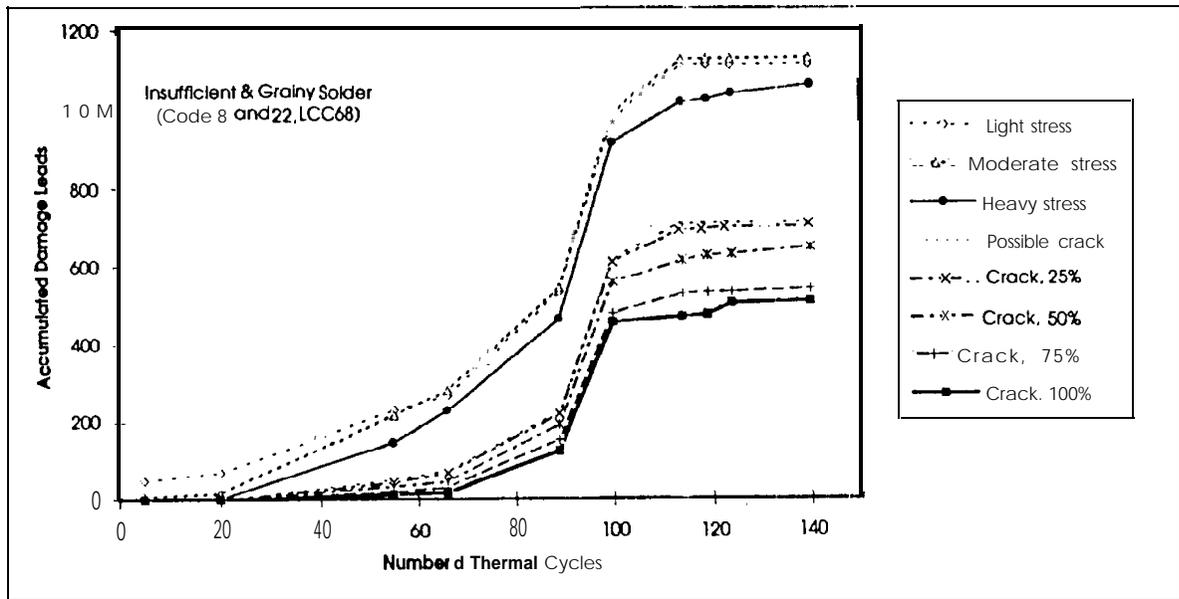
FIGURE 8. Accumulation Number of Damage Levels for 68-Pin LCC Solder Joints With No Signs of Manufacturing Defects and Those With Insufficient and Grainy Solders

For 68-pin LCC, two types of defect categories were included in one plot, there were 930 grainy and 180 insufficient solder joints with 100 having both defects. It is clear from the plots, that the solder joints with a higher defect category showed earlier signs of damage growth as well as accounting for higher failed joint percentages.

However, it can be seen from these figures that the percentages of failed leads for those with manufacturing defects are markedly higher than those with no defects. Additionally, the majority of leads with manufacturing defects failed earlier than those with no defects. The failure data points for these defective leads appear to be concentrated on the tail of the Weibull distribution, possibly from a different population than those leads with no manufacturing defects,

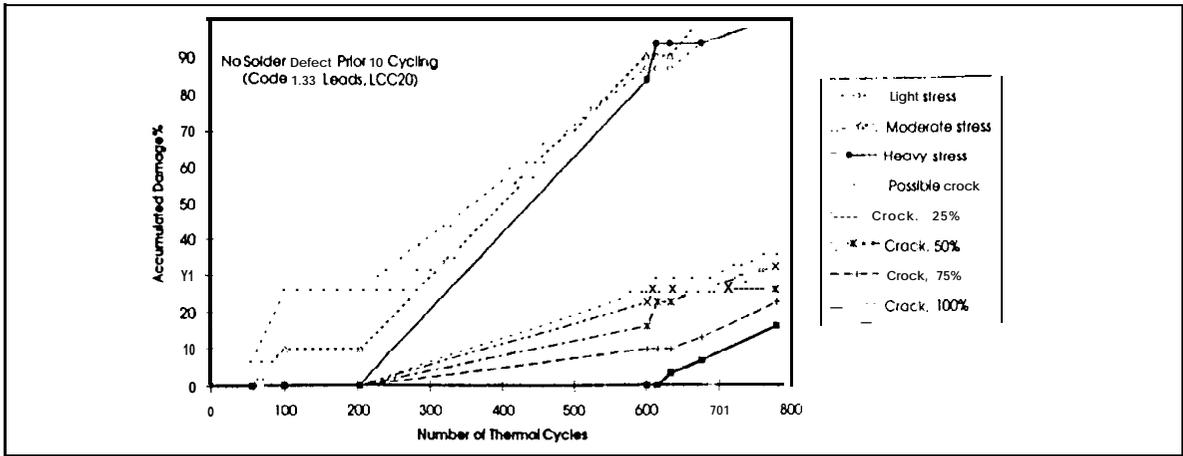
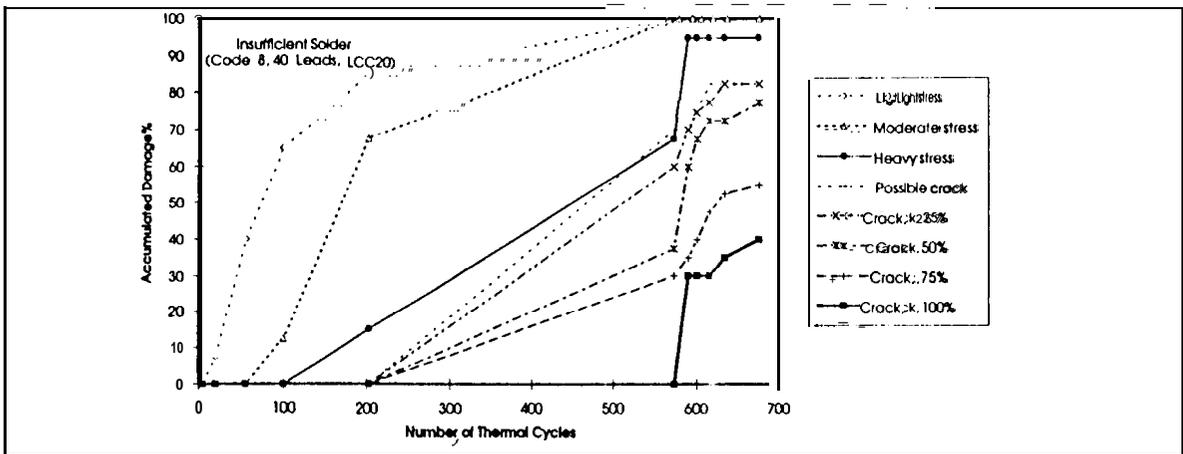
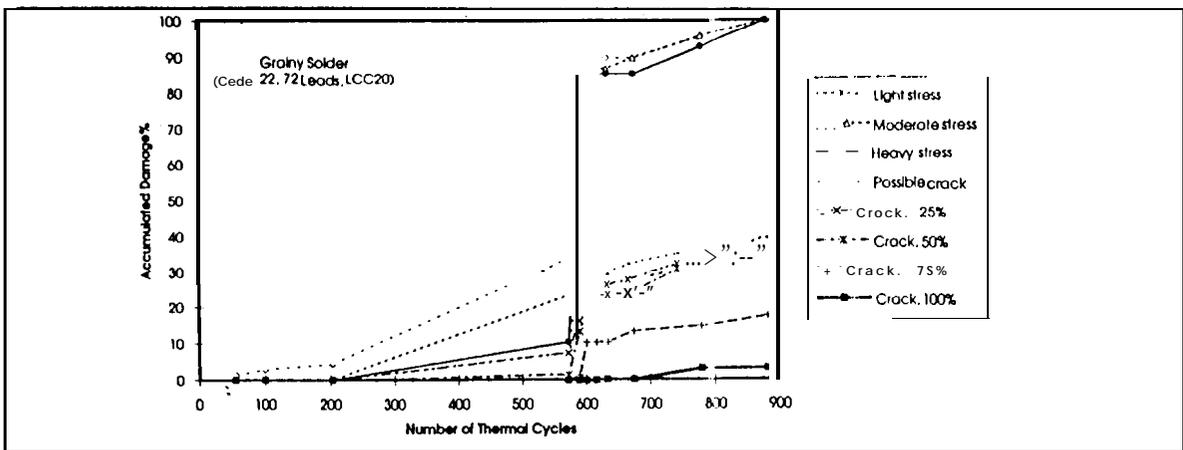
FIGURE 9. Accumulated Damage Level Percentages for 20-Pin LCCs With No Signs of Manufacturing Defects, Insufficient and Grainy Solders

For 20-pin LCC, all joints showed signs of light stress damage after only a few cycles. They started to change rapidly to the more severe damage at approximately 200 cycles. Leads with excess solder showed a damage growth trend over cycle time similar to those with no visible manufacturing damage. On the other hand, grainy and insufficient solder leads with a roughly similar crack growth trend showed much higher levels of cracking above and below 600 cycles when compared to joints with the excess solder.
