PROPULSION LESSONS LEARNED FROM THE LOSS OF MARS OBSERVER

Carl S. Guernsey*
 Jet Propulsion Laboratory
 Pasadena, CA

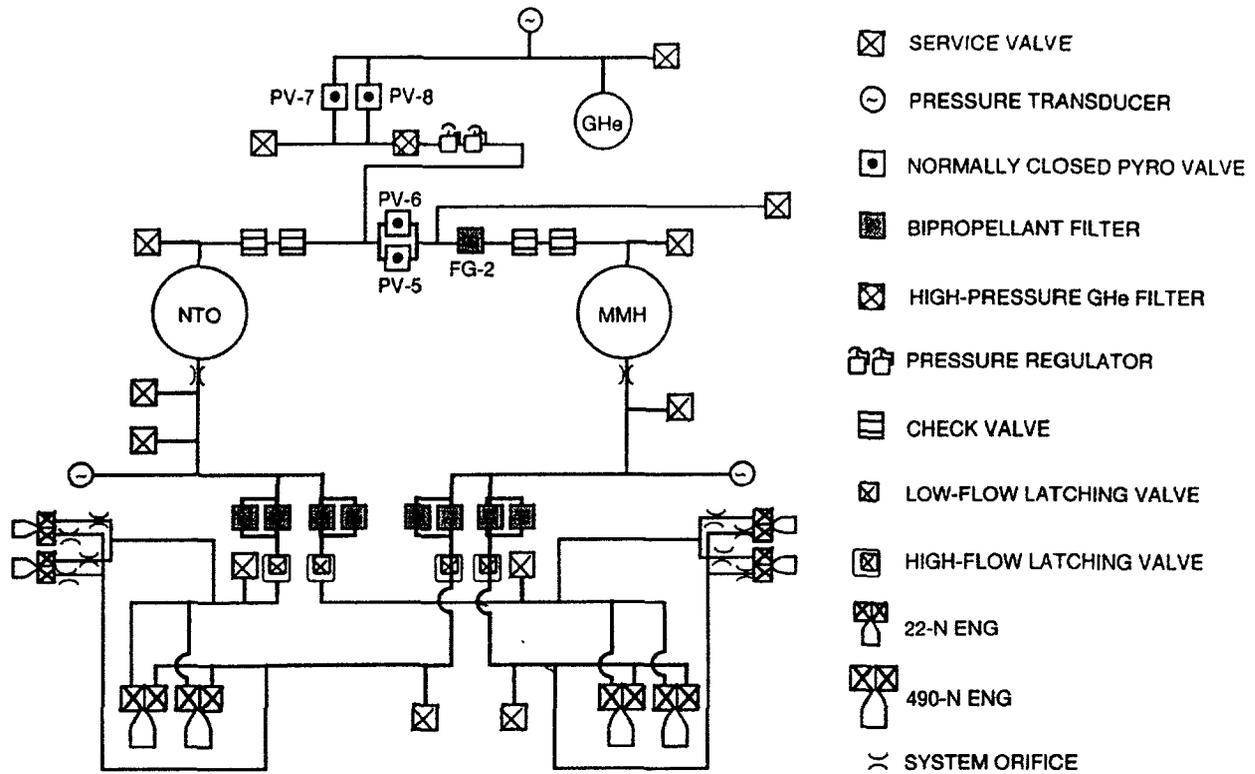
Figure 2 – Mars Observer Bipropellant Propulsion System Schematic

Under this hypothesis, oxidizer condensed in the pressurization system upstream of the oxidizer check valves. Referring to Figure 2, this would be the portion of the system bounded by PV-7 and -8, PV-5 and -6, and the oxidizer check valves. This portion of the system was subject to oxidizer permeation through the check valves from the time the propellant was loaded (approximately 6 weeks prior to launch) until the MOI pressurization event. It was further hypothesized that a portion of this condensed oxidizer was trapped in a dead-end portion of the feed system immediately upstream of pyro valves PV-7 and -8 rather than being swept into the oxidizer tank during the initial phase of the pressurization.

Finally, it was hypothesized that this oxidizer reacted with fuel prior to reaching the fuel tank, causing localized overpressures which caused rupture of the lines. Uncontrolled venting of helium and MMH would then cause the spacecraft to tumble rapidly and eventually damage the spacecraft avionics by corrosion and shorting of electrical connections.

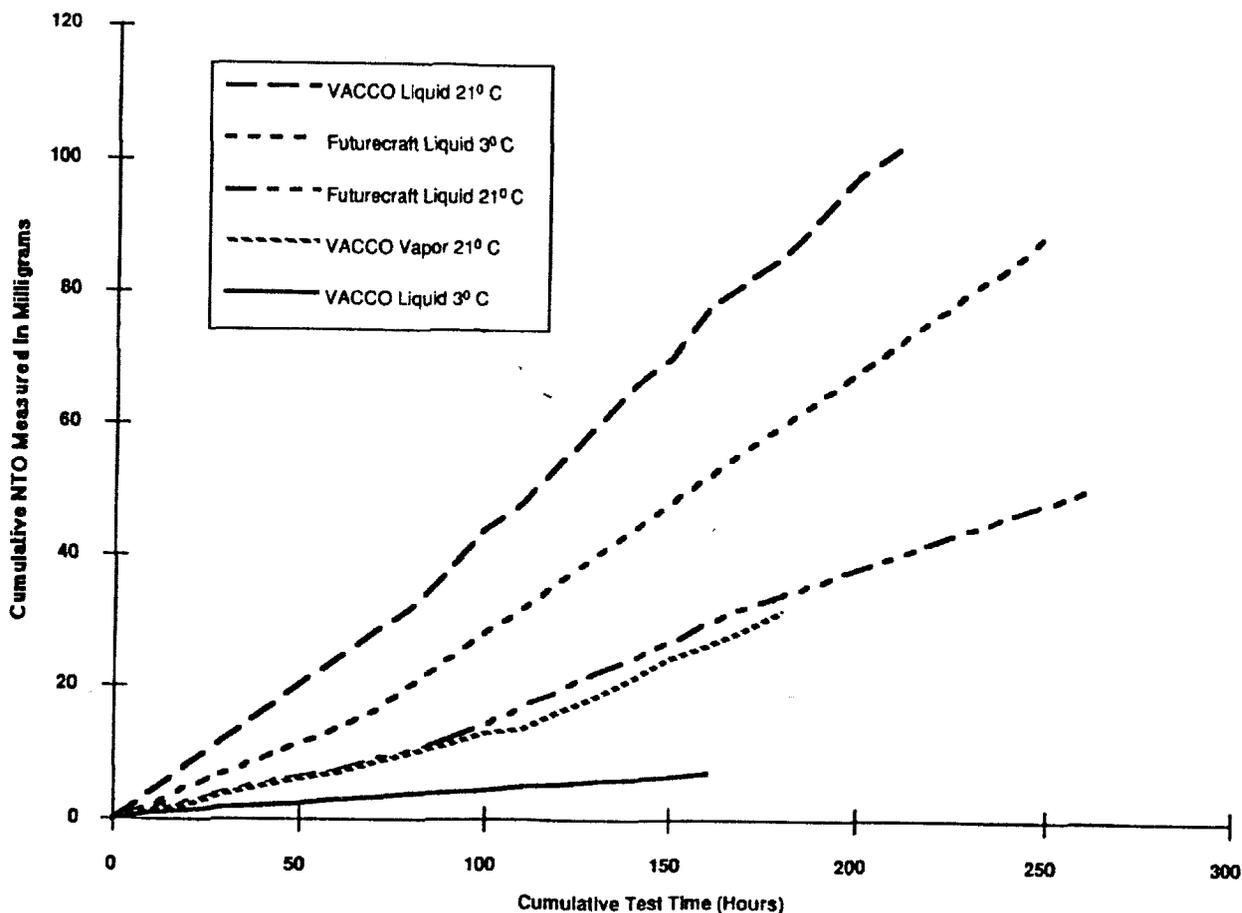
Figure 3 - Check Valve Permeation Data

downstream of the valve seal; it was felt that this was a credible worst case condition since there was no positive means to preclude wetting of the lines downstream of the check valves. A single test with NTO vapor maintained downstream of the valve seal shows a reduced transport, but only by a factor of about three. It can be seen that temperature has a significant impact on NTO transport through each valve. Transport through the Vacco unit increased

dramatically at 21°C vs., 3°C, possibly due to the higher vapor pressure of the NTO at the higher temperature. However, the Futurecraft unit exhibited the opposite behavior, possibly due to improved sealing at higher temperatures. The exact causes of this discrepancy could not be determined.

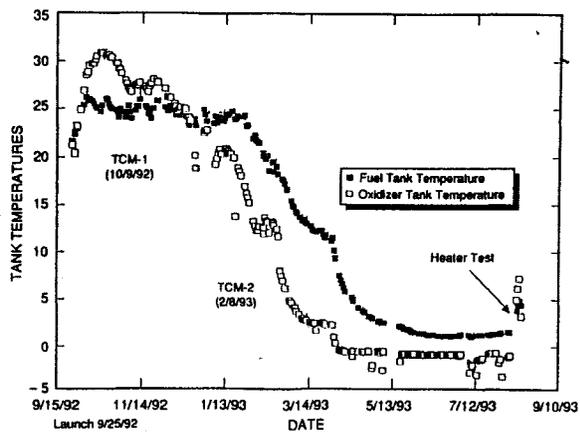
Figure 4 – MO Tank Temperatures

For condensation of liquid NTO to occur in the pressurization system, there needed to be temporal and/or spatial temperature gradients. If the entire system were at one temperature, the pressurization system might become saturated with NTO vapor, but no condensation would be expected to occur. Unfortunately, such gradients did exist; following launch, the pressurization system was consistently running (based on inferences from pre-launch thermal testing) at temperatures from -2°C to $+5^{\circ}\text{C}$, while the bulk average temperatures of the propellant tanks were significantly warmer, as shown in Figure 4. The oxidizer tank remained above 20°C for more than 4 months following launch.

oxidizer check valves. The result was that the maximum quantity of NTO that could have condensed in the feed system was less than 1 g, more probably less than 250 mg.

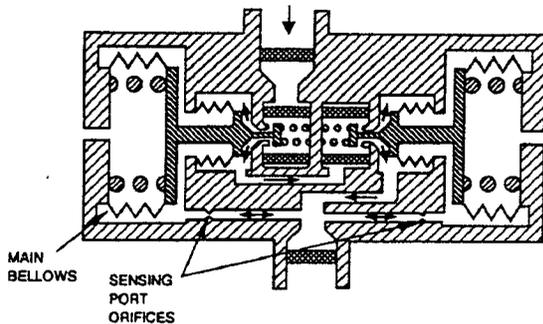
Figure 5 – Regulator Schematic

Due to the blow-down operation during TCMs 1 and 2, both stages of the pressure regulator should have been in their wide-open position at the beginning of the pressurization sequence. If the regulator stayed in that configuration, the oxidizer tank would have

reached its burst pressure about 2 minutes after PV-6 was fired. The JPL board report noted that this could be caused by contamination blocking the regulator sensing ports shown schematically in Figure 5. These sensing ports have restrictors to provide damping which have a minimum flow port diameter of less than 150 μ , making them subject to blockage by minute amounts of contamination. In some cases, blockage of the flow restrictors in similar regulators have been caused by reaction of propellant vapors with incompatible materials, such as the residue of cleaning fluids.

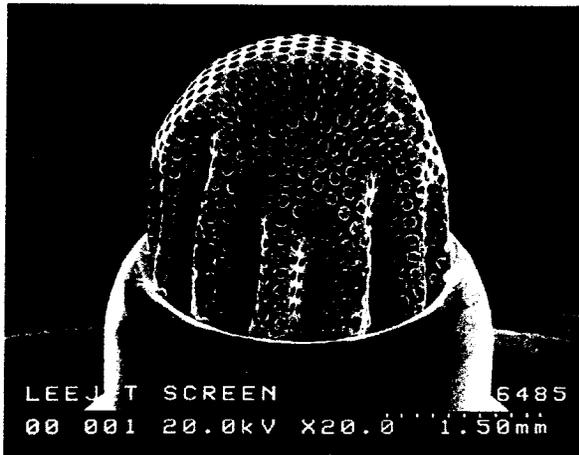
Figure 6 – Restrictor After 30-Day Exposure to NTO Vapor

Finally, a flow restrictor was placed under NTO vapor exposure. Figure 6 is a SEM image of the restrictor after 30 days of exposure. Some evidence of corrosion is evident, indicated by the whitish areas in Figure 6. Some of the 100 μ holes in the inlet screen were seen to be completely occluded by corrosion products; many were ringed by such products. However, the deposits seemed fairly tenacious. The dramatic difference between the test of the raw braze wire and the braze on the flow restrictor is not well understood, but might be caused by an alloying process occurring during the brazing process.

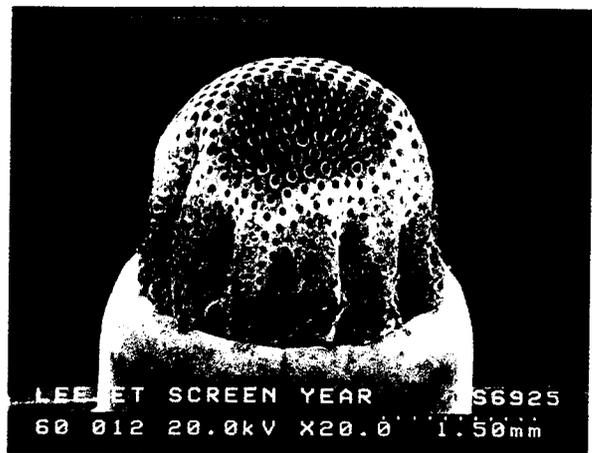
Figures 7 and 8 show the state of the braze compound after a one year exposure to NTO vapor. It can be seen that the corrosion is extensive, with fragile corrosion products literally hanging off of the inlet screen. Many of the holes in the inlet screen are occluded with corrosion product. A highly qualitative test of the tenacity of the corrosion product was made by dropping the orifice down a 50 cm tube onto a witness tape. It was observed to shed large numbers of particles.

It is important to remember that the critical flow path in the restrictor is only 1.5 times the dimension of the holes in the inlet screen. There would appear to be more than enough corrosion product to produce a nearly complete blockage of this critical orifice.

- Compatibility of pressurization system components with propellant vapors is essential for long-term missions.
- Short-term tests (days to months) may not always be adequate to show long-term compatibility.
- Vendor material lists may not always be reliable for screening of incompatible materials; long-term testing of component compatibility is preferred.

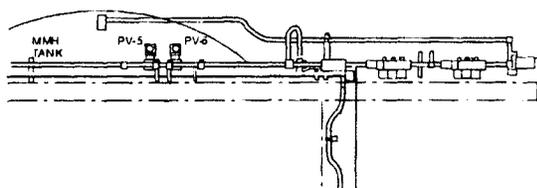
Figure 9 – PV-5 Location

Figure 9 illustrates the orientation of PV-5 with respect to the MMH tank. The view is looking directly down the axes of the redundant initiators. It can be readily seen that should the initiator facing into the plane of the figure be ejected it would have a high likelihood of striking the tank. For reasons of mass, there was no cabling attached to that NSI (since PV-6 provided the required redundancy), so there would be nothing other than a lock wire to restrain the NSI. Evidence from the other program suggested that this would be ineffective.

The root causes of the initiator expulsion on the other program were shown to be a combination of damage to the titanium threads holding the initiator in place in the valve body and use of excessive booster charge in the pyro valve, leading to low structural margins for retention of the initiator. The thread damage was caused by combustion of the threads when exposed to the combustion products from the initiators and booster charge. The failures occurred when firing of one initiator caused sympathetic ignition of the other, causing the electrically fired initiator to be expelled.

These points argue against the likelihood of this scenario for MO, which used “true” NSIs and in which the electrically fired NSI faced away from the tank. However, examination of the valves used for MO lot acceptance testing showed serious combustion damage on the titanium threads holding the NSIs in place on each valve. Although no NSIs were ejected in this ten-valve test this damage, along with extremely low structural margins based on analysis, suggest that this is a credible, if low-probability, failure mode for MO.

- Incipient failures, such as partial combustion of threads in pyro devices, should be carefully evaluated even if they have not lead to failure of the device. They should be eliminated unless their extent can be positively bounded and robust margins can be demonstrated for the degraded hardware.
- Titanium makes an excellent fuel for pyro devices; its use for structural roles in such devices should be carefully considered or avoided.
- Care should be taken with lot-to-lot variations of initiators; “equivalent” initiators may not be so equivalent in actual use.
