Mars Exploration Rover

The Spirit Anomaly Story

Glenn E. Reeves
Flight Software Architect
Mars Exploration Rover Project
Jet Propulsion Laboratory
California Institute of Technology

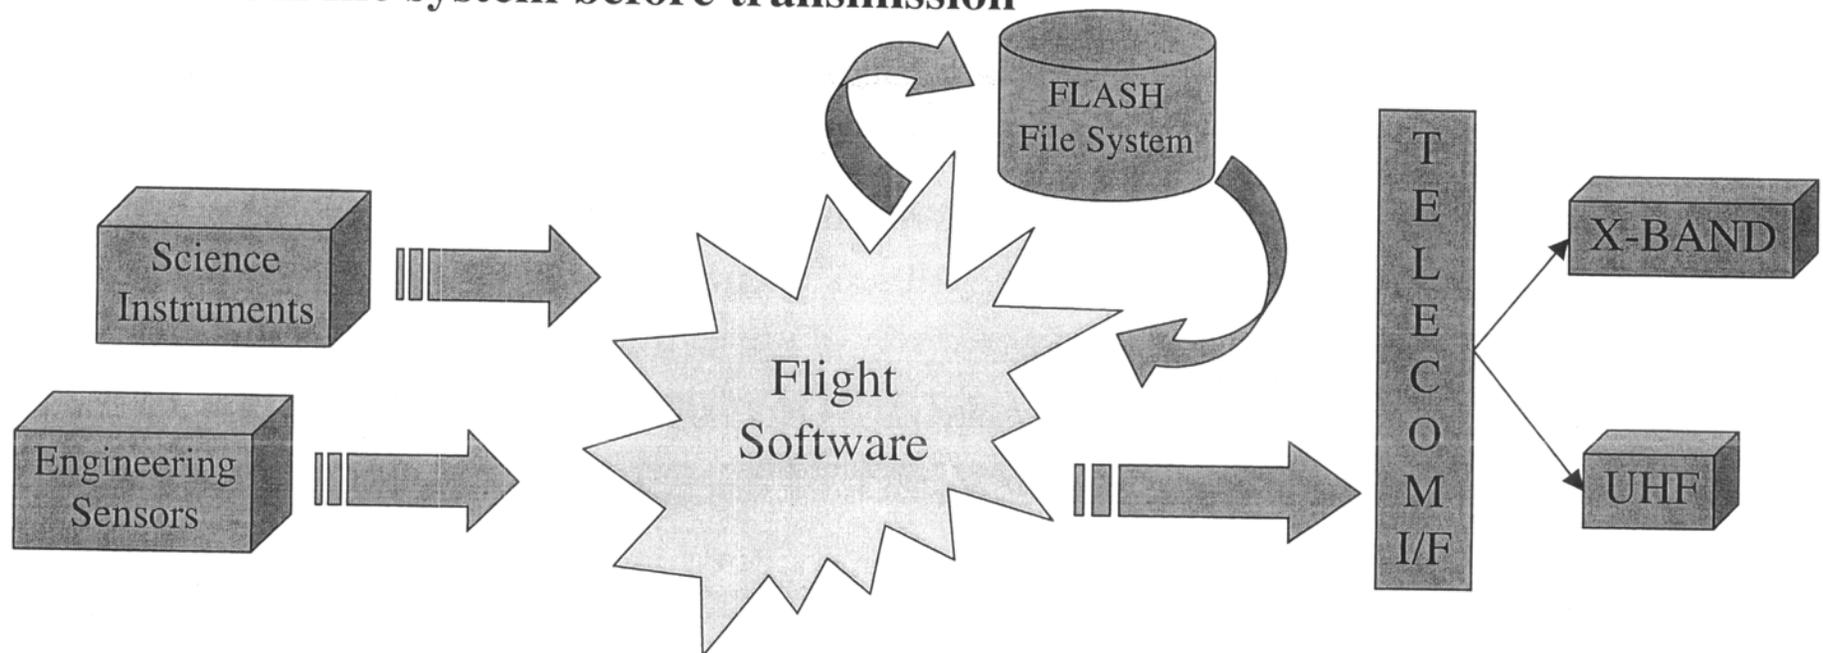
- **Multiple file systems are used on board**
 - RAM, EEPROM, and FLASH memory based
- **DOS File system structure**
- **The FLASH file system is used as the non-volatile repository for all data products (files)**

220 MBytes

- **All science data and much of the engineering data is stored in the FLASH file system before transmission**

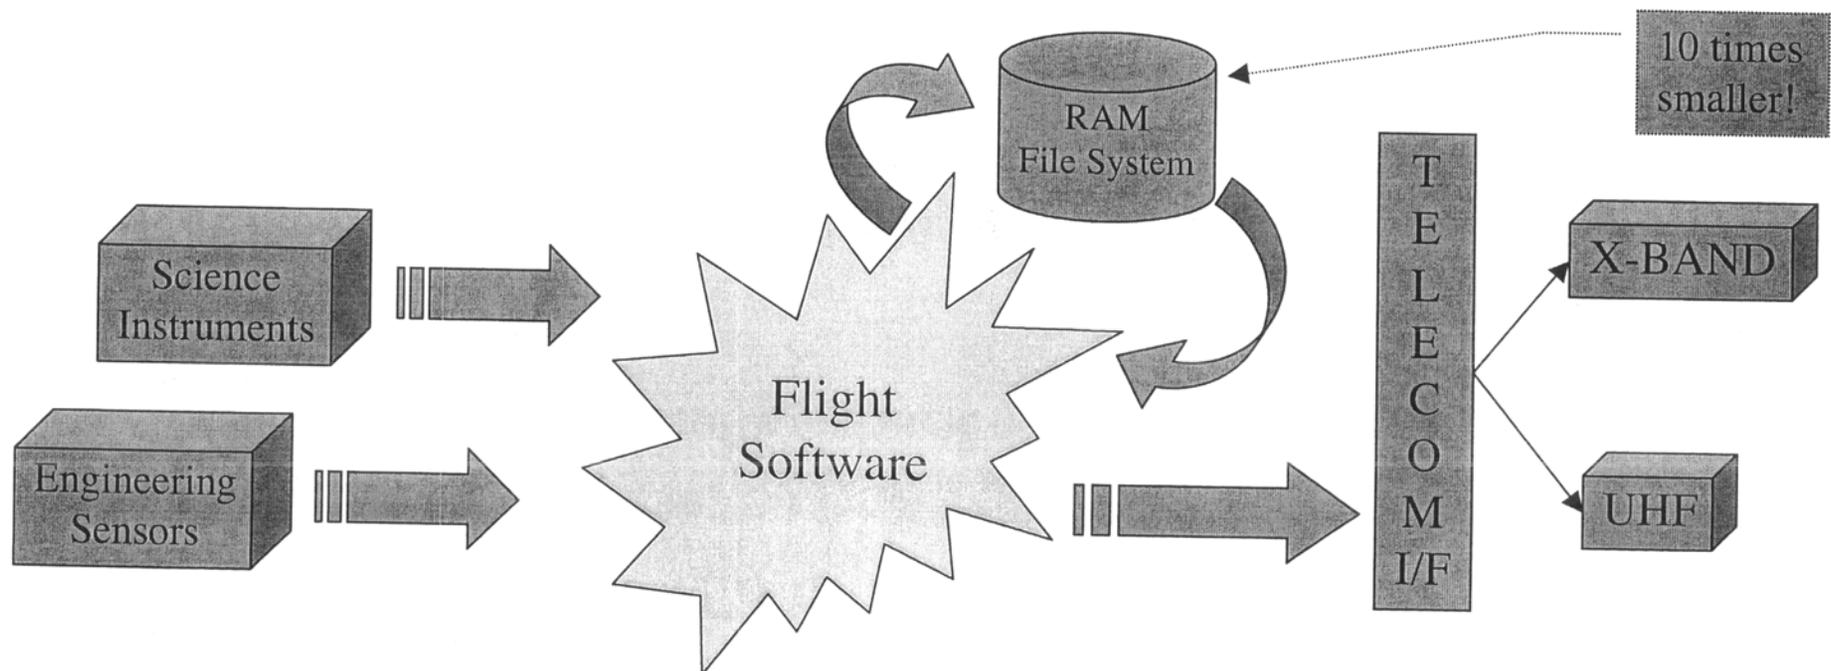
- Forces the flight software to create and use a file system in RAM memory
- This volatile file system is used instead of the FLASH file system
 - The switch is transparent to the rest of the flight software
- System is usable and could have done a limited, degraded, mission
- Loss of non-volatile storage would have severely reduced mission return
 - The RAM based file system is 10 times smaller than the FLASH file system.

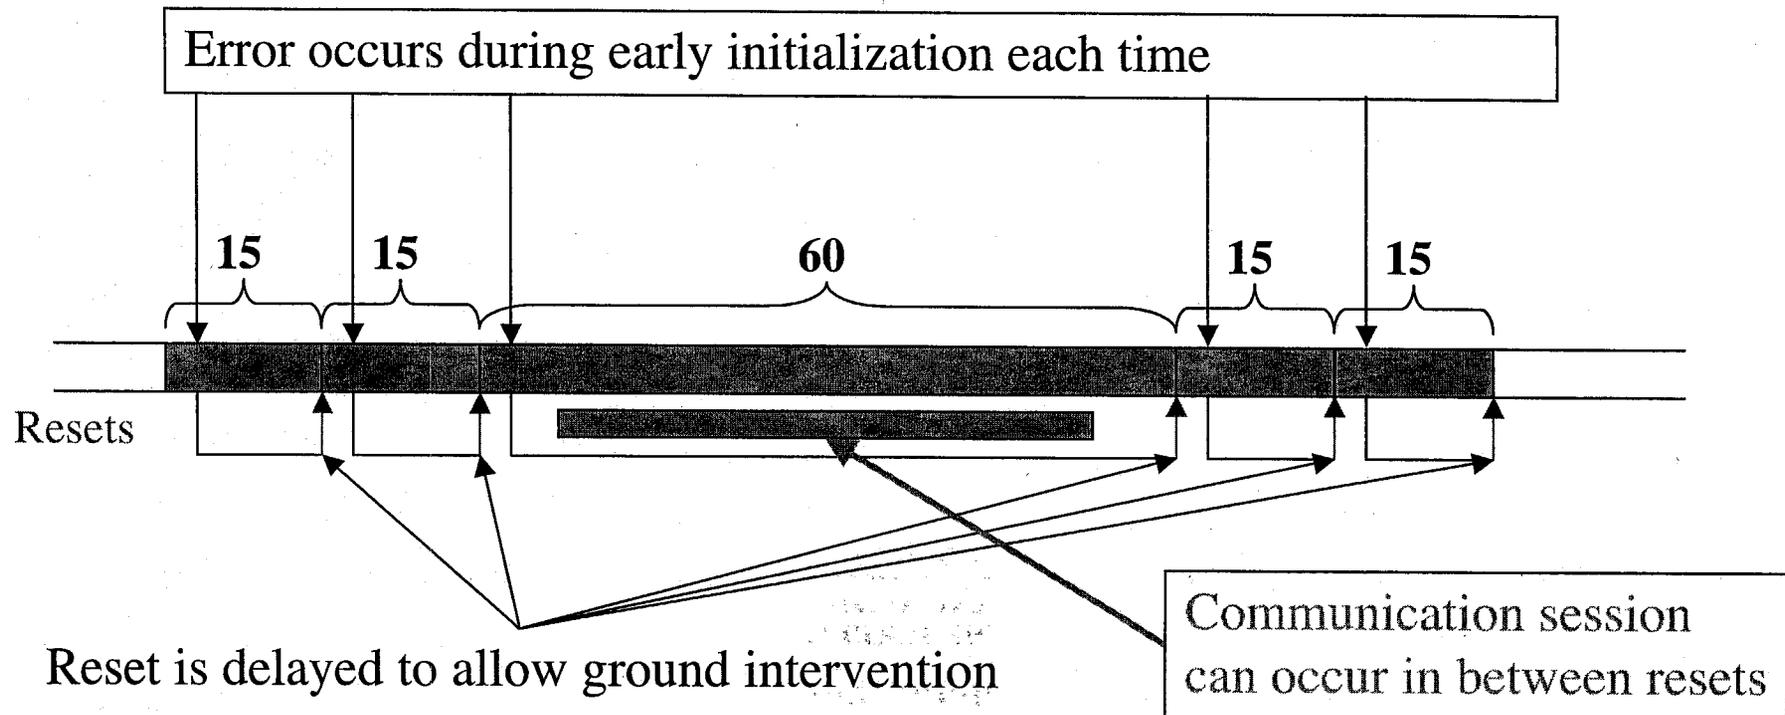
- Normally, if the flight software detects a severe error a reset is invoked
- However, if a severe error is detected during the software initialization period then the reset of the flight computer is delayed for a short period
 - On the surface the delay cycle is 15 minutes, 15 minutes, 60 minutes, and then it repeats
- This delay allows ground controllers a chance to command the vehicle even with a failure that causes repetitive resets
