Anomaly Recovery and the Mars Exploration Rovers

J. Matijevic¹ and E. Dewell.²

Jet Propulsion Laboratory, California Institute of Technology, Pasadena, California, 91109

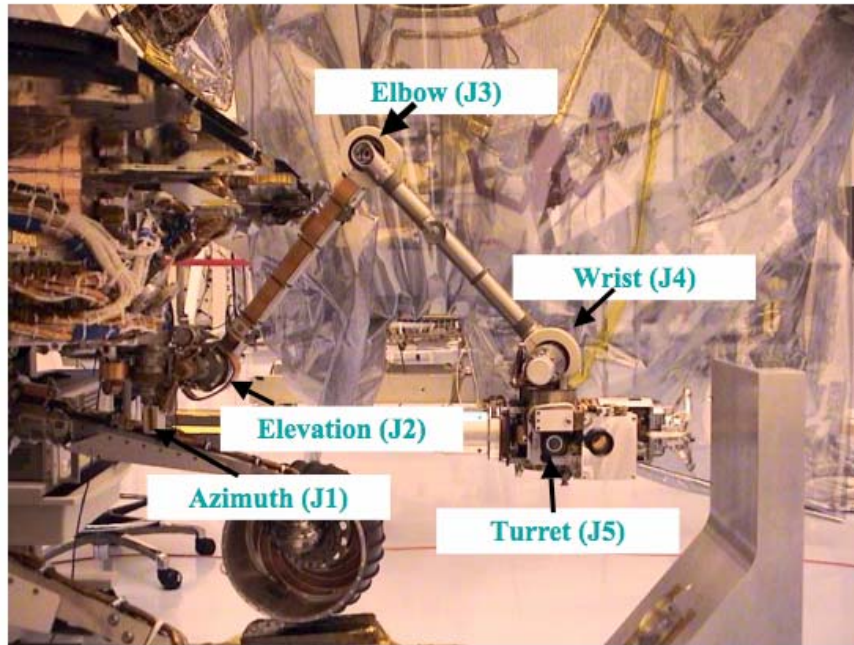
On Opportunity on sol 654, the instrument deployment device (IDD) was commanded to unstow from its location below the WEB shelf. The first motions of the IDD involve the movement of the elevation and elbow actuators that uncouple a hook on the elbow assembly from a support roller. After this operation is completed, the shoulder azimuth actuator moves the hook away from the roller in preparation for a subsequent movement of the elevation and elbow actuators to move the IDD away from all support structure below the WEB shelf. The shoulder azimuth actuator did not move in this sequence causing the unstow operation to fail.

A past characterization test conducted with the type of motor used in the implementation of the shoulder azimuth actuator revealed a failure mode in which the motor resistance had doubled due to an open wire in one of the windings. There are two windings in this brushed motor. A second open wire would cause the motor to fail. The likely cause of degradation in the motor winding is thermal cycling. This actuator is on the 'stuck-on' heating circuit and the temperature transient is nearly twice the scale of that of all but one other actuator on the IDD and elsewhere on the vehicle as a whole. The other actuator is the elevation actuator of the IDD that shares the problem of the 'stuck-on' heating circuit.

Figure 2. Instrument Deployment Device (IDD)

An anomaly team was formed to consider tests that could be conducted to both move the shoulder azimuth actuator and collect data during that motion. Changes in control parameters that define the movement profile of that actuator were proposed and planned for execution on sol 659. There was little motion on that attempt. Changes to these same control parameters, effectively allowing for more current to be supplied for longer periods during the motion, were attempted on sol 660 and sol 661. There was little motion on either attempt but what motion was seen suggested that the motor resistance had increased significantly from the nominal value calculated during prior (and successful) unstow operations. A motion with a control parameter of a higher resistance was planned for execution on sol 666. This motion succeeded and the detailed data verified that the motor resistance had doubled. With the increased resistance value as a control parameter, the IDD was unstowed successfully on sol 671. Subsequently, a science investigation using the IDD and planned at the location of Opportunity on sol 654 was carried out. The motion of the IDD and, in particular, the performance of the shoulder azimuth actuator was somewhat restricted and a little unpredictable. However, the experience in operation at this site gave the operations team a performance characterization that was used at other sites in the vicinity. This experience also provided the foundation for the operation of the IDD from this point forward in the mission.

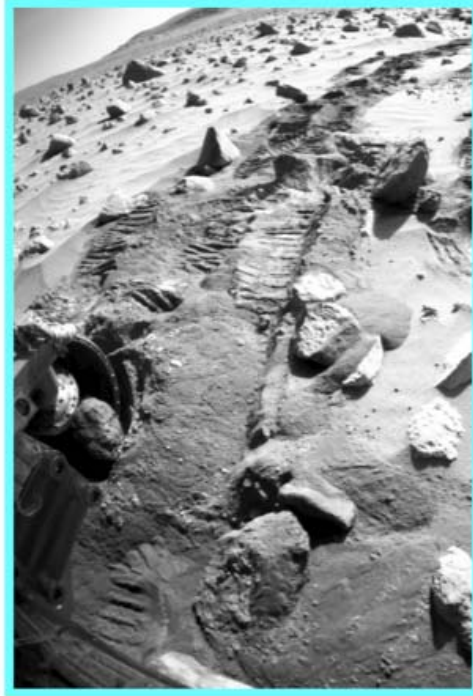
On sol 339, Spirit's rover drive planners had planned a drive up Husband Hill in route to an area deemed scientifically interesting and an ideal place to take panoramas of the hill traversed thus far. The progress had been slow, with the rover encountering high slip and surrounded by a rocky hillside. At the first turn command in the drive sequence, the rover was commanded to turn in place 15 degrees in 17.5 seconds. In the last 2 seconds of the turn, the right rear wheel current spiked to 1.8 amps (nominally the wheel actuator draws about 0.35 amps) and the drive motor actuator stalled. A rock was lodged between the inner ring of the wheel and the actuators as could be seen in the imagery transmitted on the sol 339 afternoon UHF pass. On the following sol, the operations team dislodged the 'potato' rock (so called due to its size and shape) by spinning the right rear wheel in the opposite direction of the sol 339 drive. The rock was dislodged from the actuator, but remained inside the wheel. The next challenge was to get the rock out of the wheel, and the operations team decided to try dragging the wheel in an arc. On sol 343, the right rear wheel was straightened, and then the drive and steering actuators were disabled (a temporary conditional setting in flight software). Two small 0.3 meter arcing drives were attempted using the remaining 5 wheels. However, the rock remained in the wheel. On sol 344, the rover was commanded to back down the hill (all actuators enabled this time), but the rock remained in the wheel. On sol 345, the rover was commanded to turn in place, to drive back down the hill, and to perform a final turn in place. The sequence of motions completed successfully, but the 'potato' rock was still in the wheel. Finally, on sol 346, two drives and one more turn in place were commanded. On the afternoon UHF pass, images confirmed that the 'potato' rock was out of the wheel. Nominal operations resumed for the weekend plan on sols 348-350.

During development of the rover mobility system, the design considered the potential of small rocks kicked up by vehicle motion into portions of the drive mechanism. Rock jamming in the mobility mechanisms had occurred on prior rover systems with the result that in the implemented MER system there was additional external clearances around the wheels and the drive actuator mechanisms were located within the wheel well. The wheel wells were not 'closed out' with structure due to weight considerations for the vehicle as a whole. Despite these provisions, the geometry of the vehicle and the loose rocks and regolith of the terrain on Husband Hill made this rock jamming possible.

Figure 3. 'Potato' Rock Stuck in Left Rear Wheel

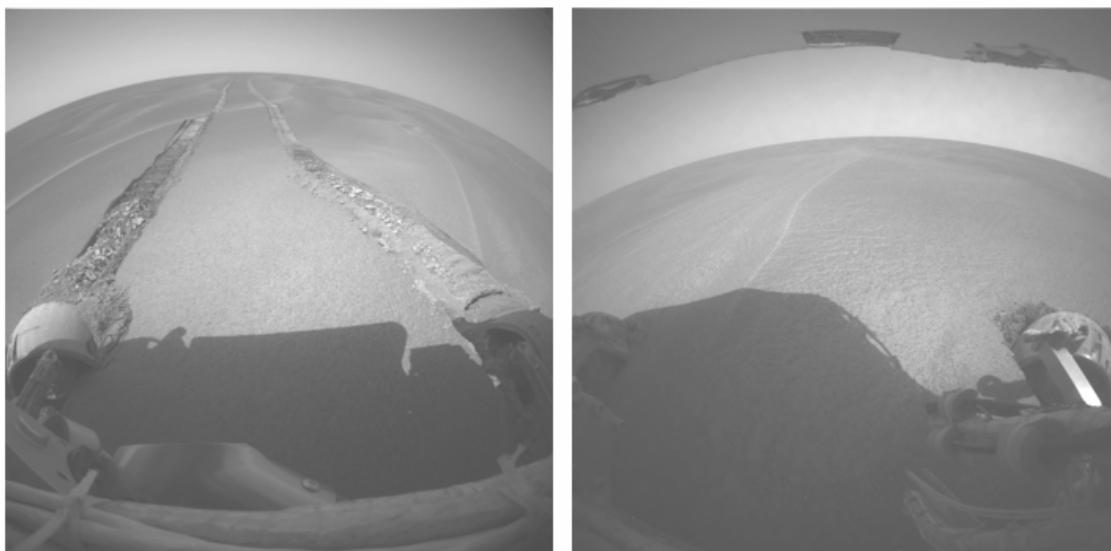
On sol 446 Opportunity drove into a dune. The drive was planned for 90m with almost all of the drive executed with the vehicle driving backwards (bogie first). This drive was the 36th segment of a drive across the Meridiani plain that had already covered over 3km in distance south from the vicinity of the landing site. As were many of the prior drives, the drive on sol 446 was conducted 'blind' with few safety checks employed during execution. The environment had enabled this type of driving since a generally flat, featureless terrain was presented to the operations team on each of the past drives, including the terrain imaged on sol 439 and used in planning for the sol 446 drive. Also ripples in the regolith and small dune features seen in previous terrain images had posed no hazard for the mobility system for Opportunity. The ripples and small dunes were unremarkable in the images of the terrain used for planning the sol 446 drive and these features were not considered any hazard for the vehicle. About 40m of the drive on sol 446 had completed when the embedding in the dune began. The vehicle was slipping and embedding itself in the dune while completing the final 50m of the drive. A final turn at the end of the planned drive to achieve the best position for return of data in a communication session was not completed and only at that time was a fault declared by the flight software. The material transition was over 2 meters and the rover climbed upon a dune over 30cm in height. The final images returned on the UHF pass on sol 446, showed the wheels about 70 percent buried.

Upon review of the data from this drive, the operations team was mainly concerned that the last segments of the drive and the turn had resulted in little change in the rover position. Also, on inspection, the wheel cleats were 'caked' with regolith. During development of the MER mobility system, tests showed that the cleats played a significant role in the engagement of terrain, modifying the ground and creating mechanical 'purchase' that allowed

Figure 4. Front and Rear views of Opportunity embedded in a dune

With these tests completed, the operations team began to drive Opportunity out of the dune. Driving the vehicle out of the dune would initially be in short movements, designed to determine if there was any chance that vehicle motion would cause further embedding into the dune. The first moves (a wheel straightening and a few meters of driving) began on sol 461 and sol 463. Subsequent drives through sol 468 resulted in less than 10cm of forward motion per each drive of about 8m or roughly 99% slip. After sol 469, 8m then 12m then 20m of motion was commanded until the vehicle was extract from the dune. In total, 2m of forward travel required almost 200m of commanded motion with the last meter of travel occurring on the final sol.

In this period, the operations team developed then tested strategies that provide protection from embedding events on future drives. These strategies included: measured current draw versus forward motion, use of visual odometry to determine slip in forward motion (applied on any drive greater than 5m), incremental turns to avoid large displacements of regolith by the wheels, analysis of terrain to predict successful traverse and drive length reduced to 30m or less (i.e., driving within the imaging range of the vehicle). The dune of this embedding was 35cm tall: the largest dune formation seen in the terrain prior to sol 446. Imagery from this location and thereafter showed that dunes of this size were increasingly common as the vehicle moved south. Reconnaissance imaging would be a part of any drive planning from this point forward.
