SDRAM SEFI on the Juno and MSL Projects

Steven M. Guertin, Farokh Irom, Greg Allen,
and Douglas Sheldon

Jet Propulsion Laboratory / California Institute of Technology
Pasadena, CA

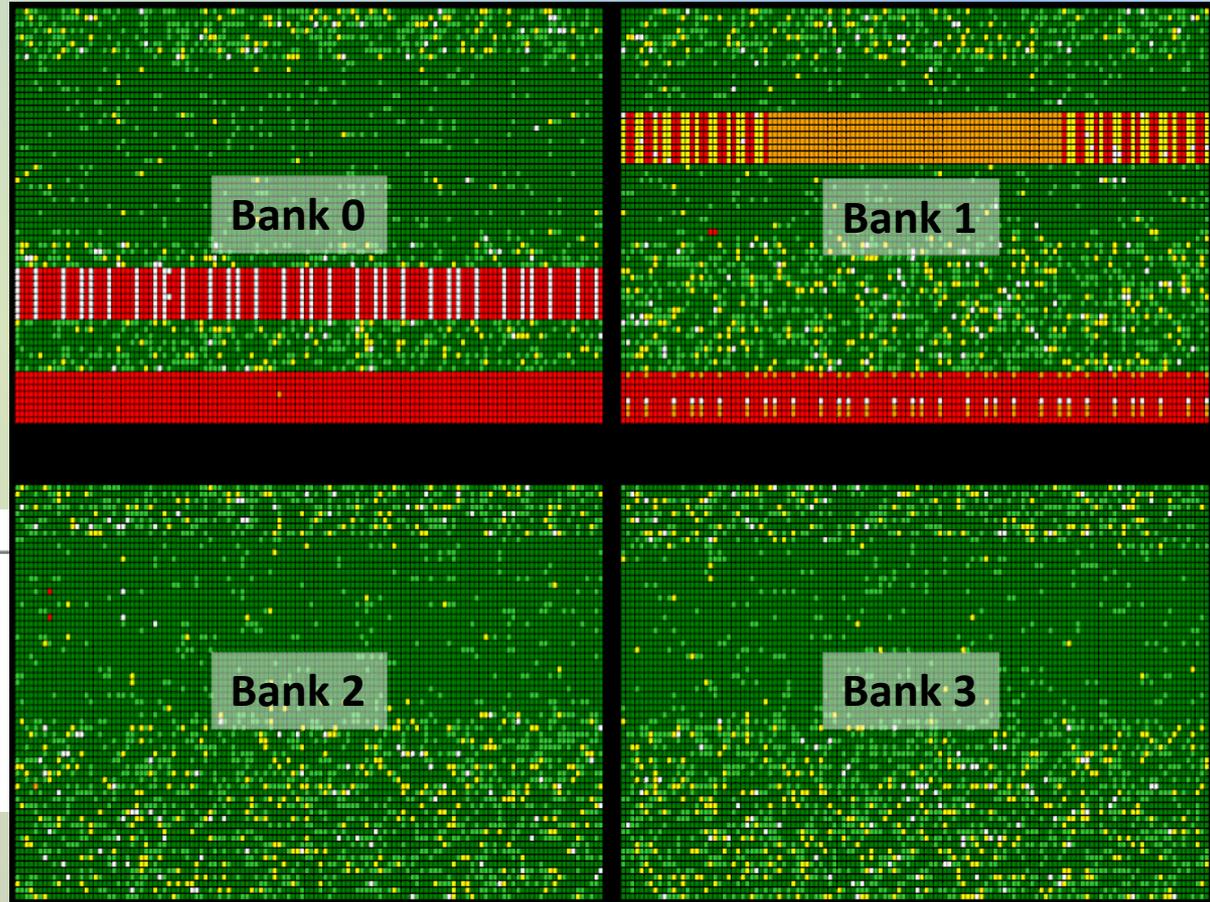
- Test data is collected with an eye towards logical mapping of errors.
- The various types of SEFIs and potential MBUs have different implications for EDAC systems.

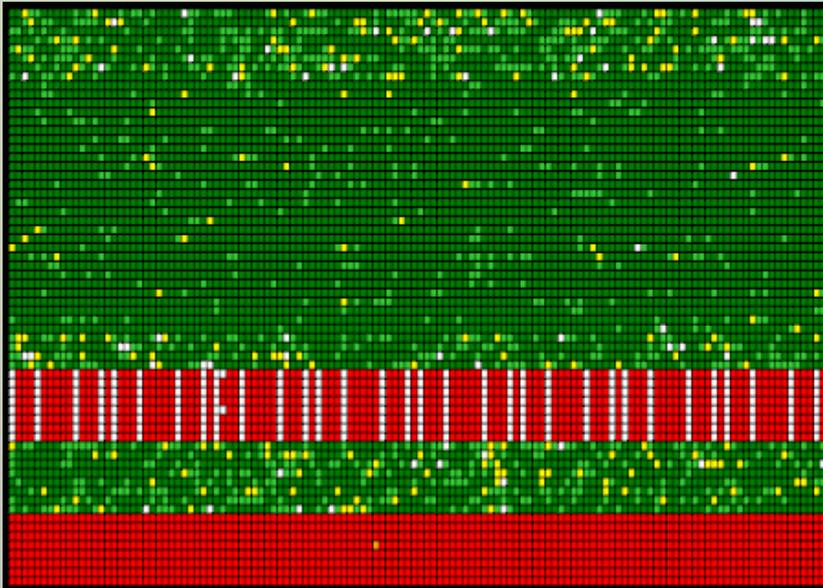
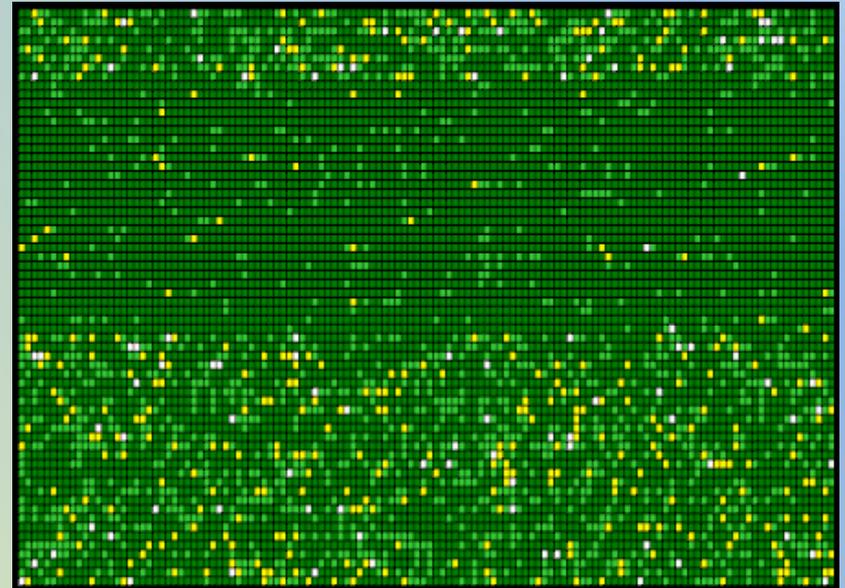
- Band SEFIs on the left are cleared by reloading the mode register in the EDS5108, producing the error map on the right.
- Approximately 90% of SEFIs are affected this way
- Only issue is whether or not the affected memory is accessed between the SEFI and the mode register reload operation...

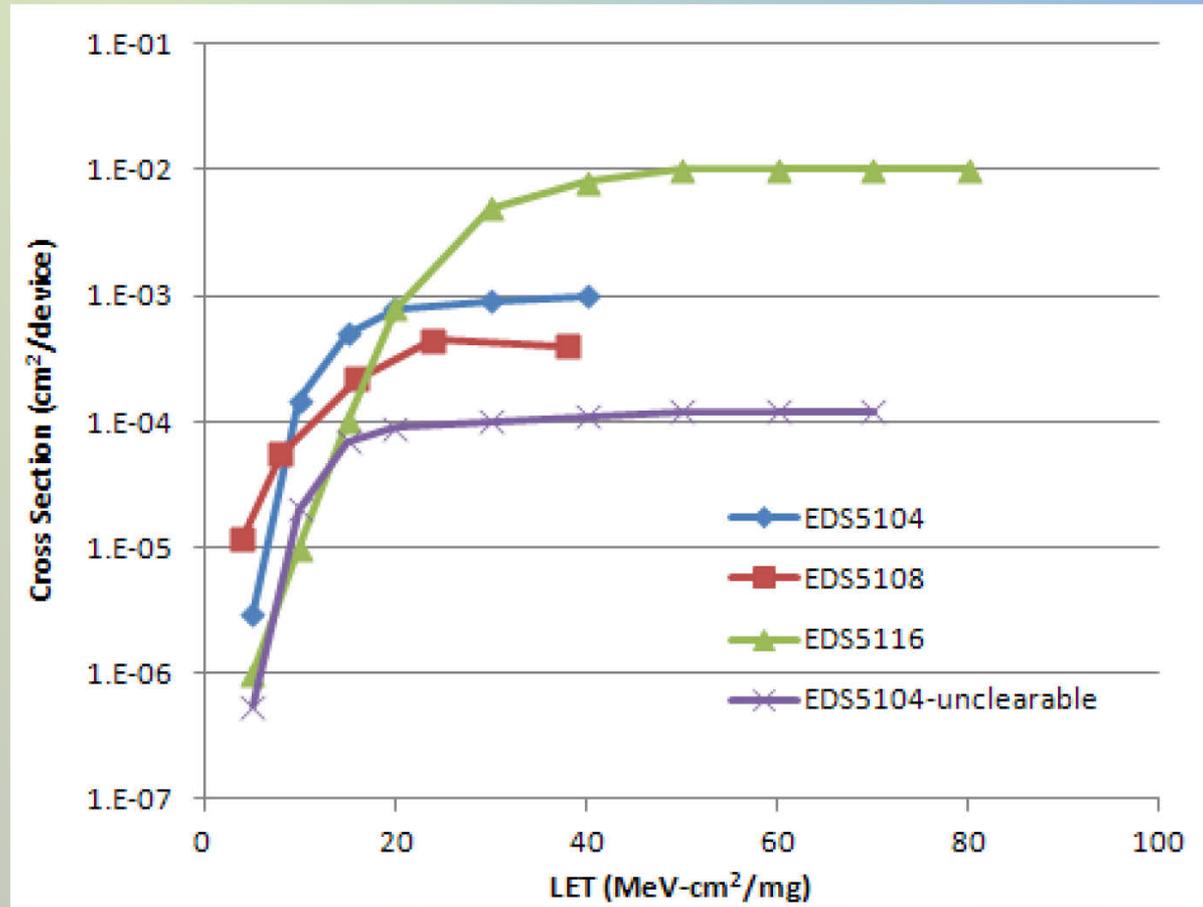
- EDS5104 and 5108 results were very similar.
- The lower curve (purple) shows that about 90% of SEFIs are effectively handled by reloading the mode register (but 10% still remain).
- EDS5116 results are impacted by testing a subset of the device and extrapolating.
