Update to Method 2017, Internal visual (hybrid)

Presented by John Puckett

Identification of anomalies for MIL-STD-883 TM2017 (internal Visual)

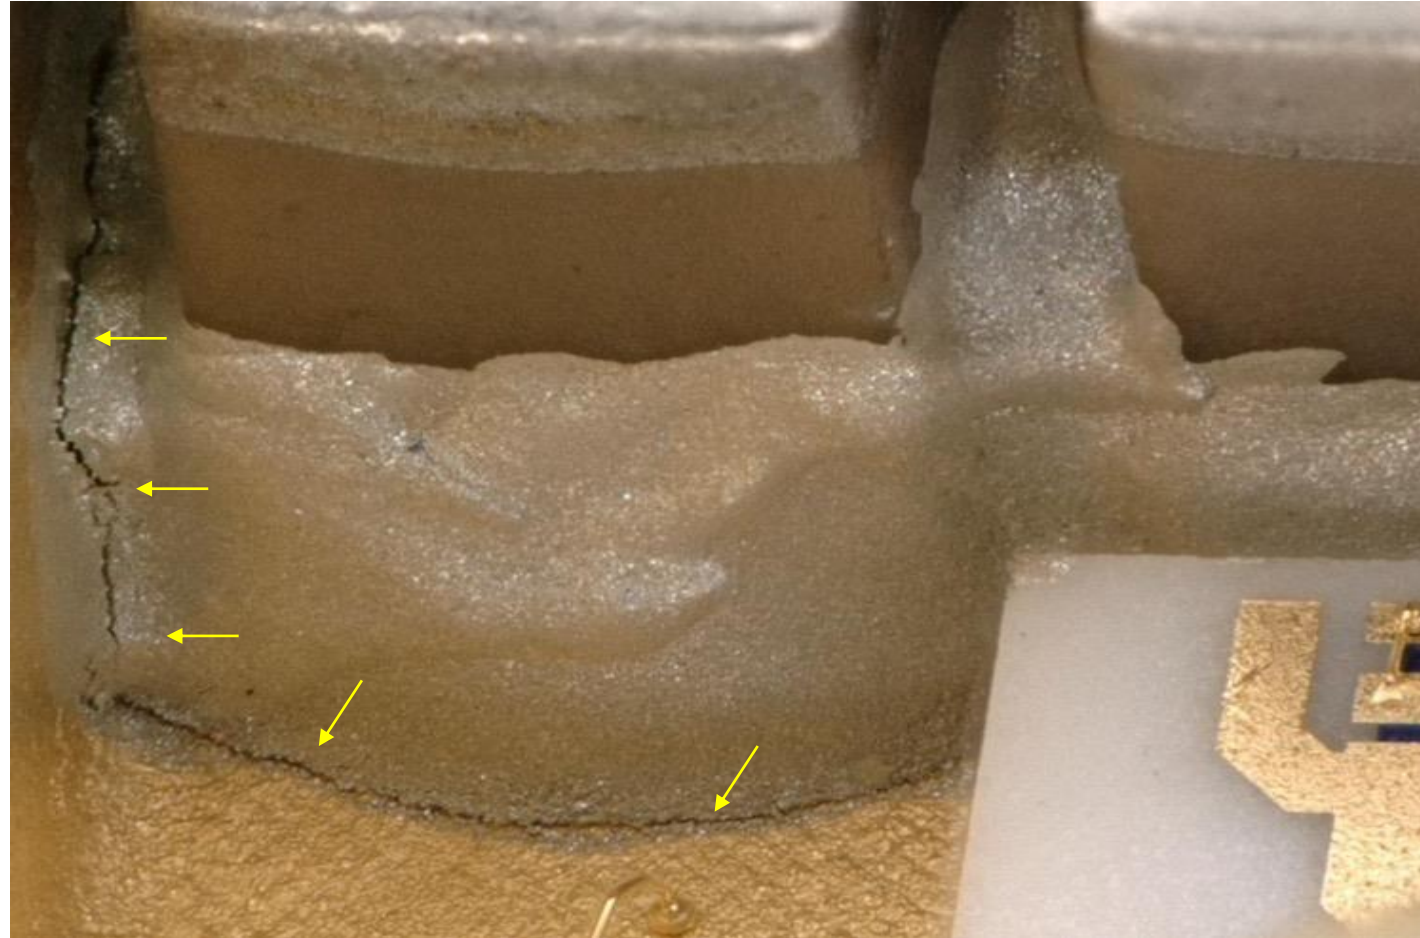
These defects look to be pull-back which are technically not a cause for rejection, but the excessive length (total width of the epoxy) makes this very concerning.

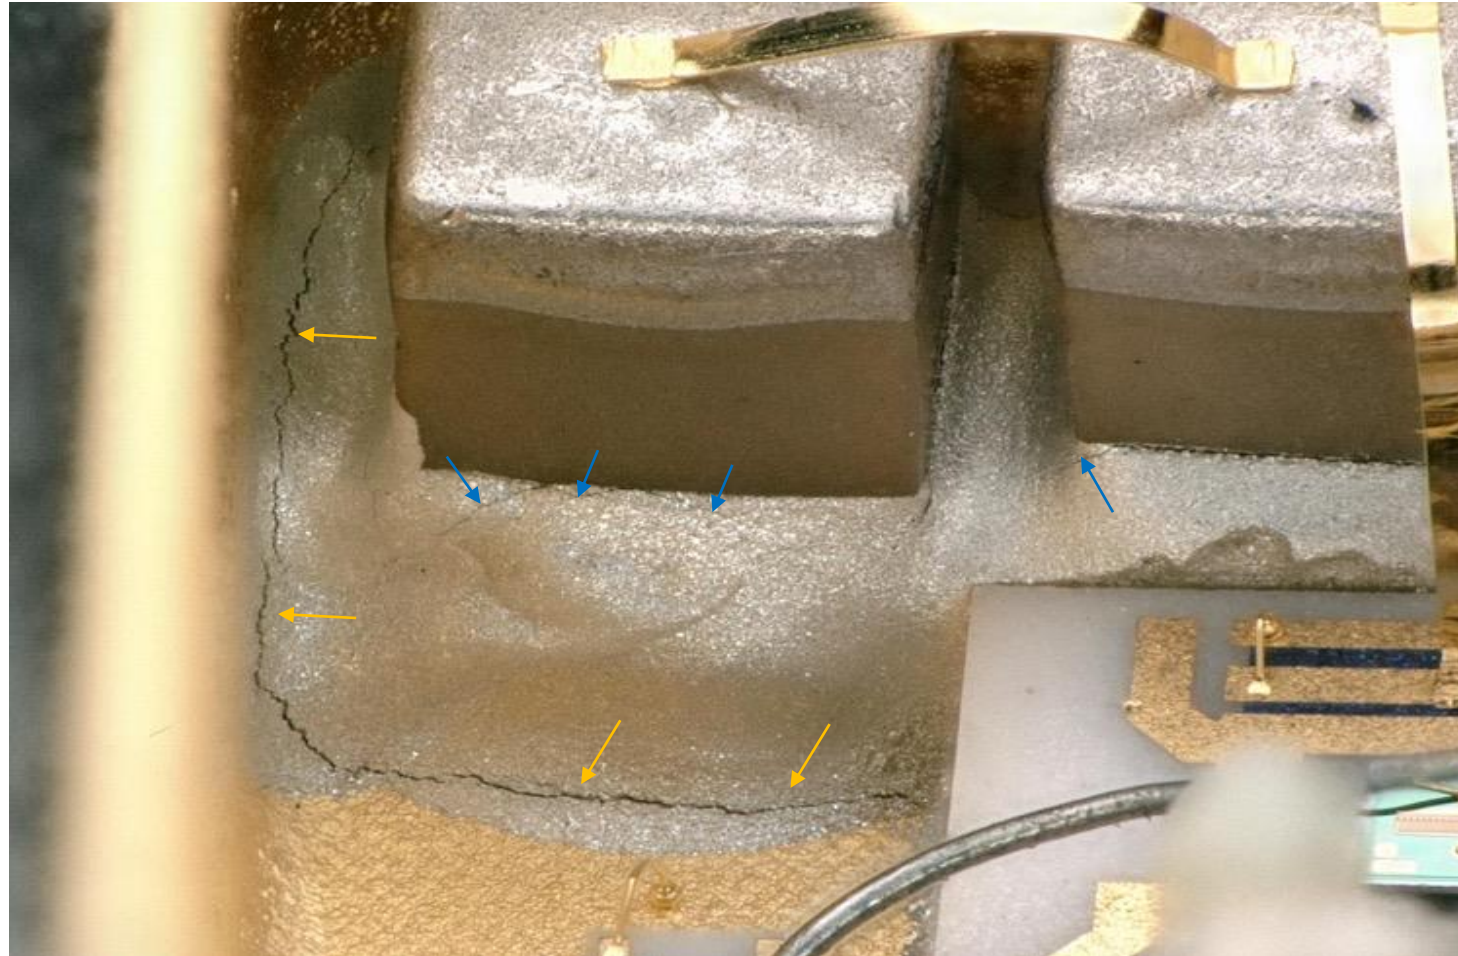
Orange arrows are Cracks. There is epoxy on both sides of the crack, meaning that it is not pulling back from another material (e.g. substrate or element). Each individual crack changes in width, meaning that it meets the TM2017 definition of a crack. **Blue** arrows are fissures and not considered rejectable.

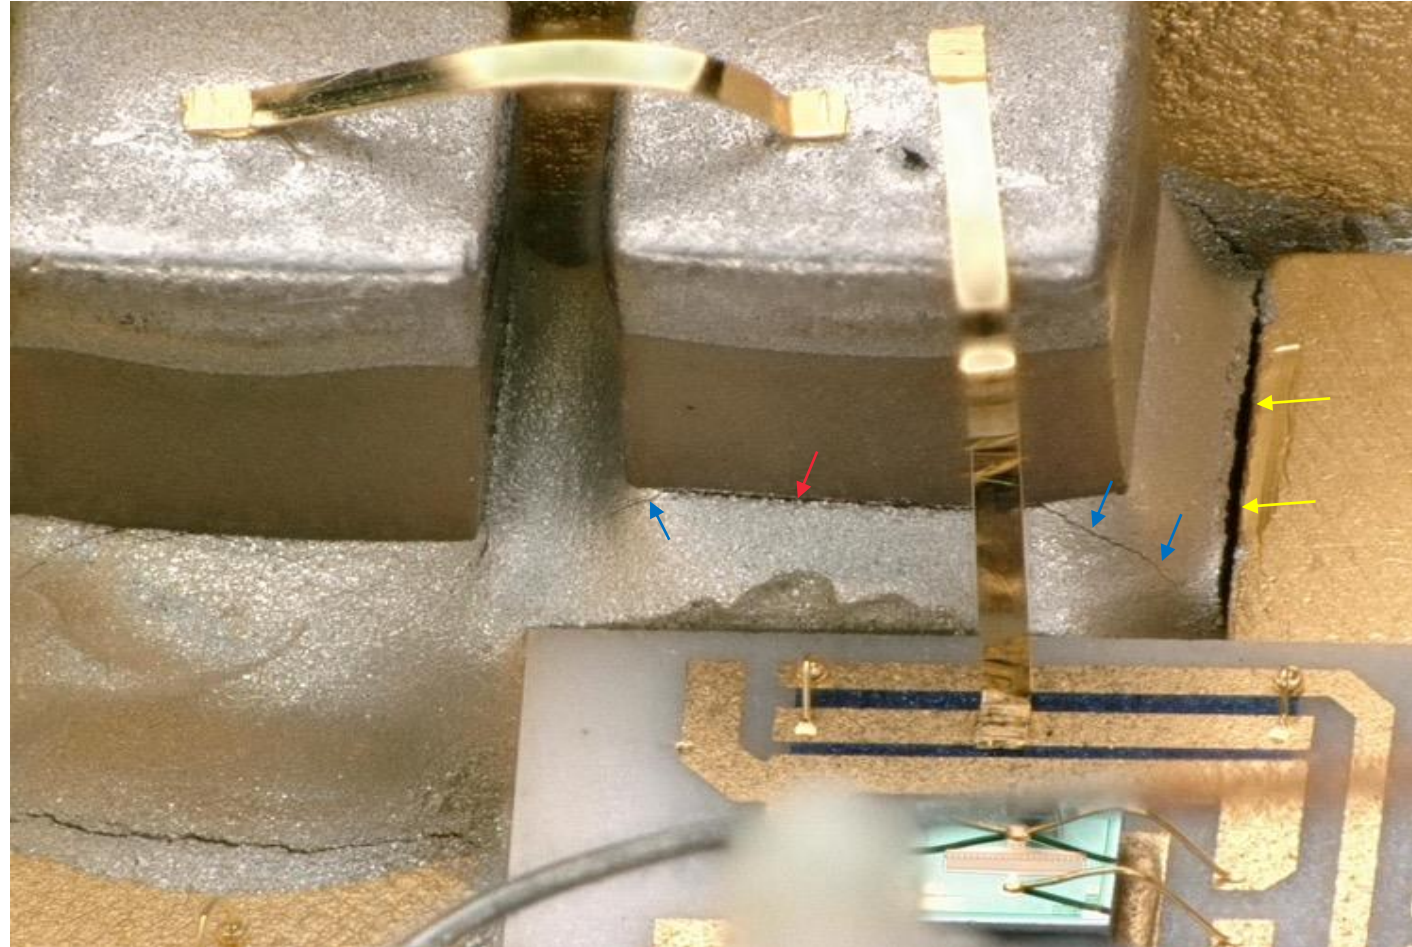
Blue arrows are fissures and not considered rejectable. The Yellow arrows show a large pull-back area. Perhaps additional DLA guidance should be added to the criteria text to properly categorize anomalies of this type.
