CloudSat Spacecraft Status

30 May 2018

CloudSat Project Manager

Jet Propulsion Laboratory, California Institute of Technology

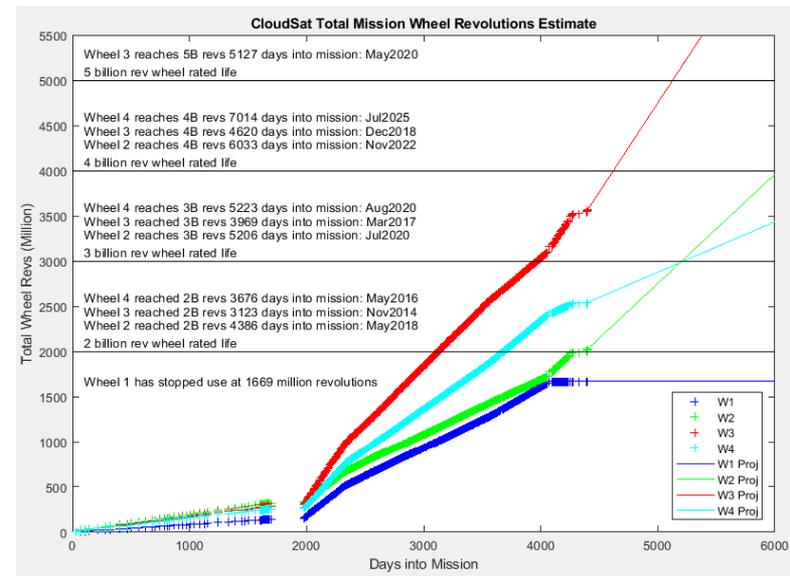
- Wheel 1 failure root-cause not clearly understood.
- Wheel 4 power relay failure not understood.
 - Wheel #4 relay is now always on.
- Wheel Life
 - Flight experience shows that 3 in the family of these wheels has lasted for 6 B revs or more.

- ❖ **Wheel-1** failed on June 2, 2017 after 1.7B revs
- ❖ **Wheel-3** will reach 4B revs in May 2020

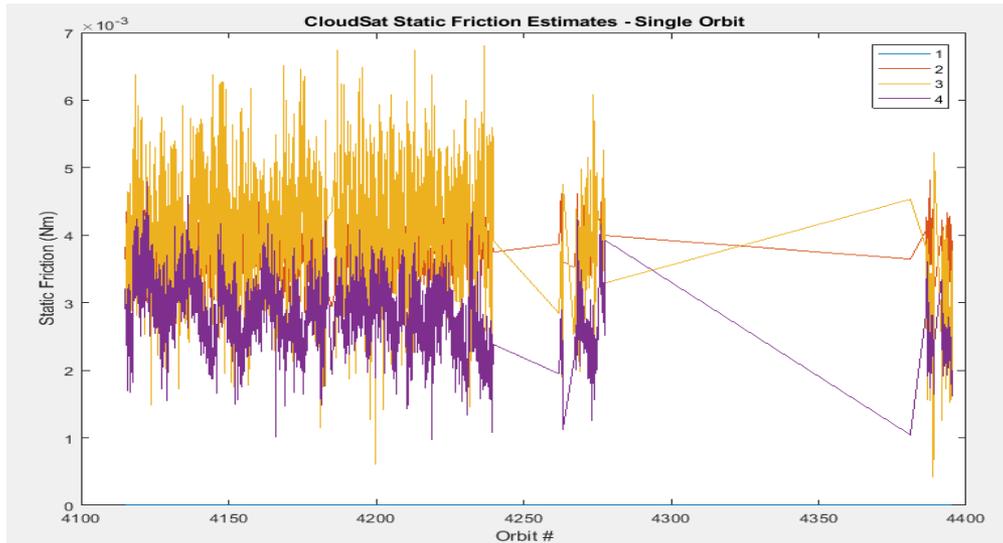
Flight Telemetry Indicates Nominal Wheel Performance

- Wheel speed and commanded torque data indicates that the wheels' friction terms have remained in family
- No friction anomalies observed on remaining wheels 2,3,4
