Update to Method 2017, Internal visual (hybrid)

Presented by John Puckett

Jet Propulsion Laboratory
California Institute of Technology

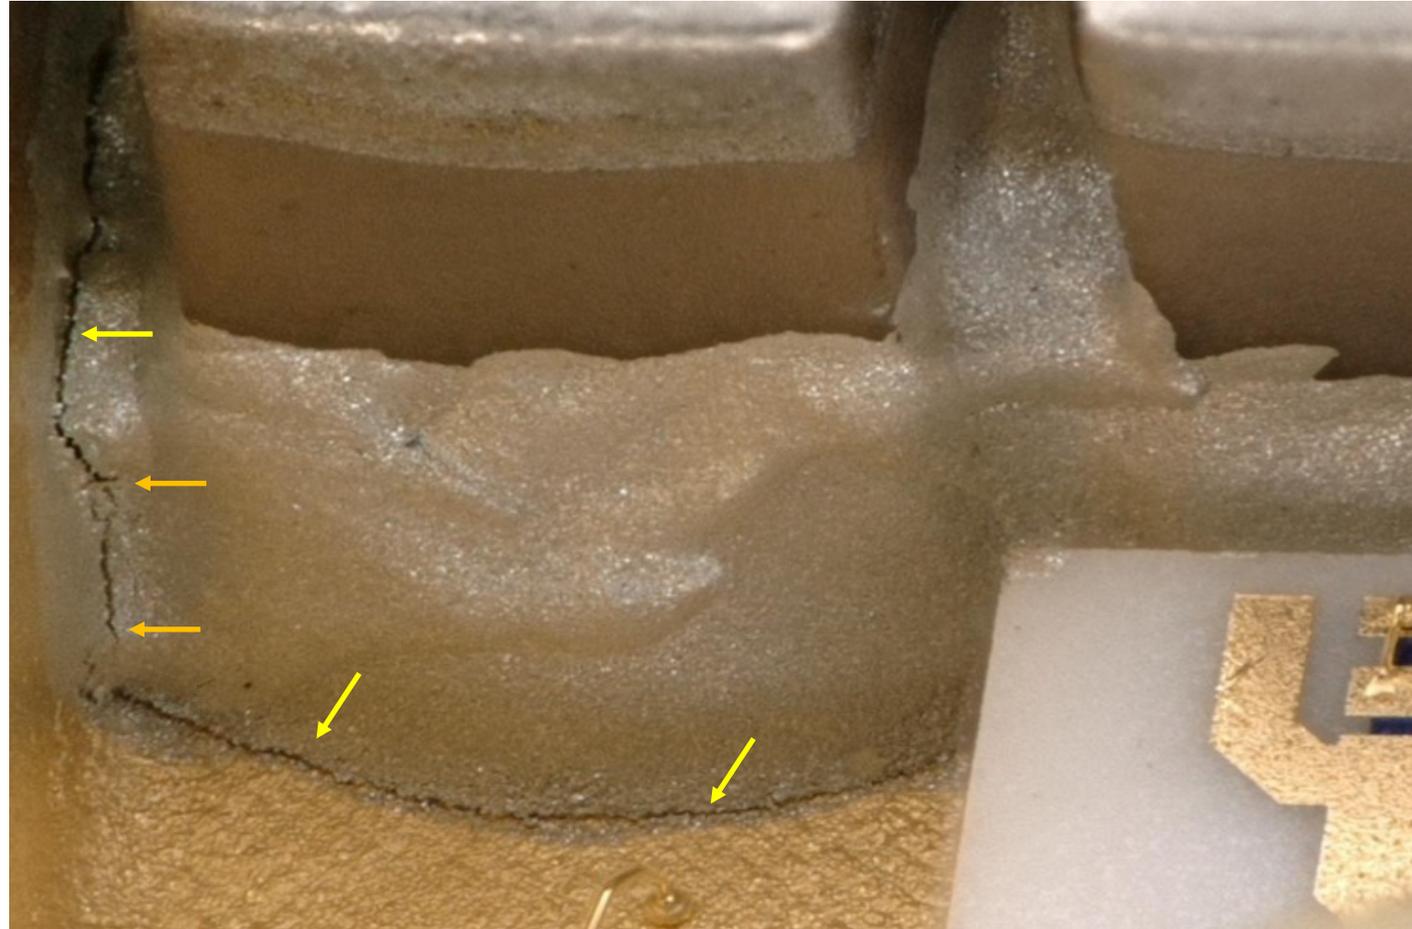
The anomalies identified with yellow arrows look to be pull-backs which are technically not a cause for rejection, but the excessive length (total width of the epoxy) makes this very concerning. The two orange arrows are cracks because sufficient epoxy is visible on both sides of the crack indicating that it is not pulling back from another material (e.g. substrate or element).

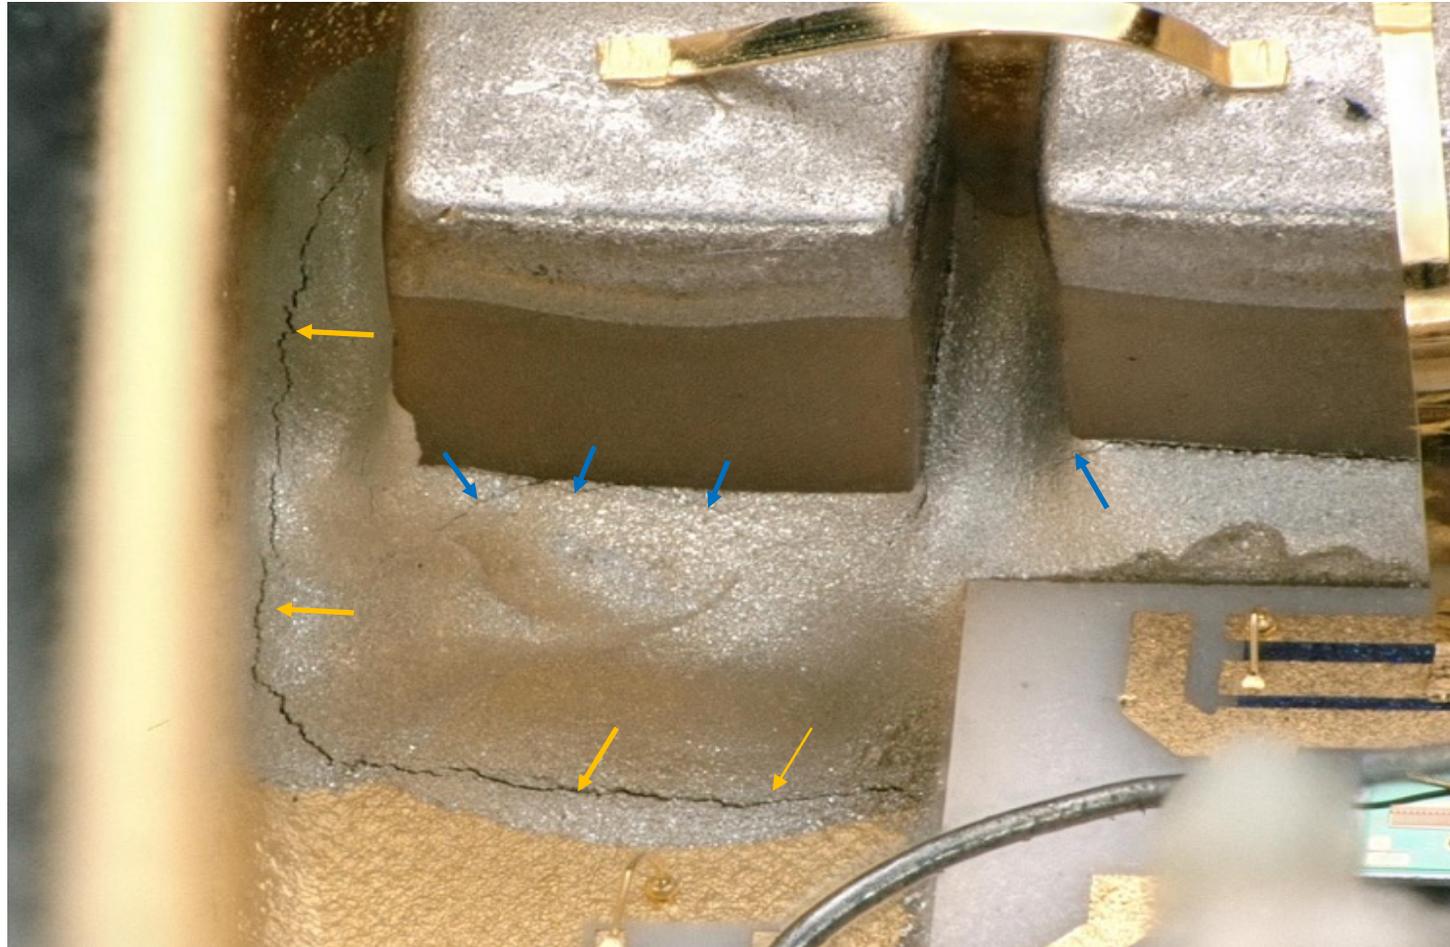
Orange arrows are Cracks because, again, there is epoxy on both sides of the crack. Each individual crack changes in width, meaning that it meets the TM2017 definition of a crack. **Blue** arrows are fissures and not considered rejectable.

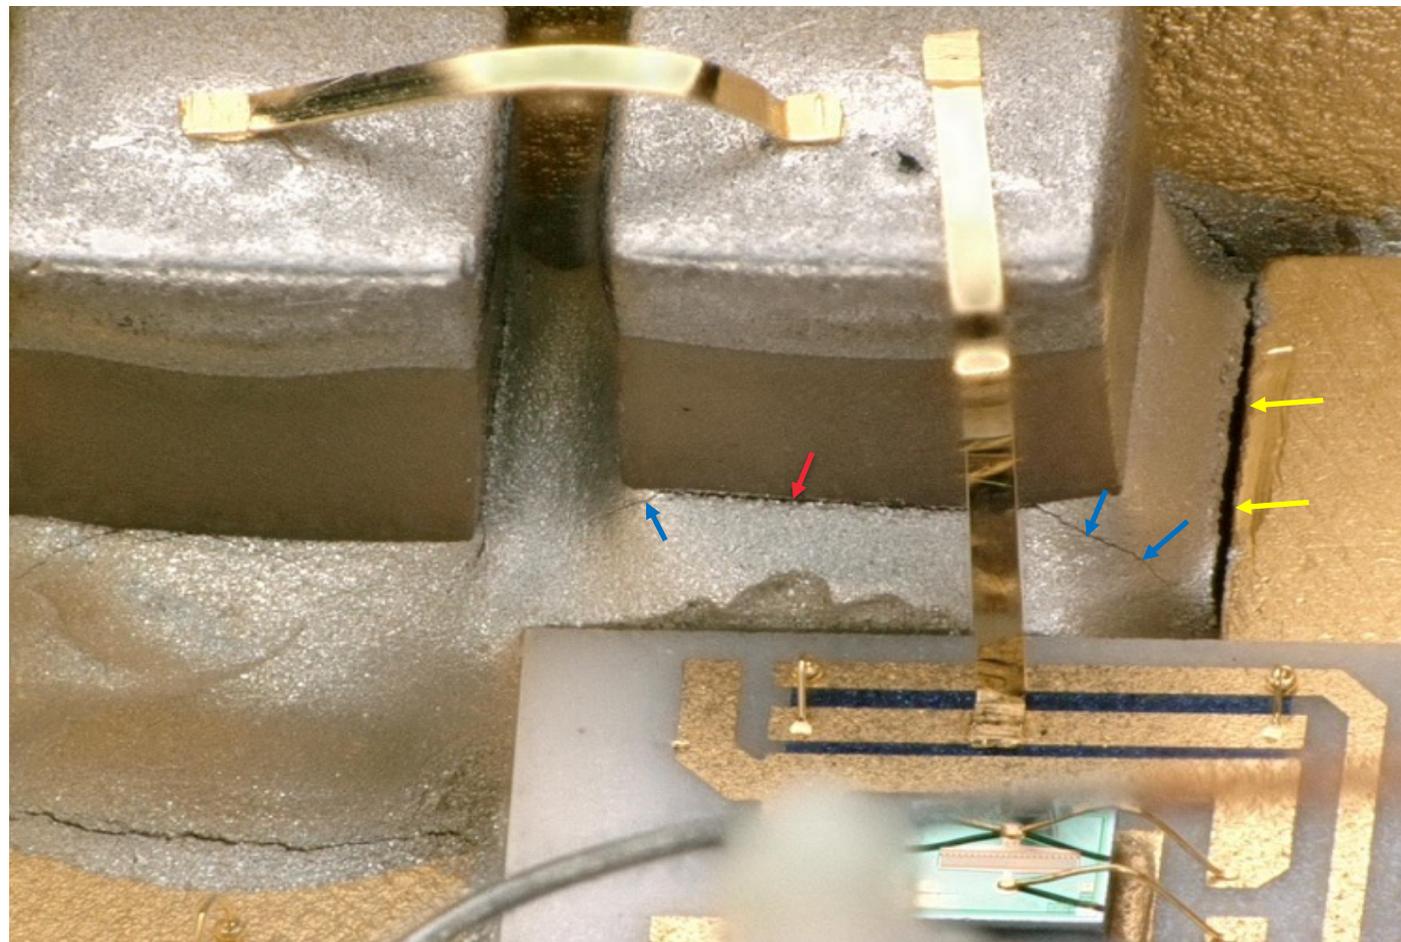
Blue arrows are fissures and not considered rejectable. The Red arrow is an example of pull-back. The Yellow arrows show a large pull-back area. Perhaps additional DLA guidance should be added to the criteria text to properly categorize anomalies of this type.
