THERMAL CYCLING FATIGUE IN DIPS MOUNTED WITH EUTECTIC
TIN-LEAD SOLDER JOINTS IN STUB AND GULL WING GEOMETRIES

A paper for consideration for the 1993 International Telemetering
Conference, Riviera Hotel and Convention Center, Las Vegas, NV,
October 25- 28, 1993

J.W. Winslow and C. de Silveira, 103-100, Jet Propulsion Laboratory,
California Institute of Technology, Pasadena, CA 91109

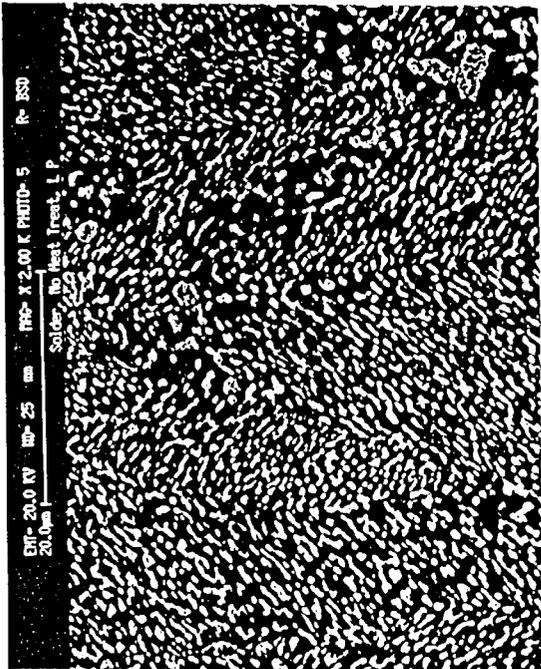
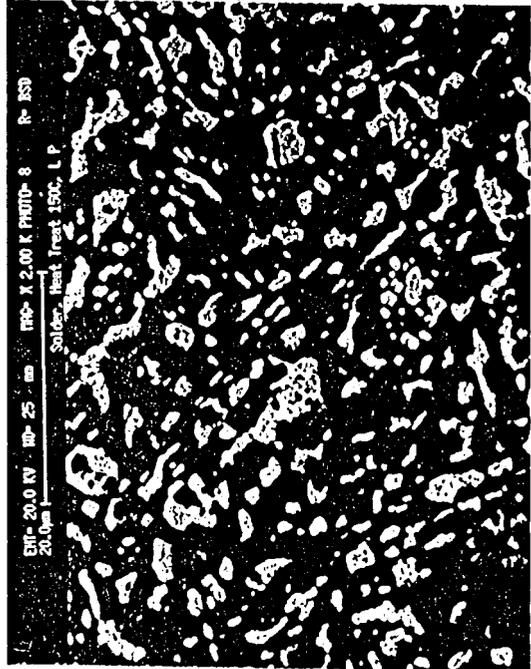
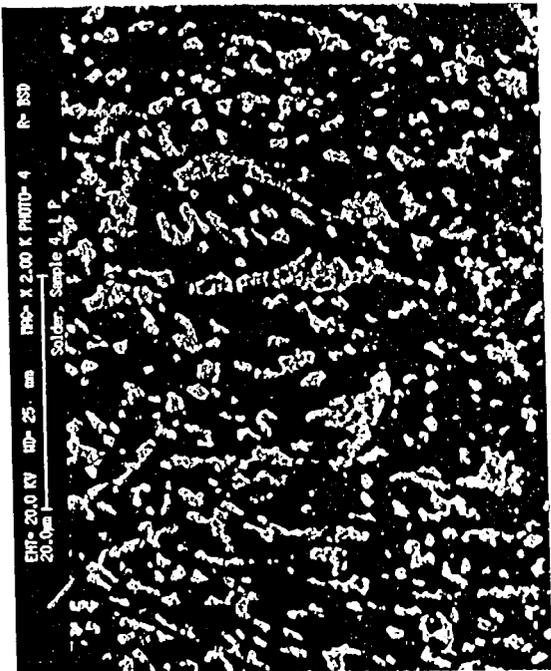
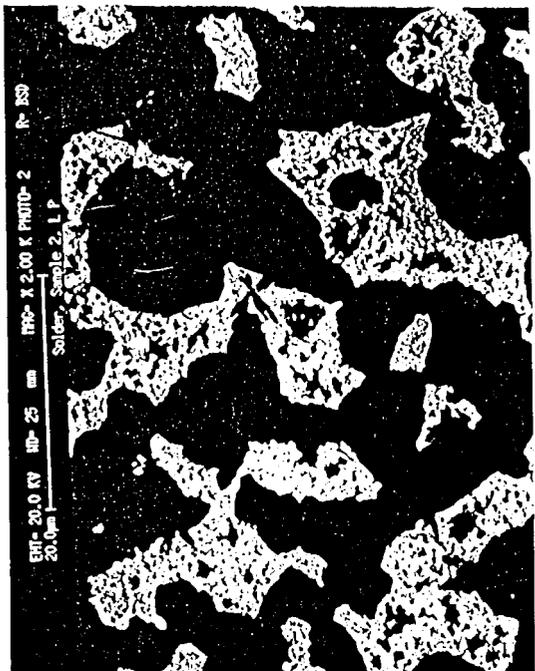
Fig 1. SEM Photos of Aged Solder. (From Pass (2))

- FIG 1. SEM Photos of Aged Microstructure, Eutectic Tin-Lead Solder
(from Ross et al⁽²⁾)
- FIG 2. Optical Microphoto of Near-Eutectic Tin-Lead Solder after
Thermal Cycling (after Frear⁽¹⁾)

1a Immediately after solidifying

1b after 10 hrs at 150 °C

1c after 5 hrs at 100 °C

1d after 5 hrs at 100 °C

We consider the doctoral thesis of Frear⁽¹⁾ especially illuminating with respect to the thermal cycling degradation of near-eutectic tin-lead solder. In the section of this thesis treating such solder, he notes the existence of time- and temperature-dependent "grain coarsening" in this two-phased material. That is, the alpha phase (lead-rich) inclusions in the beta phase (tin-rich) matrix, become both larger and farther apart, as the joint ages. The same tendency also is reported by Ross⁽²⁾, who further reports that in each of the two phases the Pb and Sn atoms monotonically segregate from each other with time and temperature. (See Fig 1 and Table I.)

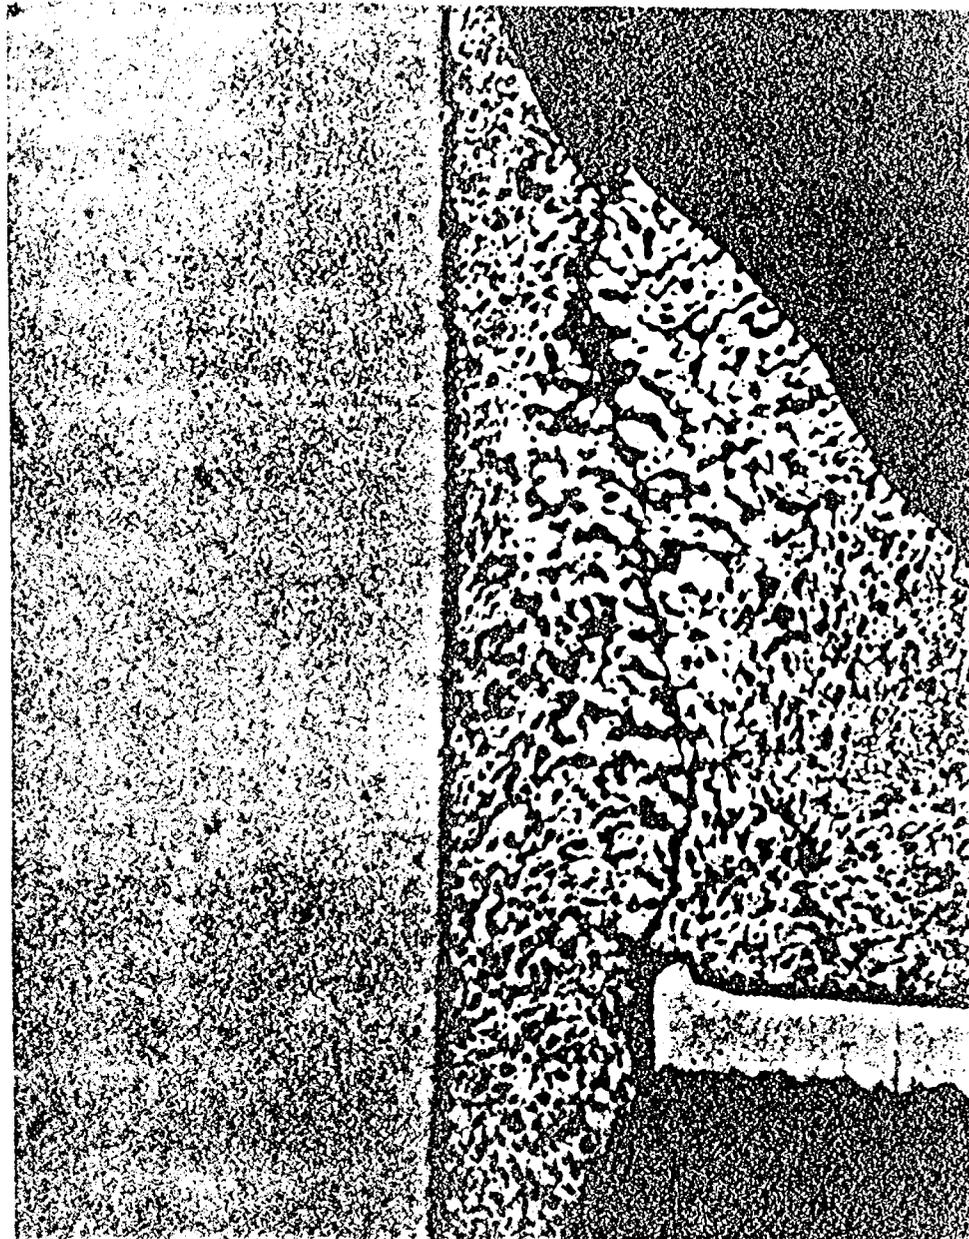
Fig 3 Eutectic Tin-Lead Solder after Thermal Cycling
(from Frankland et al⁽³⁾)

- FIG 3. Optical Microphoto of Eutectic Tin-Lead Solder after
Thermal Cycling (after Frankland et al ⁽³⁾)
- FIG 4. Polarized Optical Microphoto of Near-Eutectic Tin-Lead Solder
after Thermal Cycling. Intragranular Cracks through Beta
Phase indicated by arrows. (after Frear⁽¹⁾)

Frear also notes that certain interior regions of the near-eutectic, Sn-Pb solder joint display grain coarsening which is markedly enhanced beyond the average for the joint as a whole (See Fig 2). These regions are of special interest because solder joint fracture occurs within them. Similar observations of increased coarsening in selected regions within a thermal cycled joint, and co-location of the cracked region, also have been reported by others (for example see Fig 3, Frankland et al (3)).

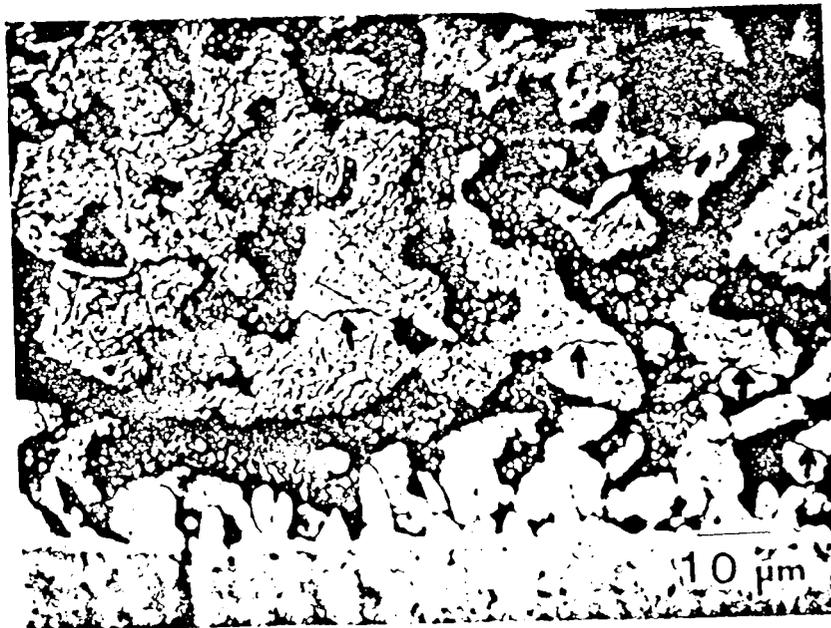
Figure 4 Polarized optical microstructure cross section of a 60 Sn-40Pb/Cu joint after 1300 cycles. Intergranular cracks through the Sn rich phase are shown.
(From Frear (1))

Finally, Frear reports the presence of small intraphase cracks in the beta phase regions when the grain coarsening has proceeded far enough (See Fig 4). This suggests that the mechanical properties of the tin-rich regions change as their compositions and dimensions change, until these regions no longer can sustain the stresses provided by the thermal cycling environment. In this circumstance, with continued cycling, the small cracks could grow until they linked up with each other, eventually leading to separation of the joint.

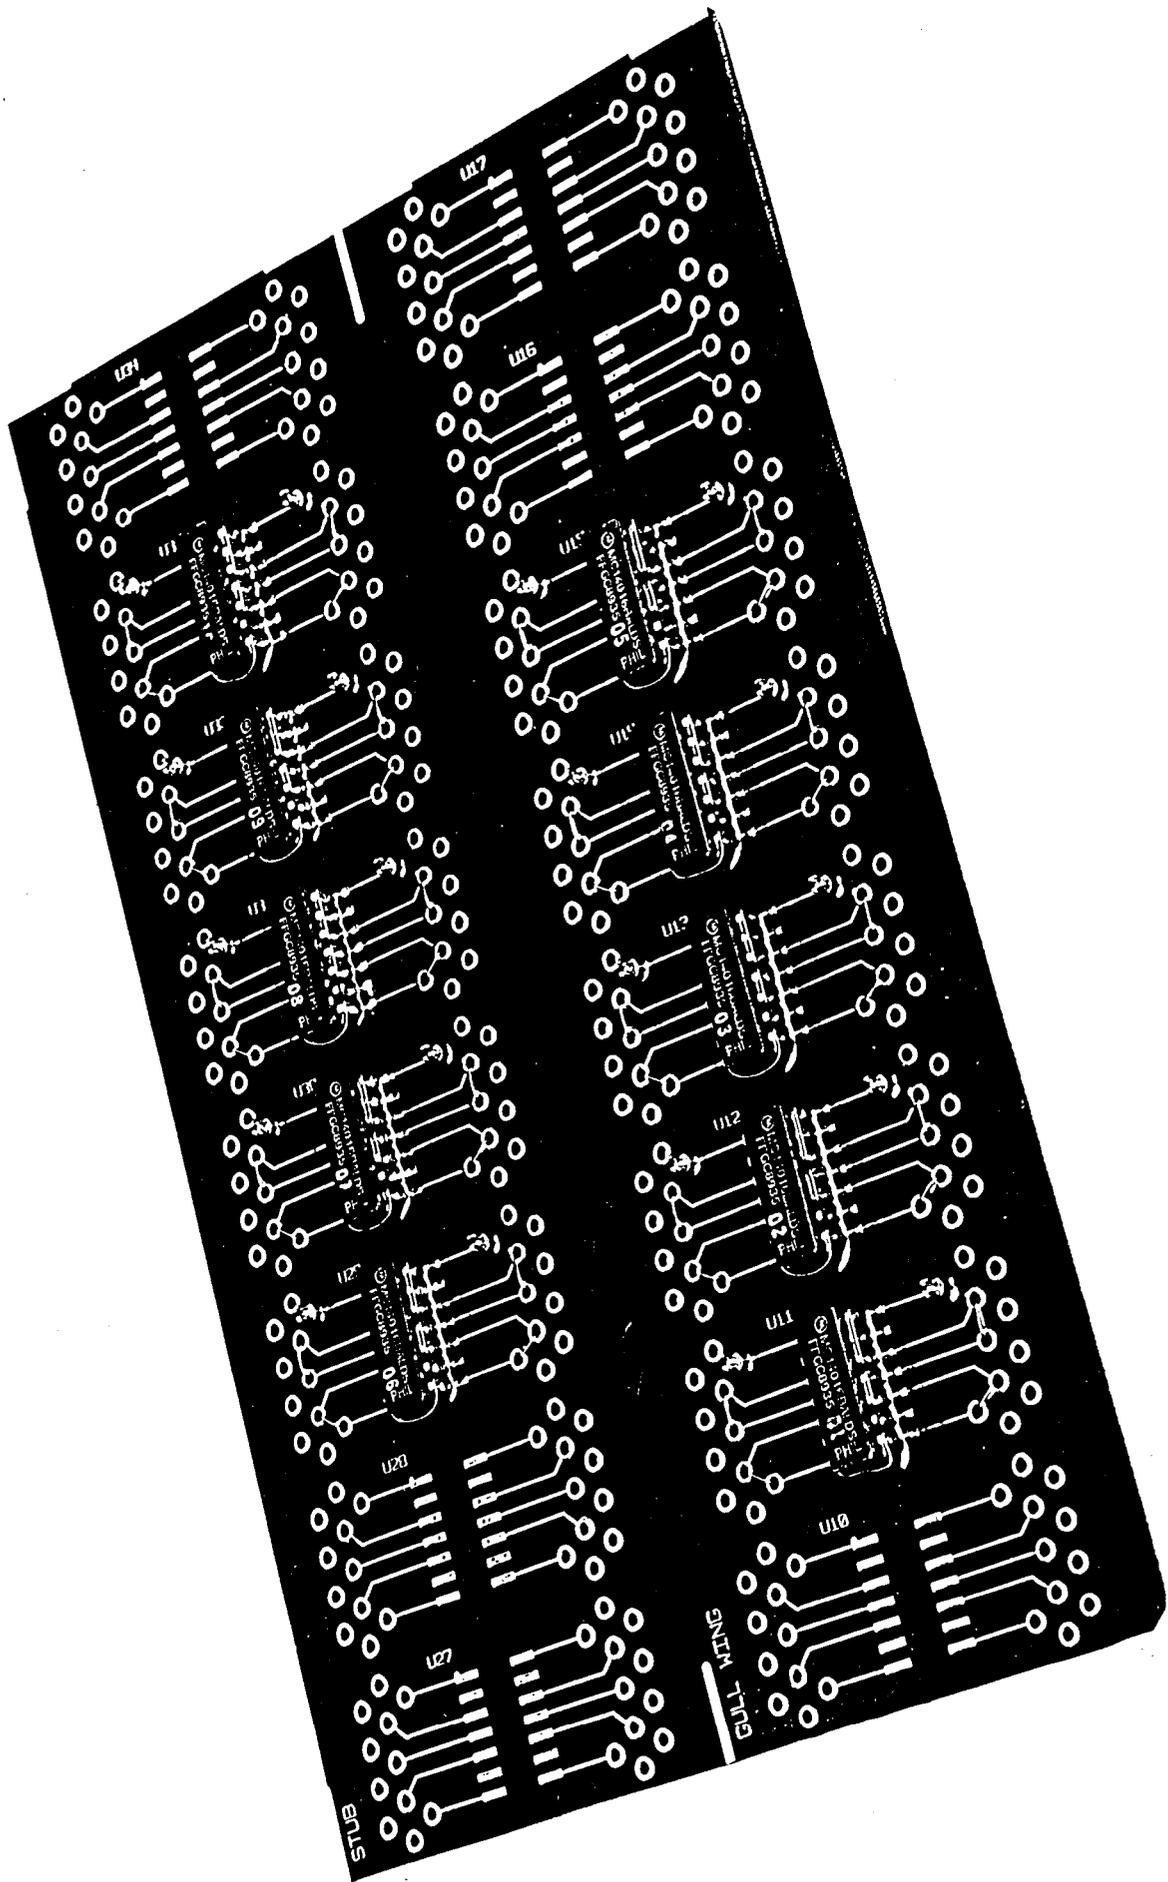
FIG 5. TA24A

- FIG 5. Test Article 24A
- FIG 6. Thermal Cycles (oven programs)
- FIG 7. First-pin Failures for Stub-mounted DIPs,
- FIG 8. First-pin Failures for Gull-wing Mounted DIPs.

To date, our experimental investigation has subjected identical test articles, each consisting of (a) five stub-mounted (sometimes call butt-joined), 14 lead DIPs, and (b) five gull-wing mounted 14 lead DIPs, on a PWB (see Fig 5), to two different thermal cycles. Tensile-compressive mechanical forces were exerted on the solder joints via a conformal coating material encapsulating the DIPs, filling the entire gap between each DIP ceramic body and its PWB. This configuration provided larger than usual driving forces due to the mismatches between coefficients of thermal expansion (CTEs) of the coating material, the DIP leads, the component body, and the PWB.

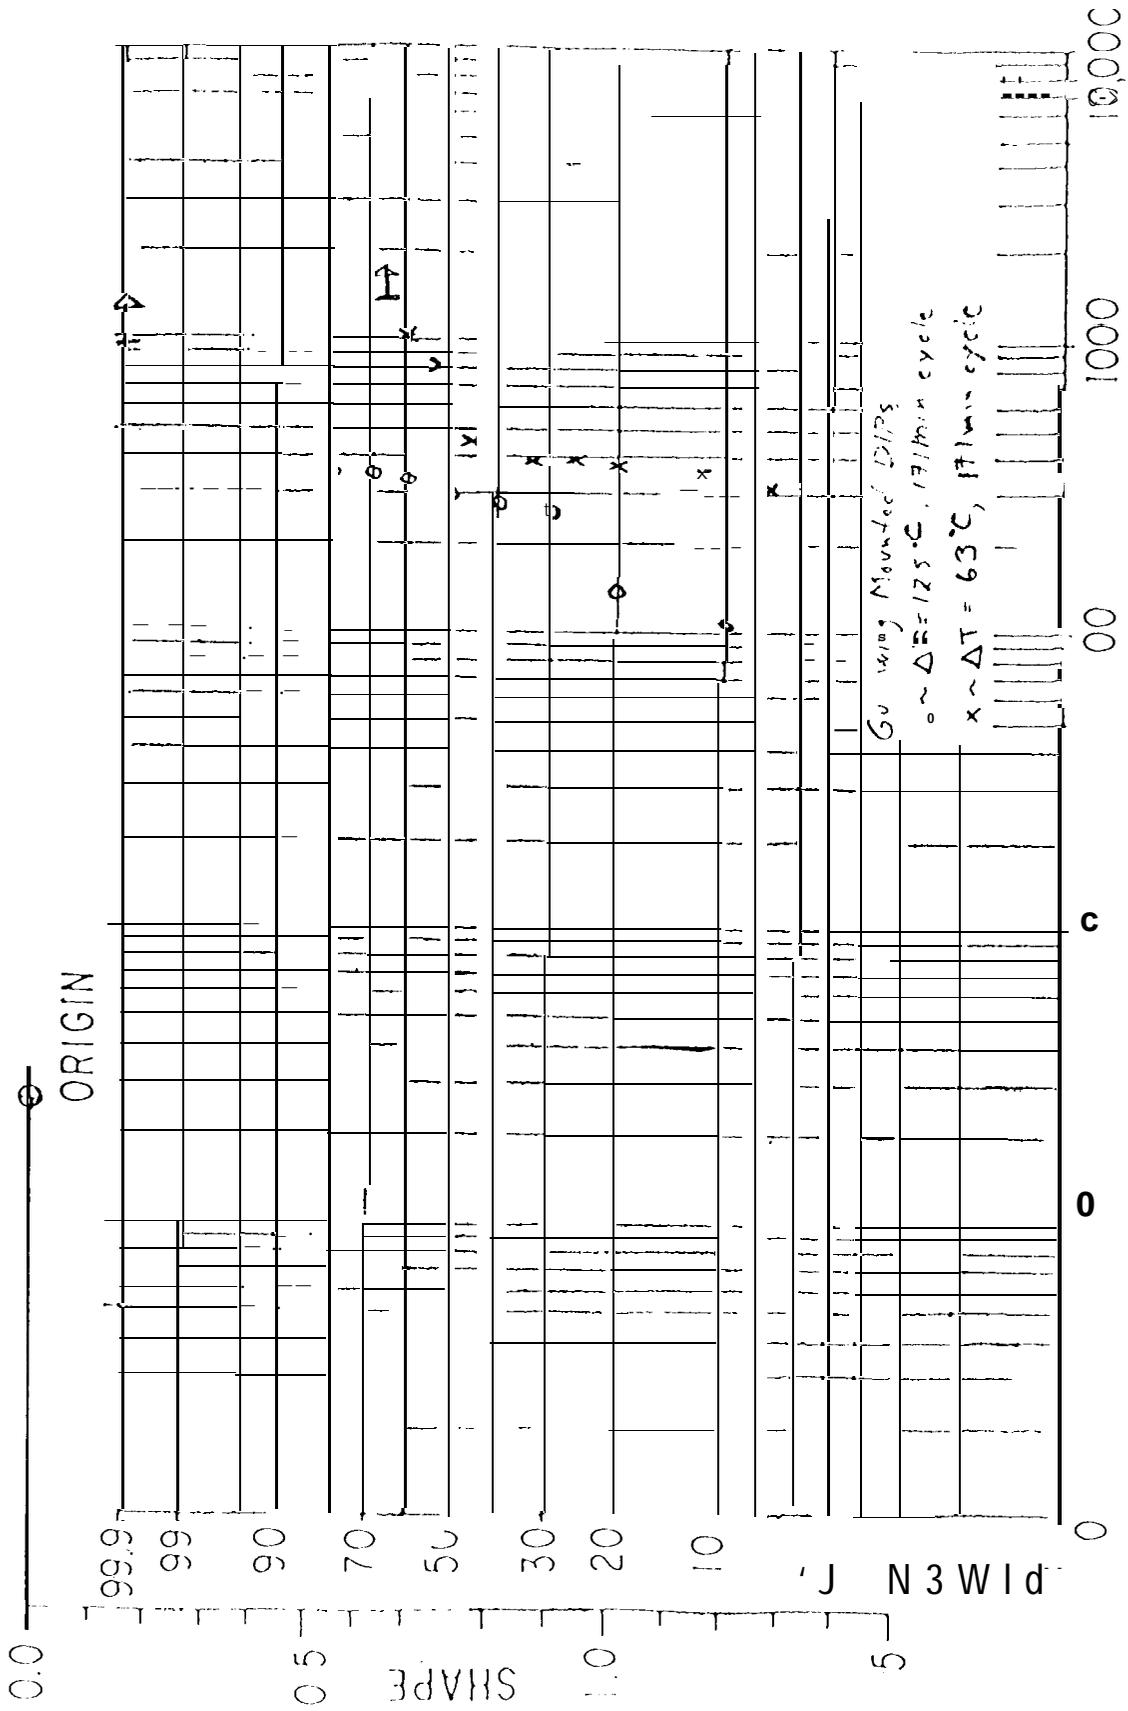
FIG. 8

Failures for Gu wing Mounted DIPs

For stub mounted DIP specimens, the number of cycles to failure was found almost independent of temperature range ΔT (see Fig 7). That is, the ratio of about 6 predicted by the proposed extrapolation relationship between the lifetimes for the two values of ΔT , was conspicuous by its 'absence. For the case of our gull-wing mounted DIPs, the story was quite different (see Fig 8). Here "the number of cycles to failure for the smaller value of ΔT was roughly three times that found for the larger ΔT .

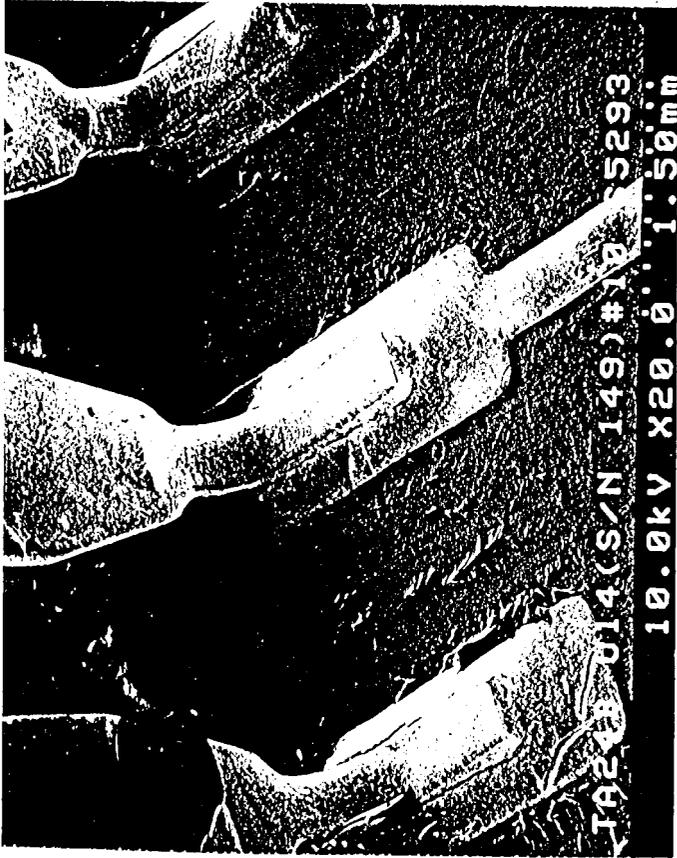
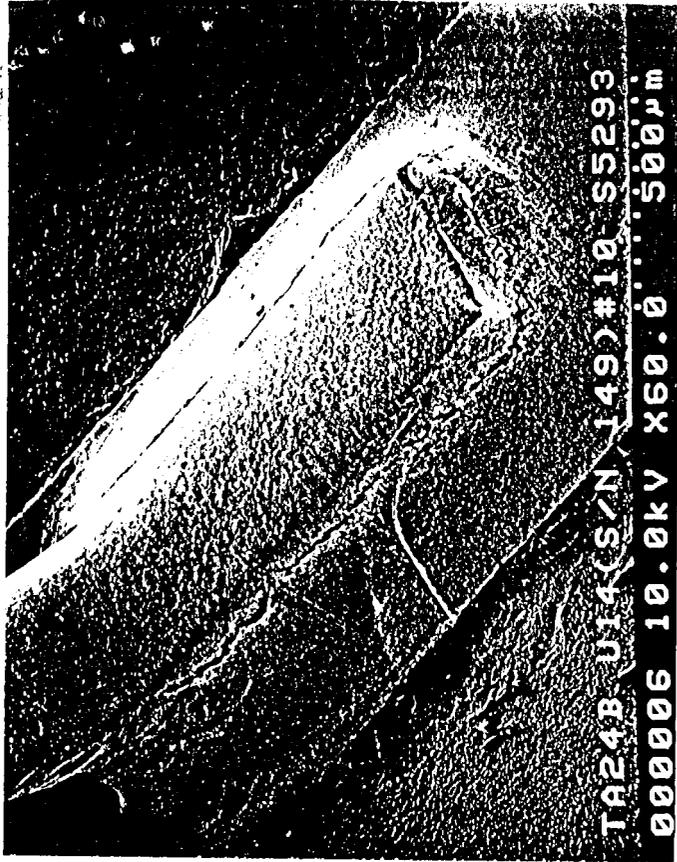
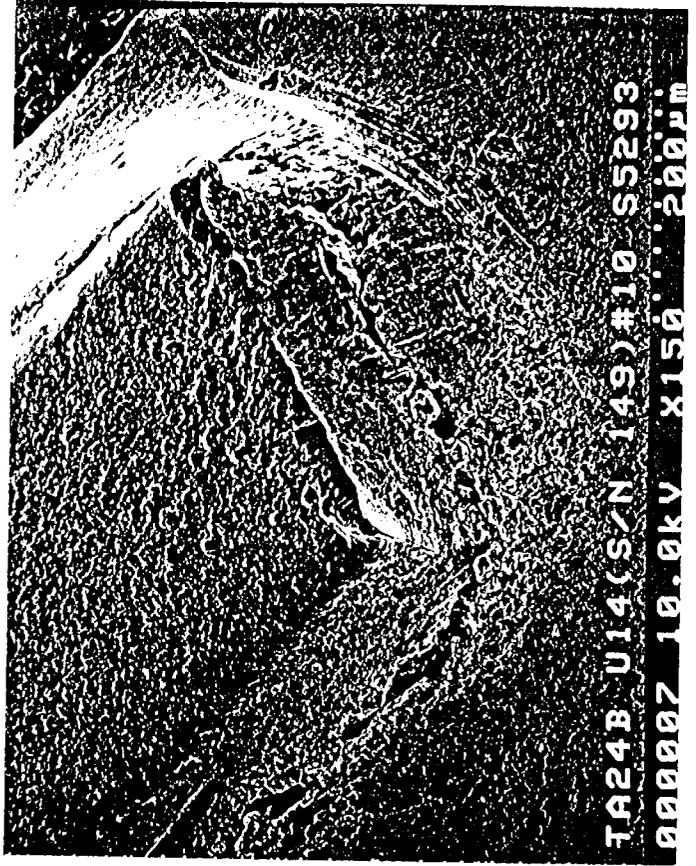
- FIG 9, SEM Photos of DIP Leads about 205 Thermal Cycles after First-
pin Failure.
- FIG 10. SEM Photos of X-sectioned Lead #9, Specimen TA24D-2,
S/N144, about 2 Thermal Cycles after First-pin Failure.

SEM Photos - DIP leads at about 205
thermal cycles after first pin failure.

We have noted in the past that solder joints in the gull-wing configuration, when thermal cycled, show surface cracks in the solder that first appear around the heel of the joint. Then, as thermal cycling continues, the cracks propagate along both sides of the lead foot until they reach the toe area. Then, the lead separates from the solder pad, as shown in Fig. 9.

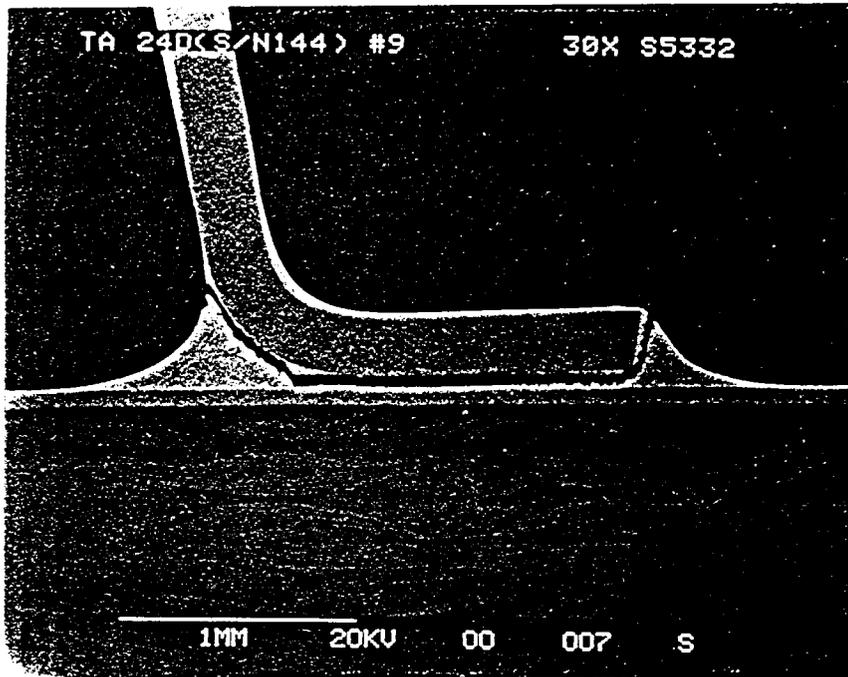
FIG 10

SEM Photos of x-sectioned lead #9, specimen TA24D-2, SN144, at about 2 cycles after failure. Photo after cycle #377, failure at cycle #375.

Figures 10 & 11 show scanning electron microscope (SEM) photos of cross sections of two leads (Nos 6 & 9) of one of our gull-wing mounted DIPs, taken some two cycles after failure as defined by our event detector criteria. We note that lead #9 has separated completely from its solder pad, while lead #6 (directly across the DIP from #9) has separated from its pad along most of the length of the foot from the heel toward the toe, but remains attached at the toe.

Based on the above observations, we speculate that the two DIP configurations fail by different mechanisms. To us it appears that the stub-mounted DIPs fail primarily by simple tensile failure of the solder, while failure of the gull-wing configuration is dominated by crack propagation through the solder, parallel to the foot.

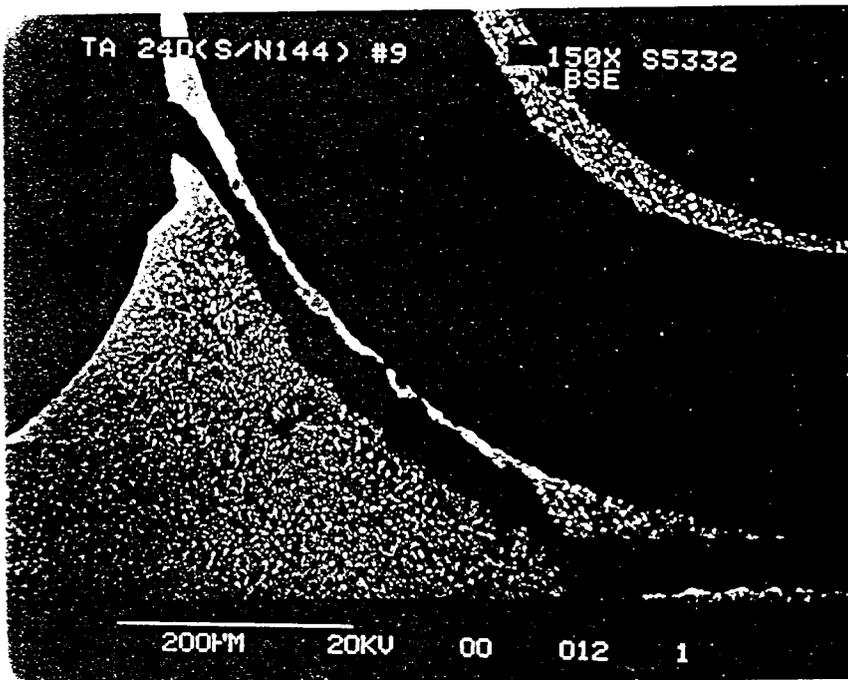
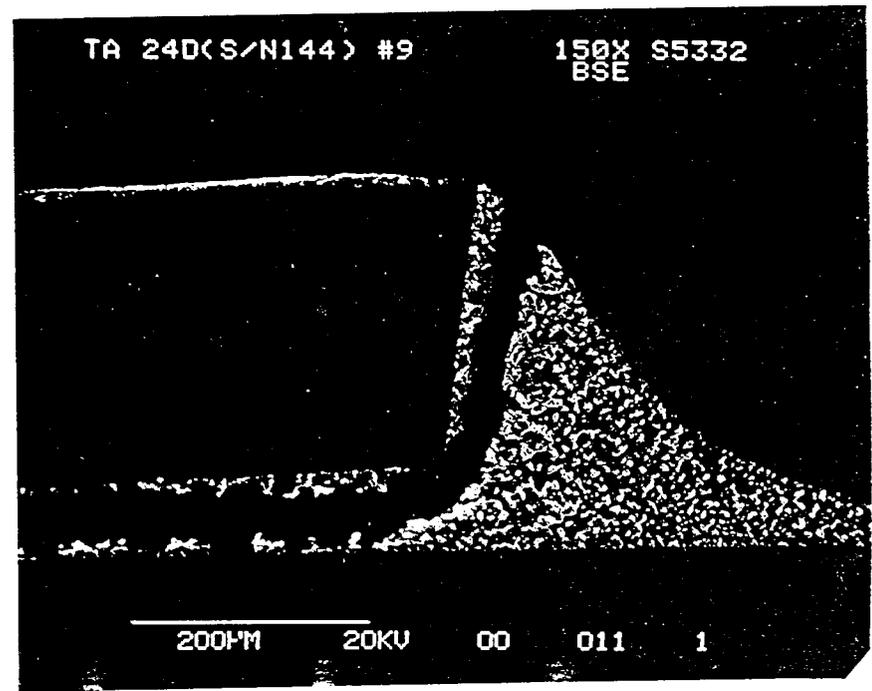
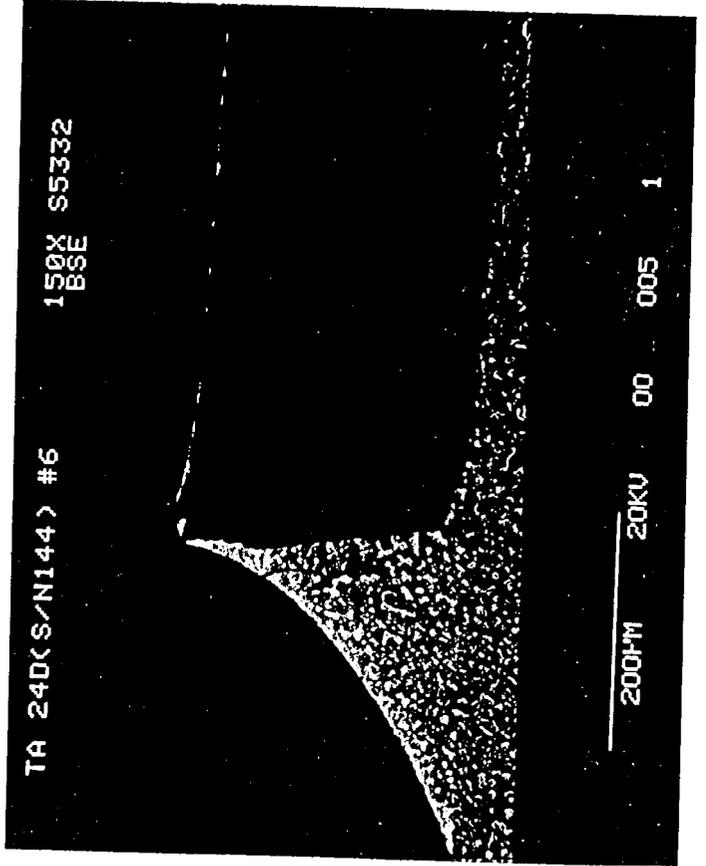
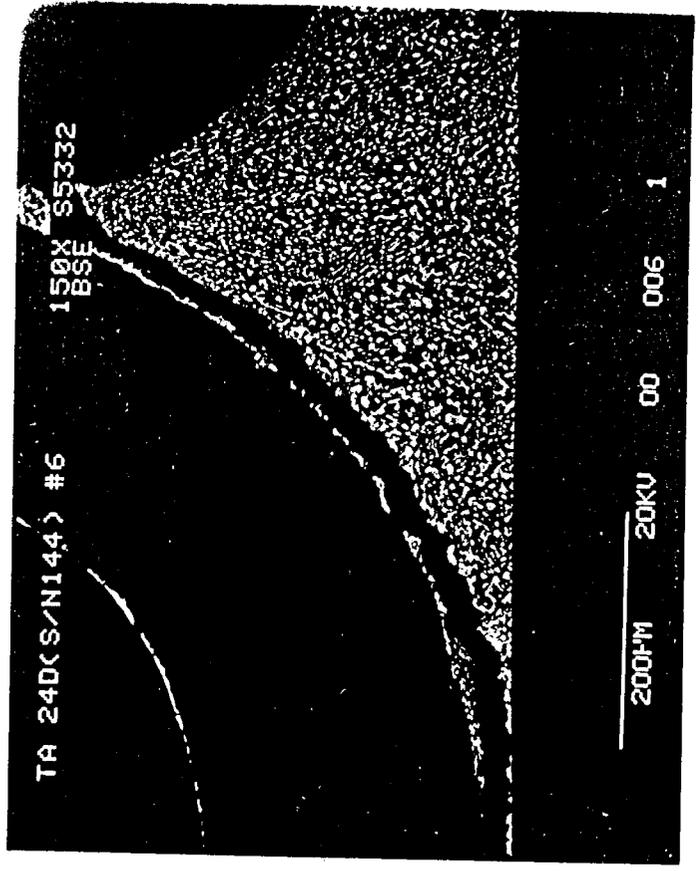
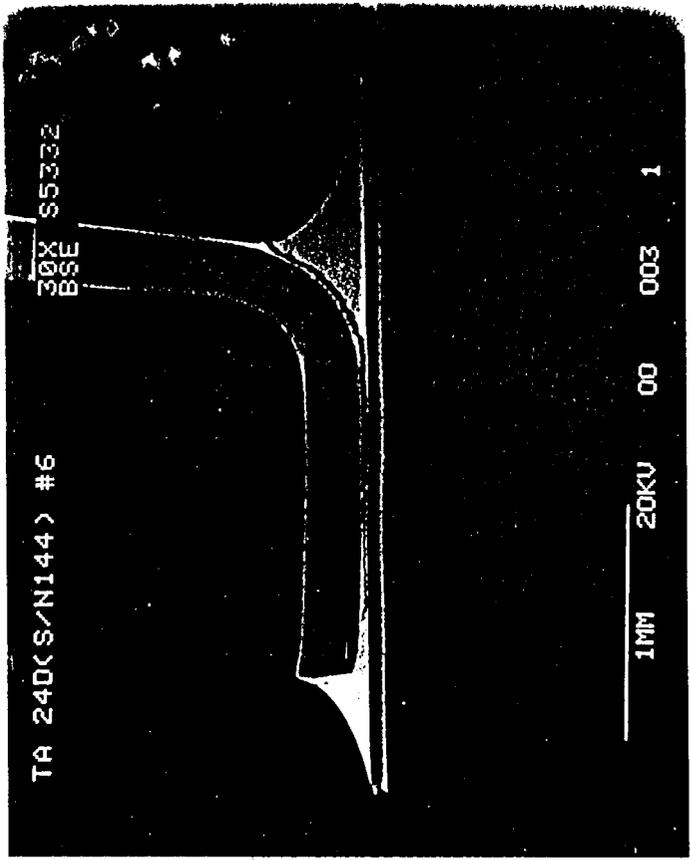
FIG 11

- FIG II. SEM Photos of X-sectioned Lead #7, Specimen TA24D-2,
S/N144, about 2 Thermal Cycles after First-pin Failure.

SEM Photos of x-sectioned lead #6,
BIP S/N 144, about 2 cycles after DIP
failure. Photos after cycle #377; failure
at cycle #375.
