***Solder Joint Fatigue Study Under Low  
Temperature Martian Conditions (#1310)***

**Carissa D. Tudryn  
California Institute of Technology,  
Jet Propulsion Laboratory  
March X, 2006**

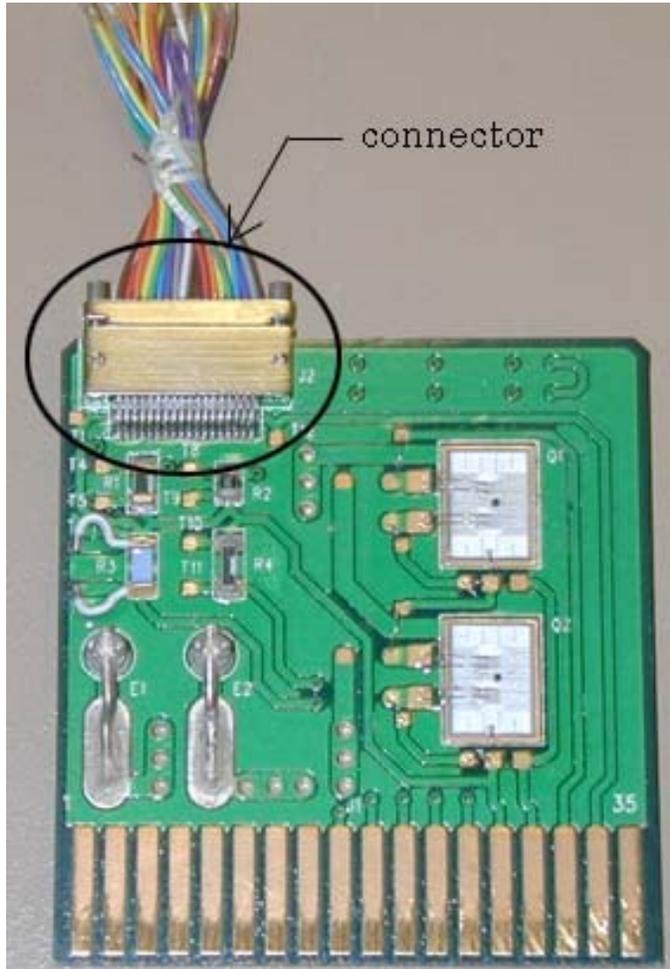
- **Connector:**
  - 37- pin Nanonics Duallobe® connector (nano-connector) with Sn60Pb40 finish
  - Selected as a part with standard finish.
- **Solder:**
  - In80Pb15Ag5 (Indalloy #2)
  - Selected for thermal fatigue resistance and better wetting to Au.
- **Coating:**
  - Dow Q1 4939 1:10 (silicone)
  - Selected for its high compliance and function as a good moisture barrier.
- **Substrate:**
  - Polyimide printed wiring board (PWB)
  - Selected for its space heritage and advantageous material properties as an organic.

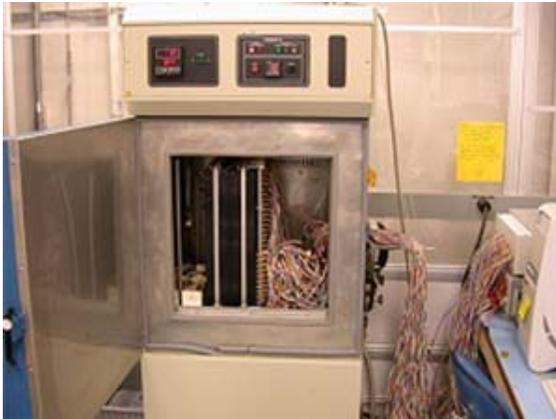
Tenney Model T6C-LN2  
Environmental test chamber

- Environmental test chamber, Tenney Model T6C-LN2, was used
- Each cycle, programmed between -130°C to 92°C, averaged a 5°C/minute ramp rate.
- The test vehicles were thermal cycled between -120°C to 85°C and held at each temperature for at least 10 minutes.
- Nano-connectors were continuously and periodically manually verified for functionality every 250-300 cycles.
- High resistance values or infinity indicating electrical opens were defined as failures.

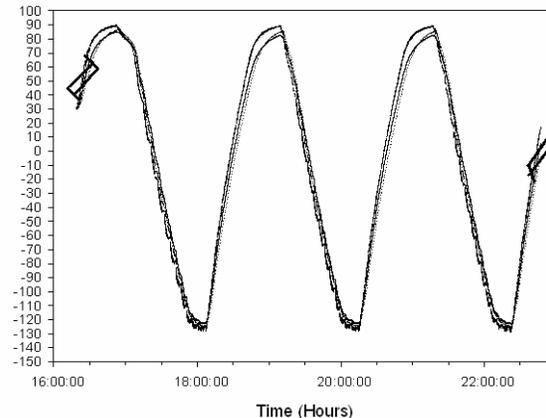
Thermocouple Cycling Data

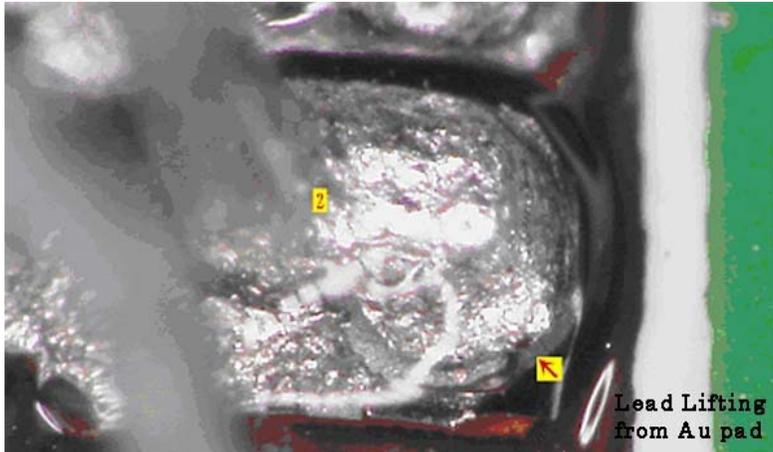
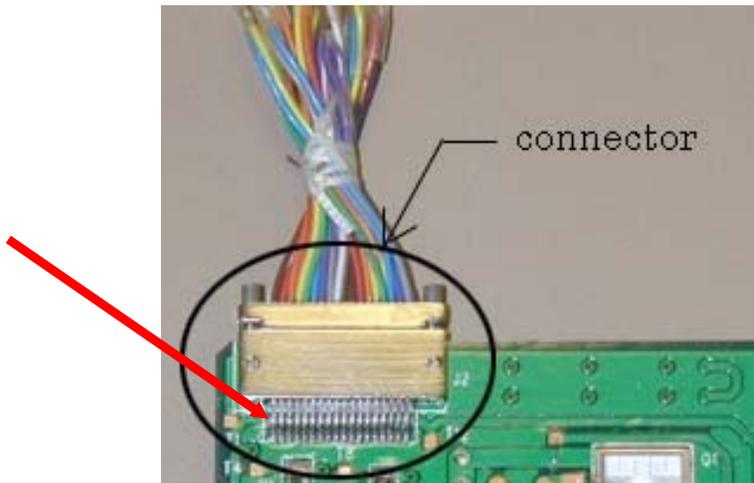
- Between 638-1431 cycles 13 out of 1110 lead contacts on 4 out of 30 nano-connectors failed.
- First failures occurred between 638 – 863 cycles.
- Optical and SEM results have indicated that lead lifting was the cause of the open.
- Root cause of failure was due to micro-cracking.
- Failure Modes:
  - Martensitic phase transformation, brittle nature of Sn phase, and intermetallic embrittlement

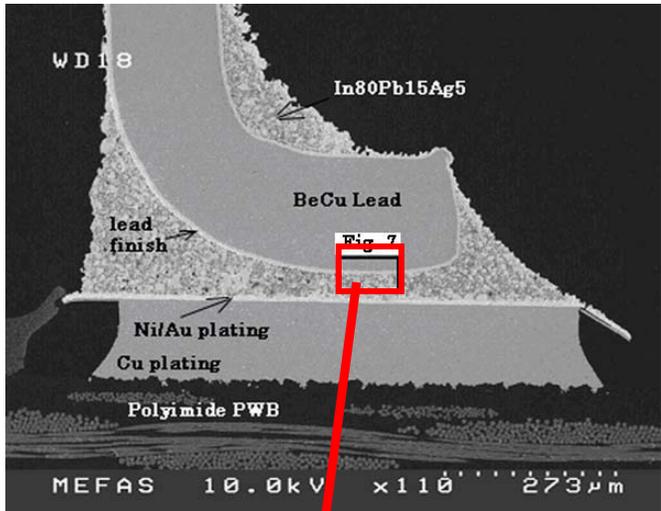
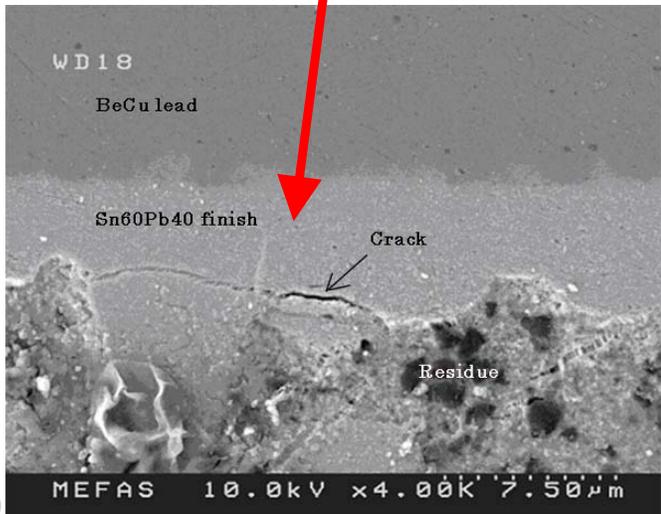
- Crack initiation site at the Sn60Pb40 lead finish and the In80Pb15Ag5 solder interface (at least one case)
- Two failure modes were crack propagation and separation at the interface.
- Martensitic phase transformation which resulted in a Sn-rich phase at low temperatures down to -120°C.
- Local stresses and volume changes within the microstructure due to phase transformation of the Sn in the SnPb phase (f.c.c) to a Sn-rich phase  $\beta$  (b.c.t)
- Loss of ductility of the Sn phase.

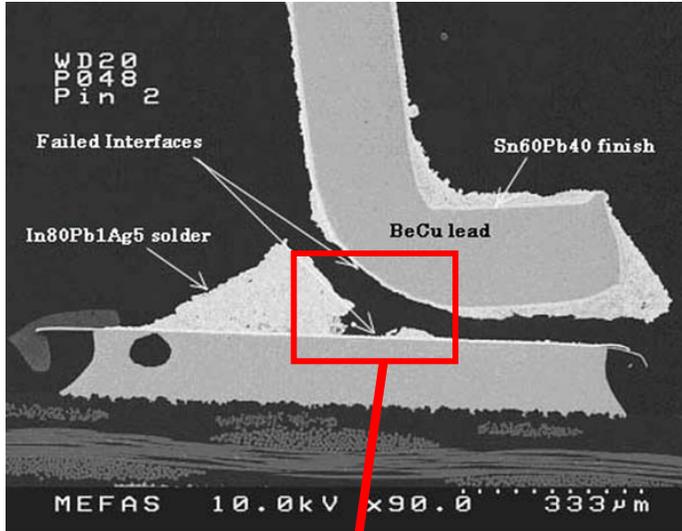
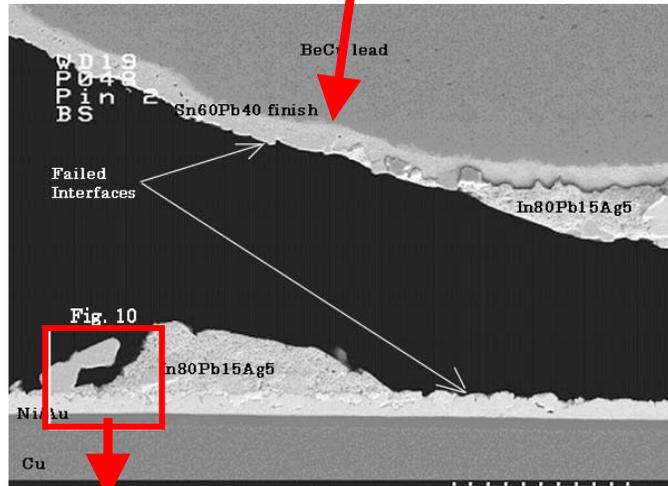
- Secondary crack propagated at the In80Pb15Ag5 solder and PWB interface.
- Fatigue failure occurred due to fatigue stress and intermetallic embrittlement.
- Repetitive thermal cycling caused cyclic strains in the solder joint
- $\Delta T = 205\text{ }^{\circ}\text{C}$
- BeCu lead- 16.7 ppm/ $^{\circ}\text{C}$  [6]
- Polyimide PWB- 16.50 ppm/ $^{\circ}\text{C}$  (measured in the x, y- dir.) [7]
- In80Pb15Ag5 solder- 28 ppm/ $^{\circ}\text{C}$  [8]

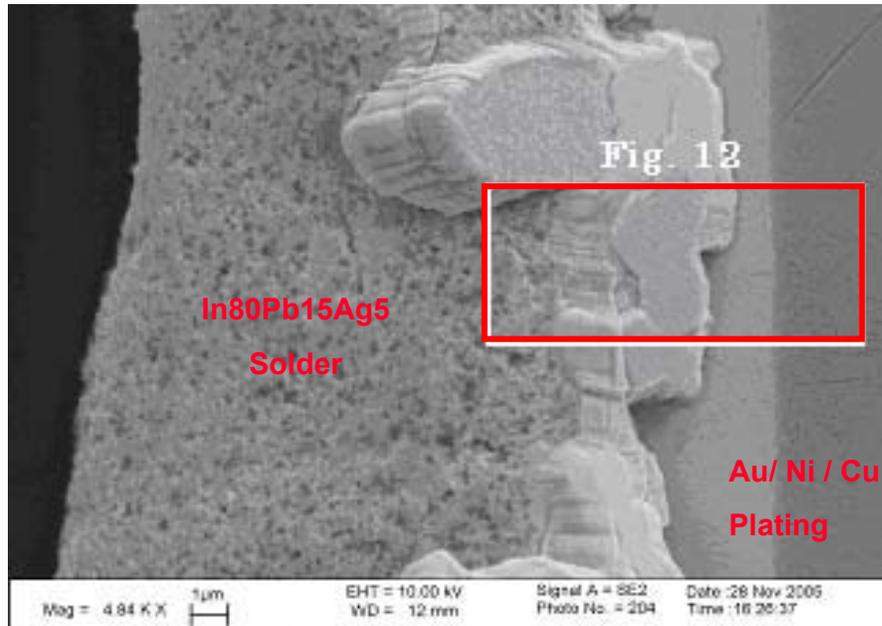
- **Spot Scans- 30keV, 10.10 kx, and a working distance of 12mm.**
  - 7 EDS Spectra (ZAF correction factor) 20 second spot scans since In and Sn are convoluted
- **Dot map- 10 keV, 10 kx**
  - 8 micro-seconds time constant for 14 minutes.
- **In, Ag, and Sn ( $L_{\alpha}$ )**
- **Au and Pb ( $M_{\alpha}$ )**
- **Ni, Cu ( $K_{\alpha}$ )**

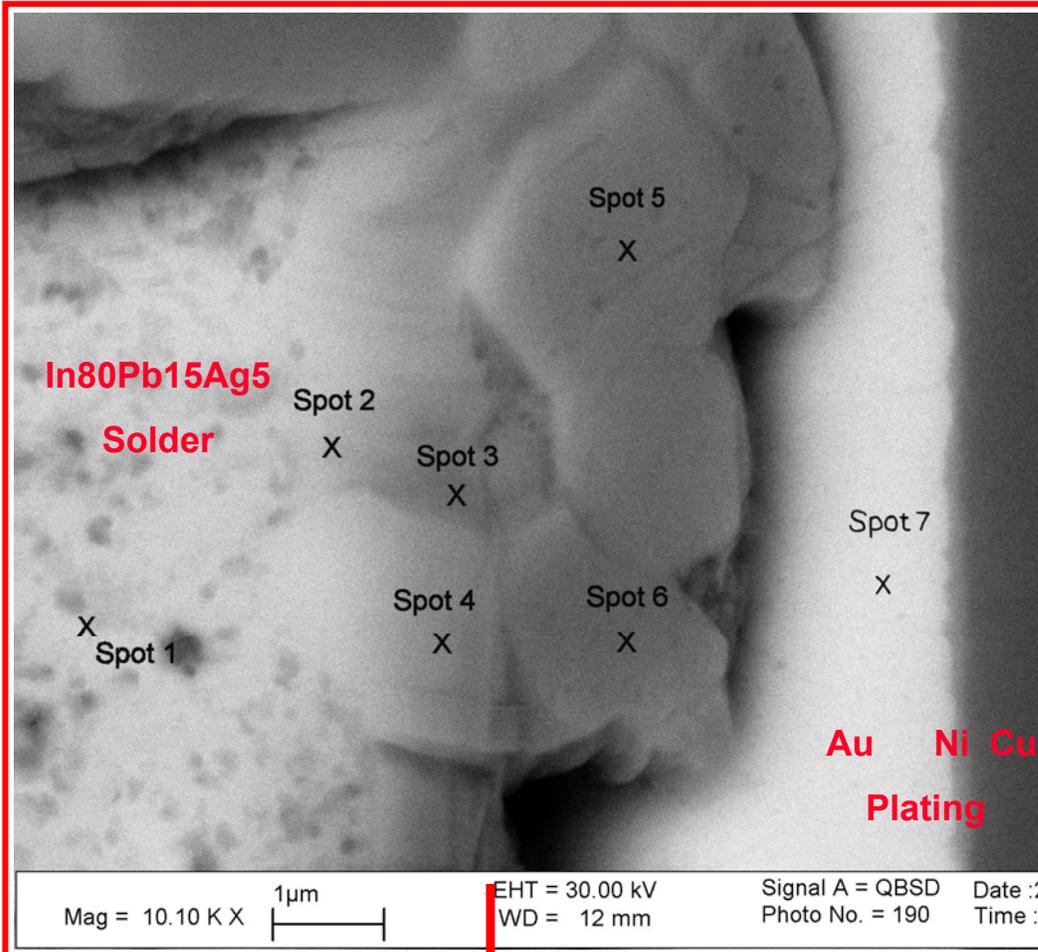
Spot	Intermetallic Compound
1	$In_xPb_ySn_z$
2	$In_xPb_ySn_z$
3	$In_xPb_ySn_z$
4	$In_xPb_y$
5	$In_xPb_y$
6	$In_wPb_xAu_ySn_z$
7	$In_xAu_ySn_z$

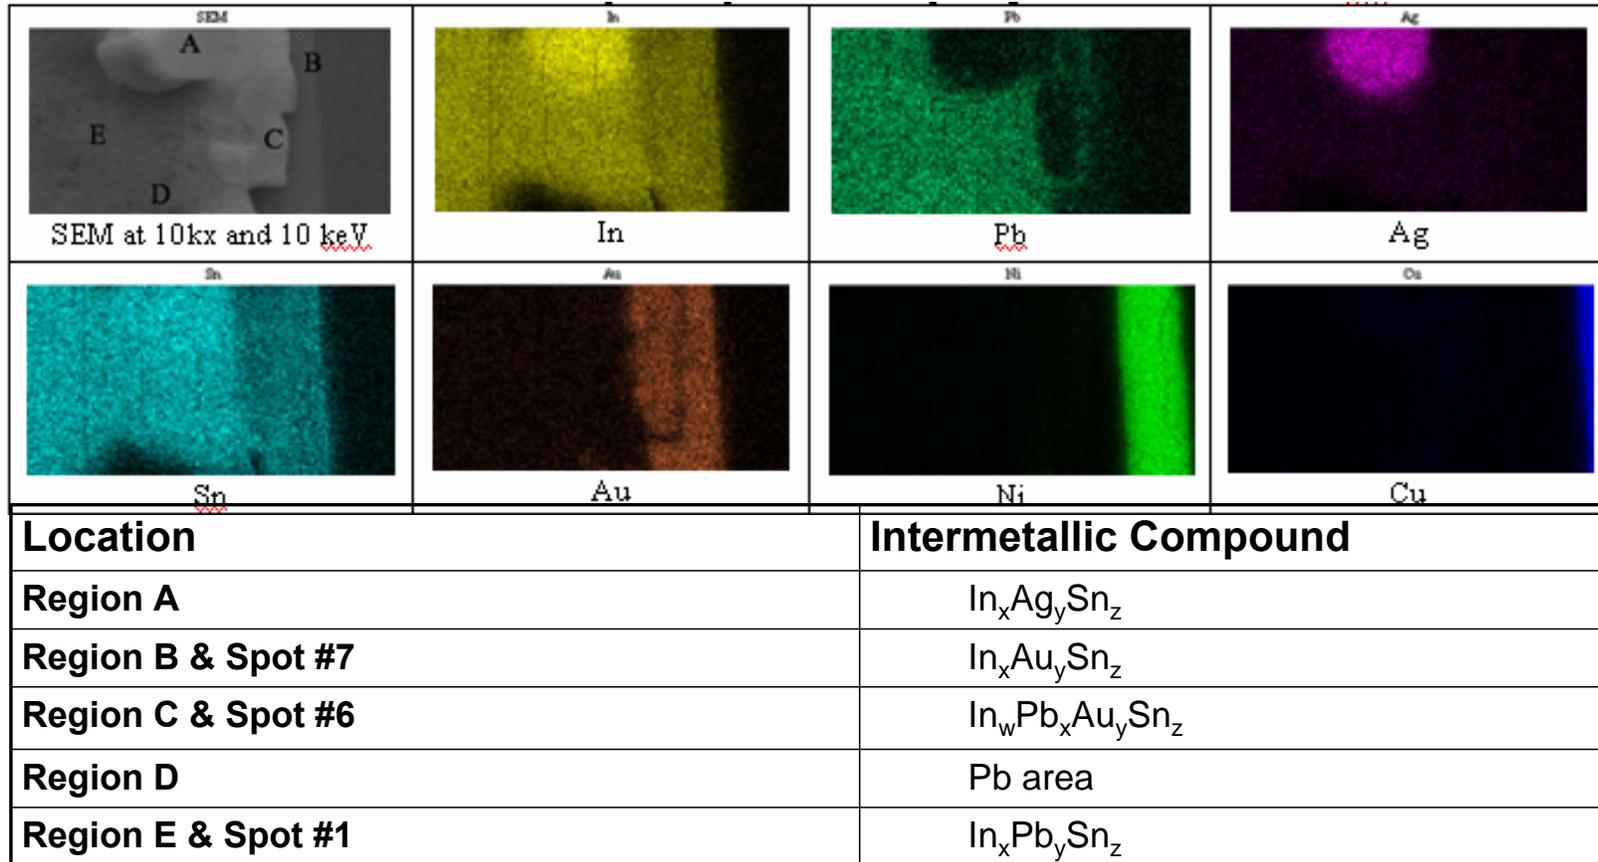
- Intermetallics at spot location #2 and 3 are also shown in the same areas of the dot map.
- Sn may have formed with  $\text{In}_x\text{Pb}_y$  found in the EDS spectra on spots #4 and #5, or it may be unlikely since In and Sn are convoluted on the dot map.

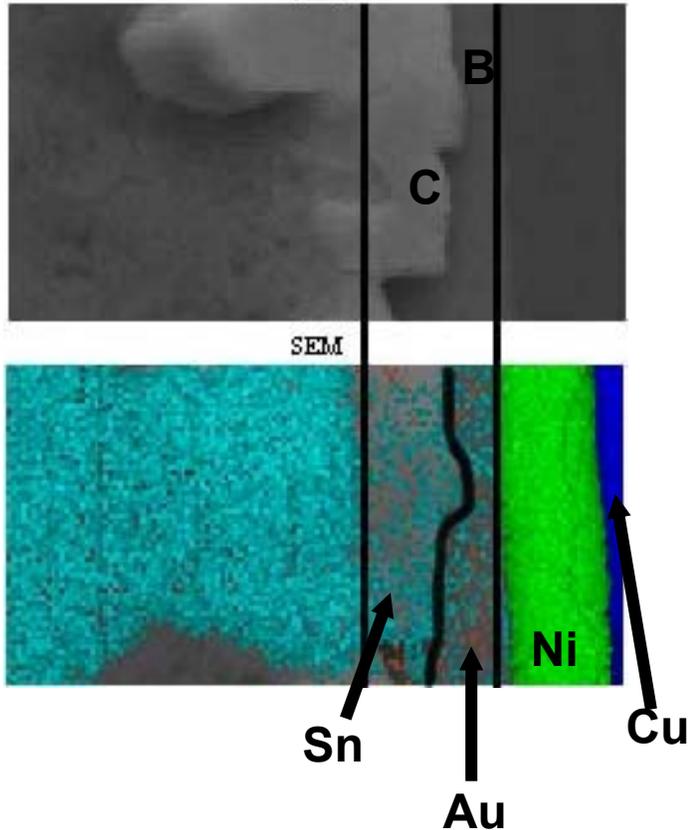
\*Note- Left side has a higher concentration of Sn  
Right side has a higher concentration of Au

Location	Estimated Intermetallic Compound
Region B	Au-Sn complex
Region C	Au-Sn complex

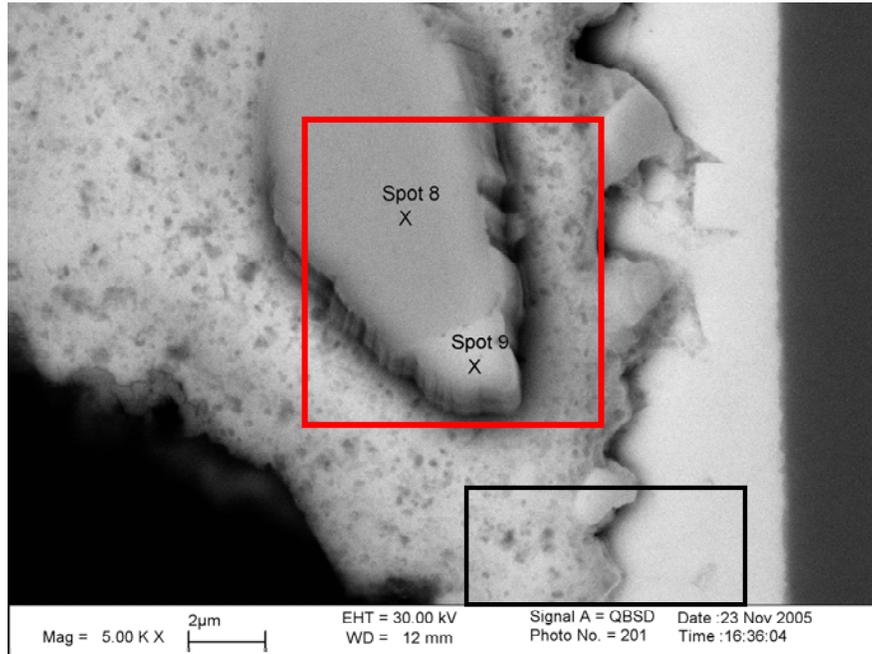
- 30 kev, Mag. of 5kx

Spot	Intermetallic Compound
8	$\text{In}_x\text{Ag}_y$
9	$\text{In}_x\text{Pb}_y\text{Sn}_z$
