Life Test Failure of Harmonic Gears in a Two-Axis Gimbal for the Mars Reconnaissance Orbiter Spacecraft

Abstract

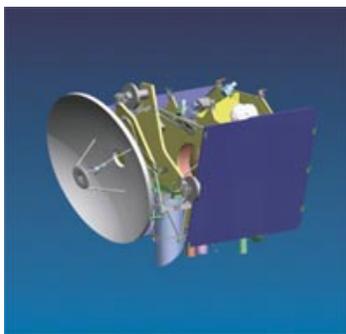
Figure 2. MRO Launch Configuration

The path from Earth to Mars orbit and mapping of the surface consists of launch, cruise, orbit insertion, aerobraking, and mapping phases. The spacecraft configuration of the solar array and the High Gain Antenna are different for each of these phases. During launch, the solar array wings are folded in half and the High Gain Antenna is positioned directly over the spacecraft bus to fit into the launch vehicle fairing (Figure 2). Once MRO is launched and in the cruise phase of the mission, the solar array and High Gain Antenna are pointing in roughly the same direction to capture sunlight and communicate with Earth (Figure 3). For Mars orbit Insertion and aerobraking, the appendages are moved slightly from the cruise configuration to produce an aerodynamically stable configuration. The High Gain Antenna and the solar array wings are the predominant source of atmospheric drag on the spacecraft and must be positioned to keep the spacecraft stable throughout the aerobraking maneuvers, which last for about 6 months (see

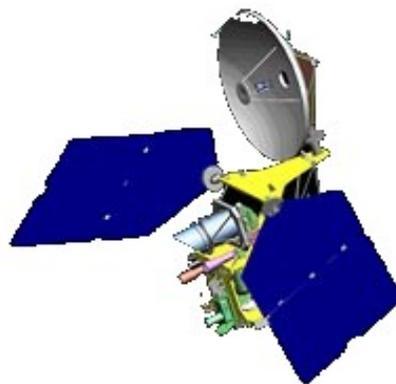
Figure 3. MRO Cruise Configuration

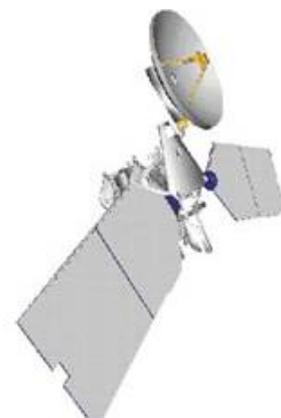
Figure 4. MRO Orbit Insertion & Aerobraking Configuration

Figure 4). For the mapping phase of the mission, the solar array wings and High Gain Antenna are almost continuously articulated so the wings remain sun pointed and the High Gain Antenna maintains a lock on Earth. This continuous motion must be performed while the spacecraft maintains precise pointing for high resolution imaging and high-speed data transmission to Earth (see Figure 1 for a mapping configuration). Because of the stringent pointing stability requirements, the gimbals were required to be exceedingly smooth and quiet.

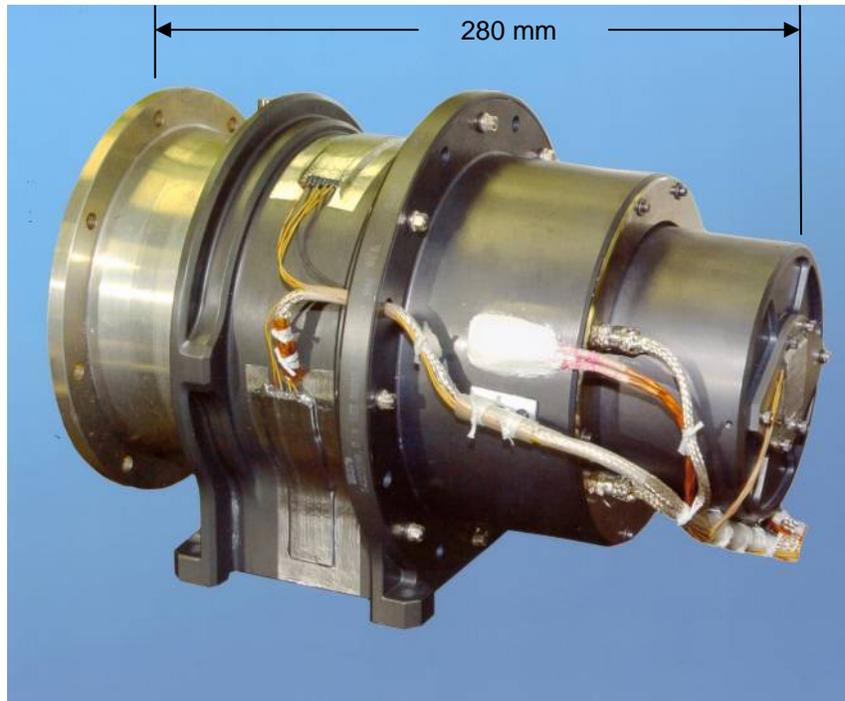
Figure 5. Flight Gimbal Actuator Assembly

Each two-axis gimbal consists of two identical gimbal actuators, structurally connected with application specific components. The core of the actuator is a 130 mm diameter two-phase brushless dc motor with a large number of poles in order to maintain smooth rotor velocity. The brushless motor is commutated using a resolver with the same number of poles as the motor to simplify the commutation logic. The motor directly drives the wave generator of the output harmonic gear component set through a bellows coupling. The bellows coupling was used to minimize speed ripple that would cause disturbances while operating. The harmonic gear is a size 32 HDC, standard cup type unit. The flexspline is mounted to the actuator housing and provides the torque reaction mount. The circular spline is mounted in a pair of preloaded angular contact ball bearings. A multi-speed output resolver is installed between the angular contact bearings for a compact assembly that measures the output position to the accuracy required for the MRO mission pointing. This arrangement of drive components provides a zero backlash actuator with minimal mechanically generated disturbance sources and applies all of the externally generated loads directly to the harmonic gear teeth. A photo of a completed flight gimbal actuator assembly is shown in Figure 5.

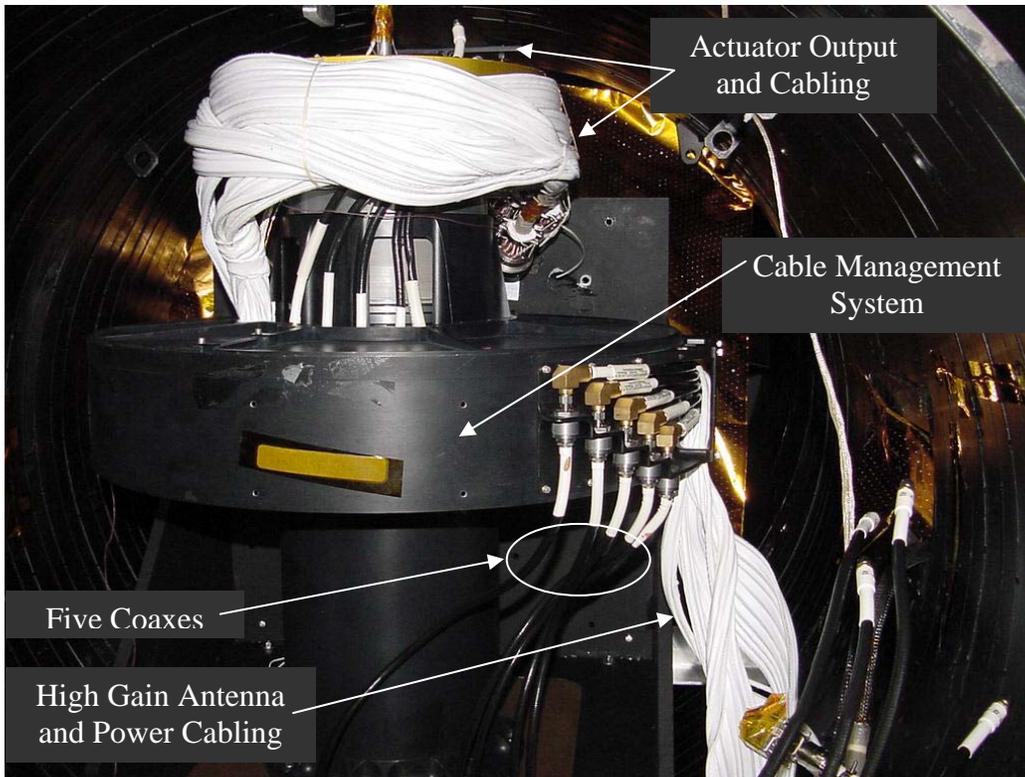
Figure 6. Engineering Development Unit Life Test Configuration in Vacuum Chamber

The next life test was performed on an Engineering Development Unit (EDU) actuator in a flight-like configuration. The EDU actuator used the flight housings with output hardware that supported the high Gain Antenna cable management system. The cable management system was incorporated to test the life of the cabling as well as provide flight like output loading to the harmonic gear. The High Gain antenna application was chosen because it has the largest number of cables across any of the gimbal axes. The EDU actuator was operated over a total output angle of 340 degrees. The EDU actuator was tested in a thermal/vacuum environment, with the temperature slowly cycled from -25°C to +40°C at the rate of one thermal cycle every 18 hours. The actuator was driven back and forth through an output angle of 340 degrees at a motor rate of 125 RPM for approximately 3.8 million input revolutions, and then 65 RPM for the remainder of the test. The EDU motor was driven with an industrial stepper motor driver, severely limiting visibility into the performance of the actuator. The stepper motor driver was used for this testing for several reasons: flight actuator drivers were not available for the start of the life testing, the motor is a two-phase brushless dc (not three phase), and the rotary life was believed to be low risk so the limited visibility was not considered to be significant. The EDU Life Test setup is shown on Figure 6.

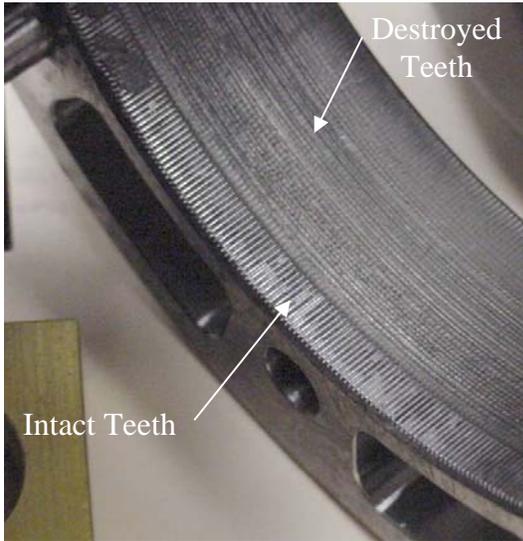
The EDU actuator operated up to 6.1 million input revolutions, when the output telemetry indicated the actuator was not following the input signals properly. Later analysis revealed there were indications of improper operation as early as 4 million input revolutions that were not diagnosed due to limitations in the test setup with the stepper motor driver. The EDU actuator was removed from the chamber, disassembled, and inspected. Figures 7, 8, and 9 show the condition of the harmonic gear teeth at this inspection. Note that the tooth profile was completely obliterated and damaged across the entire width of the flexspline teeth and most of the width of the circular spline.

Figure 7. EDU Circular Spline Life Damage

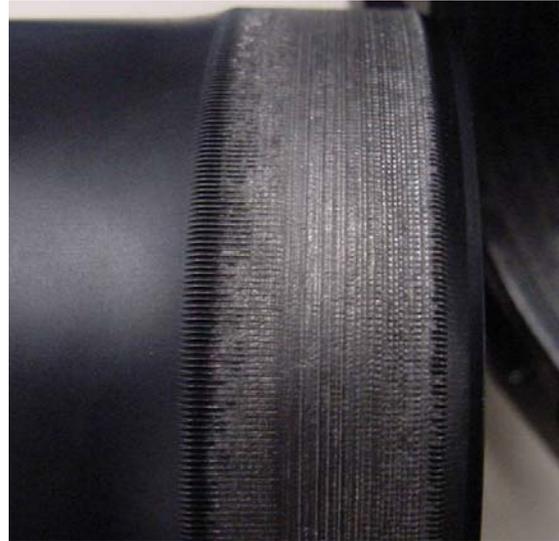
Figure 8. EDU Flexspline Life Damage

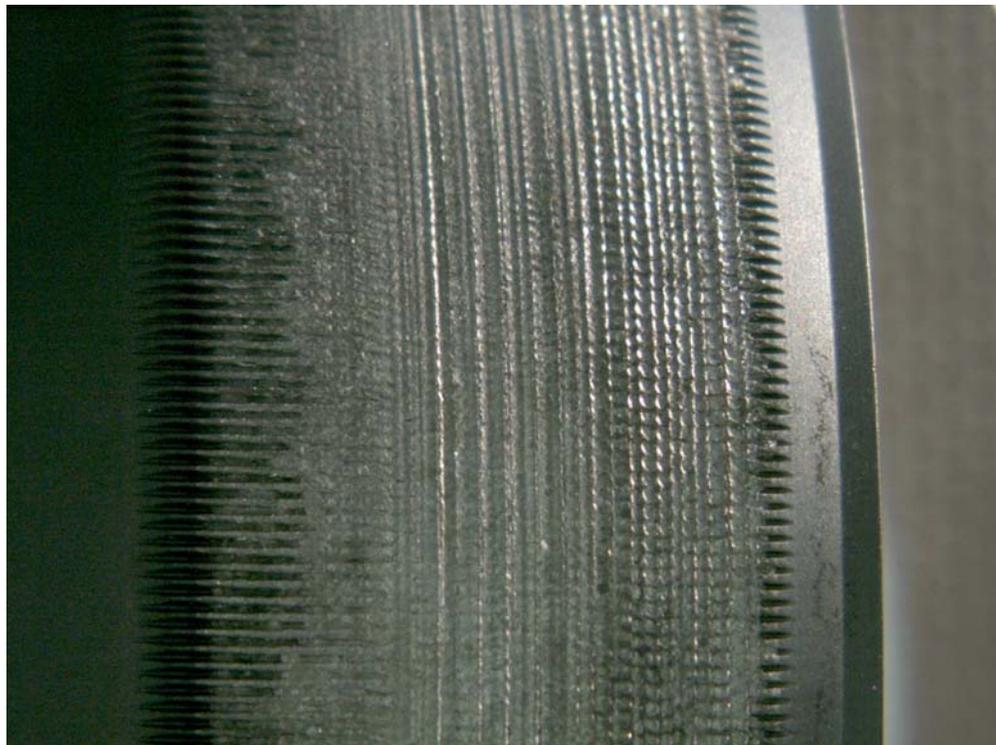
Figure 9. Magnification of EDU Flexspline Life Test Damage

Once the dramatic failure of the harmonic gear assembly was identified, a detailed investigation uncovered that there was some processing problems with the Melonite coating on the group of flexsplines that included the life test unit, labeled Lot B. Two additional Melonite processing groups of flexsplines had been received at the time of the failure, labeled Lot C and Lot D. Testing was started to determine if the Melonite processing on the EDU life test unit was the source of the failure. A harmonic assembly from each of the two remaining Melonite process groups was placed in a harmonic gear test fixture (not in the gimbal actuator) and operated in vacuum with thermal cycling over 12 hours, an output load of 11.3 N·m, and an input speed of 130 RPM. Additionally, one of the two units was tested using the same Penzane family of lubricants as the EDU and the other was tested using Braycote® 602. Both assemblies failed at approximately two million input revolutions. Figure 10 shows the failed splines that were tested with the Penzane family of lubricants. Figure 11 shows the failed splines that were tested with the Braycote® 602 lubricant. A significant result of these two tests was that the lubricant type made no difference at all, with both assemblies failing at nearly the same number of revolutions with the same type and level of damage.

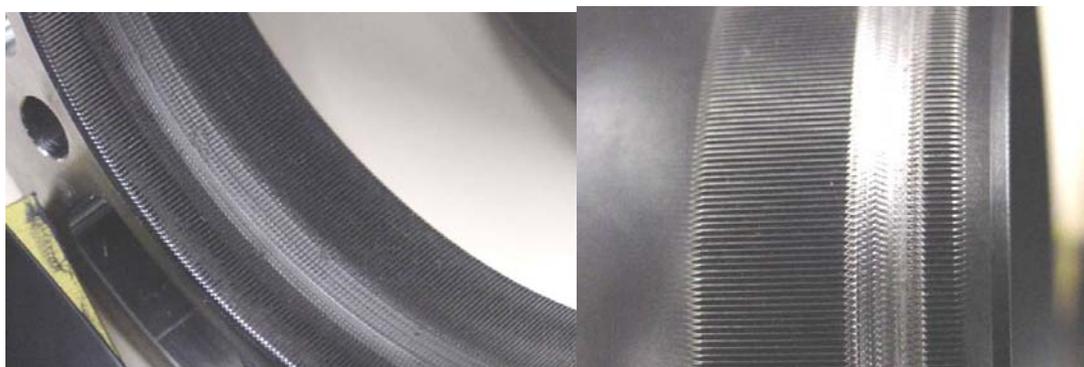
Figure 10. Circular Spline and Flexspline from Harmonic Only Test #1 Tested with Penzane

Since the lubricant type made absolutely no difference in the life capability of the harmonic drive gear teeth, it was clear the problem was related directly to the material combination of the components and their internal stress level. The appearance of the failure surfaces gave the impression of a possible galling condition at work, but it was not clear if galling was the initiator of the failure or a consequence of the damage once the failure had been initiated. Rough mathematical analyses were performed to estimate the contact stress at the harmonic gear teeth from the preload and under the applied load in the life testing. The constant external 11.3 N-m load in the harmonic fixture life tests represented the worst case load from the cable management system and was responsible for a roughly 40% increase in tooth contact stresses over the preload. The estimated contact stresses in the EDU life test were in the realm of 750 MPa. The galling threshold listed for a 15-5 PH stainless steel contact pair is around 14 MPa. This indicated that the contact stresses compared to the galling threshold for the selected materials was a strong candidate for the cause of the failures. To maximize the success of the next group of tests, Nitronic 60, with a listed galling threshold value greater than 345 MPa, was identified as a candidate in addition to standard commercial materials for the harmonic gear assemblies. Also, reducing the output stiffness requirement so the internal harmonic gear preload (and with it the internal tooth stresses) could be reduced was needed. At this point in the project schedule, the flight solar array panels had been fabricated and their stiffness was measured, allowing reduction of the stiffness margin for these panels in the MRO spacecraft stability analysis. This made it possible to reduce the gimbal actuator stiffness requirement significantly.

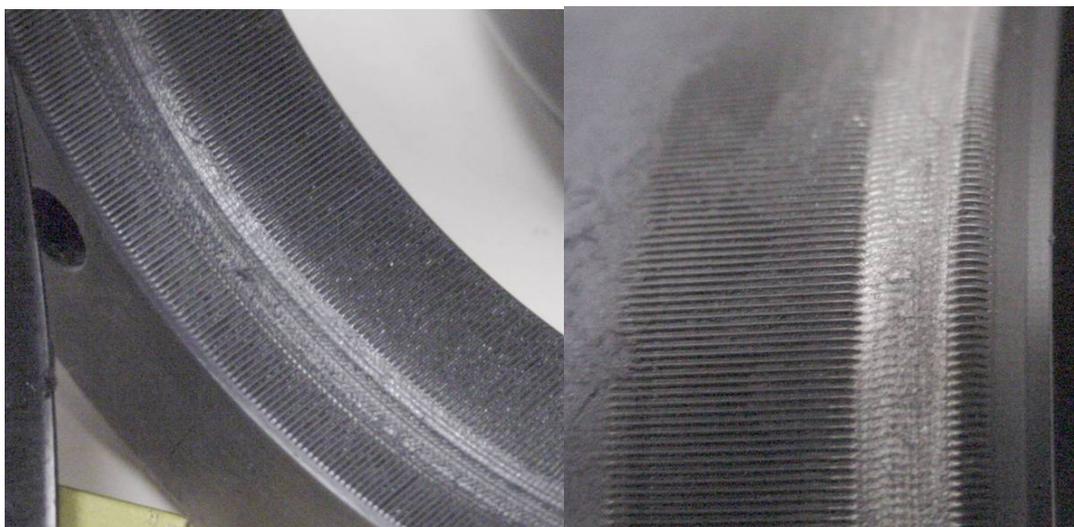
Figure 11. Circular Spline and Flexspline from Harmonic Only Test #2 Tested with Braycote® 602

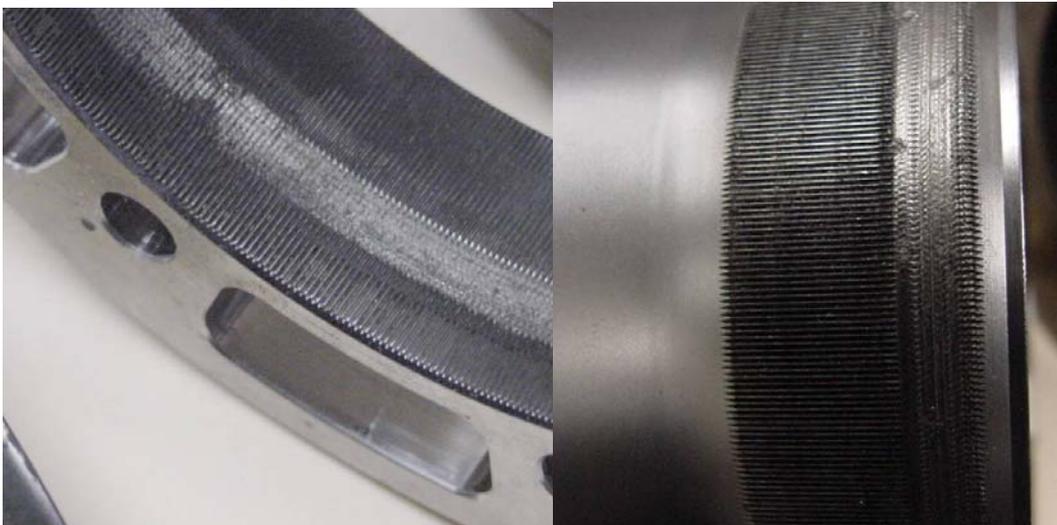
Figure 12. Circular Spline and Flexspline from Harmonic Only Test #3

Note the damaged regions show where the flexspline was engaged with the circular spline.

- The LM Harmonic Life Test #3, with nodular iron and a reduced preload, had a longer life to failure than the stainless steel, supporting the galling hypothesis. Note the regions of damage in Figure 12.

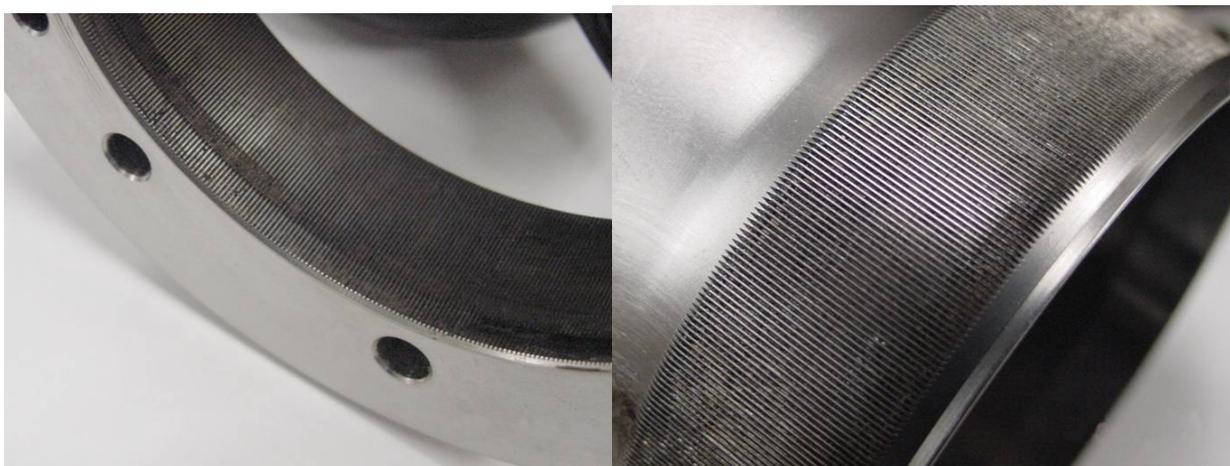
Figure 13. Circular Spline and Flexspline from Harmonic Only Test #4

Note the slight wear region on the circular spline showing where the flexspline was engaged with it.

- The LM Harmonic Life Tests #4 and #5 used Nitronic 60 for the circular spline, the highest galling threshold material that could be obtained in a harmonic gear assembly. The late date of the testing permitted a reduction of the output stiffness to two-thirds of the initial values used for the gimbal actuators. The stiffness of the test unit in test #4 was reduced as the test progressed and a method of setting the harmonic gear preload was established. The result of the life test was no failure at all with some minor wear of the harmonic gear teeth, as shown in Figure 13. The schedule dictated that the first successful combination be used, so the final material selection was a Nitronic 60 circular spline and a flexspline of E4340 with no additional surface processing. Note that schedule dictated changing more than one variable at a time.

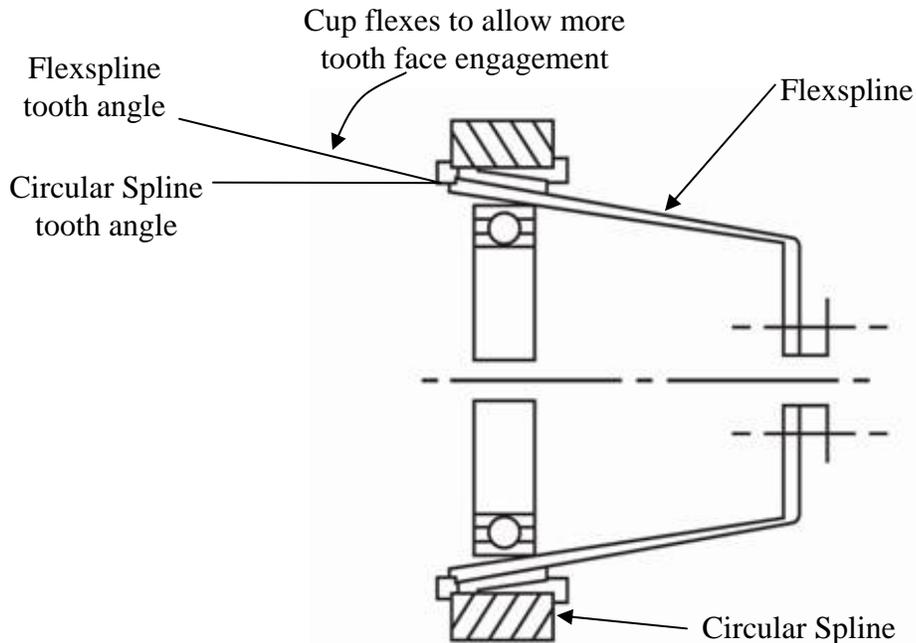
Figure 14. Harmonic Drive Cross Section Showing Significant Source of Variable Stiffness

Note the largest stresses on flexspline teeth occur at the point of initial contact, the open end of the cup.

The cup type harmonic gear assembly has zero backlash due to the angle of approach, along the rotation axis, of the flexspline teeth relative to the circular spline teeth (see Figure 14). This arrangement leads to a two-sloped stiffness curve of the output of a harmonic gear. As torque is applied to the gear, the cup flexes to allow more of the width of the teeth to engage with the circular spline. As more tooth area is engaged, more load sharing occurs and the stiffness increases. Once the angle between the teeth of the splines is reduced to near zero, the stiffness has reached its maximum value. As the torque is increased from this point, the stiffness is related to deflection of the individual teeth and the change in roundness of the housing and circular spline. Figure 15 shows a stiffness curve for one of the 15-5 PH assemblies prior to increasing the internal preload for stiffness improvement.

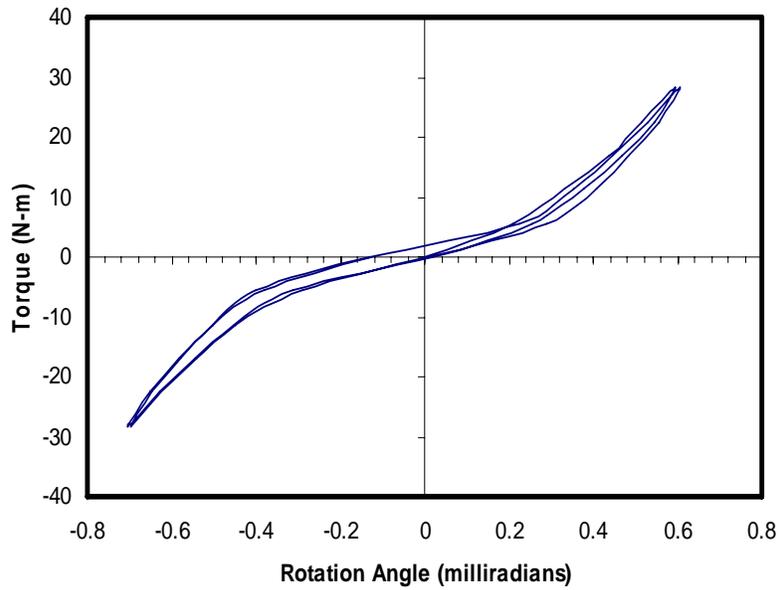
Figure 15. Harmonic Gear Assembly Stiffness as Measured on 15-5 PH Unit
 Note two regions of stiffness: low near zero torque and larger at high torques.

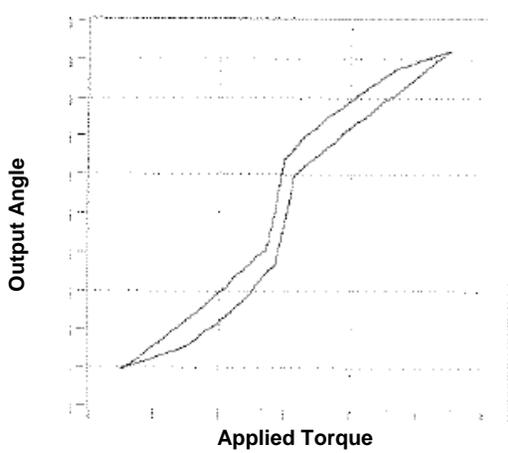
Figure 16. Stiffness Curve Showing Low Stiffness Region

The following figures are from measured data on the flight harmonic gear assemblies:
 (Note: the following figures' axes are rotated relative to Figure 15)

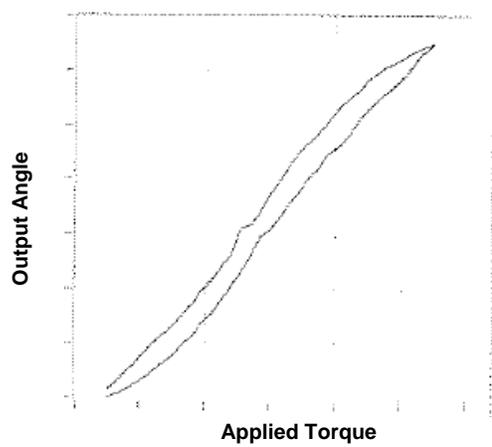
Figure 17. Stiffness Curve with Minimal Low Stiffness Region

The process of increasing the output stiffness of a harmonic drive assembly involves increasing the diameter of the wave generator in the area where it forces contact between the teeth of the two splines. This is accomplished by using a different wave generator plug with a larger major diameter of the oval. As the diameter is increased, the flexspline cup is deflected in the direction of engaging more of the face of the teeth. This has the same effect as increasing the torque on an unmodified unit in the low stiffness region. As the wave generator plug size is increased, the low stiffness region gets smaller. This trend continues until the stiffness curve is essentially straight. At this point, a further increase in the diameter of the wave generator plug will increase the overall gear assembly stiffness and significantly increase the internal tooth stresses. Figures 16 through 19 show the process of testing different wave generator plugs in one of the MRO flight harmonic drive assemblies. The low stiffness region is very evident in Figure 16. A larger plug was selected and tested again, with the low stiffness region nearly eliminated, as seen in Figure 17. Figures 18 and 19 show the next two larger size wave generator plugs, without a significant change in the shape of the stiffness curve. The selection criteria used for picking the flight plug was the smallest one that exhibited a fairly straight curve. If there was any uncertainty between units, the smaller one was always selected to guarantee that the gear teeth were not being jammed together with high, and unknown, internal stresses. The wave generator plug selected for this flight assembly was Figure 17's.

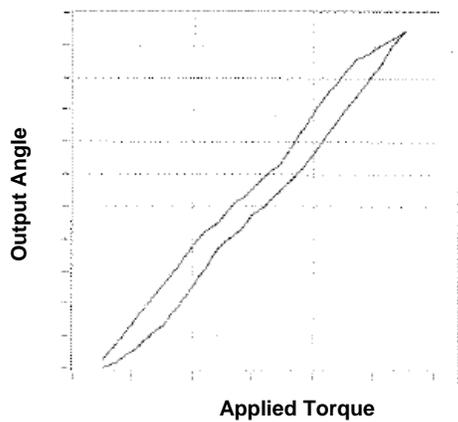
Figure 18. Next Larger Plug Size Over Figure 17 Showing Little Change

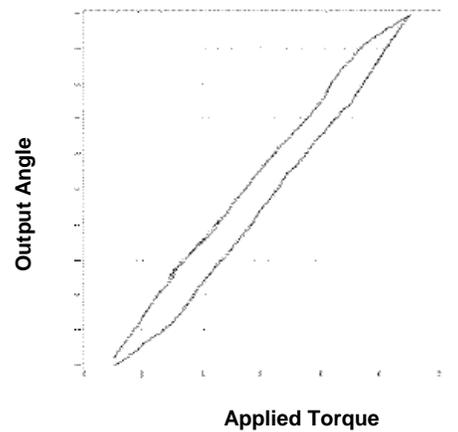
Figure 19. Next Larger Plug Size Showing Showing a Small Change in Shape
