CloudSat Safety Operations at Vandenberg AFB

Steve Greenberg, JPL System Safety Program Office

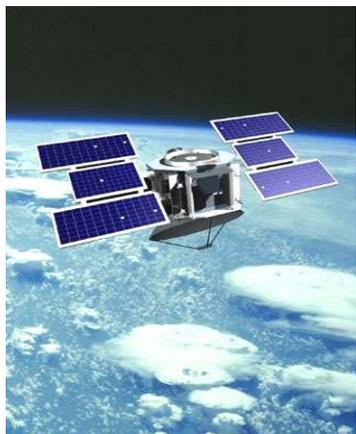
CloudSat arrives from Boulder - May 3, 2005

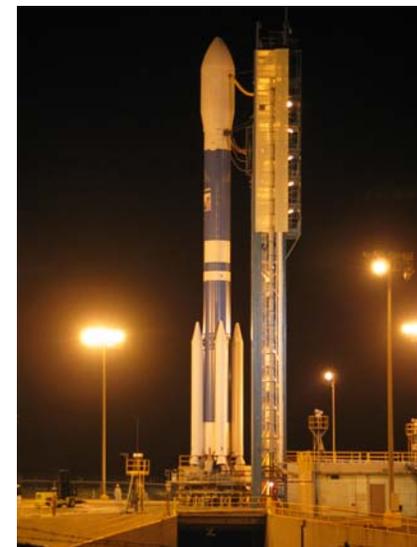
Launch at SLC-2

- Co-manifested launch with Calipso-CENA
- Delta II (7420-10C) vehicle
- Dual Payload Attach Fitting (DPAF) to accommodate two spacecraft
- CloudSat in lower DPAF attach position
- Launch from Vandenberg Air Force Base (VAFB)
- Launch vehicle mass performance
 - Mass to orbit capability = 1003 kg
 - CloudSat Measured Mass = 847.6 kg
- Launch time: 03:02:17 PST

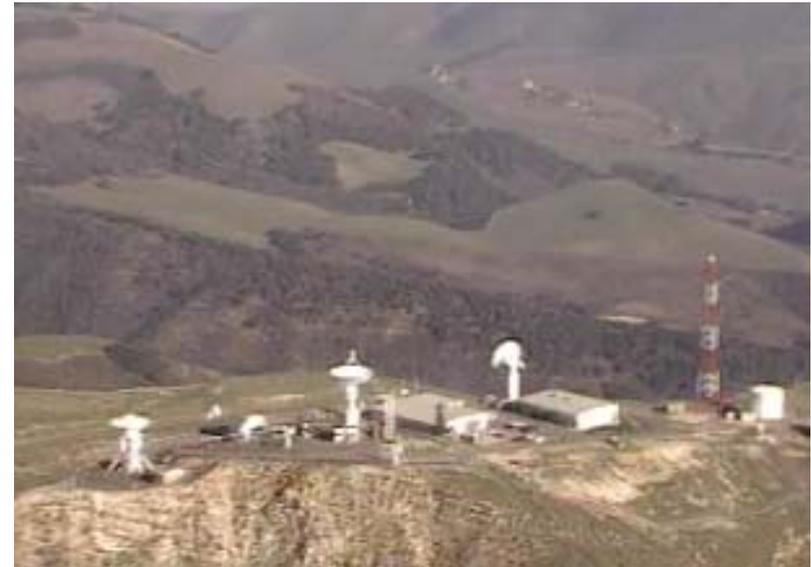
- **Vandenberg Tracking Station (VTS) range radar and tracking systems in periodic use - supporting USAF launch and space operations**
 - Periodic CloudSat receiver lock-ups occurred resulting in the inability to verify S/C system status
 - Could have resulted in additional launch delays if occurrence coincided with a launch attempt
 - NASA and Project Mgmt worked with VTS to establish sector blanking where possible, and advanced notifications of pending VTS operations
 - Communication between NASA and VTS helped assure successful launch
