## **Reliability of PWB microvias for high density package assembly**

**Reza Ghaffarian**

Jet Propulsion Laboratory  
California Institute of Technology  
Pasadena, CA, USA  
E-mail: Reza.Ghaffarian@JPL.NASA.Gov

**Reference** to this paper should be made as follows: Ghaffarian, R. (2008) 'Reliability of PWB microvias for high density package assembly', *Int. J. Materials and Structural Integrity*, Vol. 2, Nos. 1/2, pp.47–63.

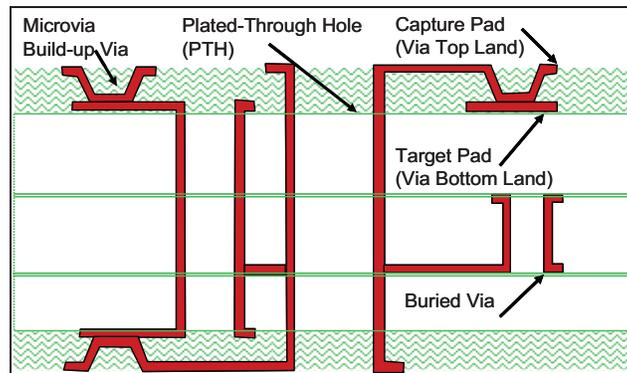
Figure 1 compares plated-through-hole (PTH), via, and microvia technologies used for conventional and fine pitch BGA (ball grid array) and CSP (chip scale package) board assemblies. The vias can be buried (providing interconnection between inner layers), semiburied (providing interconnection from one of the two outer layers to one of the internal layers), or through vias or PTHs that provide interconnection between the outer two layers. Microvias are fine feature vias that generally are blind surface vias with sizes of six mil (150  $\mu\text{m}$ ) or lower.

**Figure 1** Comparison of plated-through hole via and microvia technologies (see online version for colours)

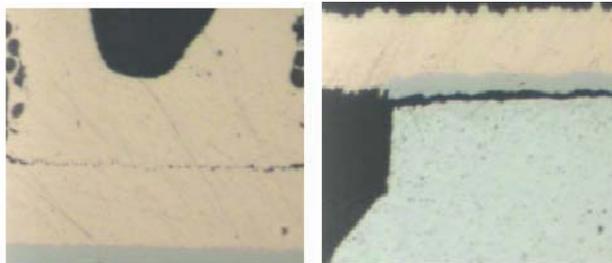
**Figure 2** Package via crack and solder joint crack during drop test (see online version for colours)

Jonnaalagadda (2002) investigated the effect of ViP on the mechanical cycle bending behaviour for 196 I/O Globtop PBGA packages with one mm pitch that were assembled on PWBs with ViP structure. Test results in conjunction with finite element analysis indicated that the ViP structure by itself does not pose a reliability risk. However, increase in applied loads could induce dielectric cracking that in turn can lead to trace and via failures.

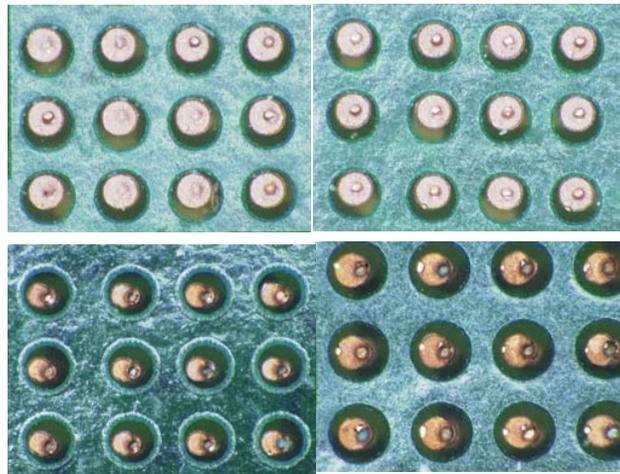
Figure 3 shows optical photomicrographs of acceptable and ‘unacceptable’ (bottom) microvias chosen from the two PWB lots. Note that visually acceptable microvias are generally located at the center of pads whereas unacceptable microvias in this case cut the pad’s edge at various distances. This condition was observed more often for finer pitch/pads array configuration than for conventional package. Even though such a condition is considered to be unacceptable from an assembly perspective, the microvia itself might be good and acceptable. Inspection by microsectioning is the only assured method of determining if the vias are acceptable.

**Figure 3** Optical photomicrographs of acceptable (top) and unacceptable microvias (see online version for colours)

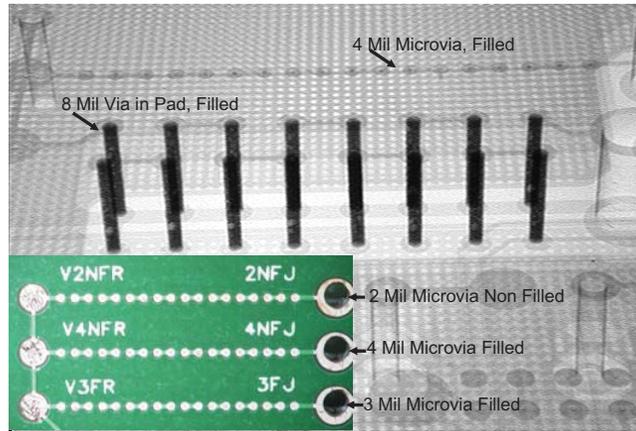
A number of microvias were designed with a daisy-chain configuration to monitor their integrity during environmental testing. Figure 4 shows representative daisy-chaining in three photomicrographs taken by optical microscopy and X-ray. Apparent in the figure are two of the daisy-chain microvias (filled) with three and four mil diameters showing darker images by X-ray, whereas the two mil microvias are unfilled (top row daisy chain). Resistance changes of these and other daisy chains were monitored during environmental tests to determine cycles to failures.

**Figure 4** X-ray and optical photographs of daisy-chain microvias, filled (dark) and unfilled vias (see online version for colours)

- Visual inspection using optical microscopy was more effective in determining the condition of the microvias than X-rays. X-ray radiography clearly identified filled vias but was of limited value for detecting other conditions. Added daisy chain pattern representative of microvia type/size/fill for evaluation was found to be valuable. Verification by microsectioning is a must similar to PTH requirement for high reliability application.

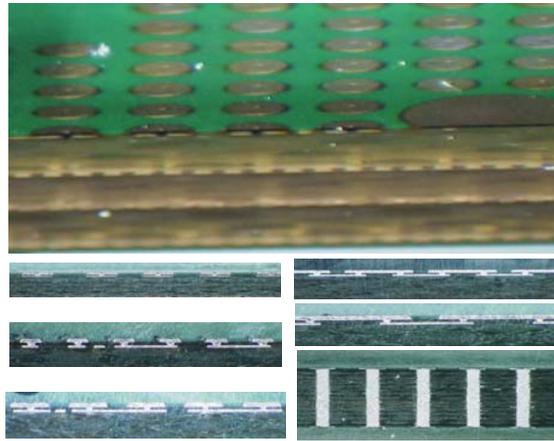
Cross-sectioning with subsequent optical and SEM characterisation was carried out to determine microvia quality and to compare these techniques to the daisy-chain resistance monitored during thermal cycling. Figure 5 shows a representative of optical photomicrographs of microvias and THViPs. Optical inspection and photomicrographs can provide some insight as to the quality of microvias, but because of their fine sizes, other more power techniques such as SEM are required to better characterise failures. A representative of SEM photomicrography showing a failure is included in Figure 6.

Figure 5 Optical photomicrographs of cross sectioned microvias and THViPs after 100 thermal cycles (-65°/150°C) (see online version for colours)

- Cross-sectional examination after 100 thermal cycles revealed cracks at via/layer interface for the two mil microvias, but no appreciable cracks for any other vias.

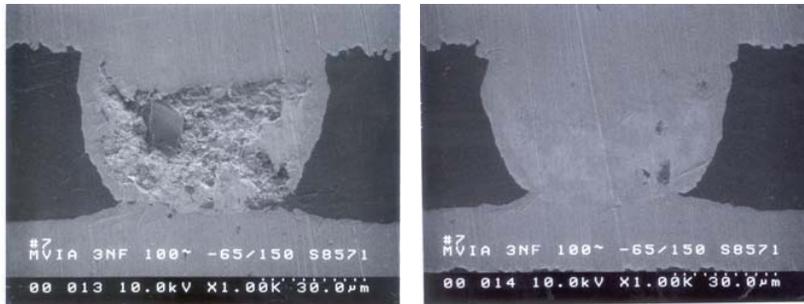
Figure 6 SEM photomicrographs cross-sectioned from a three mil nonfilled microvia after 100 thermal cycles (-65°/150°C)

Note: The microvias are filled even though a nonfilled condition set at design.

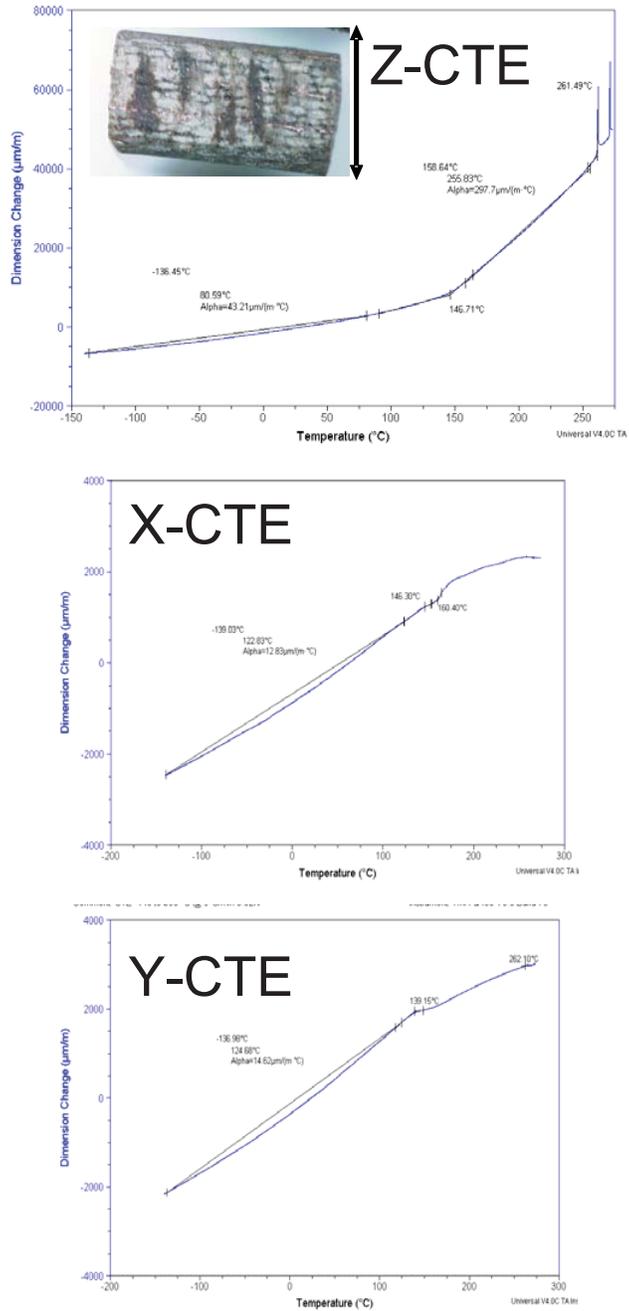
Figure 7 The x, y, z CTEs by TMA for a thermal-cycled PWB (see online version for colours)

Figure 7 shows thermal expansion and CTEs for the z, x, and y directions, respectively. The CTE for the z direction is 43.21 ppm, which is about three times that of the y and x directions having values of 14.62 and 12.83 ppm, respectively. Above the Tg, the CTE in the z direction significantly increases and become 297.7 ppm. The Tg of the PWB is about  $145^{\circ}\text{C}$  ( $146.71^{\circ}\text{C}$ ). The Tg experiences significant changes detected at about  $260^{\circ}\text{C}$ . After exposure to this temperature, the sample was cooled to RT, and it was noticed that the PWB had delaminated. It was presumed that at lower temperatures, even with repetitive exposure, delamination would not occur.

Since there was minor PWB damage due to 100 thermal cycles, representative samples from a cycled PWB, SN01, were characterised for Tg, CTE, and extreme thermal cycles. The expansion variation and therefore Tg, CTEs in x/y/z, and exposure to thermal cycling in the range of  $-150^{\circ}\text{C}$  to  $+275^{\circ}\text{C}$  were all carried out using suitable thermal mechanical analysis (TMA) equipment. Generally high stress in a PWB via or microvia occurs due to through-thickness (z direction) thermal expansion during a thermal excursion.

- TMA characterisation of cycled PWBs revealed that the Tg of the test board was about  $150^{\circ}\text{C}$  with delamination starting at  $260^{\circ}\text{C}$ .

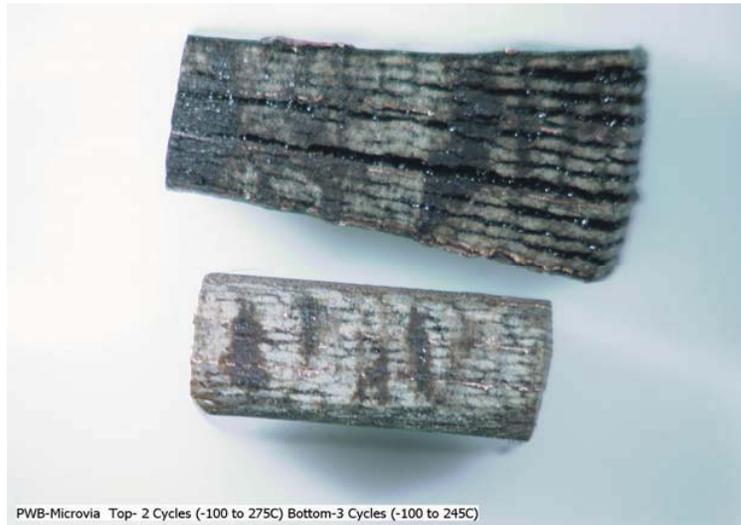
The peak reflow temperature was reduced to  $245^{\circ}\text{C}$ , representing a lead-free solder joint assembly process. Again, the TMA technique was used to determine microvia behaviour under this and a lower extreme temperature using a thermal cycle in the range of  $-100^{\circ}\text{C}$  to  $245^{\circ}\text{C}$ . Three thermal cycles were executed, while at the same time dimensional changes due to thermal cycling were continuously monitored by TMA. There was a small deviation in CTEs during the second cycle, but the deviation disappeared during the third cycle. Visual inspection after one, two, and three cycles revealed no delamination. Figure 8 compares samples from this (bottom photo) and the previous one with thermal excursion to  $260^{\circ}\text{C}$ . No delamination was noted for the  $245^{\circ}\text{C}$  maximum reflow temperature.

**Figure 8** Condition of TMA samples: the top one exposed to one cycle ( $-100^{\circ}$  to  $+275^{\circ}\text{C}$ ) and the bottom one exposed to three thermal cycles ( $-100^{\circ}$  to  $+245^{\circ}\text{C}$ ) (see online version for colours)

- TMA was also used to thermal cycle specimens between  $-100^{\circ}\text{C}$  and  $245^{\circ}\text{C}$ . The latter temperature is representative of the maximum temperature for a lead-free assembly. After three cycles, no delamination was observed. The samples exposed to  $260^{\circ}\text{C}$ , however, did exhibit delamination.
