Post-Test Analysis of the Deep Space One Spare Flight Thruster Ion Optics

John R. Anderson, Anita Sengupta, John R. Brophy

*Jet Propulsion Laboratory
California Institute of Technology
Pasadena, California*

The Deep Space 1 (DS1) spare flight thruster (FT2) was operated for 30,352 hours during the extended life test (ELT). The test was performed to validate the service life of the thruster, study known and identify unknown life limiting modes. Several of the known life limiting modes involve the ion optics system. These include loss of structural integrity for either the screen grid or accelerator grid due to sputter erosion from energetic ions striking the grid, sputter erosion enlargement of the accelerator grid apertures to the point where the accelerator grid power supply can no longer prevent electron backstreaming, unclearable shorting between the grids caused by flakes of sputtered material, and rouge hole formation due to flakes of material defocusing the ion beam. Grid gap decrease, which increases the probability of electron backstreaming and of arcing between the grids, was identified as an additional life limiting mechanism after the test. A combination of accelerato

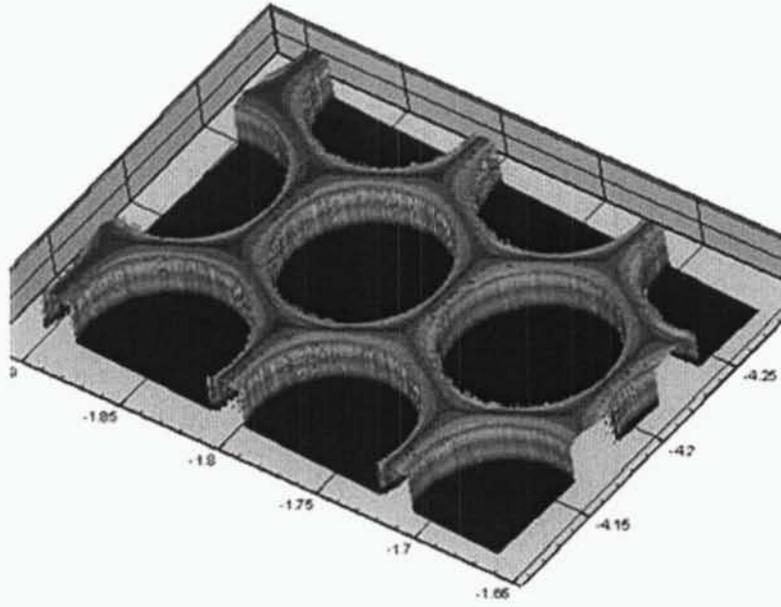
Figure 1. Upstream Screen Grid Profilometry at Center Hole

Post-test profilometry was obtained on the upstream surface of the screen grid at various locations. Shown in Figure 1 is a profilometry scan taken at the center of the screen grid. Chamfering of the upstream surface is evident; the highest points are located on the webbing at the symmetry points furthest from the three surrounding holes. Figure 2 is a two-dimensional plot of the data shown in Figure 1. Also shown in Figure 2 are lines representing cross-sections across the webbing. The path labeled A-A is a typical cut across the thin section of the webbing and is located at the 4 o'clock position in the plot; there are a total of 6 of these cross-sections shown in Figure 2. The path labeled B-B cuts through the high points and along the ridge line of the chamfer pattern. Figure 3 shows the six cuts across the thin part of the webbing (including path labeled A-A). The erosion around the center hole is nearly uniform. The difference in elevation between the ridge and the edge of the webbing is about ~ 25 μm .

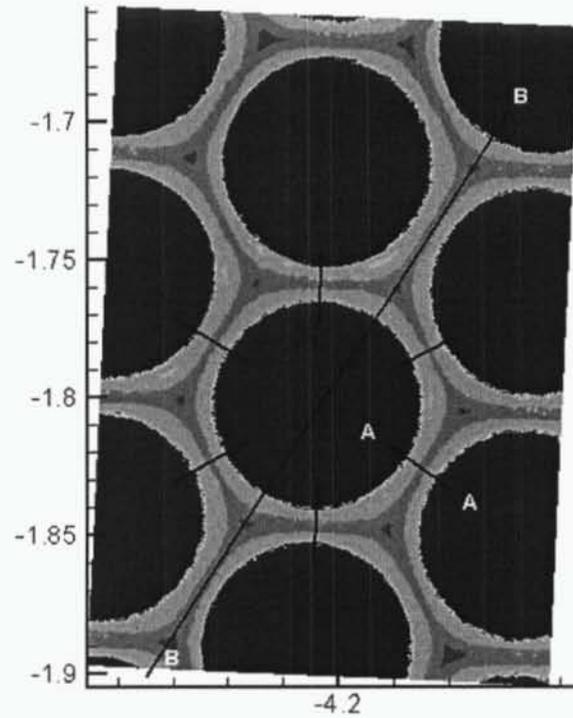
Figure 2. Upstream Screen Grid Profilometry at Center Hole

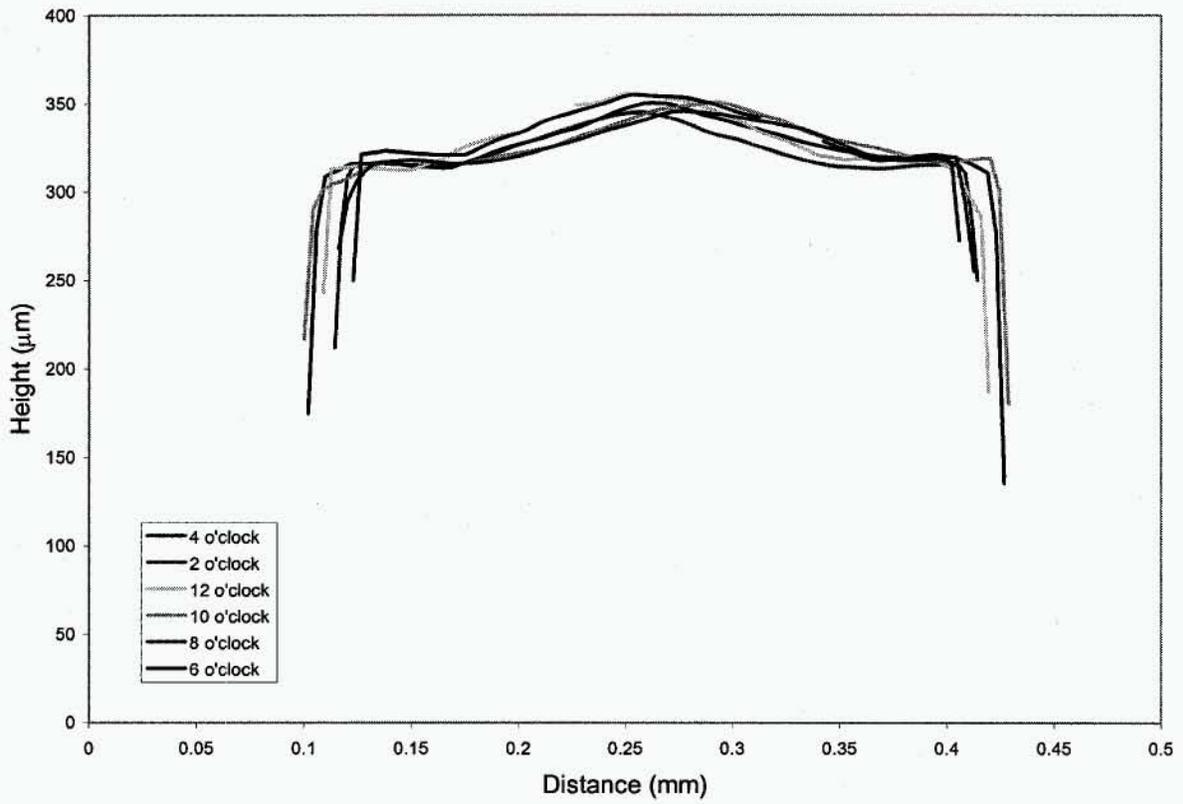
Figure 3. Upstream Screen Grid Surface Cut Along Paths A-A

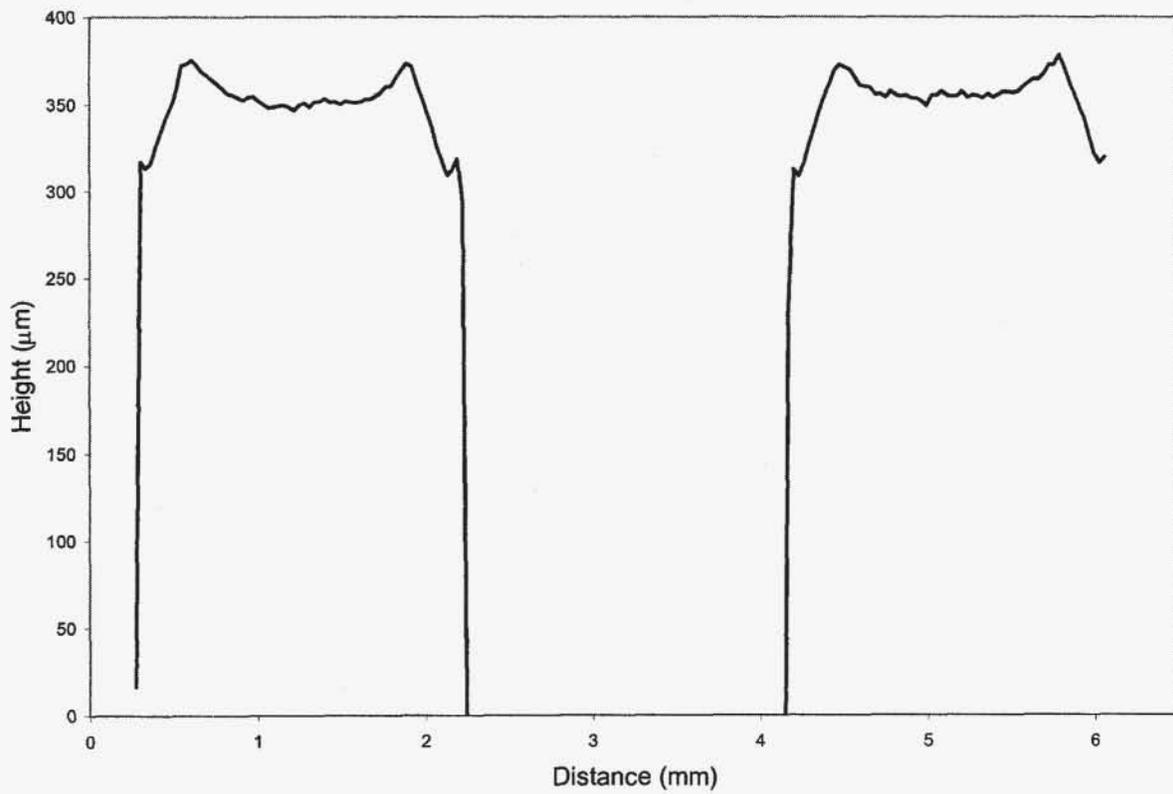
Figure 4. Upstream Screen Grid Profilometry Cut Along Path B-B

Figure 4 show the cross-section along path B-B which traverses the ridge line between two high points. The ridge drops is about ~ 25 μm between the peaks. The most severe chamfering occurs between the peaks and the hole where the height decreases about ~ 60 μm .

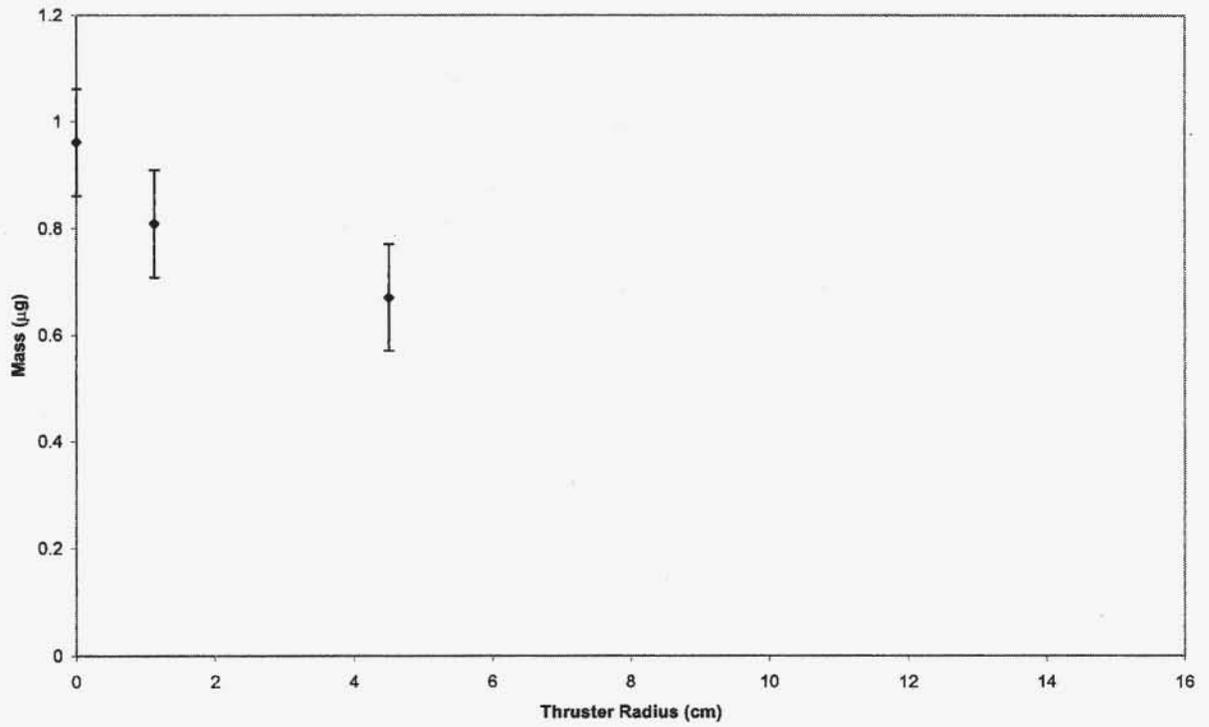
Figure 5. Screen Grid Net Mass Loss per Hole

center hole the mass loss was 0.96 mg/hole which is 17% of the initial mass of webbing surrounding the hole. Although profilometry was only obtained out to 4.5 cm thruster radius photographs show that chamfering diminishes at larger thruster radii and is almost non-existent at thruster radii greater than 8.5 cm.

Although more data will be obtained to provide information on the radial mass loss variation across the grid, the existing data along with limiting case assumptions can be used to provide minimum and maximum estimates of the net mass loss by integrating over the local mass loss data. If it is assumed that the mass loss per hole decreases to zero at 8.5 cm, the integrated net mass loss is 2.2 g. If it is assumed that the mass loss per hole is constant between 4.5 cm and 8.5 cm at the 4.5 cm radius value, the integrated net mass loss is 4.0 g. The values of 2.2 and 4.0 g are observed to bracket the measured mass loss of 3.2 g.

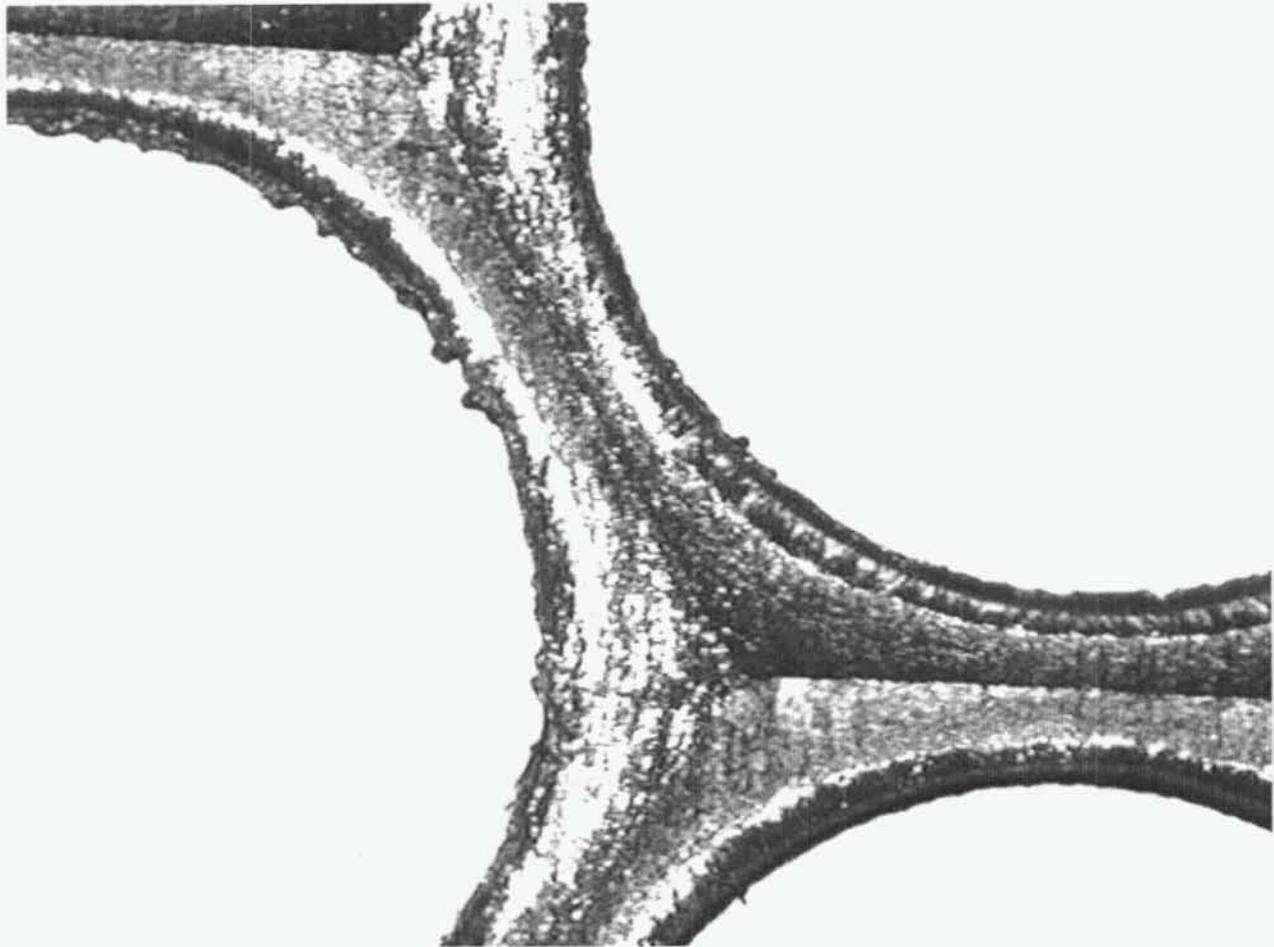
Figure 6. Screen Grid Webbing Near Center Hole Viewed From the Upstream Side

Figure 6 shows a view of the upstream side of the screen grid webbing near the center of the grid. Evident in the photo is the chamfering of the upstream side of the grid as well as rough edges along the apertures. The material protruding into the apertures is sputtered material that deposited on the downstream side of the screen grid cusp. The largest protrusion extends about 40 μm into the aperture. Since no rouge holes were observed after the conclusion of the ELT, this protrusion did not cause enough beamlet distortion to result in damage such as that observed in Ref [10]. Figure 7 shows additional photographs of the upstream side of the screen grid at locations where profilometry was obtained. In the ELT screen grid these protrusions are evident in the photographs at thruster radius out to 2.3 cm and are not discernable in the photographs at and beyond 3.4 cm thruster radius.

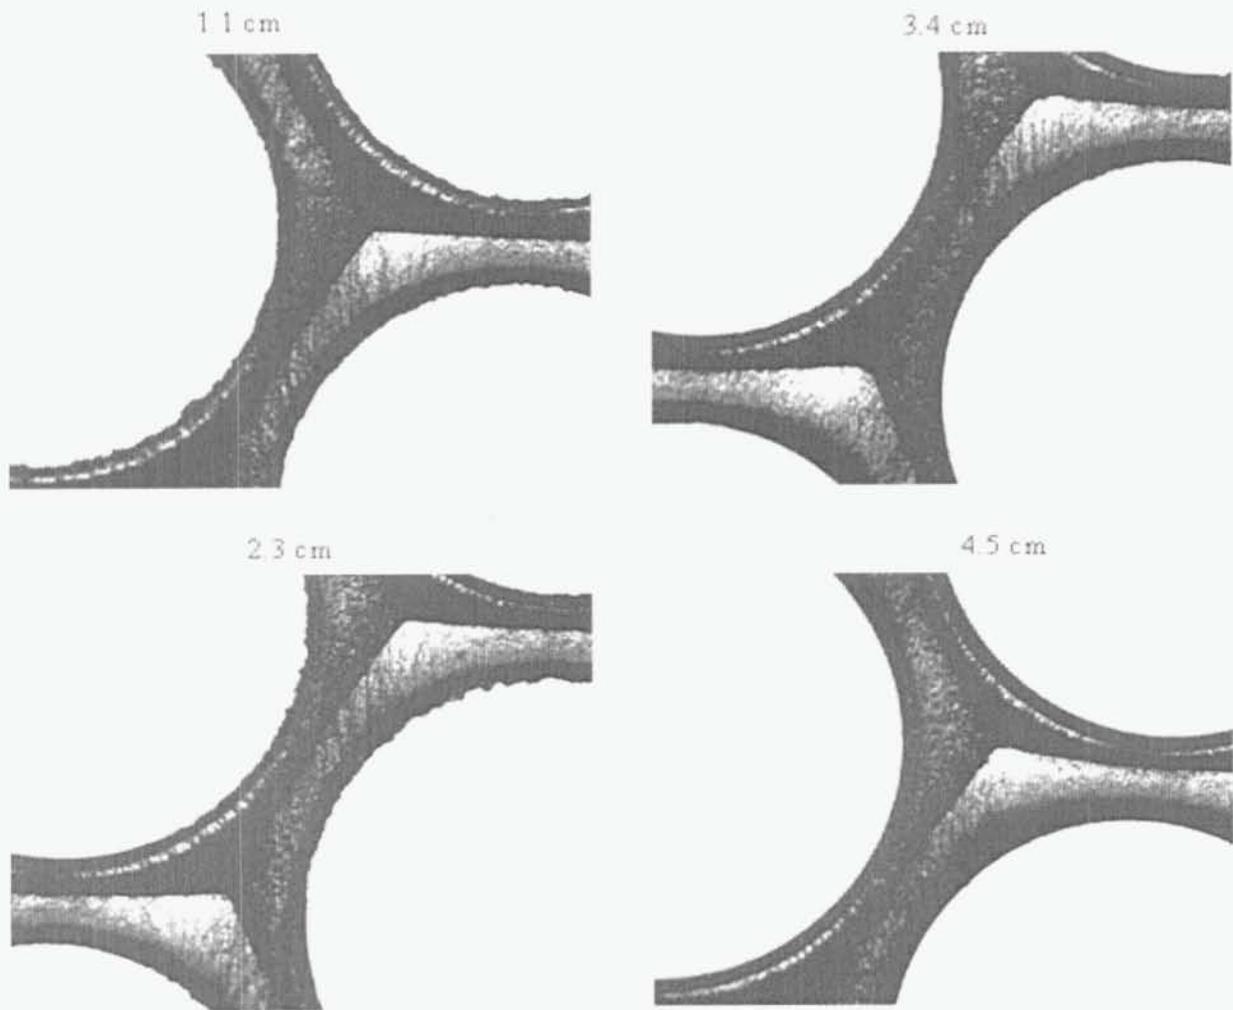
Figure 7. Screen Grid Webbing at Locations Where Profilometry was Obtained

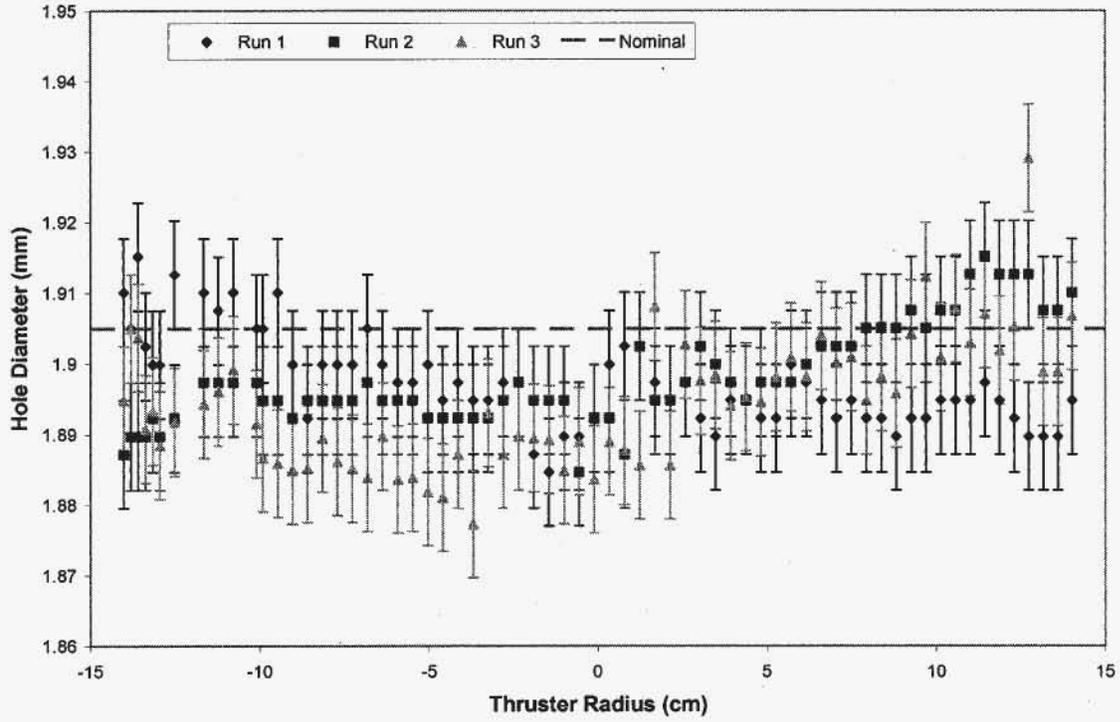
Figure 8. Post-test Screen Grid Aperture Diameter

Figure 8 shows post-test screen grid aperture diameters measured with an optical CMM. The nominal manufactured aperture diameter is shown for reference; measured pre-test aperture diameters were within 0.01 mm of the nominal dimension. The data in Figure 8 suggest that the screen grid hole diameters decreased slightly less than 1% due to sputter deposited material accumulating on the downstream side of the grid.

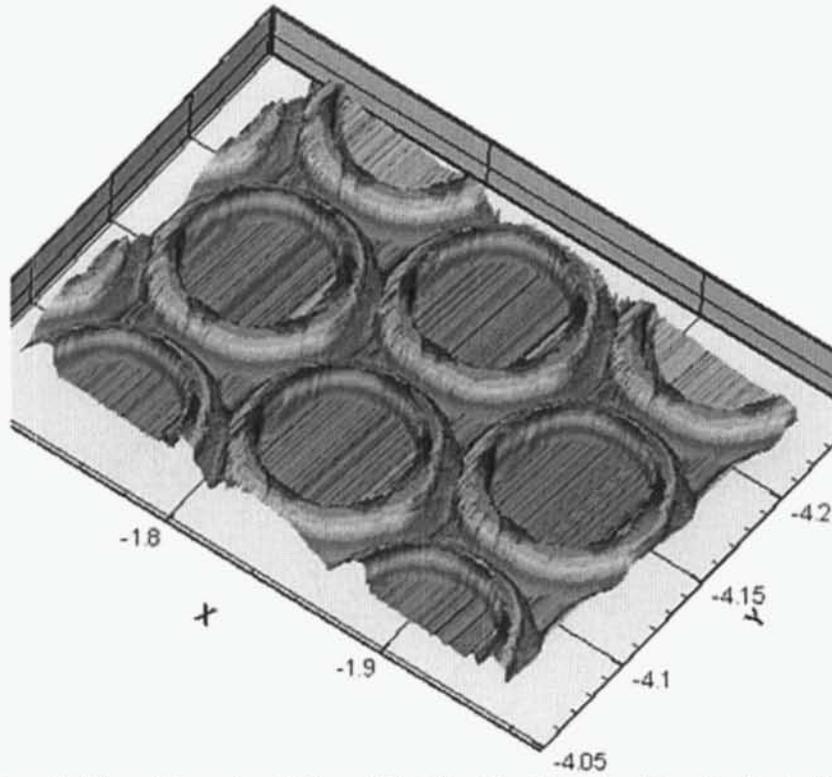
Figure 9. Three-Dimensional View of Post-Test Profilometry Near the Center Hole

After the conclusion of the ELT profilometry data was obtained at a number of locations on the accelerator grid. Figure 9 shows a three-dimensional view of profilometry data taken on the downstream side of the accelerator grid at a location near the center of the grid. The pits and grooves pattern on the webbing between the apertures is clearly visible. Figure 10 a two-dimensional plot of the same data. Also shown in Figure 10 are lines cutting through cross-sections of the bridge pattern (section A-A) and through the pits and grooves pattern (section B-B).

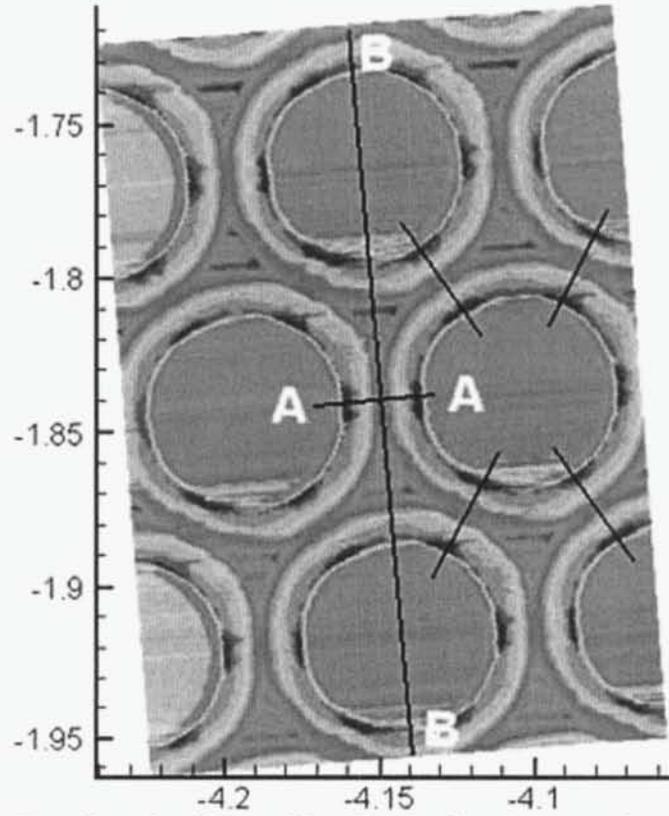
Figure 10. Two-dimensional View of Post-Test Profilometry Near the Center Hole

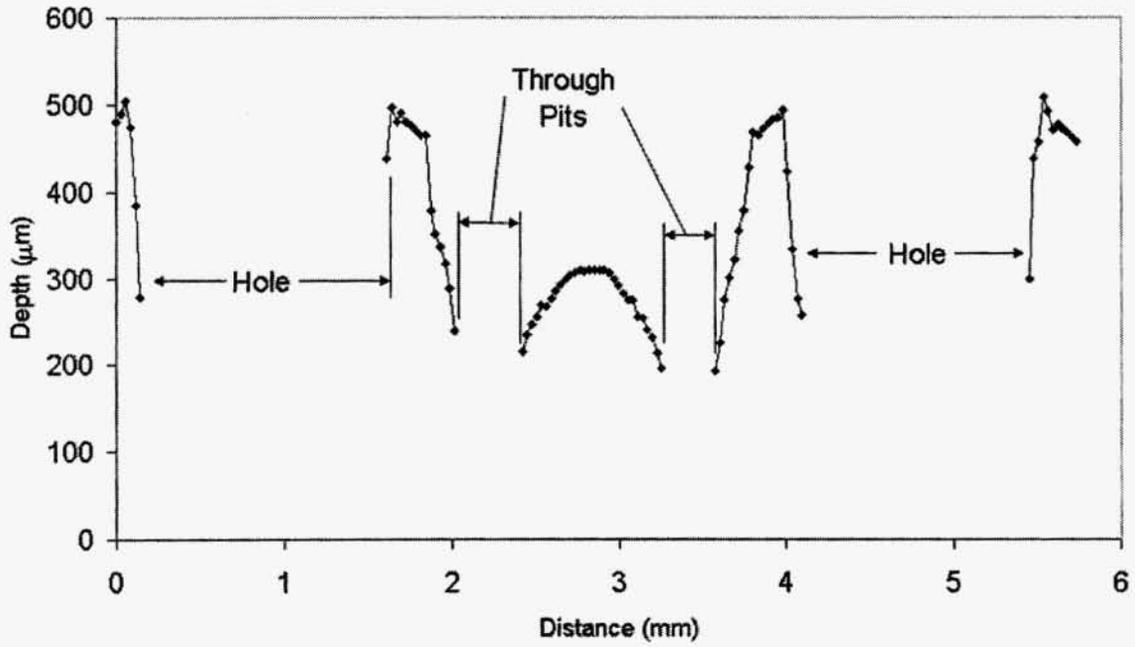
Figure 11. Cross-Section Through Pits and Grooves Pattern of Profilometry Data Near Center Hole

The cross-section through the pits and grooves pattern near the center of the grid is shown in Figure 11. The cross-section cuts through two holes, the pits centered in the regions of the webbing furthest from the three holes surrounding each pit, and through the groove between two pits. During the ELT the pits wore completely through the grid inside a thruster radius of 5.6 cm. The grooves in the vicinity of the center hole eroded to a depth of 230 μm or about 45% of the thickness of the grid.

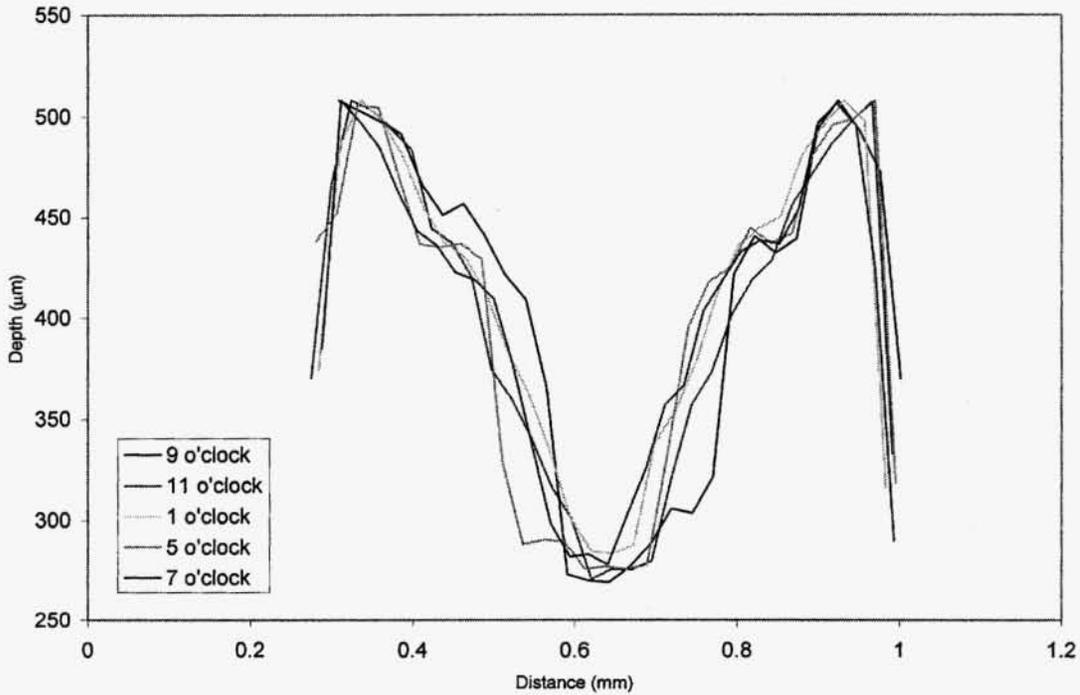
Figure 12. Cross-Sections Through Grooves and Center Hole

To determine if there were variations in the groove depth around the center hole, cross-sections of the profilometry data along the five lines cutting through the grooves shown in Figure 10 (section A-A) were obtained. These cross-sectional data are shown in Figure 12. The erosion pattern appears to be uniform around the center aperture. All 5 cross-sections are similar and the depth of the groove is about 230 μm .

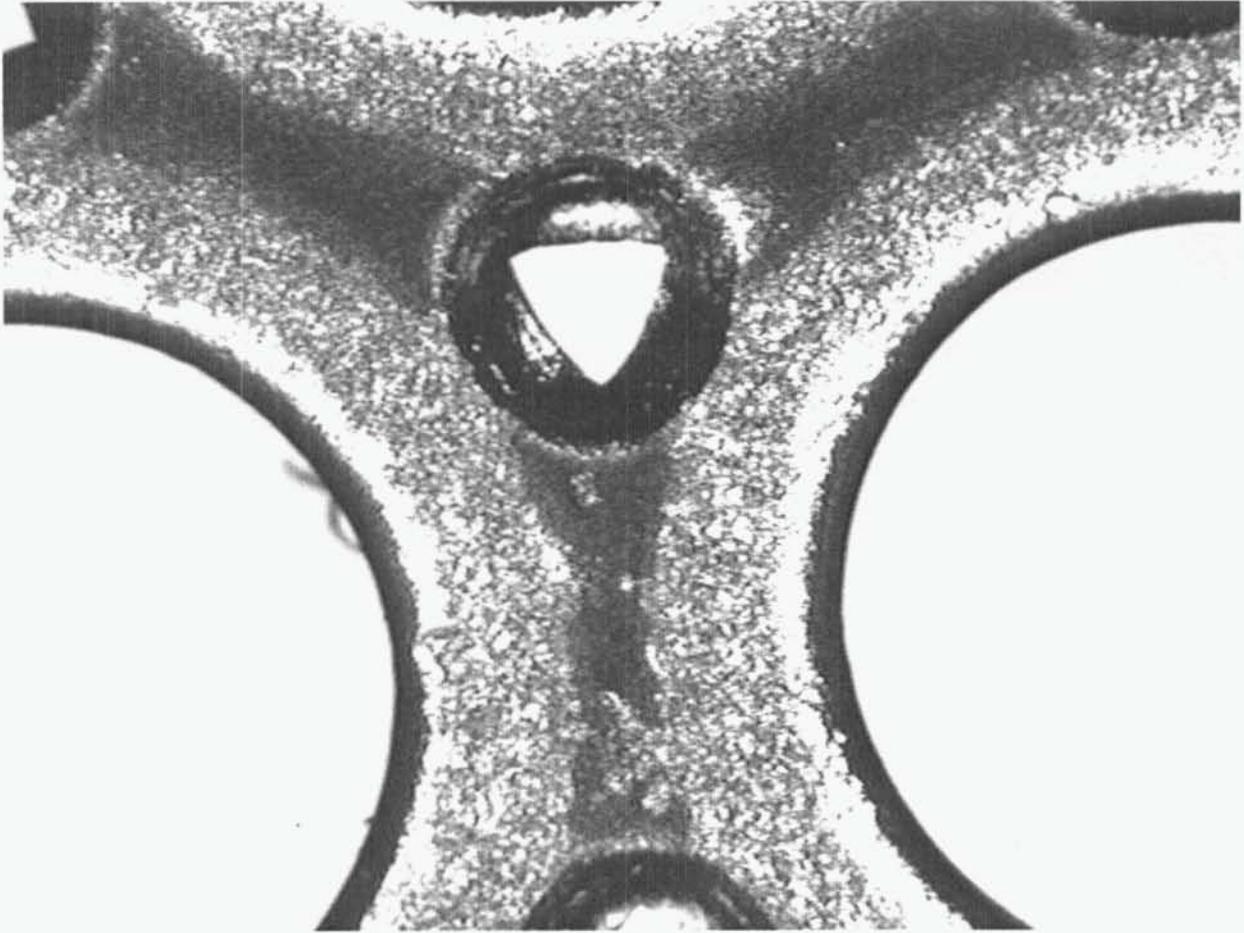
Figure 13. Accelerator Grid Upstream Side Undercutting at Through Pit

When the groove erodes through the webbing the accelerator grid structurally fails. Once through pits occur, ions travel through the holes and are reflected back onto the upstream side of the accelerator grid. These reflected ions begin to undercut the upstream side of the grid, hastening loss of structural integrity. This undercutting is evident in Figure 13, which shows the upstream side of the accelerator grid near the center of the grid. The triangular through pit is surrounded by an oval shaped region which has been undercut to a depth of 65 μm . It is estimated that the accelerator grid lost 0.3 g of mass in the undercuts.

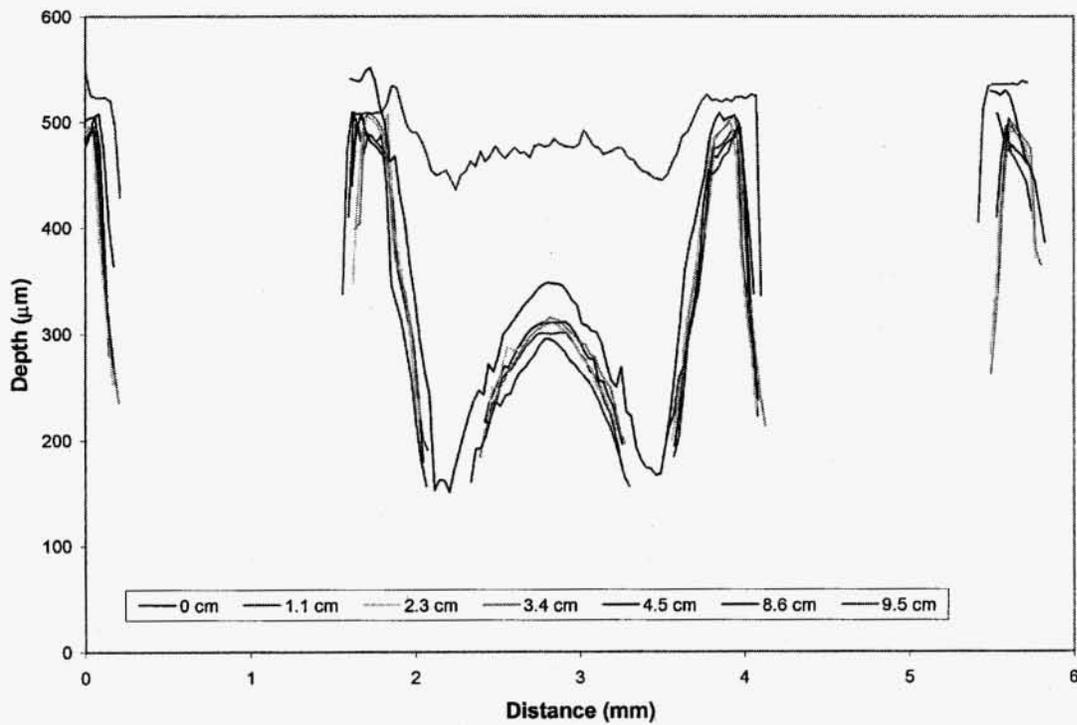
Figure 14. Pits and Grooves Cross-Sections to 9.5 cm Thruster Radius

Pits and grooves cross-sections from the center out to 9.5 cm thruster radius are shown in Figure 14. The eroded depth in the groove region is nearly uniform out to a radius of 4.5 cm. The depth decreases slightly between 4.5 cm and 8.6 cm. Between 8.6 and 9.5 cm the eroded depth decreases to almost zero, indicating that the beam current density is significantly lower at thruster radii greater than 9.5 cm than it is in the central portion of the thruster.

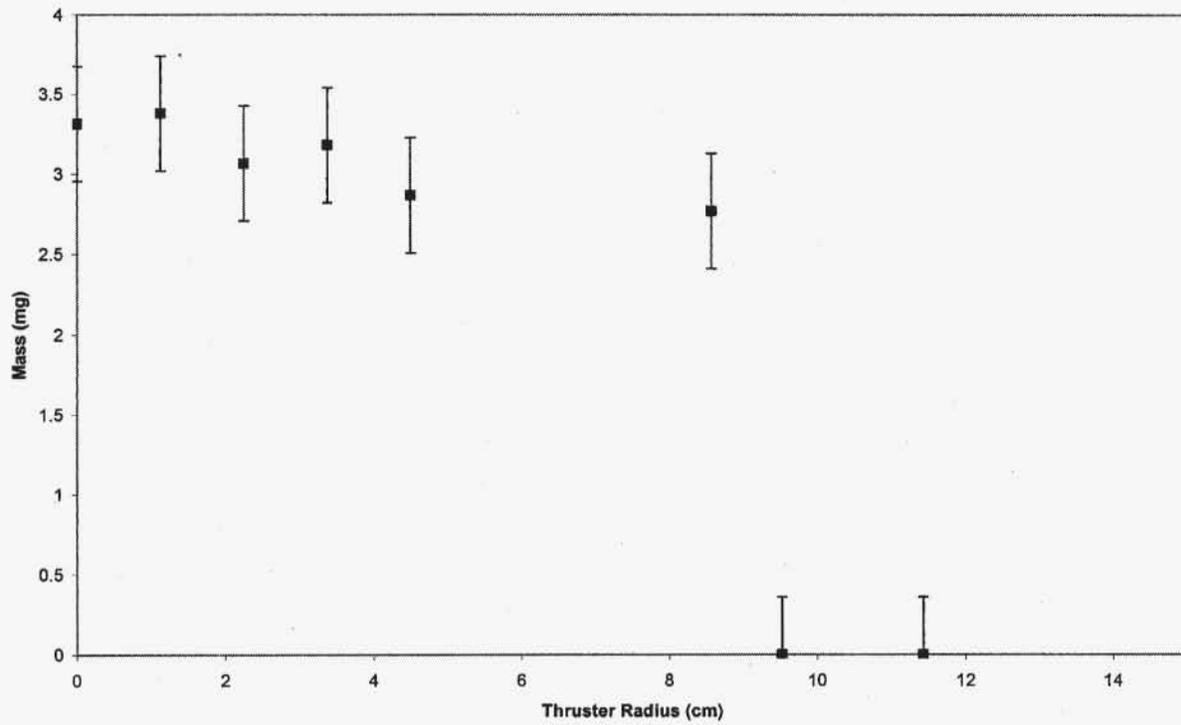
Figure 15. Mass loss in pits and grooves pattern

The downstream accelerator grid profilometry data was integrated to determine the volume remaining in the webbing. This was subtracted from the initial (uneroded) webbing volume and the difference multiplied by the mass density of the grid material to determine the mass loss in the pits and grooves pattern. Figure 15 shows integrated mass loss per hole in the pits and grooves pattern. Each pit is split between 3 holes and each groove between 2 holes. Since there are 6 pits and 6 grooves surrounding each hole, there are two pits and three grooves associated with each hole. The mass loss per hole is ~3.5 mg/hole near the center of the grid and decreases to about 2.8 mg/hole at about 8.6 cm. The grid transitions from net erosion to net carbon deposition between about 8.6 cm and 9.5 cm. The mass loss data was integrated over the grid yielding an estimate of 17.3 g mass loss in the pits and grooves pattern.

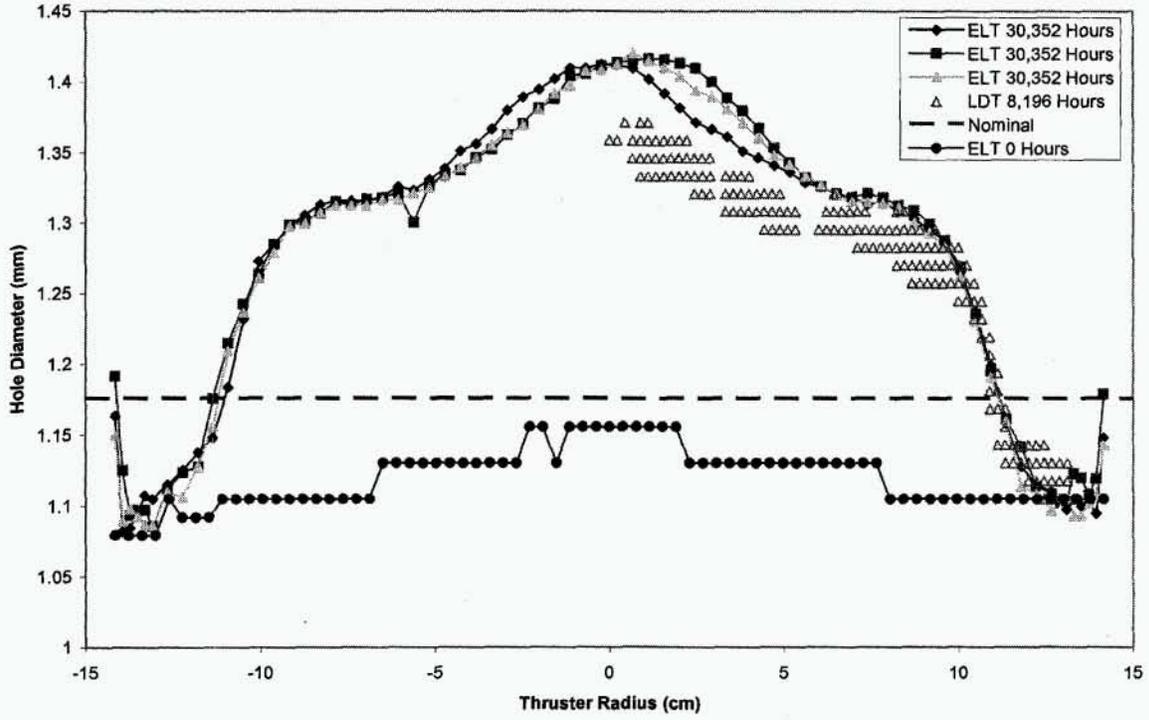
Figure 16. Post-Test Accelerator Grid Aperture Diameters

Accelerator grid aperture diameters measured after the ELT and LDT are shown in Figure 16. The post-test ELT data in Figure 16 were taken across the grid at three different azimuthal locations. The differences in the data indicate that the wear pattern is azimuthally asymmetric.

The diameters shown are the minimum aperture diameter. Photographs of the grids suggest that the apertures were chamfered toward the downstream surface after the ELT. Although better measurements of the eroded aperture cross-sections will be made after the grids are sectioned, it is estimated from the photographs that the downstream screen diameter is ~15% larger than the upstream diameter for thruster radii less than about 8.6 cm. Using this estimate and averaging the aperture diameters shown in Figure 16, the mass loss per hole due to aperture wall erosion, shown in Figure 17, was estimated. It is estimated that 2.7 mg per hole is lost near the center of the thruster and the mass loss per hole decreases to almost zero at large thruster radii. Cross over ions resulting from poor focusing, due to low plasma density, results in erosion of near the edge of the grids; this causes the increase in mass loss per hole at the outer edge of the grid. Integrating the mass loss per hole over the grid yields an estimate of 12.2 g lost due to aperture wall erosion.

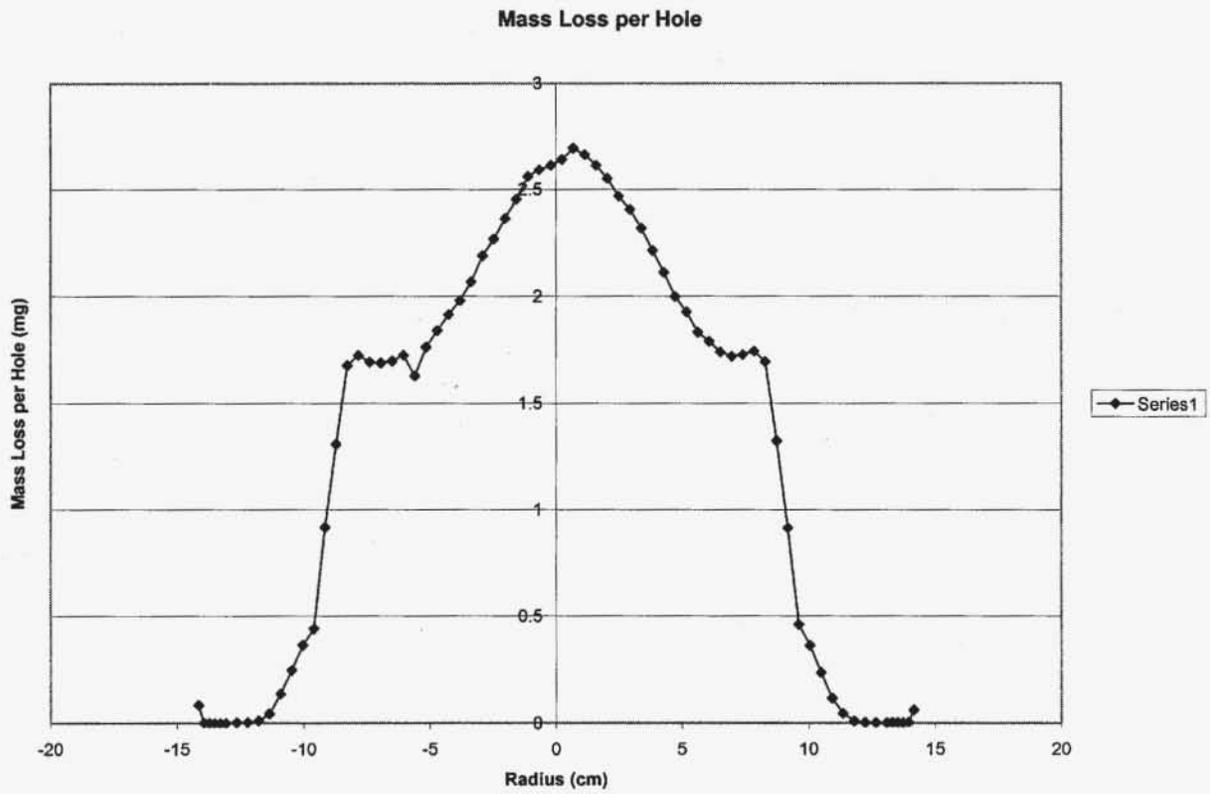
Figure 17. Estimated Mass Loss per Hole due to Aperture Wall Erosion

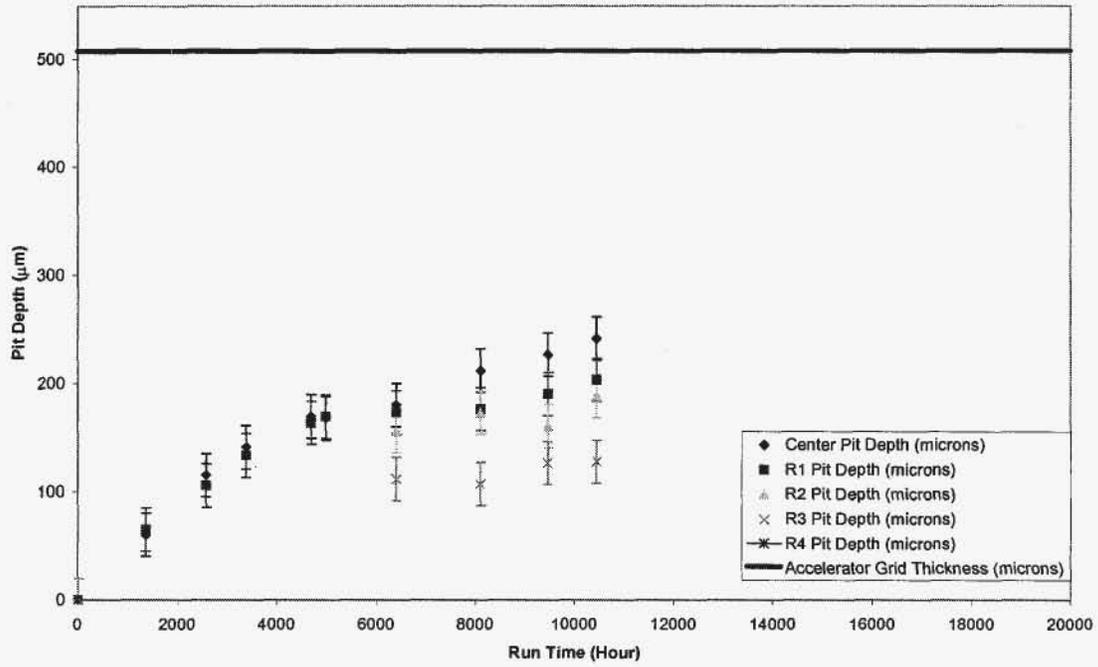
Figure 18. ELT Pit Depth Data

Profilometry was performed on the webbing adjacent to the center hole and along a radius at 2.9, 5.7 and 8.6 cm from the center of the grid. The pit depth at the center hole at the conclusion of the full power segment was 170 μm ; the pit depth at the center of the accelerator grid during the LDT, which was run at full power, was about 155 μm at the same run time [17]. During both the ELT and the LDT initial erosion rate over the first ~2,000 hours was about 45 $\mu\text{m}/\text{hr}$. After ~2,000 hours the center hole pit erosion rate decreased to an approximately constant rate of 25 $\mu\text{m}/\text{hr}$. In the ELT after ~2,000 hours the center aperture pit erosion rate was 23 $\mu\text{m}/\text{hr}$ until the throttle level was changed at 4,937 hours. During the ELT 1.46 kW test segment, the center hole pit erosion rate was 13 $\mu\text{m}/\text{hr}$.

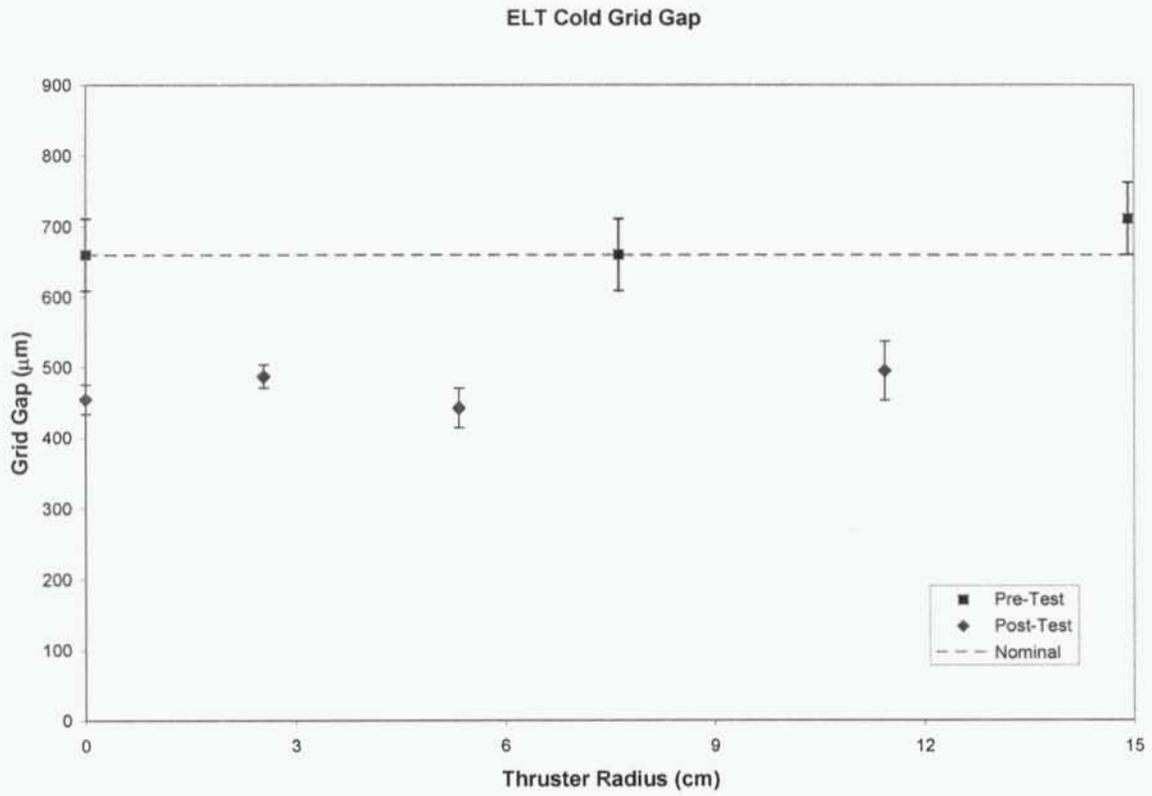
Figure 19. ELT Cold Grid Gap Change

As noted earlier the gap between the screen and accelerator grids decreased during both the ELT and the LDT. The pre- and post-test grid gap data are shown in Figure 19. The cold grid gap changed from the nominal value of 660 μm prior to the test to a post-test gap of 460 μm ; this change in gap contributed to the thruster electron backstreaming limit being exceeded at full power during the ELT.

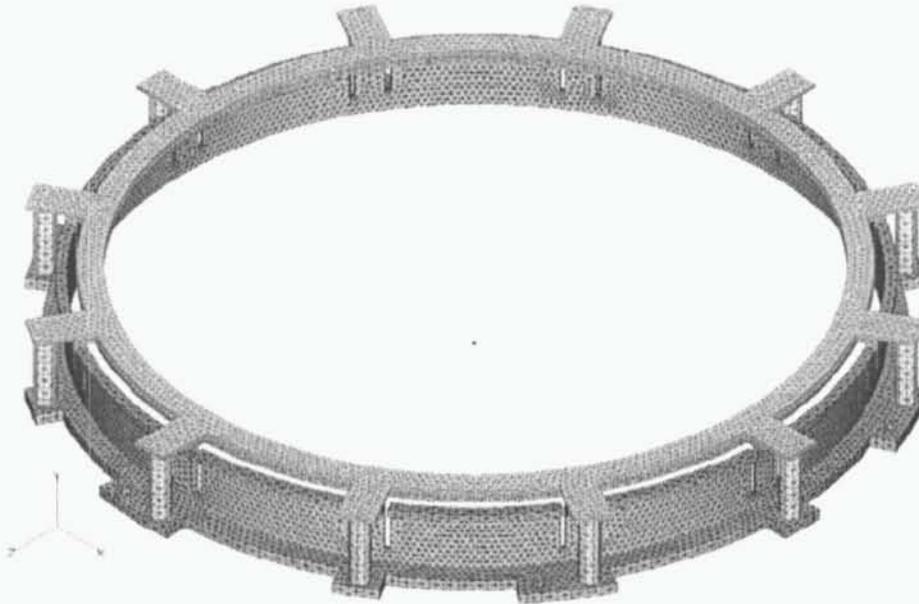
Figure 20. ELT Optics Assembly Model Used in Structural Analysis of Accelerator Grid Stiffening Ring

In order to determine what caused the grid gap change, a preliminary structural analysis of the ion optics system was performed. The finite element model used in the analysis is shown in Figure 20. Shown are the accelerator grid stiffening ring mounted on top the optics ring which attaches to the thruster. The accelerator grid electrode, which attaches to the stiffening ring, was modeled analytically and is not shown in the finite element model drawing. Residual stresses from the manufacture of the electrode were determined and applied to the stiffening ring. During thruster operation at normal optics temperatures (~200 C) the residual stresses in the electrode transmit forces to the stiffening ring which result in a stress level of ~75 ksi in the stiffening ring. The stress levels in the stiffening ring are shown in Figure 21. The yield strength for the molybdenum stiffening ring is 80 ksi at room temperature but the yield strength decreases to about 63 ksi at 200 C; as a result permanent deformation of the stiffening ring tabs is expected. Under these conditions the prediction from the analysis is that the grid gap will decrease to 400 μm .

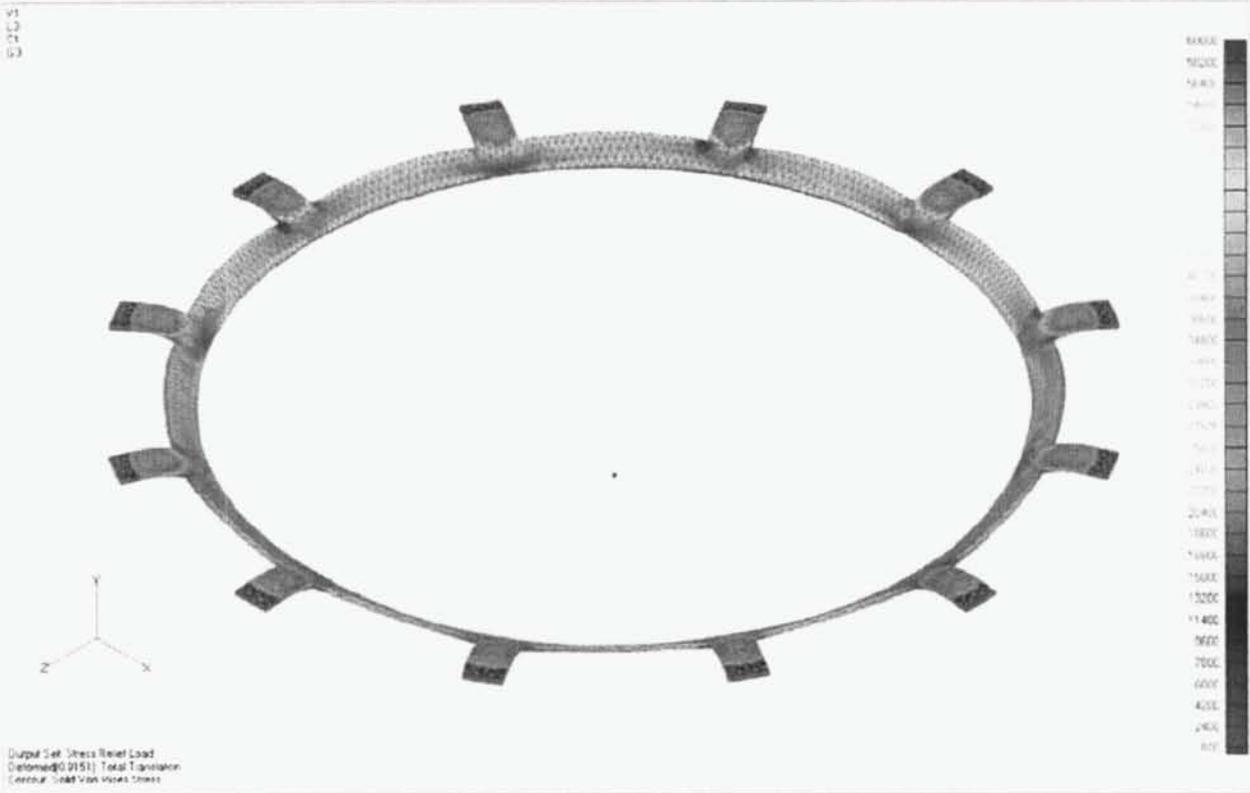
Accelerator Ring, FEA Results, Stress Relief Load

Figure 21. Computed Residual Stress Load (Von Mises Stress) of the Accelerator Grid Stiffening Ring

In the preliminary structural analysis, it was assumed that the accelerator grid electrode did not exceed its yield strength; however, the post-test measurement show that both the electrode and the stiffening ring deformed. The accelerator grid electrode is domed with a flat area at the outer edge which is riveted to the stiffening ring. After the ELT the stiffening ring was detached from the electrode. The outer edge of the stiffening ring tabs, which was designed to be flat, were deflected up an average of 50 μm . The outer edge of the electrode, which also was designed to be flat, had deflected upward by an average of 210 μm . Although the accelerator grid electrode needs to be modeled more accurately, the conclusion from the structural analysis is that the grid gap change is caused by residual stresses introduced during the manufacturing of the grids. In order to correct this problem, the electrode should be stress relieved or the optics assembly should be redesigned to accommodate the manufacturing stresses.
