## **Pinhole Effects on Venus Superpressure Balloon Lifetime**

Jeffery L. Hall and Andre H. Yavrouian

Jet Propulsion Laboratory  
California Institute of Technology

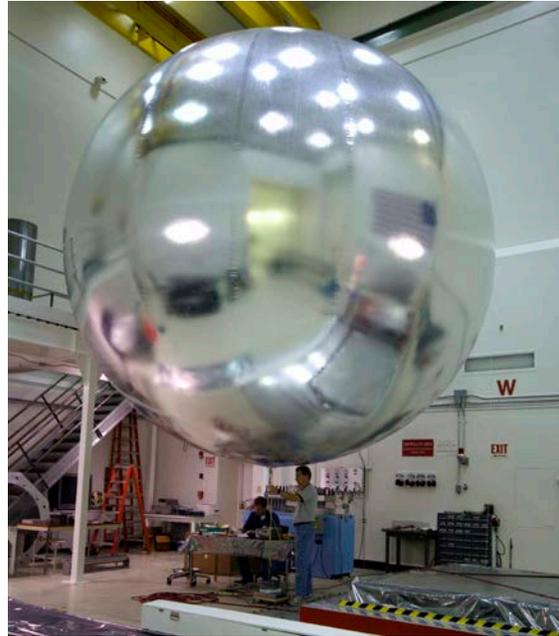
Fig. 1: 5.5 m diameter Venus prototype balloon undergoing testing in 2008. It used the laminate material described in Fig. 3.

JPL has led a technology development effort in recent years aimed at producing a Venus superpressure balloon that can carry a large payload in the range of 40-120 kg at a 55.5 km altitude for one (Earth) month.<sup>1,2,3</sup> Two 5.5 m prototypes have been constructed (Fig. 1) and tested under a variety of conditions. This includes a successful floating test in the laboratory that exceeded one month of duration without losing all superpressure (Fig. 2). The deduced leakage rate from that experiment was consistent with helium diffusion through the envelope material and demonstrated that there were no pinhole defects through the material.

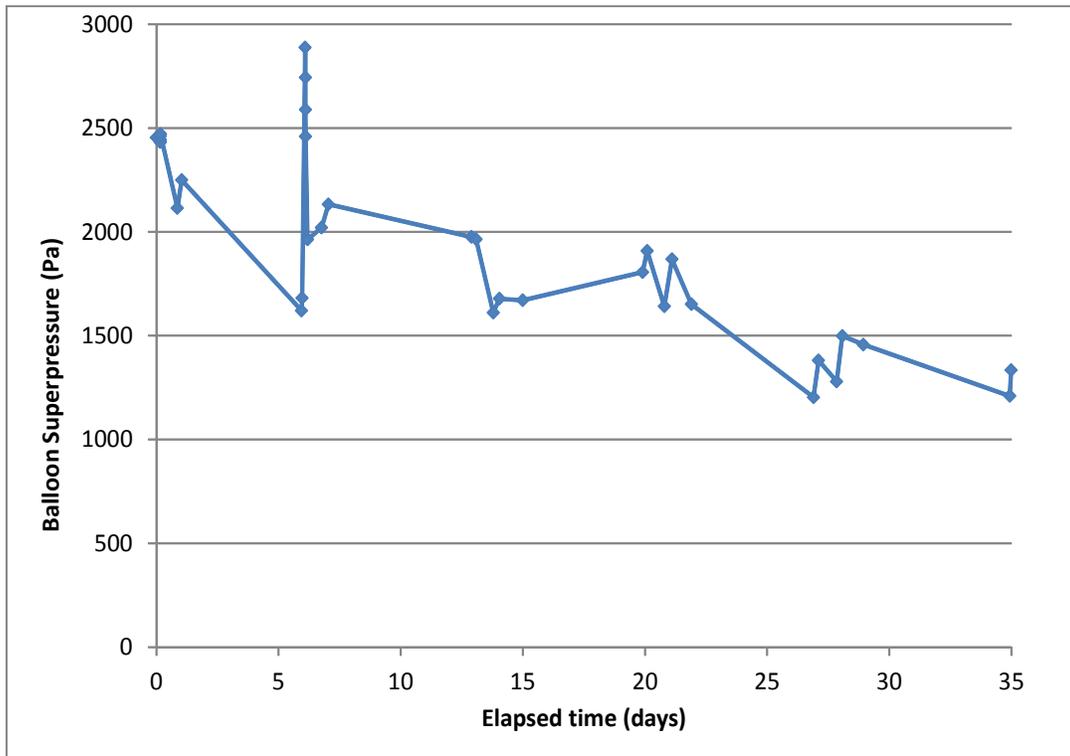
Fig. 2: Venus balloon 35 day buoyancy test data demonstrated pinhole-free performance. Non-smooth data trend reflects small changes in ambient temperature and barometric pressure in the laboratory.

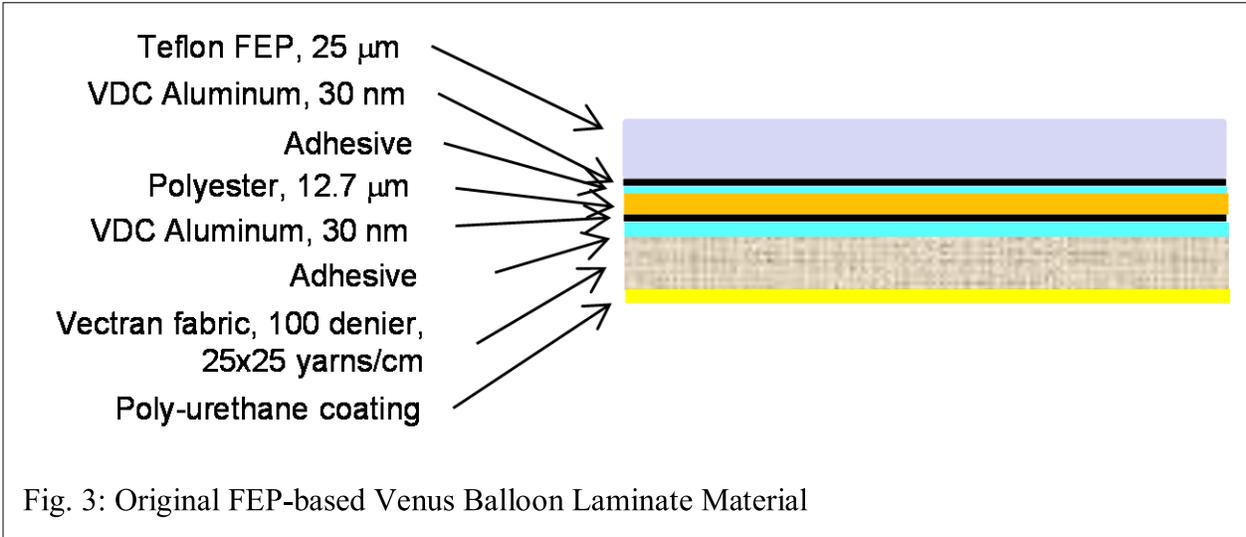
1. The original JPL balloon material (Fig. 3)<sup>3</sup> consisting of:
  - An outside layer of 25.4  $\mu\text{m}$  thick fluorinated ethylene propylene (FEP) film. This film is metalized with a 30 nm vapor deposit coated (VDC) layer of aluminum on the inside surface to reflect sunlight.

- A layer of 12.7  $\mu\text{m}$  thick polyester film. This serves as the primary barrier to helium permeation through the laminate. This layer is also metalized with a 30 nm VDC layer of aluminum on the inside surface.

- Vectran fabric composed of 100 denier yarns. This is the strength element of the laminate.
  - A polyurethane coating on the inside Vectran surface. This coating assists with the adhesion of tapes to form gore-to-gore seams in the balloon.

- Adhesives to connect all of the layers together.
2. The current JPL balloon material (Fig. 4) consisting of:
  - An outer protective layer of 12.7  $\mu\text{m}$  thick perfluoroalkoxy (PFA) film. This is the primary acid barrier.

A total of 8 material samples were tested in the apparatus described in Fig. 6. Seven utilized the FEP-based laminate (Fig. 3), taken from surplus material left over from the original manufacturing run in 2006. The eighth sample was PFA-based (Fig. 4), taken from a newly manufactured laminate in 2012. The entire test sequence is summarized in Tables 1 and 2 for the FEP and PFA samples respectively. Note that most of the tests are divided into an “a” and a “b” phase: this denotes the same material sample kept in the same apparatus, but subjected to a significant change in the test conditions. These changes are noted in the Tables and generally correspond to a change in and/or stoppage of the gas flow rate.

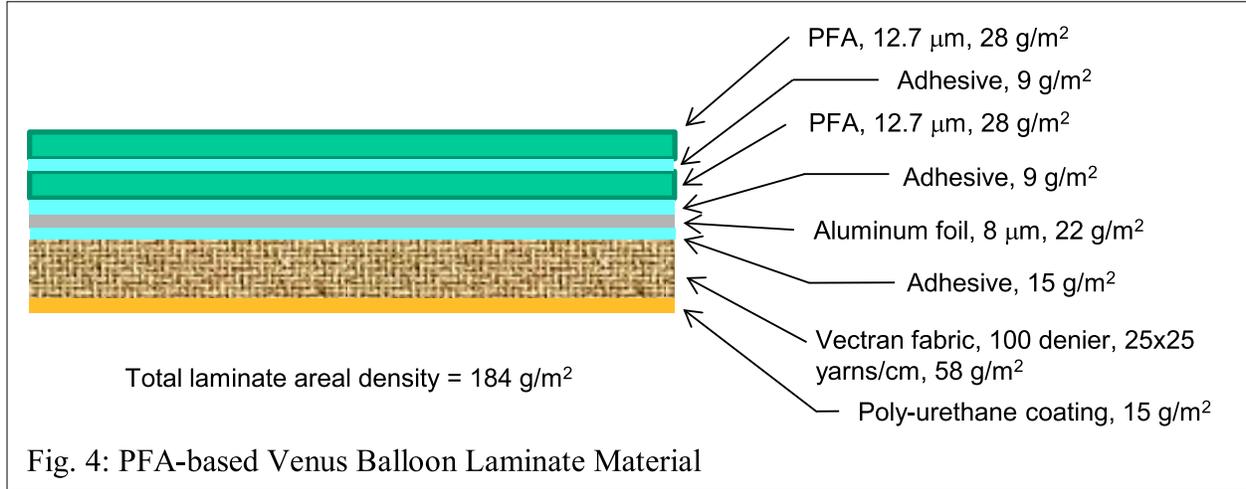
- A second layer of 12.7  $\mu\text{m}$  thick perfluoroalkoxy (PFA) film that forms a PFA bilaminate with the first layer for extra acid resistance.

- A layer of 8  $\mu\text{m}$  thick aluminum foil. This serves as both the sunlight reflector and the barrier to helium permeation through the laminate.
- Vectran fabric composed of 100 denier yarns. This is the strength element of the laminate.
- A polyurethane coating on the inside Vectran surface. This coating assists with the adhesion of tapes to form gore-to-gore seams in the balloon.
- Adhesives to connect all of the layers together.

The key differences between the two materials are replacement of the single layer of FEP with two layers of PFA and the use of aluminum foil to reflect sunlight and to provide a superior barrier to helium gas diffusion. Bilamination of the outer protective layer has been adopted into the design to ensure acid protection even if the film has one or more defects.

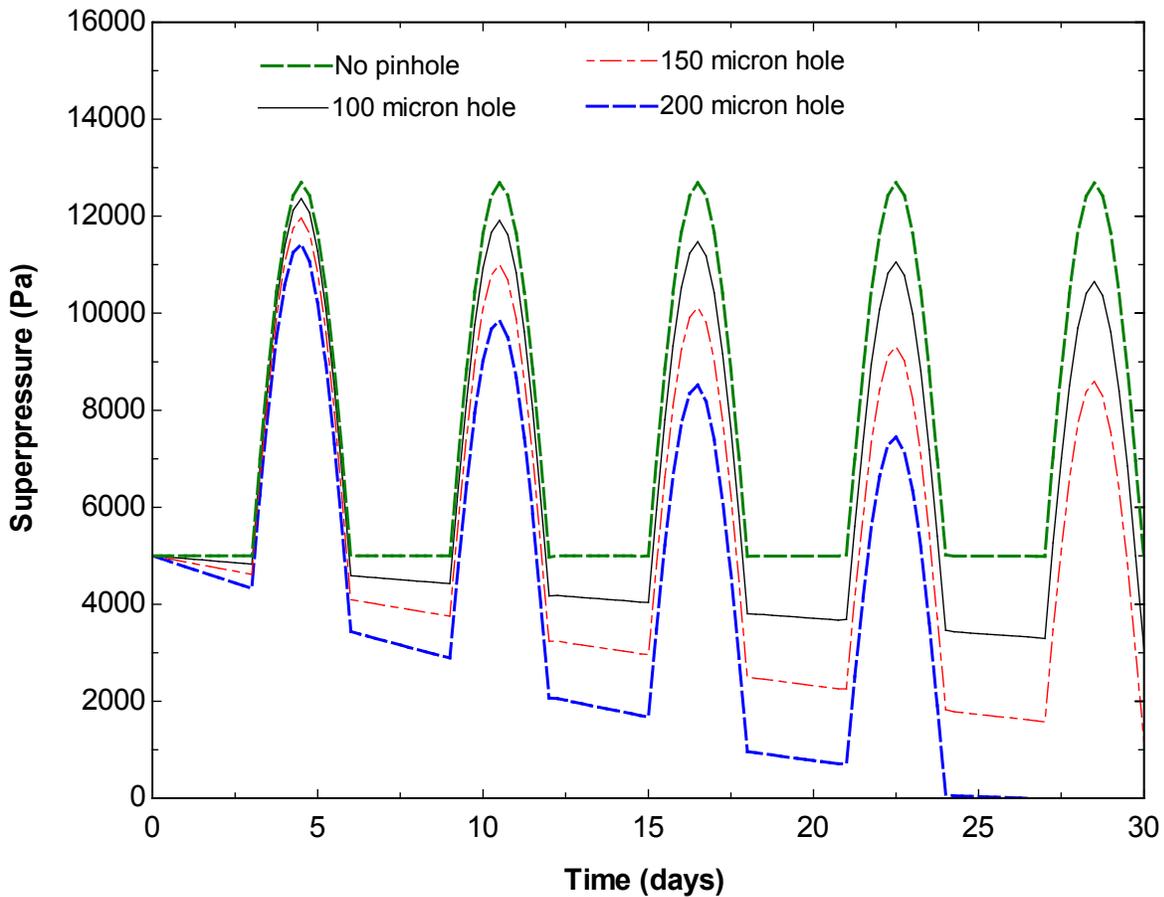
Fig. 5: Analysis results showing balloon pressure loss due to single pinholes of different sizes.

The results are shown in Fig. 5 as four parametric curves of different pinhole diameters. The diurnal pressure spikes are clearly visible every 6 days and correspond to an additional pressure increase inside the balloon of approximately 7,000 Pa. This pressure rise exacerbates the gas loss due to helium venting through the pinhole. The top line shows the pressure history without any pinholes: clearly, the gas loss from diffusion through the envelope is very small and demonstrates the gas retention effectiveness of the aluminum foil layer. The largest hole shown in Fig. 5, 200 microns in diameter, just barely reaches zero superpressure at the end of Day 24. Although not shown in the figure, a slightly smaller pinhole size of 190 microns does reach the 30 day mark with positive superpressure, indicating that it is the critical pinhole size for this mission concept.

Given these leakage results, the focus of the acid effect investigation clearly needs to be on pinholes smaller than this critical size of 190 microns. Balloons with larger holes will be unable to complete the desired 30 day mission due to helium gas loss alone. The important

This blockage phenomenon indicates that the two possible origins of a pinhole could have very different effects on the balloon lifetime. If the pinhole is created before acid wets the hole, then gas will leak out continuously until buoyancy is lost over the many day or week timescales depicted in Fig. 5. Conversely, one can imagine a scenario in which there is initial no through-hole but there is a scratch or other defect in the outer acid-resistant layers of the laminate. In this case, acid could react its way through the underlying aluminum and urethane layers and create a through-hole over time. If the resulting hole is sufficiently small, surface tension forces will be large enough to keep the acid from being dislodged by the gas, effectively plugging the hole. This second pinhole mechanism is very unlikely to shorten the mission below the one month threshold since no buoyancy gas will be lost and the damage rates listed in Tables 1 and 2 are too small to cause structural failures on this time scale, as will be argued below.

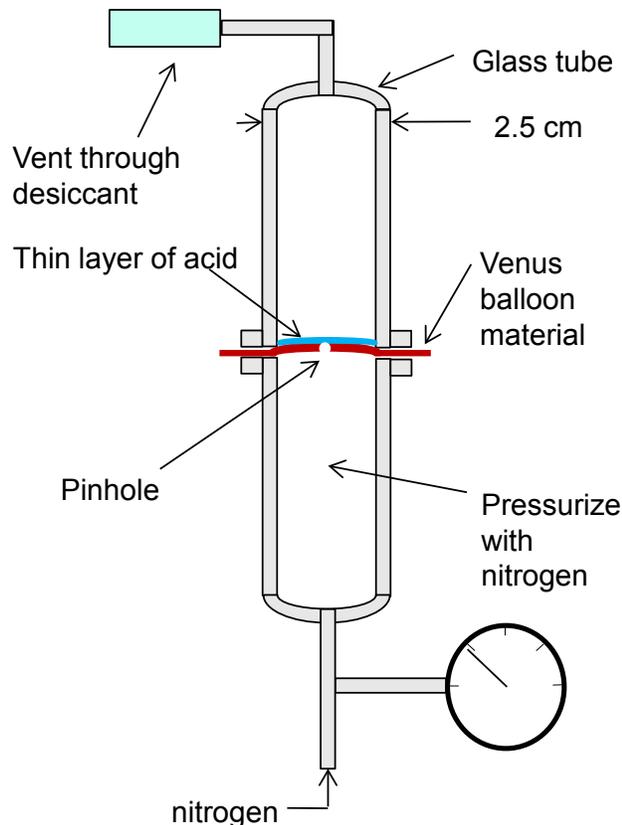
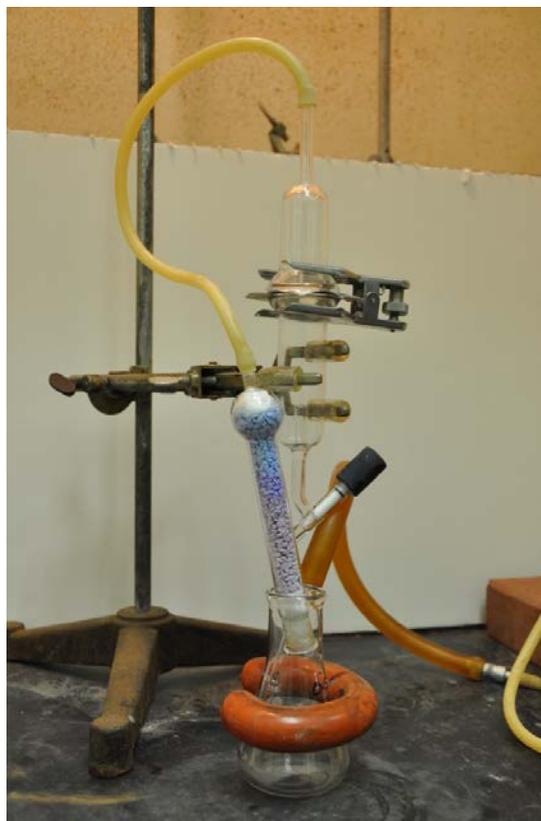
Fig. 6: Experimental Setup

Figure 6 shows the simple apparatus that was put together to do the deliberate pinhole experiments. It consisted of a two-part glass test tube between which was sandwiched a piece of balloon material. The balloon material had a pinhole approximately in the middle of the sample that was created by piercing with a metal pin prior to mounting in the test apparatus. A 2-3 mm thick layer of sulfuric acid was placed on top of the material with an eye dropper. This is certainly more than the thickness of acid that will accumulate on the outside of a Venus balloon due to collisions with aerosols and therefore constitutes a conservative upper limit on the damage potential. Nitrogen gas was used to pressurize the underside of the material to mimic balloon pressurization. In the presence of the pinhole, this pressurization resulted in a small gas flow through the hole and into the top part of the test tube. This gas vented to atmosphere through a desiccant that prevented moisture from entering the apparatus in the opposite direction and diluting the acid. The desiccant is visible in the Fig. 6 photograph as the blue and white granular material inside the foreground glass tube. Figure 7 shows a microscope image of one of the

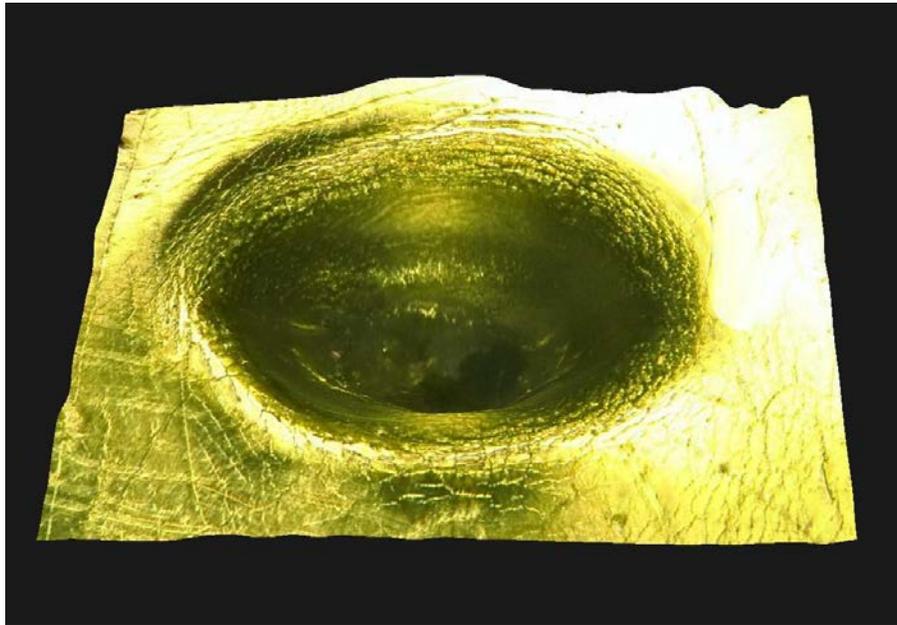
Fig. 7: Microscope Photograph of Pinhole (Test 5 in Table 1)

pinholed materials from Test 5, which is representative of all of the samples. The hole is essentially circular with a taper going into the sample. The top surface is the FEP film. Wrinkling caused by the puncture is visible around the perimeter of the hole. Direct measurement just inside of this wrinkled region shows that the diameter was approximately 300 microns, which corresponds to the measured diameter of the pin that was used to make the hole. This hole (and all the others reported below) was generally not visible to the naked eye unless a bright light was placed on one side of the sample in a darkened room. In that case, a pinpoint of light was visible through the pinhole.

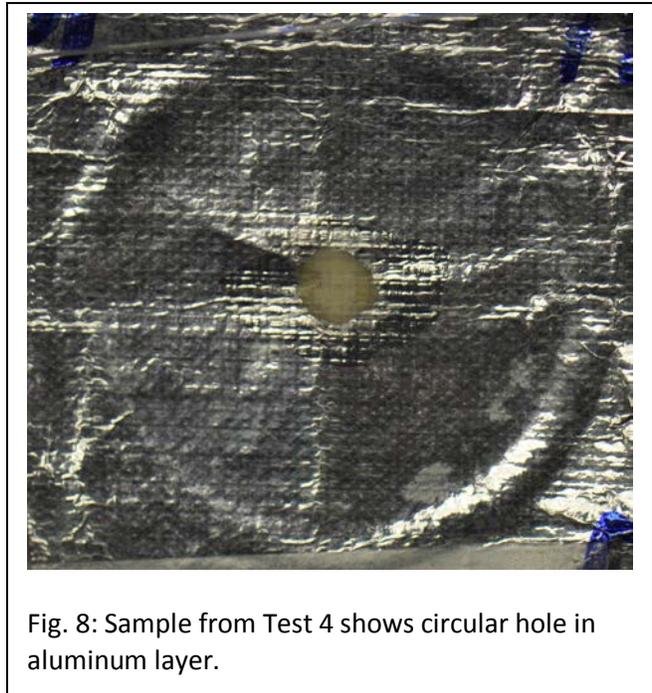
Fig. 8: Sample from Test 4 shows circular hole in aluminum layer.

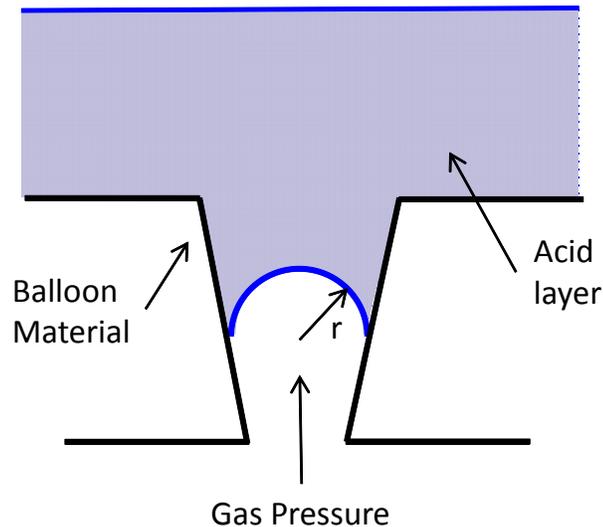
Fig. 9: Schematic diagram showing air bubble trapped in a pinhole.

Note that merely pressurizing the backside of the material did not necessarily cause gas to flow through the pinhole. For example, the transition from Experiment 2a to 2b consisted of a 1 minute interruption of the gas flow. Prior to the interruption, there was a steady stream of gas bubbles clearly visible through the acid pooled on the top. After the interruption, there were no bubbles and hence no gas flow at all despite exactly the same pressure setting. The explanation for this phenomenon is as follows: while gas is flowing through the hole, the acid is kept at the top surface and the inside walls of the pinhole remain dry. During the interruption, acid penetrates into the hole and wets the sidewall. When gas pressure is reapplied, it cannot push the acid back out of the hole due to surface tension. In essence, the pinhole has been sealed by the acid and no gas escapes. It was observed that the pinhole was slightly tapered to match the shape of the sharpened pin used to make the holes; therefore, acid entering the hole and moving lower will see a smaller diameter and hence larger surface tension forces, which makes it even more difficult for the gas to exhaust through the hole. This geometry is shown schematically in Fig. 9.

a spherical bubble, we can use Eq. 1 to estimate the radius of the hole. Substituting values, we compute that:

$$r = 2T / \Delta P = 2 (0.065) / 5000 = 26 \mu\text{m} \quad [2]$$

For such a simple model, this value of 26  $\mu\text{m}$  radius compares favorably to the microscope measured Test 2 pinhole size at the top surface of 40  $\mu\text{m}$  radius (80  $\mu\text{m}$  diameter). The agreement becomes even better when the tapering of the hole is accounted for given that the interface was likely located in a narrower part of the hole.
