The Challenges in Applying Magnetostrictive Sensors on the “Curiosity” Rover

Michael R. Johnson

Jet Propulsion Laboratory
California Institute of Technology
4800 Oak Grove Drive
Pasadena, CA
91214-3134

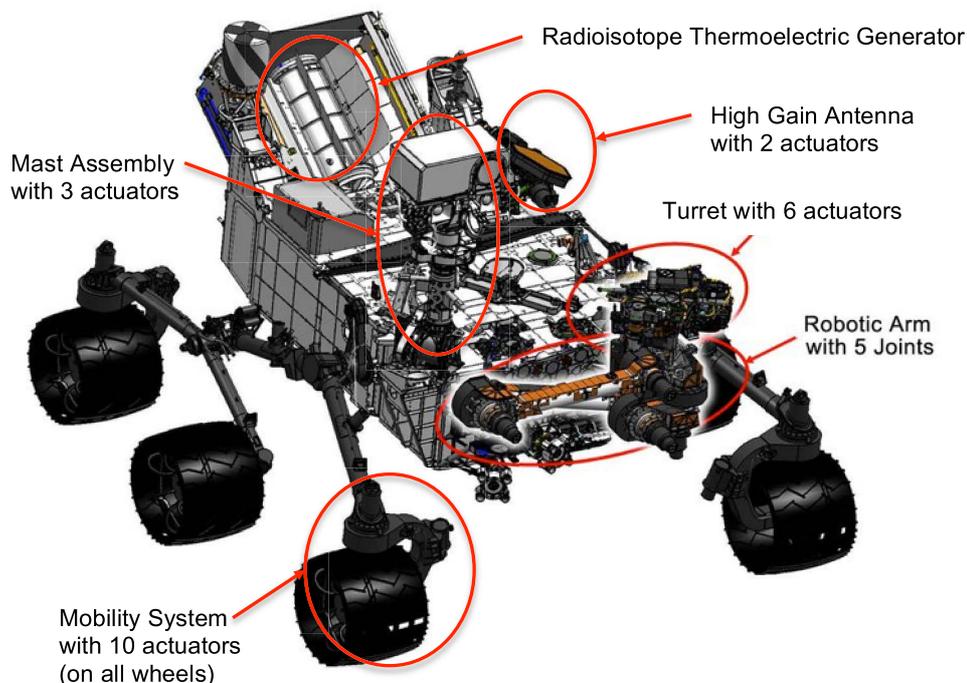
Figure 1. Locations of Actuators on the Rover and the Position of the Radioisotope Thermoelectric Generator (RTG). The locations of the Sample Inlet Cover Actuators on the top of the rover body are not visible in this view

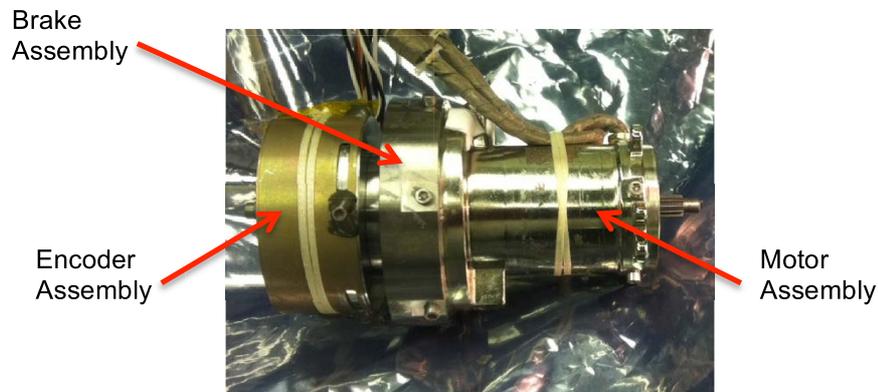
Figure 2. Motor Assembly with Brake and Encoder Assembly Attached

Each actuator is composed of a brushless dc motor, a brake assembly, a gearbox, and an encoder assembly. Figure 2 shows the basic configuration of a typical motor without the attached gearbox.

The brake assembly is a disc style friction brake that uses an electromagnet to move the friction disc against a set of springs, releasing the motor rotor so it can rotate freely. Removal of the current from the electromagnet will allow the friction pad to clamp the disc connected to the motor rotor, stopping rotation of the motor. The magnetic flux path for the electromagnet is closed when the magnetic brake disc has moved against the pole piece of the electromagnet and mechanically released the motor rotor.

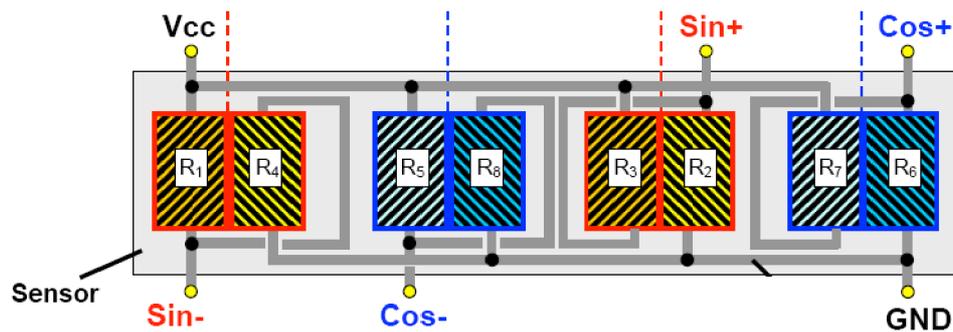
Figure 3. MR Sensor internal configuration showing the Sine and Cosine elements wired together as an H-Bridge. For the Home Sensor, only one of the two H-Bridges was used to provide the output signal to the reading electronics. Each independent H-Bridge is made up of four magnetoresistive sensors.

The encoder assembly has two groups of paired MR sensors within the reading circuitry. The configuration of the sensor is shown in Figure 3. One of the sensor pairs reads the equally spaced poles of the magnetized wheel as it rotates. The second sensor pair reads the single pole of a "Home" position feature on a magnetized wheel. This allows the encoder assembly to provide the typical A-B quadrature outputs with a Z home output, the same as standard industrial encoders provide. The Home signal is compared with the number of quadrature signals between home pulses to maintain proper alignment of the electrical drive signals to the motor coils. The magnetized wheel and sensor combination are a matched set of hardware from Sensitec GmbH and maxon motor ag.

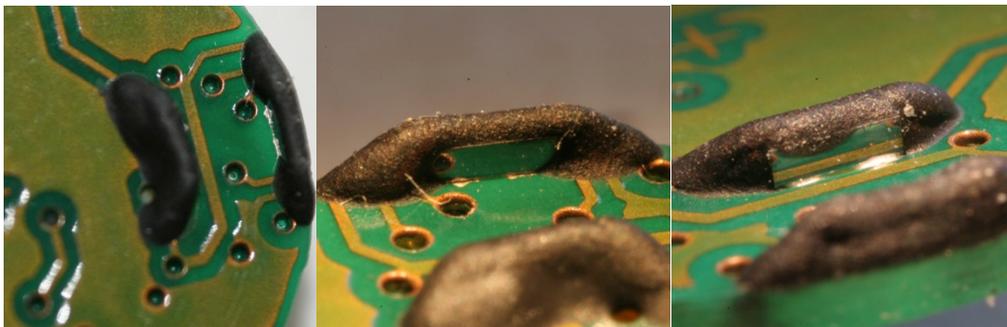
Figure 4. Photos of the Magnetoresistive Sensor Installation on the maxon motor ag Encoder Assembly that Flew on the Spirit and Opportunity Rovers.

The encoder design approach for Curiosity was based on the successful use of maxon motor ag (Maxon) encoders that were purchased with the motors directly from Maxon. The sensors on the encoder assembly from Maxon were provided by Sensitec GmbH to Maxon where they were incorporated onto a circuit board designed by Maxon. The electronic circuit boards were populated at the Jet Propulsion Laboratory with Established Reliability electronic parts and then returned to Maxon for final assembly into the motor/encoder assemblies. Figure 4 shows three photos of the sensor installation that was used for the flight encoder assemblies on the Spirit and Opportunity rovers. The sensors were mounted using chip-on-board with a covering of epoxy to protect the wirebonds.

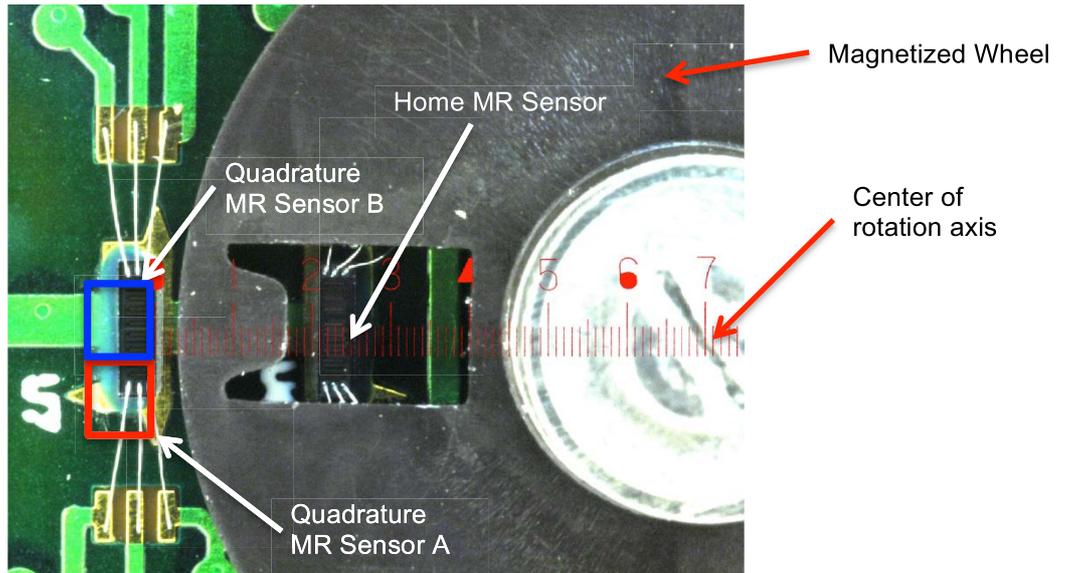
Figure 7. Back side of Encoder Assembly installed on a motor showing the relative positions of the MR sensors and the magnetized wheel.

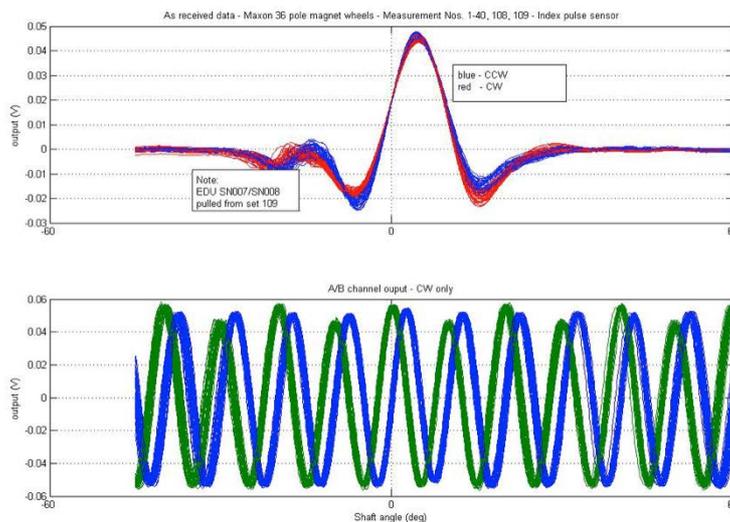
Figure 8. Waveforms from the magnetized wheel and MR sensor combination. Top trace is the home sensor output as the home pole passes by the MR sensor. Bottom trace is the quadrature MR sensor output with the A and B waveforms shifted by 90 electrical degrees. Waveforms shown are multiple measurements in both directions for several sensors. Outputs shown are at 25°C.

The reading electronic circuit for the sensor assembly is a complex version of an electronic comparator. The sensor output is compared to a reference voltage and the output is toggled high or low depending on where the sensor output voltage is relative to the reference. A North polarity field produces a high and a South polarity produces a low output signal from the comparator. The voltage output of the sensors is shown in Figure 8.

The voltage magnitude and separation along with the background noise levels, indicated that the basic comparator approach was a viable solution to get quadrature square waves and a square home signal output from this type of MR sensor. Note that the home index MR sensor output signal is different from the smooth quadrature signals because it has low voltage lobes on each side of the main pulse. These undesirable signal lobes are well below the magnitude of the main signal peak, so a threshold voltage value could be found that triggered only on the main pulse and not the side lobes.

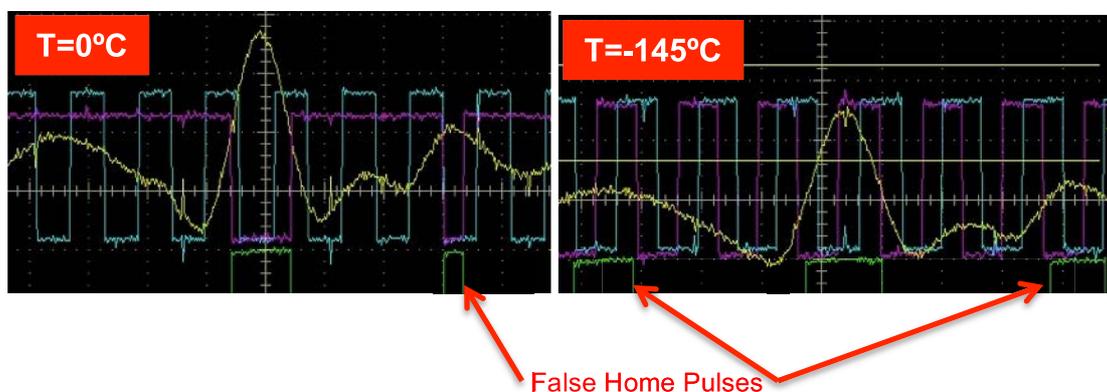
Figure 9. The output signals from the MR Home Sensor, the resulting home output signal, and the two quadrature output waveforms. The quadrature outputs are the blue and violet traces, the home MR sensor output is the yellow trace, and the home output waveform is the green trace. Note the “extra” home pulses triggering off of the side lobes around the main MR sensor home output signal.

However, as the MR sensor gets cold, the strength of the MR sensor output signal increases, providing more signal to detect. Additionally, the operational amplifiers that were used for the encoder assembly have a gain that drops as the temperature drops (faster than the output of the MR sensor increases), opposing all of the change in the output signal from the sensor. The MR sensor impedance also changes with temperature, causing the bias of the output signal to move as the temperature is reduced. Finally, the height of the side lobes increases relative to the main pulse making the area for triggering margin smaller. The combination of these several effects on the waveforms produced traces as shown in Figure 9.

The result of the temperature variation of these parameters is that a single threshold voltage value in the circuitry could not be made to work over the entire temperature range. When the threshold was set for room temperature and warm operation, several “extra” home pulses would show up as the temperature was lowered, as shown in Figure 9. The change of the side lobe magnitude relative to the main pulse seemed to be a feature of the sensor and magnetized wheel combination, not the sensor alone. Several circuit modifications were put into the reading electronics to eliminate the “extra” home pulses and logic was also put into the motor controllers to determine if the home pulse the controller received was valid.

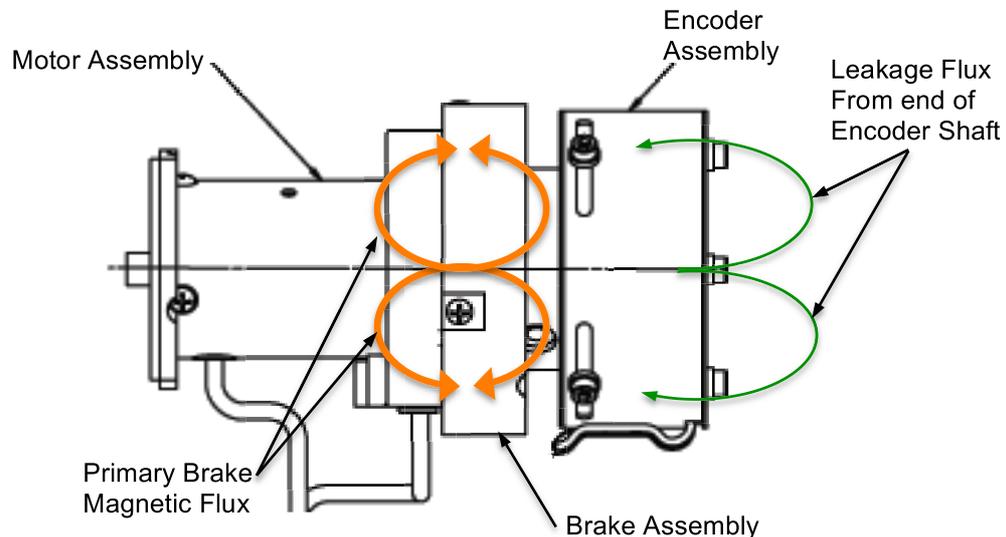
Figure 10. Motor, Brake, and Encoder Assembly showing the magnetic flux paths for the primary brake electromagnet and the leakage flux that exits the rear of the motor from the end of the encoder shaft.

This Martian Hurdle did not occur until very late in the project, after almost all of the hardware was built and being tested. The late arrival of this issue limited the possible solutions that could be pursued. The motor assembly that includes the encoder on the back also has an electromagnetic brake on its end. The brake assembly was designed using high permeability material to provide a closed loop for the magnetic flux when energized, in order to prevent the field from interacting with the sensitive MR sensor and magnetized wheel pair. The encoder is mounted on the back of the brake assembly with a shaft that extends through the brake assembly and into the encoder. This shaft rotates the magnetized wheel that then provides the signals used to commutate the motor and control its position. Figure 10 shows a motor, brake, and encoder assembly and a representation of the primary internal brake magnetic flux and the external magnetic field that leaks from the electromagnet. The image shows that the magnetic field follows the shaft into the encoder assembly, out the end of the encoder, and back toward the electromagnetic brake assembly. The housing of the encoder assembly was made from aluminum for low mass and good thermal conductivity, which also does not provide any magnetic path help for the leakage flux as the magnetic flux expands from the end of the encoder shaft.

The consequence of the leakage flux at the rear of the encoder assembly intermittently produced spurious encoder counts and home pulses that were not representative of any shaft rotation. When the brake is energized (which releases the mechanical braking function), the motor is not turning. The resulting spurious counts clearly cannot be from the rotation of the motor shaft. The controller did not know the difference, however, and added or subtracted these counts from the motor position register. This led to motor position errors that were then responded to by the servo controller, resulting in sudden movement of the motor that was not appropriate.
