THE CHALLENGES OF RE-STARTING AND OPERATING AN INHERITED NON- FUNCTIONAL FACILITY FOR GROUND SEGMENT TESTING

**Jet Propulsion Laboratory
California Institute of Technology
Pasadena, California**

**Environmental Test Laboratory
10/13/2009**

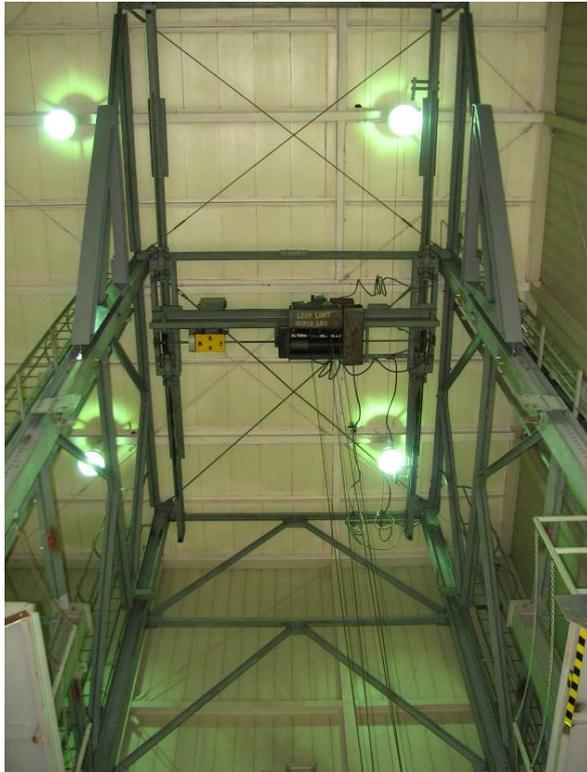
Fig. 1a Looking up 40 feet to top of test tower

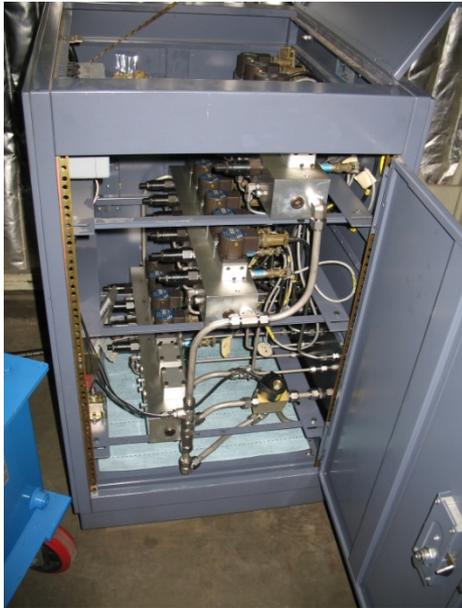
Fig. 2a Hydraulic load controller

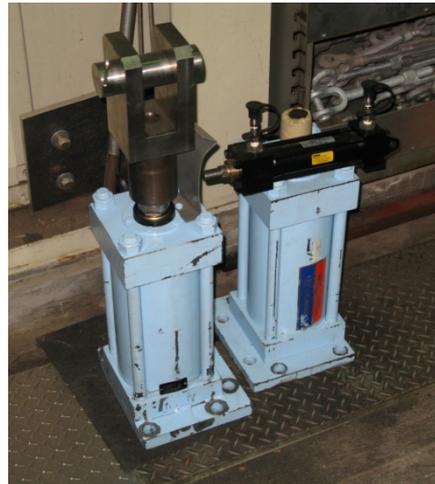
Fig. 2b Hydraulic cylinders

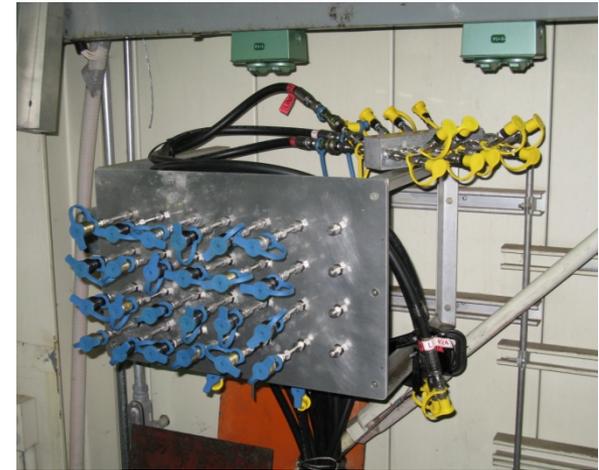
Fig. 2c Bulkhead panel and return manifold

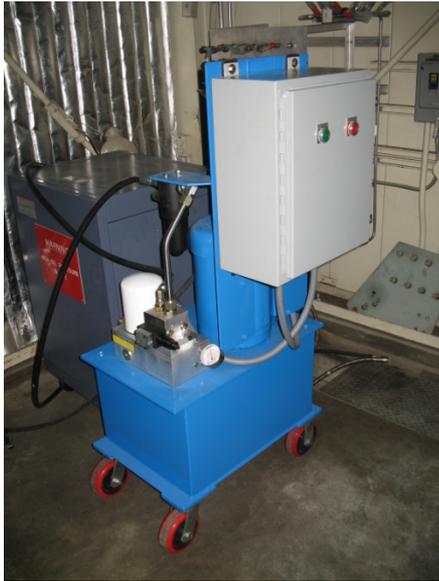
Fig. 3a Hydraulic power unit (pump)

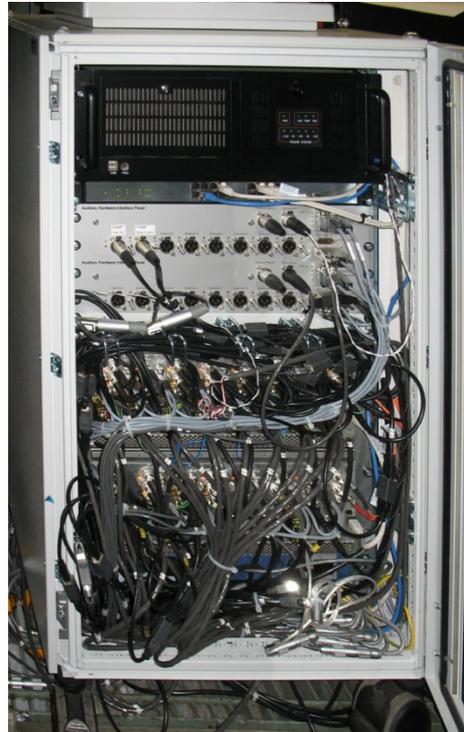
Fig. 3b Digital controller

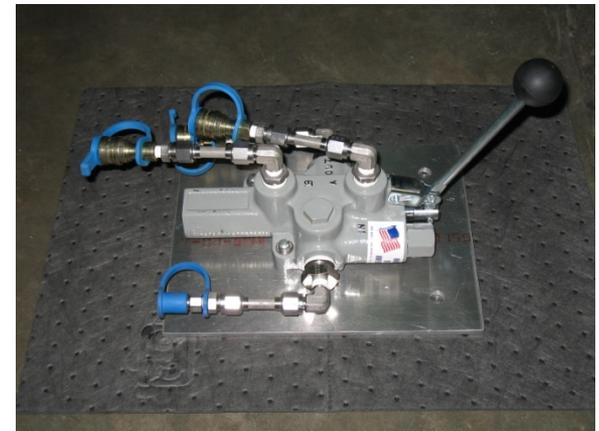
Fig. 3c Directional control valve

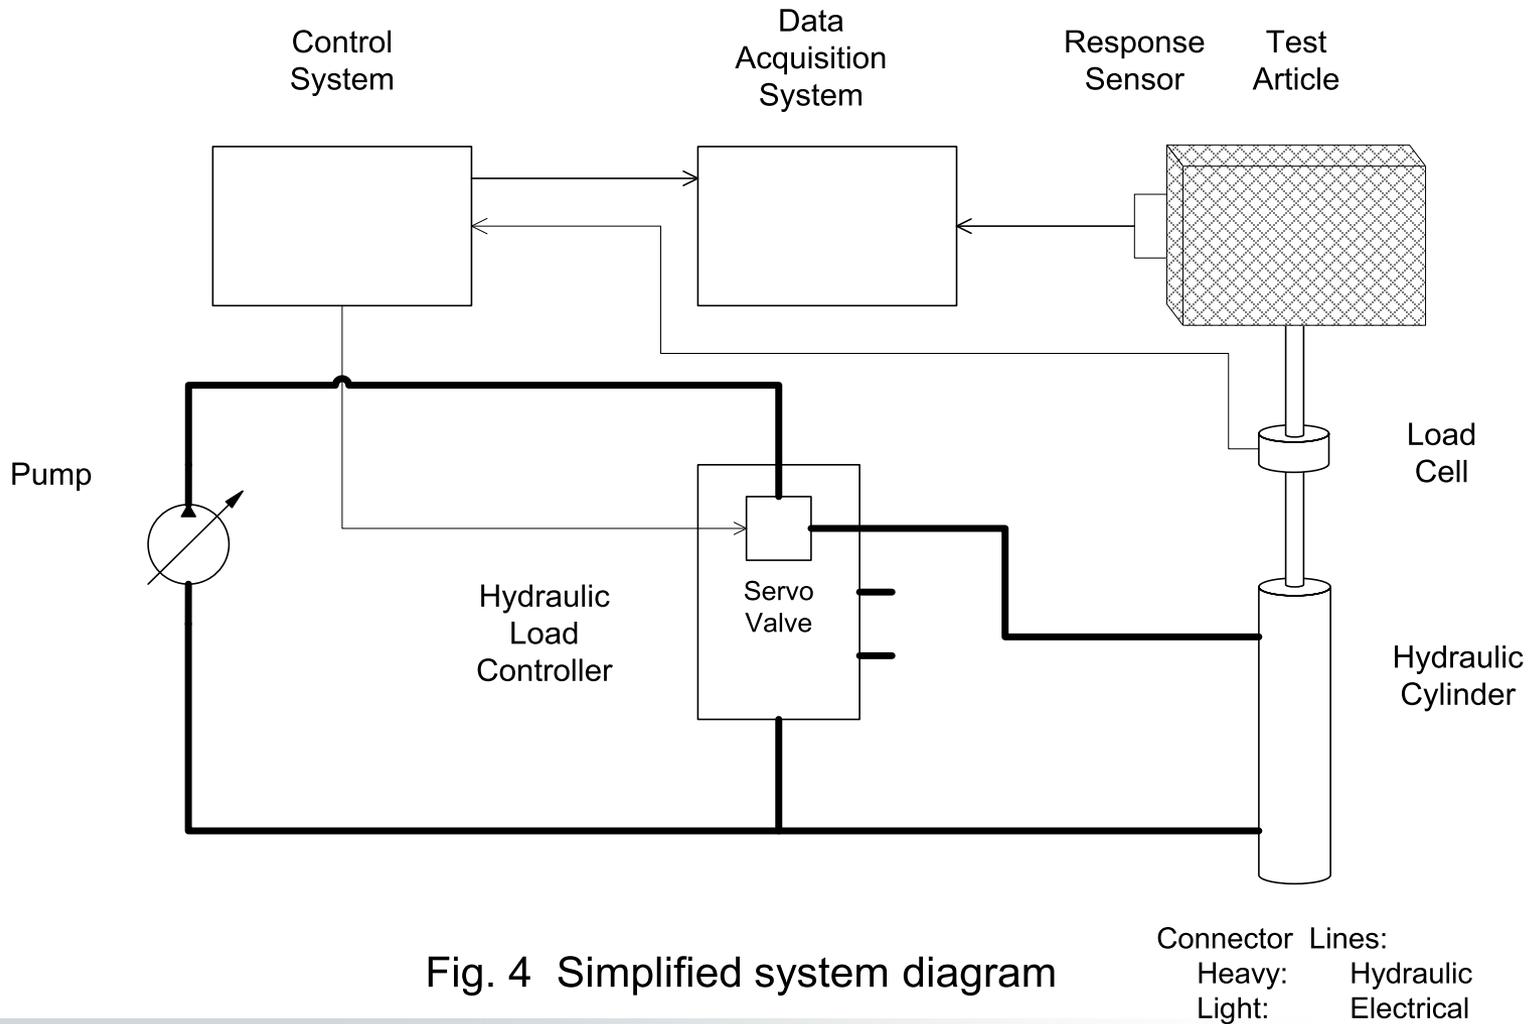
Fig. 4 Simplified system diagram

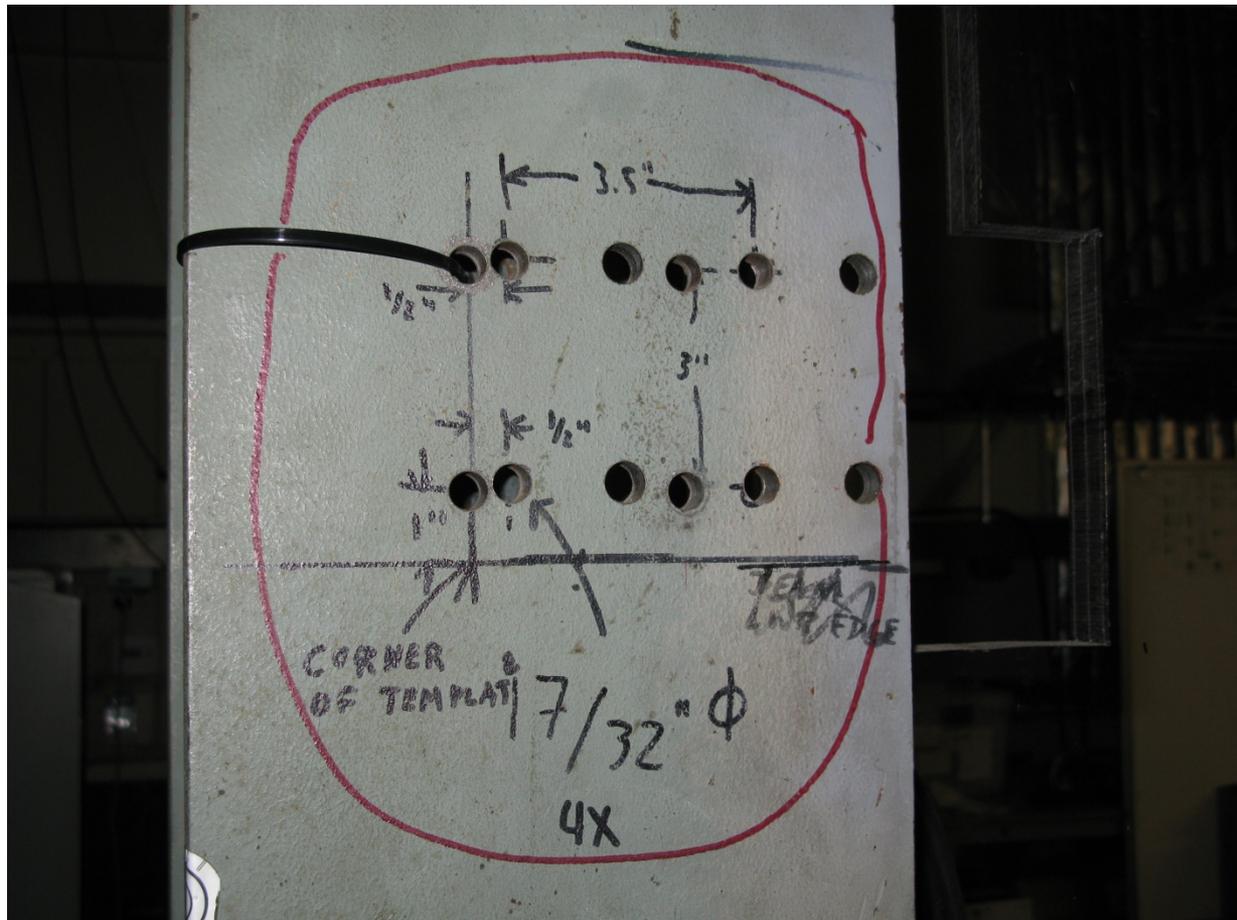
Fig. 5 Iron-enriched Swiss cheese
(Tower I-beam with holes resulting from multiple
location attempts by the customer)

- Limited experience of customers
- Develop an introduction to static testing (e.g., Static Testing 101)
- Provide facility technical documentation
- Use standardized mechanical interface points
- Inattention to detail can degrade/damage the facility. (See Fig. 5)

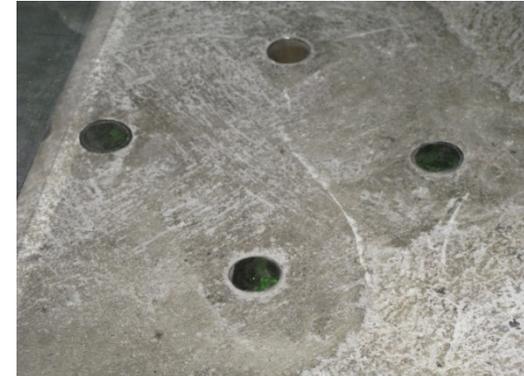
Fig. 6b Studs cut off following test

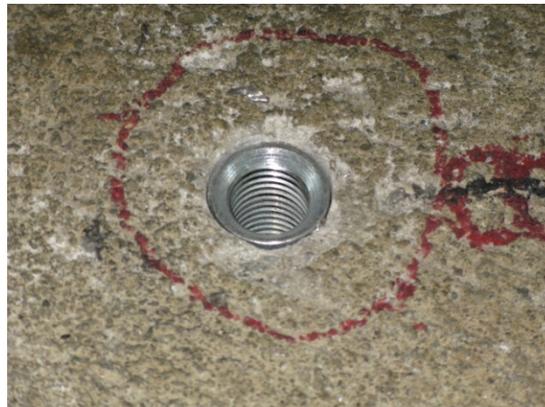
Fig. 6c Reusable solution:
Threaded insert

- Use non-hazardous and reusable floor anchors

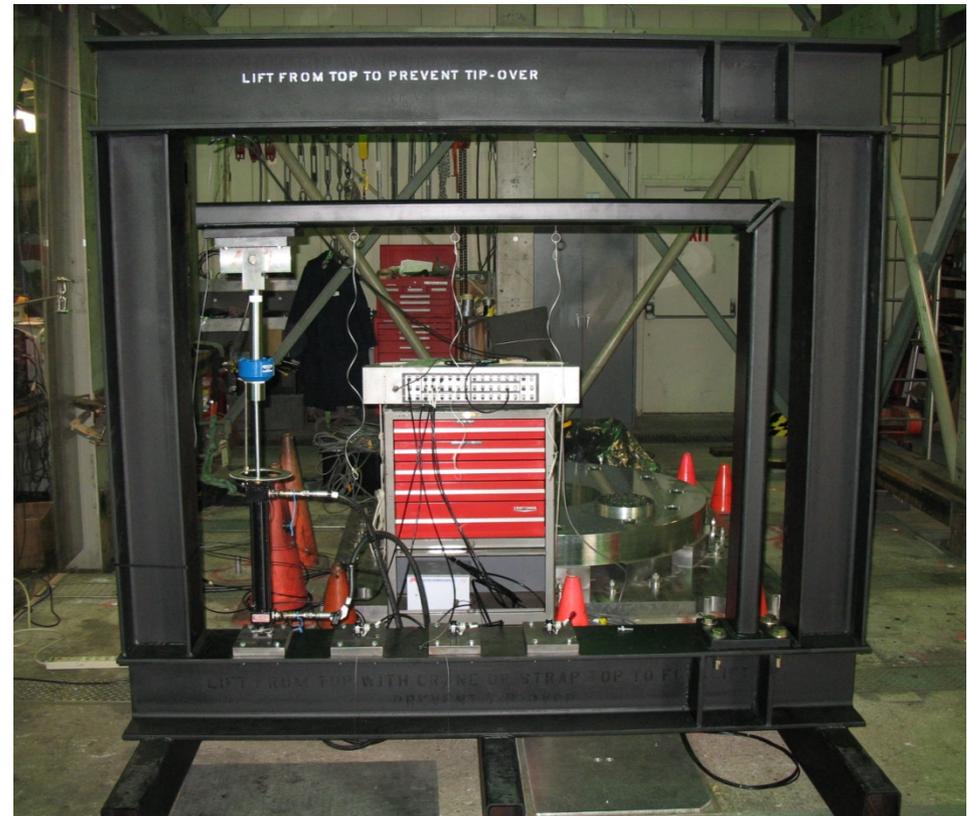
- The use of a test frame supported the verification of our overall configuration.

Fig. 7 Test frame
