## **Second generation prototype design and testing for a high altitude Venus balloon**

### **Abstract**

This paper describes the development of a second generation prototype balloon intended for flight in the upper atmosphere of Venus. The design of this new prototype incorporates lessons learned from the construction and testing of the first generation prototype, including finite element analyses of the balloon stresses and deformations, measured leak performance after handling and packaging, permeability and optical property measurements on material samples, and sulfuric acid testing. An improved design for the second generation prototype was formulated based on these results, although the spherical shape and 5.5 m diameter size were retained. The resulting balloon has a volume of 87 m<sup>3</sup> and is capable of carrying a 45 kg payload at a 55 km altitude at Venus. The design and fabrication of the new prototype is described, along with test data for inflation and leakage performance.

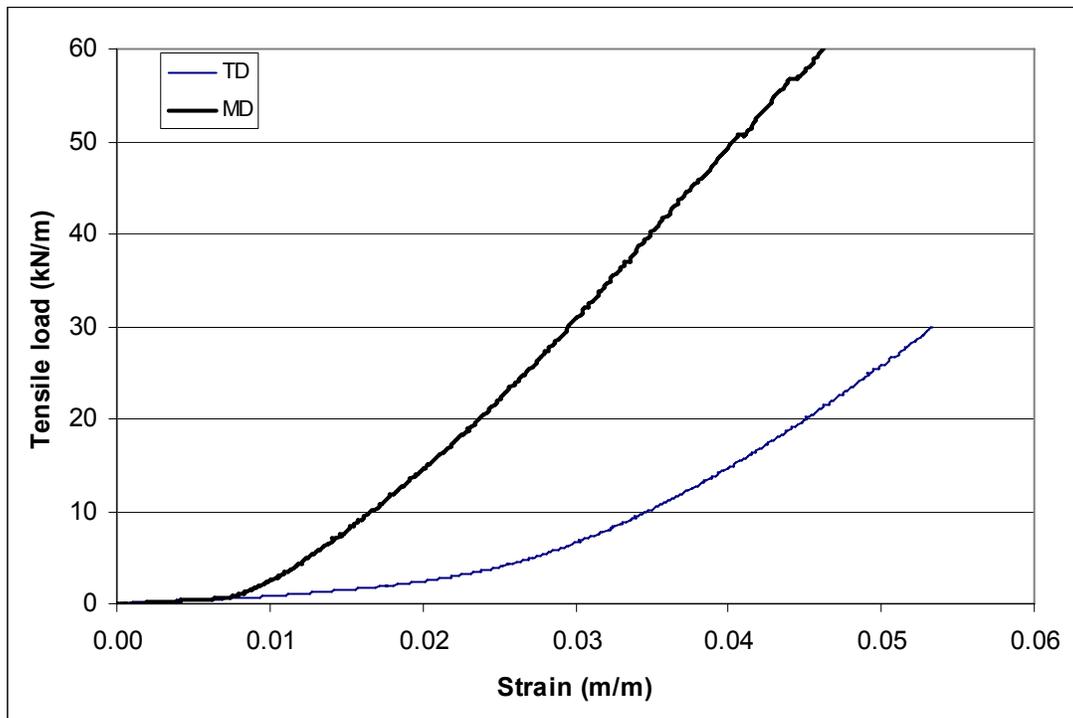
Fig. 1: Load-strain curves for new Vectran structural tapes at room temperature

Measured stress-strain curves for the balloon material were presented in the previous paper (Hall et al, 2007). Room temperature tests were repeated in preparation for the second prototype and showed lower tensile strength in the machine direction, 52.1 kN/m vs 71 kN/m and slightly lower strength in the transverse direction, 54.8 kN/m vs 57 kN/m. New structural tapes were used in the new prototype, in which the previous polyester fabric was replaced with a layer of the same Vectran fabric as used in the balloon gores. As before, this fabric is sandwiched between layers of polyurethane coating to promote good adhesion to the gores during fabrication of the balloon. The room temperature stress-strain curves for this new structure tape are shown in Fig. 1. Note that the ultimate tensile strength of the new seam is comparable to the previous one, 58.4 kN/m vs 57 kN/m, but the thickness is much reduced, from 0.51 mm to 0.22 mm. Note also that the Vectran tape was measured to be much weaker in the transverse direction (30 kN/m), so this direction is aligned with the balloon gores to yield the strongest possible joint.

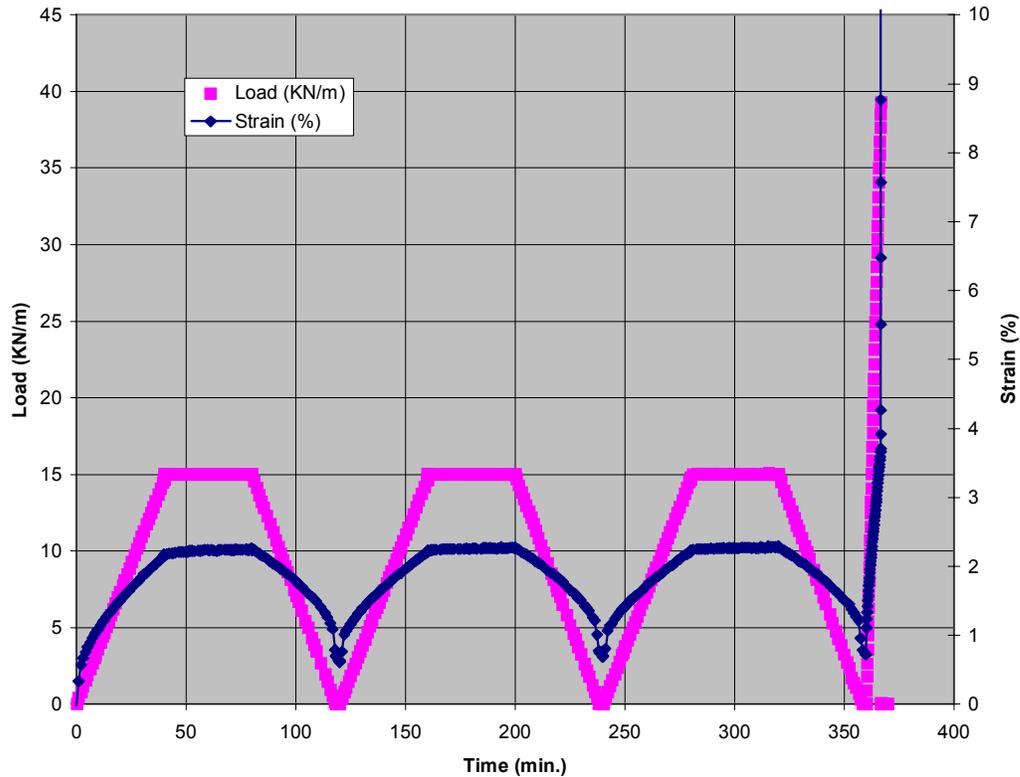
Fig. 2: Strain and recovery response of the balloon material at repeated maximum cyclic loading of 15 KN/m.

Additional materials tests were done to assess the creep, relaxation and cyclic effects on the balloon material. Figure 2 shows the creep response for uniaxial specimen exposed to three cycles of load-hold-unload regimen. The test specimens were cut to allow loading along the machine direction. The dimensions of the specimens were 172 mm gauge length and 25.4 mm in width. All testing was conducted on an Instron 8501 Servo-hydraulic machine. In the first testing regimen, the specimen were loaded to 15 KN/m in 40 minutes, held at peak load for 40 minutes, and finally unloaded to nearly zero load in 40 minutes for a total cycle time of 2 hours. During the test, the actuator initial position and displacement was recorded to allow for strain calculations. Upon completion of the first cycle, the loading sequence was repeated twice for a total of three cycles, as shown in the figure. At the end of the three cycles the specimen was taken to break as shown in the last segment of the test. The total duration of the test was a little over six hours. The figure shows a total strain of approximately 2.8% at maximum loading of 15 KN/m, also note the slight creep that occurred during each cycle, as the material is held at the peak load for 40 minutes. Upon gradual load removal during each cycle, the strain was recovered to nearly 1% as shown in the third stage of each cycle. It is also important to note that the total strain did not change significantly as the cycles of loading were repeated.

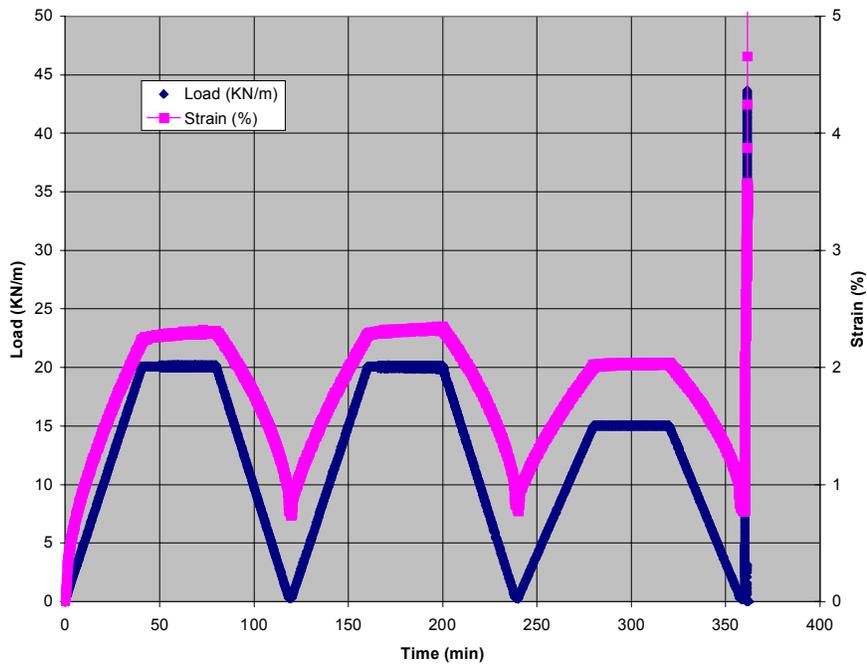
Fig. 3: Strain and recovery response of the balloon material at a combination of maximum cyclic loading of 20 KN/m (2 cycles) and 15 KN/m (1 cycle)

To assess the ability of the material to recover at higher loads, the test was repeated at higher initial loading of 20 KN/m for two sequences followed by 15 KN for the third sequence (Fig. 3). The duration of each segment, however, was kept the same as the previous test.

It is interesting to note that the residual strain at the end of the three sequences was almost identical to that seen at maximum loading of 15 KN/m, indicating little or no effect on the residual strain when the specimen is loaded up to 20 KN/m. Similar results were also obtained when the test was repeated at loading of 25 KN/m (Fig 4).

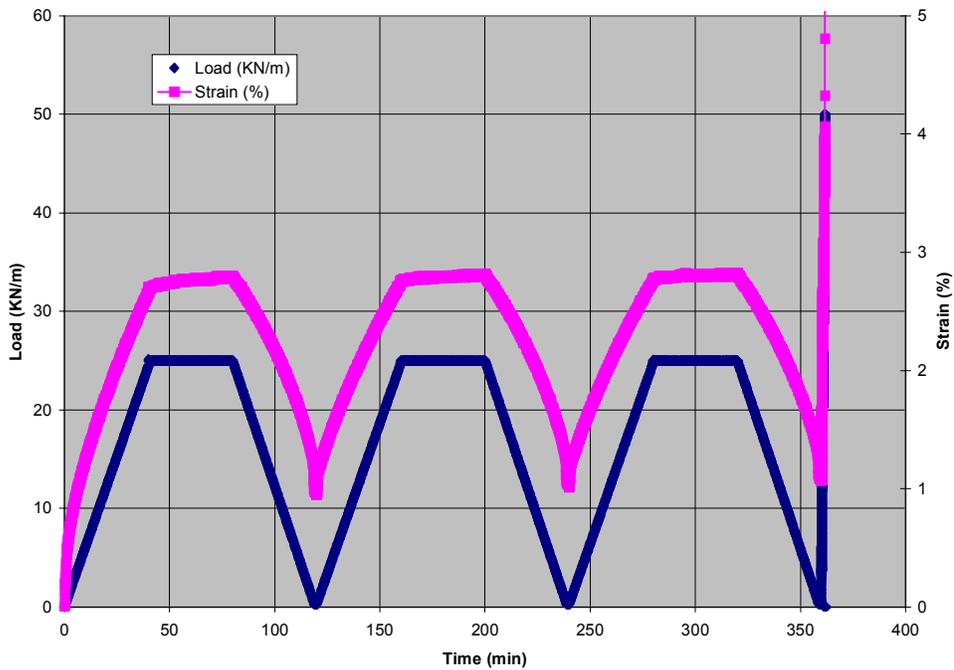
Fig. 4: Strain and recovery response of the balloon material for three cycles at maximum cyclic loading of 25 KN/m.

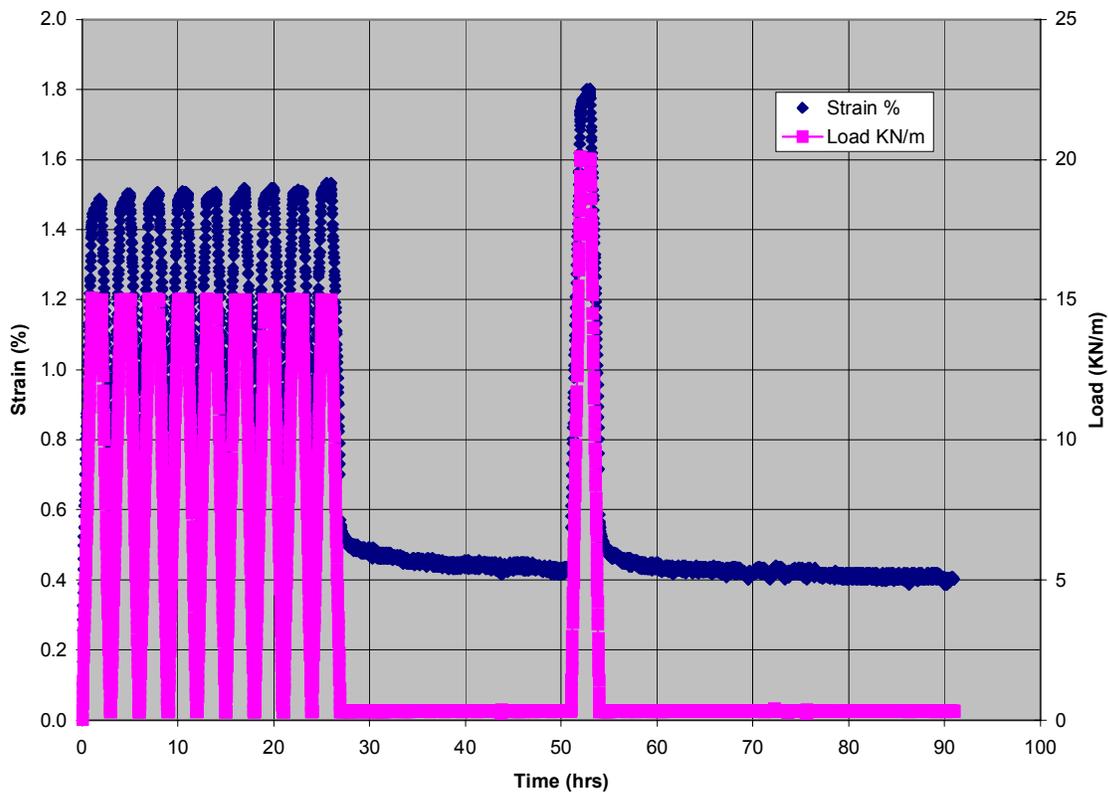
Fig. 5: Repeated cyclic and relaxation response of the balloon material at 15 and 20 KN/m.

The viscoelastic behavior of the material was studied further to explore the effect of the number of cycles and duration on the residual strain or strain recovery of the VALOR material. Figure 5 shows a specimen loaded in a similar manner to that shown in Fig. 2 and to a load level of 15 KN/m. However, the duration of each segment was increased to one hour for a total cycle time of 3 hours. The cycles were repeated nine times for a total time of twenty-seven hours. Upon completion of the last cycle, the loading was held to 15 KN/m and the strain recovery was monitored for 24 hours. As shown in the figure, the material recovered from a strain value of 1.5% to approximately 0.4 % in 24 hours. The load was then increased to 20KN/m and the material allowed to recover for another 40 hours reaching a value of less than 0.4% residual strain at the end of the 90 hours test. The stability of the material shown upon loading to relatively high loading levels and the strain response to cyclic loading and recovery reflects the dimensional stability of the composite and the suitability for the planned long duration mission.

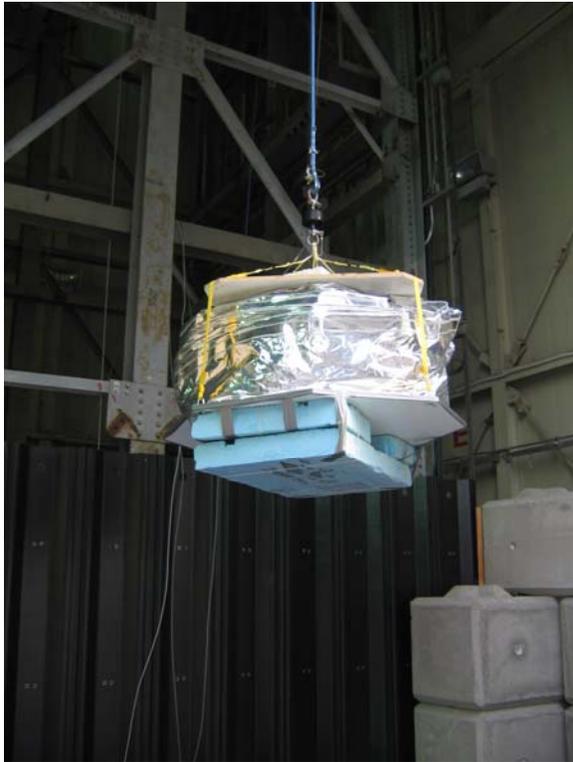
Fig. 6: Packaged balloon before drop test

In August 2006, the prototype balloon was aggressively packaged into an annular volume that approximated that expected for a trip to Venus on an actual mission. Fig. 6 shows a similarly packaged balloon from just before the deployment experiment to be described shortly. Approximately dimensions on the annulus were 0.5 m inner diameter, 1.2 m outer diameter and 0.5 m height. The balloon was wrapped in a spool-like fashion around the inner boundary from one end to the other, with the individual gores longitudinally folded on top of one another. The balloon was stored at the JPL aerobot laboratory for 3.5 months in this configuration with no attempt made to regulate the temperature or humidity. This 3.5 month period roughly corresponds to the expected time of flight from Earth to Venus on an actual mission.

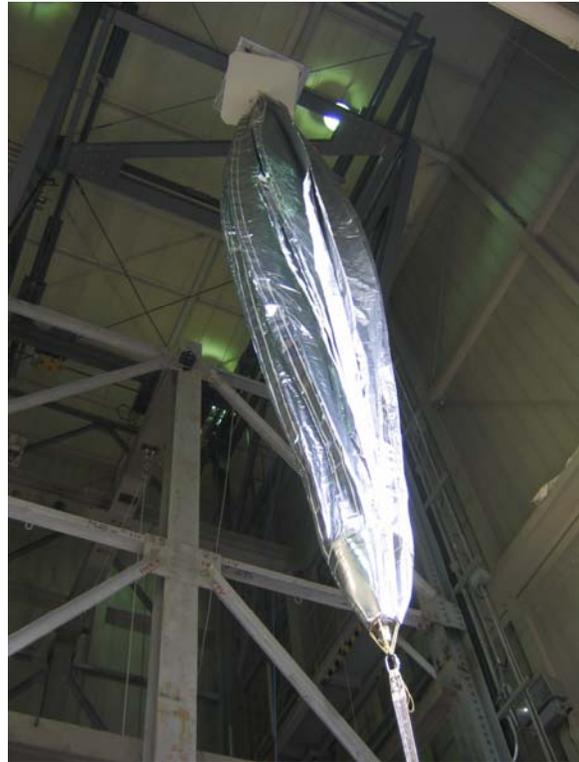
Fig. 7: Successfully deployed balloon

The deployment test was conducted at JPL from this packaged condition. A simple gravity deployment scheme was used in which the balloon was anchored to the top of the drop tower and a simulated 37 kg payload mass at the bottom pulled the bottom of the balloon downwards until the full length was achieved. Total drop distance was approximately 9 meters. Ripstitch was used at the bottom of the balloon to mitigate the transient stress load and dissipate kinetic energy from the drop. The measured peak force in the balloon was 1800 N, approximately 20% lower than predicted based on JPL's ripstitch model. Post drop inspection of the balloon revealed no structural damage (Fig. 7).

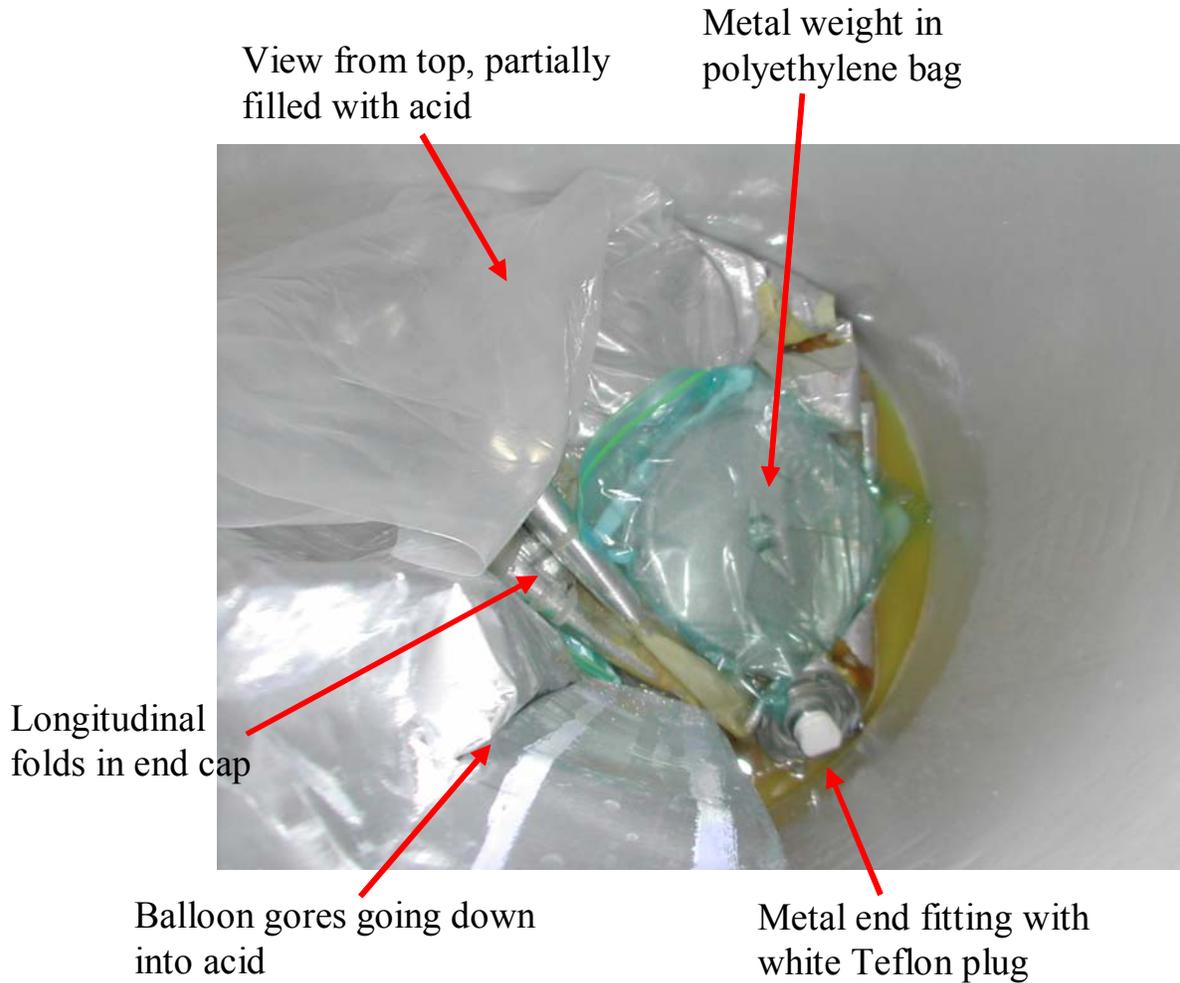
Fig. 8: View of balloon in acid container during immersion test.

The final test performed on Prototype #1 was a sulfuric acid immersion test. The actual experiment did not attempt to submerge the entire balloon, primarily because of safety concerns with handling that much acid. A compromise was implemented in which only one end of the balloon was immersed, consisting of the metal end fitting, the reinforced fabric region around the fitting, and approximately a 1 meter length of adjacent balloon gores. One complication was that

the balloon and its trapped air inside floated in the sulfuric acid; therefore, a metal weight had to be placed on the balloon to keep it submerged. Fig. 8 shows a view looking down into the acid during the experiment.

No changes in the balloon or the acid bath were observed for the first 5 hours of the experiment. However, between hours 5 and 6 a slight yellowish-brown discoloration was detected. At this point the JPL staff went home for the night. When they returned the next day, the acid bath had a very noticeable brown color (Fig. 8) and it was clear that the balloon itself had been damaged. The acid was drained later that day, the balloon was washed and the inspection began. Total immersion time was approximately 24 hours.

The balloon was badly damaged by the acid. Inspection showed that the acid had penetrated inside the balloon from where it proceeded to dissolve essentially all of the Mylar film and internal polyurethane coating it came into contact with. Also, virtually all exposed gore to gore seams were damaged and delaminated. The Teflon, Vectran and Inconel fitting components appeared to be undamaged.

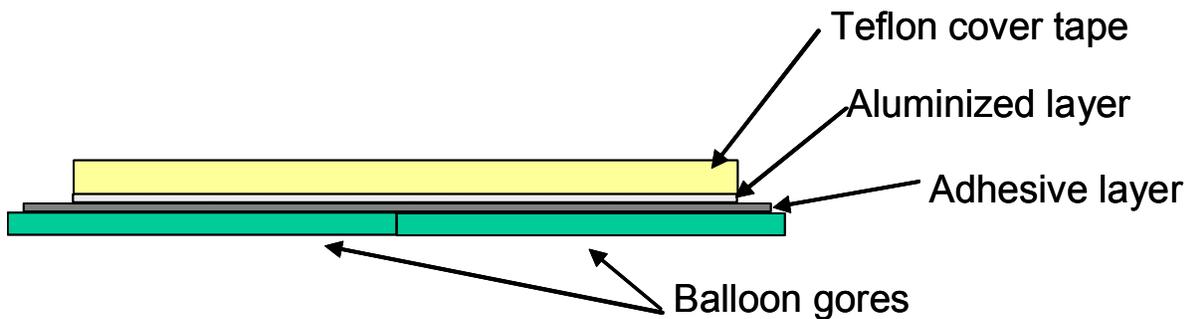
Fig. 9: Schematic diagram of flawed gore-to-gore joint

Extensive analysis was performed on the remnant of the balloon, plus numerous laboratory acid immersion tests on material samples were performed as will be described in the next section. The final conclusion was that the design of the gore-to-gore seams contained a flaw that led to the failure. Specifically, the design used a metallized Teflon cover tape on each seam to protect the balloon from sulfuric acid penetration (Fig. 9). However, the adhesive bond between the metal surface of the tape, the ILC glue and the underlying Teflon gores was not very strong and easily peeled when relatively small forces were applied. Subsequent lab testing showed that the ILC glue provided a very strong joint when applied directly to Teflon film itself, but that the metallization could be very easily peeled off the Teflon. This flaw was exacerbated by the fact that the cover tape has an exposed edge at which the exposed metallization can be directly attacked by sulfuric acid, weakening it further still. We believe that the stresses imposed on the gore-to-gore seams from the folding and, particularly, from the weights placed on the balloon to keep it submerged, eventually led to a peeling of one cover tape in the immersion test and the rapid introduction of acid into the seam and thence into the balloon itself. Prior laboratory testing at JPL on seam samples did not impart any peeling force on the joint and therefore did not find this failure mechanism (Hall et al, 2007). It is arguable that the actual flight balloon will not experience this kind of peeling force in the Venusian atmosphere; nevertheless, a fix to this design flaw was quickly found and implemented, as will be described in a later section of this paper.

Seam testing was performed next. Both an original seam (Fig. 9) and a “backwards” seam with metallization on top of the cover tape were tested at 85% concentration. The result (Fig. 11) clearly showed that the acid ate its way in from the free edge of the original seam, whereas the backwards seam lost its surface metallization but no damage was done to the glued joint between the Teflon cover tape and the Teflon gores. This provides more direct evidence for the plausibility of the seam failure mechanism described above for the immersion test.

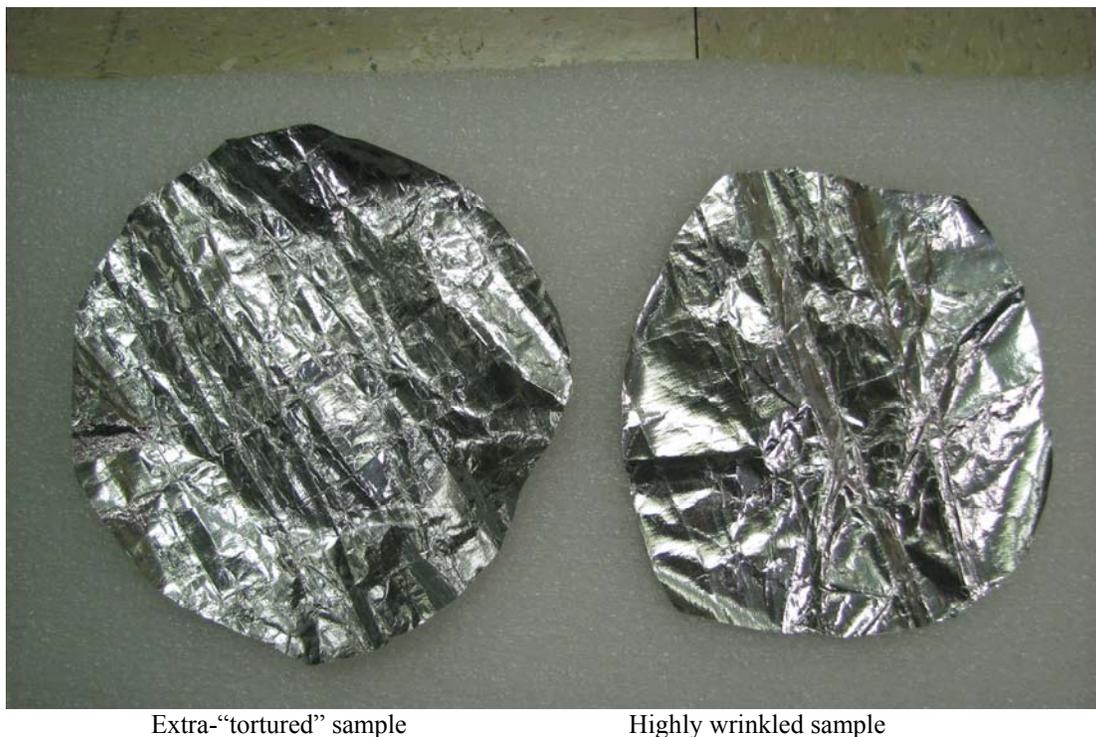
Fig. 10: Acid-tested samples from Prototype #1 balloon

The next acid experiment consisted of 85% concentration exposure over 8 days to a pair of balloon material samples cut from previously unexposed gores of Prototype #1. A region of highly wrinkled material was selected for this purpose, and then one of the samples was folded many more times by hand to give it an “extra tortured” character. Despite this rough handling, however, neither sample showed any acid penetration to the backside over the 8 day test (Fig. 10). This result illustrates the robust character of the outer Teflon layer.

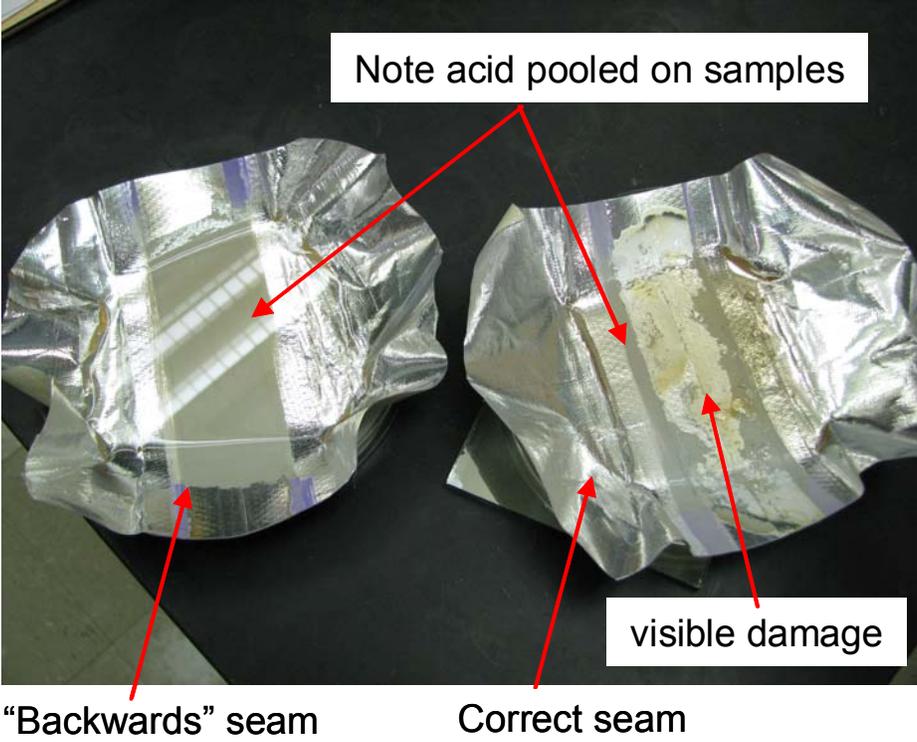
Fig. 11: Acid exposure results on seam samples

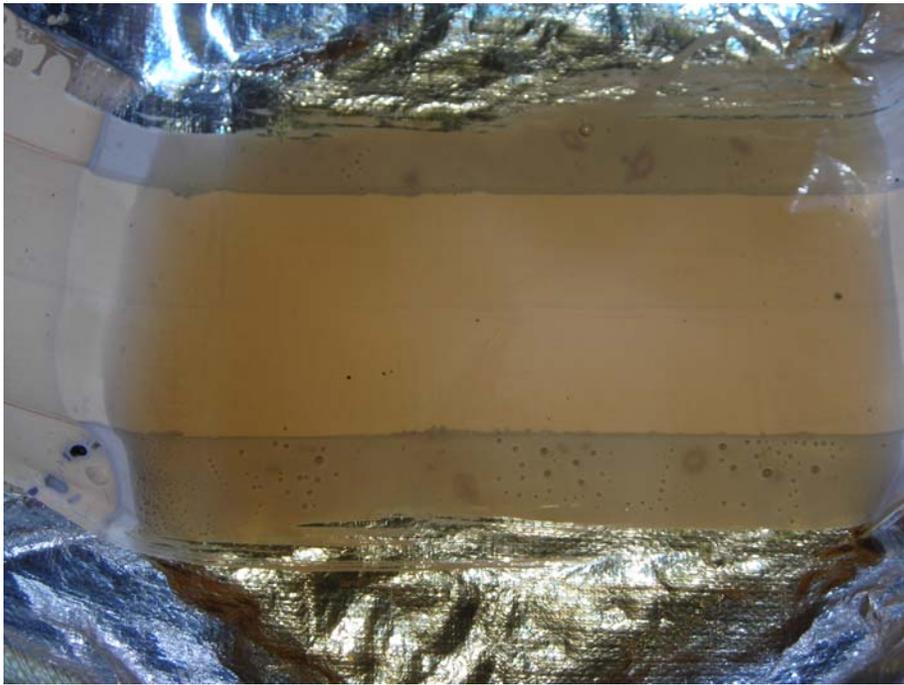
Fig. 12: New seam after 33 day acid immersion

These results convinced us that the seam design had to be modified so as to not have the metallization on the cover tape and thereby ensure a strong, acid resistant adhesive bond between the Teflon cover tape and Teflon gores. ILC Dover constructed a sample joint with this new design and sent it to JPL for acid immersion testing. This sample was exposed to 85% concentration (rising to 92% concentration by the end due to unexpected removal of water from the acid) and 70 °C temperature for 33 days and showed no penetration of the acid to the backside of the material. However, the acid did take on a yellowish color after 12 days, and there was some point-like discoloration of the exposed adhesive (Fig. 12). Also, small bubbles were

seen in the acid pool on the surface of the material. We concluded that a very slow chemical reaction was occurring between the acid and the adhesive, but that it was not serious enough to cause a failure under these aggressive acid exposure conditions. It was on this basis that the new seam design was selected for Prototype #2.

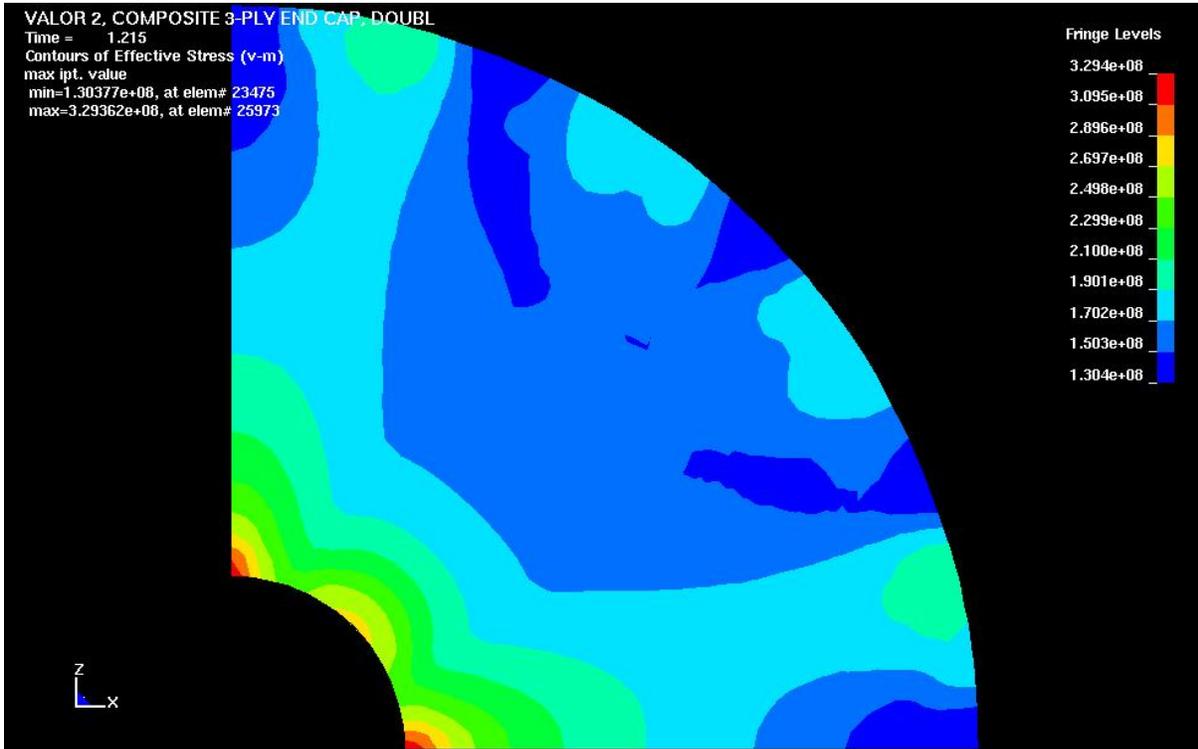
Fig. 13: Plot of von Mises stress in balloon end cap, Prototype #2 design at 20000 Pa of internal pressurization. The units on the color bar are Pa.

The main finding was that the Venus balloon had two regions of stress concentration that elevated significantly above the thin-membrane limit. One region was in the fabric end cap immediately adjacent to the junction with the metal fitting; the other region was in the gores at the three-way junction of the gore, the end cap and the structural tapes on either side of the gore. Figure 13 presents a von Mises stress plot that shows the end cap stress concentration, and Fig. 14 presents a von-Mises stress plot that shows the gore stress concentration.

There are two end cap stress concentration points as seen in Fig. 13. The peak von Mises stress is 329 MPa which, given the 3 layer construction of thickness 0.507 mm, corresponds to a force per unit width of 166.8 kN/m. This is substantially higher than the thin membrane value ( $\sigma$ ) of 27.5 kN/m. Given that each Vectran layer of the end cap has an ultimate tensile stress of approximately 340 MPa, the simulation pressure of 20,000 Pa corresponds to the very close to the failure point despite being at roughly half of the thin membrane burst pressure prediction (Eq. 1) and having three layers of material in the end cap. The cause of the stress concentration appears to be related to the anisotropic nature of the Vectran fabric that makes up the end cap. Simulations performed with uniform thickness isotropic material show only a 29% increase in stress near the metal fitting, evidently arising from the stiffness mis-match between the balloon material and the metal at the boundary. The aligned nature of the Vectran threads in warp and fill directions combined with the high stiffness of those threads therefore leads to much higher stresses at the points shown in Fig. R. Note that the one of the Vectran layers is oriented at 45° to the other layers in an attempt to mitigate the anisotropy. Also, the end cap balloon material is modeled as having a clamped boundary condition at the metal at the metal junction.

It is unclear how this very high stress will manifest itself in the real structure at high loads. It would not take much plastic deformation of the material at these points to relieve the stress, whether or not this would result in a macroscopic balloon failure is not known. An obvious design change that can be considered in the future is to replace the 3 layer Vectran construction with many more thinner layer so as to better approach the isotropic ideal limit that has much reduced stresses.

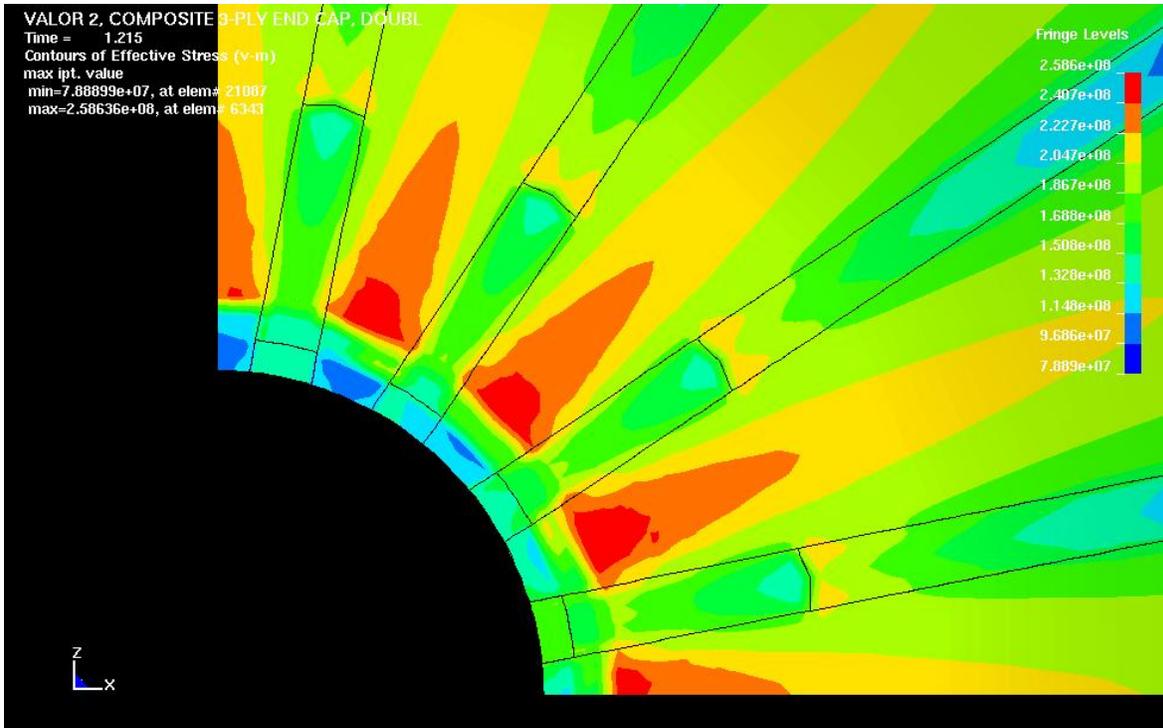
Fig. 14: Plot of von Mises stress in balloon gores and tapes, Prototype #2 design at 20000 Pa internal pressurization. The units on the color bar are Pa.

The gore stress concentration shown in Fig. 14 results from the stiffness mismatch between the relatively thin gore and the much thicker and stiffer end cap and adjacent structure tapes. Note that the structure tapes are doubled-up for a short 20 cm length on each gore-to-gore junction (there is a black line in each tape denoting the end point of the doubling), a design feature that eliminates a similar stress concentration seen in the structure tape itself in this region. The peak stress seen is 259 MPa, compared to a thin membrane value of 169 MPa given a 20000 Pa pressurization. This is an increase of 53% over the thin membrane limit.

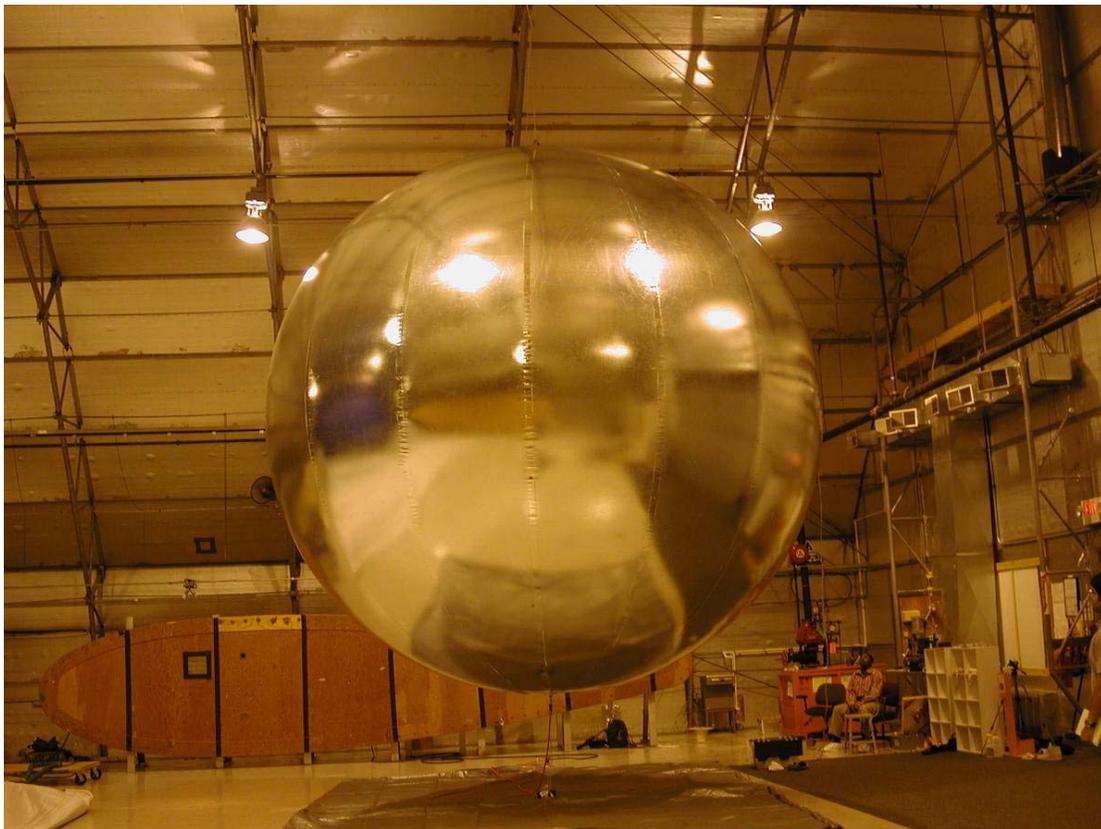
Fig. 15: Inflated balloon Prototype #2 during leak check at ILC Dover

The end cap assemblies were fabricated by thermally welding their constituent layers. Once sealed together, the center hole pattern for the inflation fitting was cut. End fitting assemblies were then installed, starting with the epoxy bonding of the diffuser/clamp ring to the interior face of the end cap. The Hastelloy inflation fitting with Viton o-ring and gasket was then attached to the exterior of each end cap with twelve 4-40 UNC A286 flathead screws. Once installed, the fittings were covered in padding to ensure that they did not damage the surfaces of the FEP envelope during subsequent assembly operations. With only a portion of the final gore seam left open, the end cap assemblies (with hardware) were thermally welded into the assembled gores. The final length of gore seam was then thermally welded, completing the envelope. A photograph of the finished balloon is shown in Fig. 15 during the initial leak test at ILC Dover.

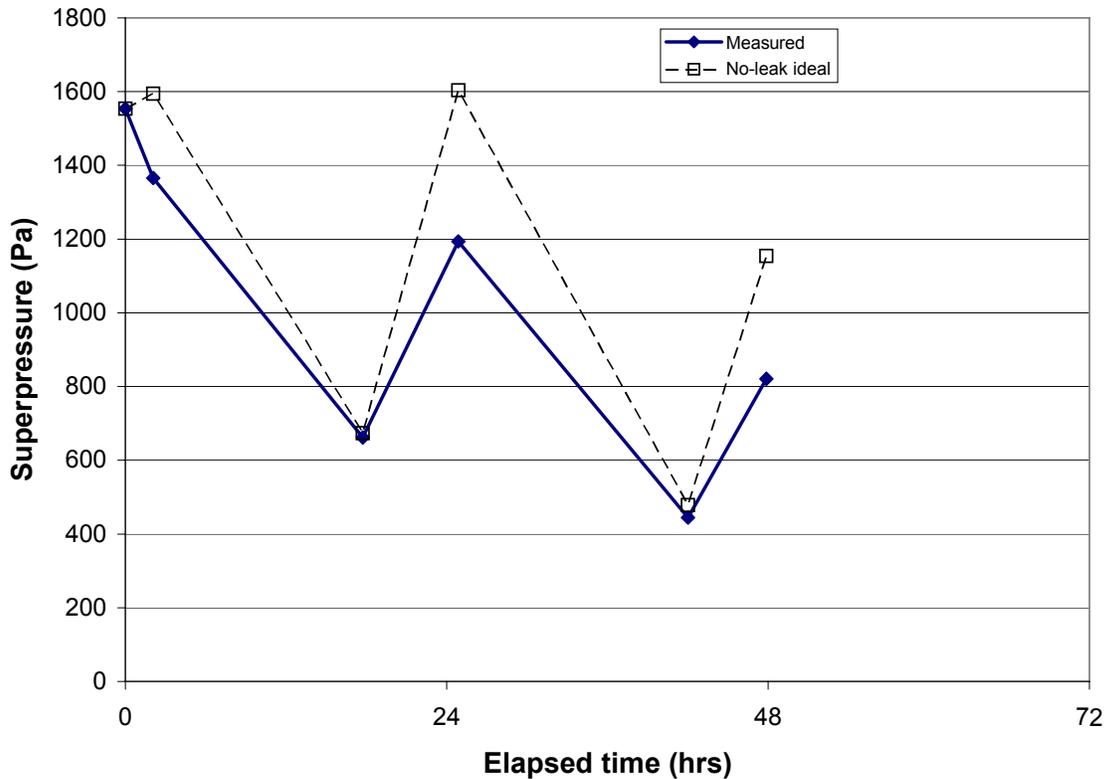
Fig. 16: Prototype #2 superpressure versus time

The balloon was sent to JPL and then inflated for a long duration buoyancy and leak check. The change in superpressure over time is plotted in Fig. 16, compared to a “no leak” superpressure that has the effects of atmospheric pressure and temperature changes subtracted out. As can be seen, the superpressure time history does not show a large divergence from that expected by changes in the environment, indicating a low to negligible level of leakage.
