# **Fabrication Assembly & Test of the Mars Science Laboratory Descent Stage Propulsion System**

Morgan Parker \*  
Ray Baker  
Art Casillas  
Dellon Strommen  
Rebekah Tanimoto

13 Feb 2013

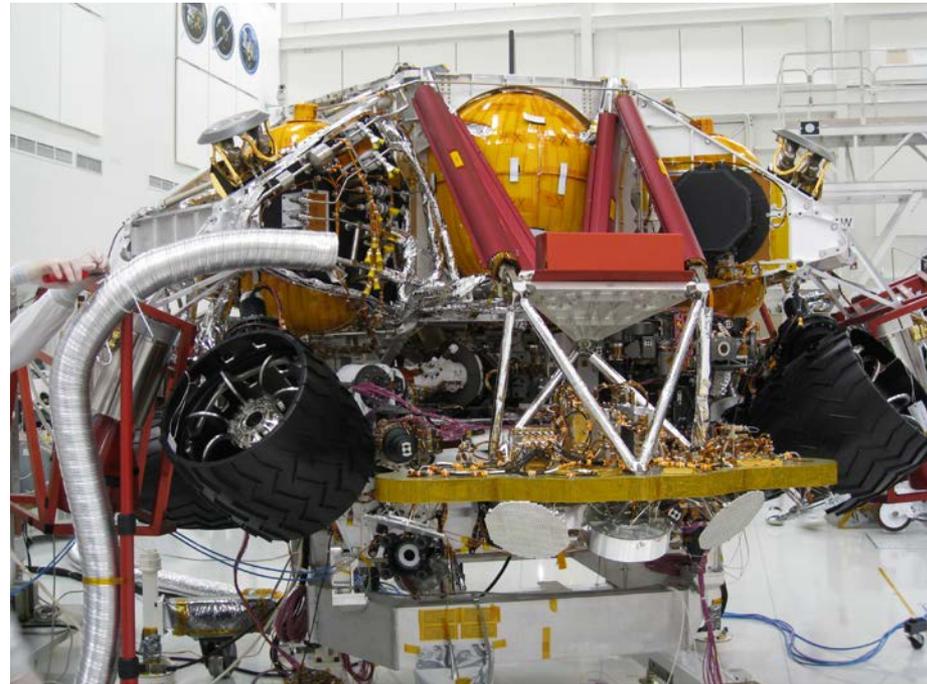
- Most of the major components had to be integrated sequentially.
- Components, subassemblies, even weld heads, tooling, and “Jack” the universal technician were modeled in CAD to verify access.

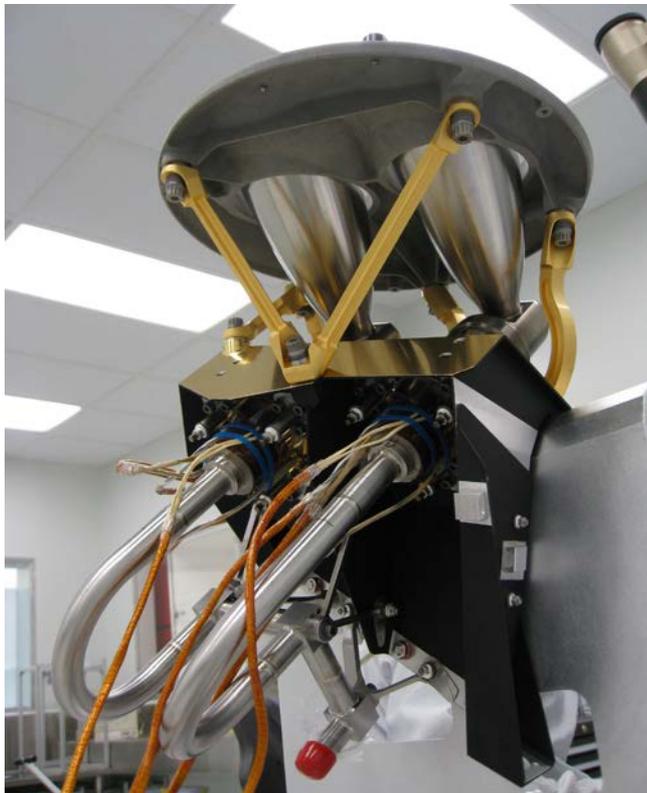
The RCS nozzles had to be precisely positioned & alignment verified through Computer Machine Measurements to prevent “close clearance” contact with their aeroshell portals during launch and entry vibration.

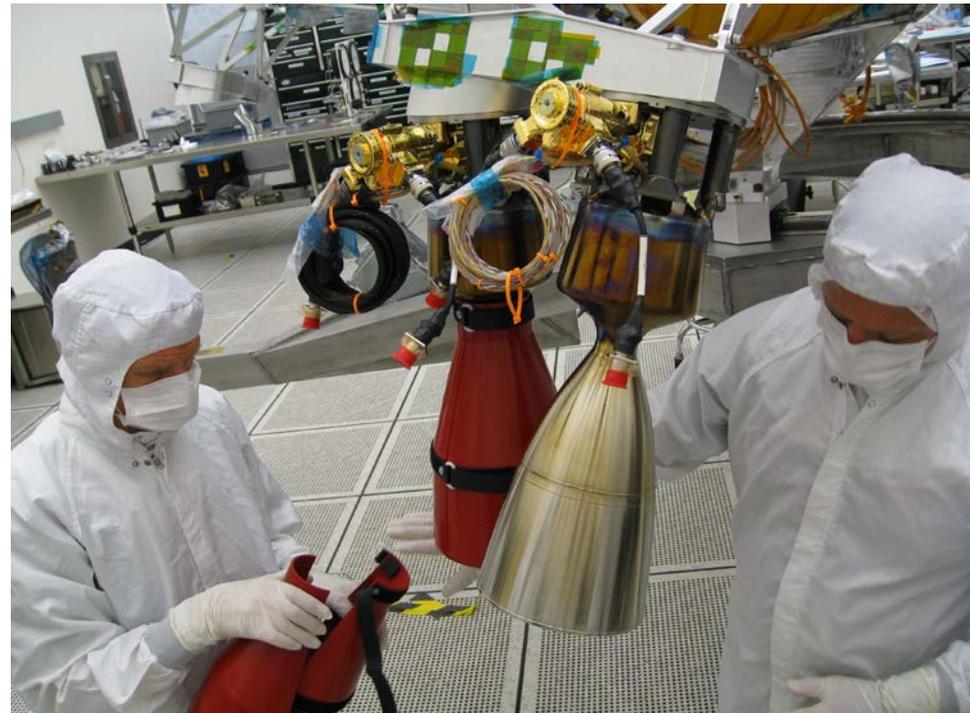
The Mars Lander Engine assemblies included a newly design cavitating venturi throttle valve, with a range of ~ 15% to 100% throttle, an LVDT for position feedback, and nozzles canted 5 degrees apart to mitigate plume sheeting impingement.

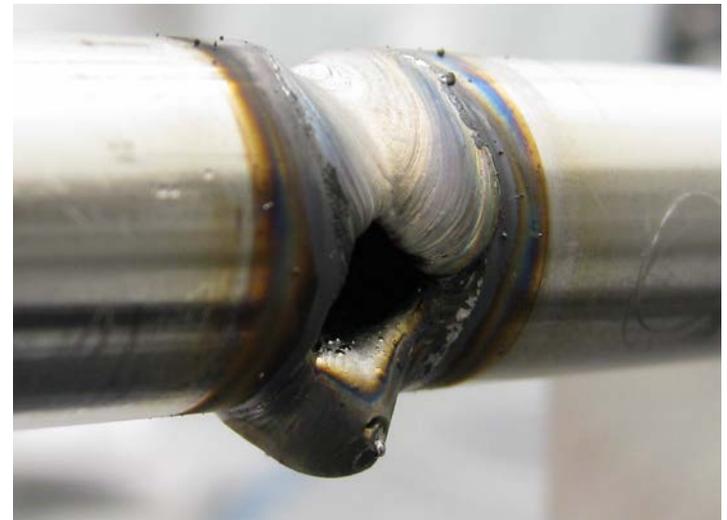
- 7 different tubing sizes, 0.25" up to 1.25" O.D, tubing wall thicknesses from 0.028" to 0.083", various component materials, & varying metallurgical content, all combined to necessitate 53 unique weld schedules and over 260 original welds.
- Many of the welds had very difficult purging setups due to long tubing runs and many dead ends in the system.
- Ultimately the DSPS welding experienced only 2 weld failures out of 260+ (and later still only 2 out of over 300 including the Rework), i.e., a >99% success rate/<1% weld failures.
- However one of those 2 weld failures occurred in a most challenging location. It was a dead-headed purge, on the high-pressure side of the contamination-sensitive pressure regulator; one of the 0.500 inch O.D. × 0.083 inch wall thickness "gun barrel" tubing welds.

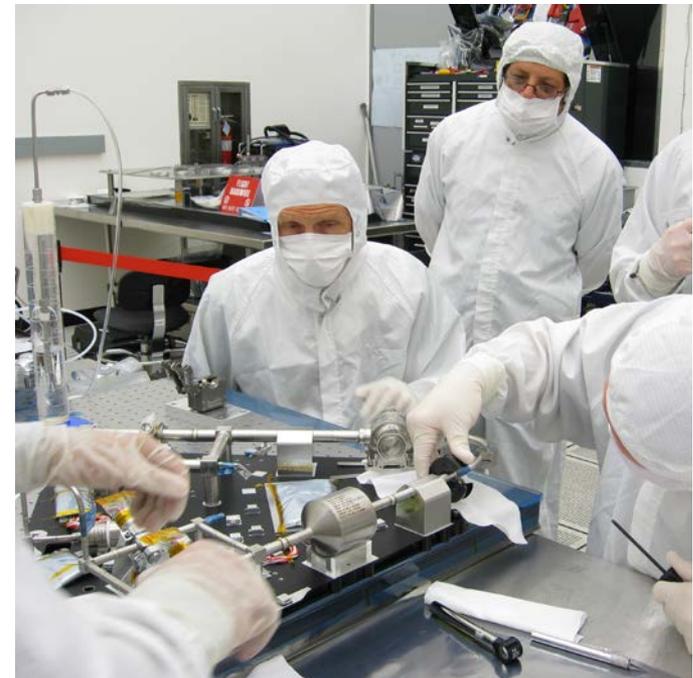
- The Propulsion team investigated the problem and devoted roughly 50% of our resources for over two weeks to repair the PCA.
- The problem was arc flow – the weld arc meandered and favored one side of the weld joint. It was intermittent & only exhibited on this thick walled tube & ultimately traced the weld head's grounding method.
- We disconnected the ground within the weld head, and configured a clamping block that bridged the weld joint to be the ground.
