Mars Exploration Rover Heatshield Observation Campaign

Abstract

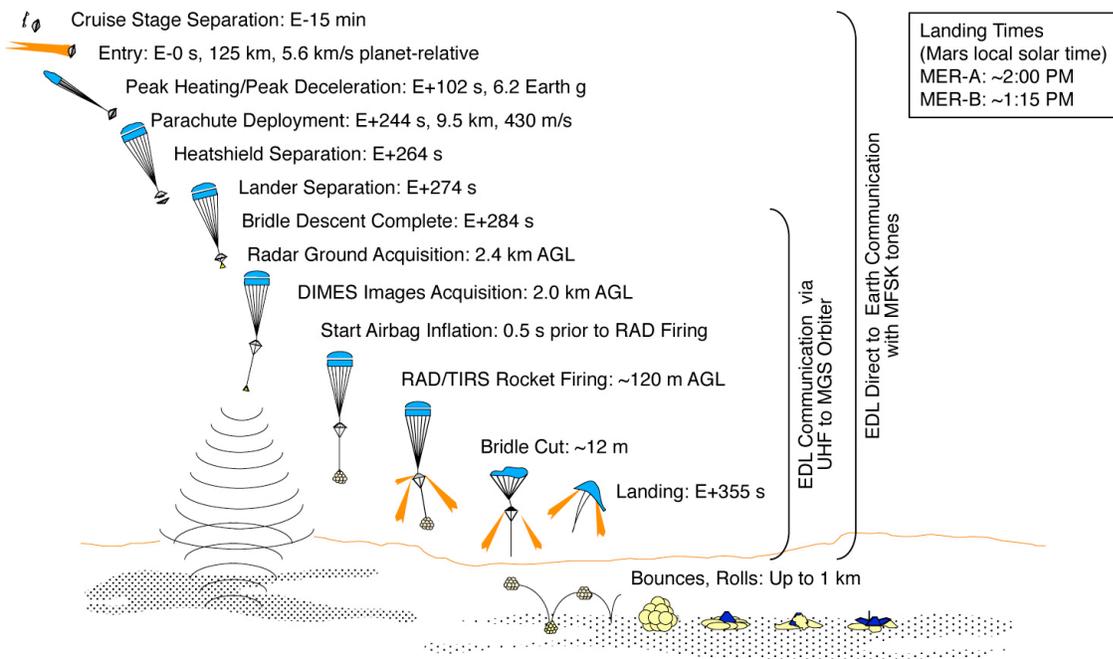
Figure 1: MER Entry, Descent, and Landing Timeline (MER-A, *Spirit*; MER-B, *Opportunity*)

Figure 1 shows the entry, descent, and landing (EDL) timeline for the mission.¹ The MER mission leveraged off of the successful Mars Pathfinder landing system by utilizing a bridle descent from the entry vehicle and air bags to protect the rover upon surface impact. As shown in Figure 2, the entry vehicle forebody, like Viking and Mars Pathfinder before it, was a 70 degree half-angle sphere cone, with a diameter of 2.65 m. Figure 3 shows the entry vehicle mated to the cruise stage with half of the external thermal blanket installed. Successful entry into the Martian atmosphere relies on thermal protection systems (TPS) to protect the rover, inside the entry vehicle, from the harsh heating environment experienced during atmospheric entry. The heatshield thermal protection system utilized on MER was SLA-561V, a Lockheed-Martin ablative material that was used on the Viking and Mars Pathfinder missions. The SLA-561V material is composed of phenolic honeycomb cells that are packed with organic compounds and fillers. The material is designed to ablate as a heat rejection mechanism, as shown in Figure 4. An ablative material contains organic resins, which through an endothermic process, decompose (or pyrolyze) and escape from the material surface in the form of pyrolysis gases that then thickens the boundary layer. In addition, carbonaceous products from the decomposition process deposit on the material surface to create a char layer with a high emissivity, which re-radiates back into the boundary layer. The net heat flux is then conducted through the material thickness to the spacecraft structure.

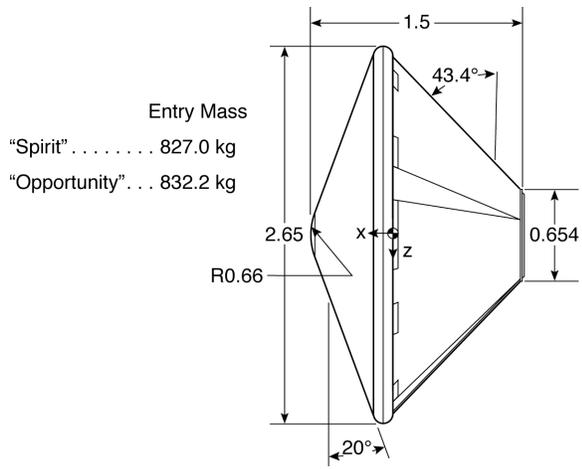
Figure 2: MER Entry Vehicle Configuration (dimensions in meters)

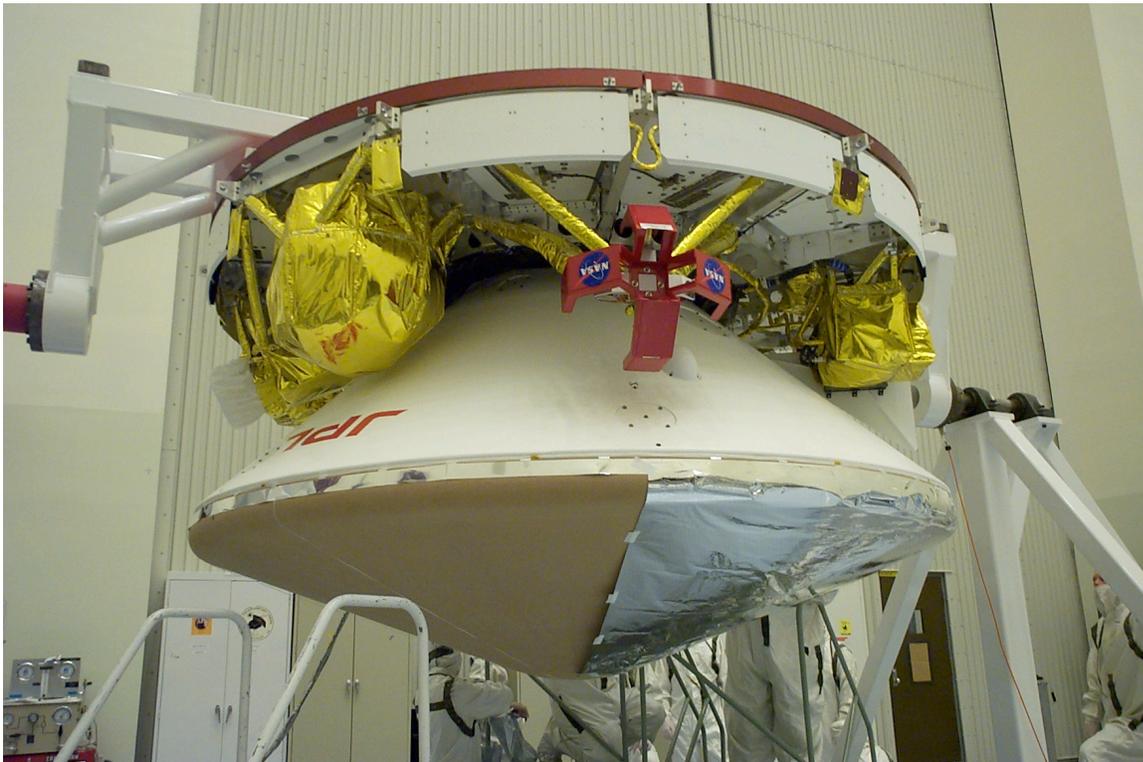
Figure 3: MER spacecraft mated to cruise stage (half of external thermal blanket installed)

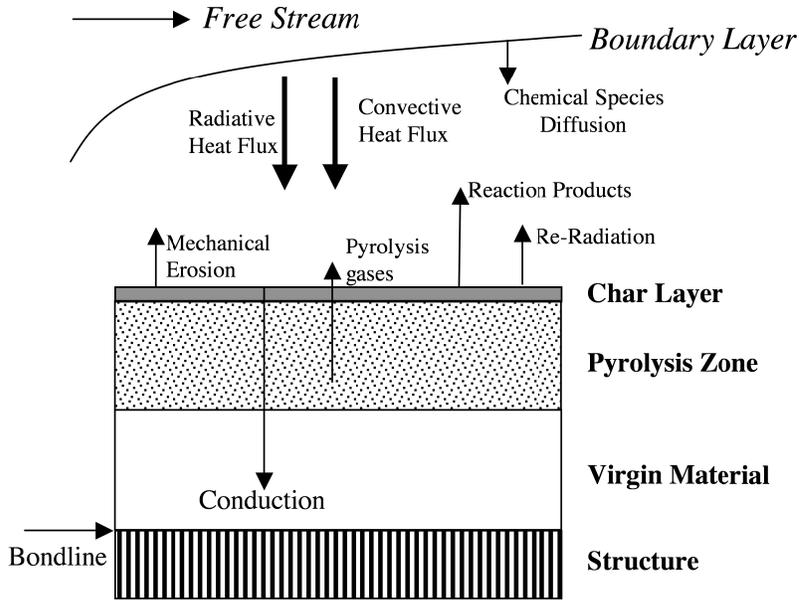
Figure 4: The ablation process of a thermal protection material

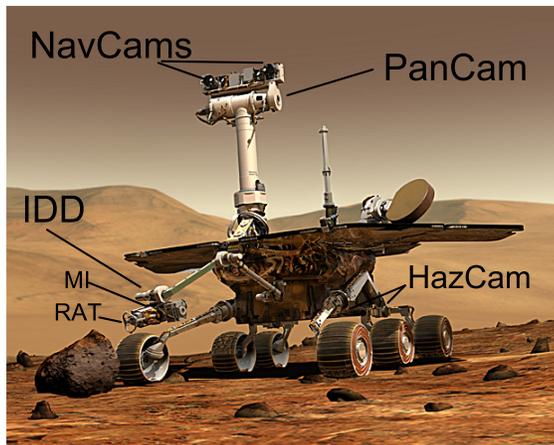
Figure 5: Mars Exploration Rover and Heatshield Observation Science Assets

The rover’s science payload includes a five degree of freedom IDD arm that carries four tools: the MI, an Alpha Particle X-ray Spectrometer (APXS) for elemental chemistry, a Mössbauer Spectrometer (MB) for the mineralogy of iron-bearing materials, and a Rock Abrasion Tool (RAT) for removing dusty surfaces and exposing fresh rock underneath.⁵ The RAT and the MI were considered for use in the observation campaign. The MI could be used for close-up magnification (fixed at 0.4) of the heatshield surface and the RAT could be used to remove a certain depth of material to obtain images of the material char layer. Laboratory tests were conducted with an engineering RAT unit and a charred SLA-561V material sample to evaluate if this tool could be used on the heatshield. Test results showed that the RAT abrasion process on the char surface layer produced a large amount of carbon dust that then prevented an assessment of char layer depth within the resultant cross-section. This char dust also contaminated the engineering RAT and thus was unacceptable for *Opportunity*’s RAT since it may cross-contaminate future science investigations on Martian rocks. Thus it was decided that the RAT would not be used for the heatshield observation campaign. The MI could still be utilized, however, as long as the MI surface did not come in contact with the heatshield. The rover and location of these science assets are shown in Figure 5.

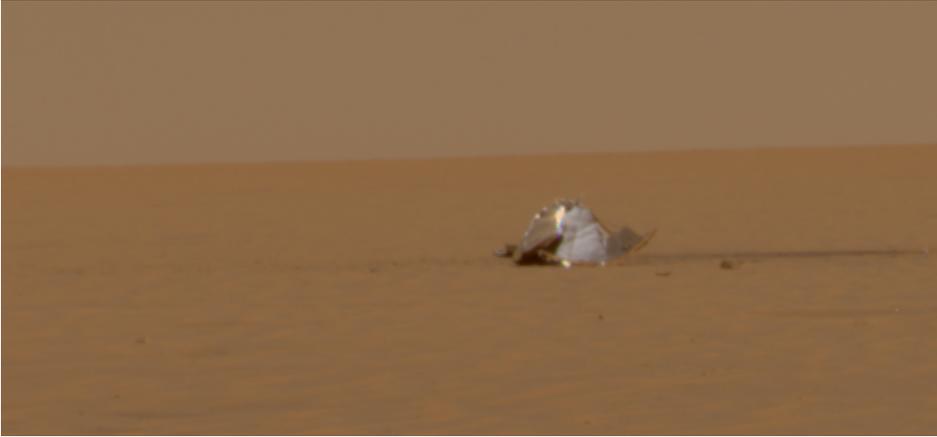
Once *Opportunity* exited “Endurance” crater, the rover began driving towards the heatshield. Figure 6 shows a PanCam image of the heatshield taken on Sol 322 as the rover was about 130 m away. At this point, it was clear that the heatshield was not intact after impacting the surface at about 75 m/s (170 mi/hr). The shiny, reflective material was determined to be internal multilayer insulation (MLI) blankets, which were integrated to the inside of the heatshield. Images were taken on Sol 324, shown in Figures 7 and 8, as the rover was about 30 m away the heatshield. These images provided a clear view of the impact divot, the main heatshield, and a secondary debris site. This image provided the information needed to implement the prioritized investigation plan. The images provided a clear view that the heatshield was unexpectedly inverted, or “inside out”. This is seen from the fact that the internal thermal blankets are observed on the outside of the heatshield debris (the silvery, glinting region in Figures 7 and 8).

Figure 6: Heatshield Debris Image from Sol 322 (Rover approximately 130 m away)

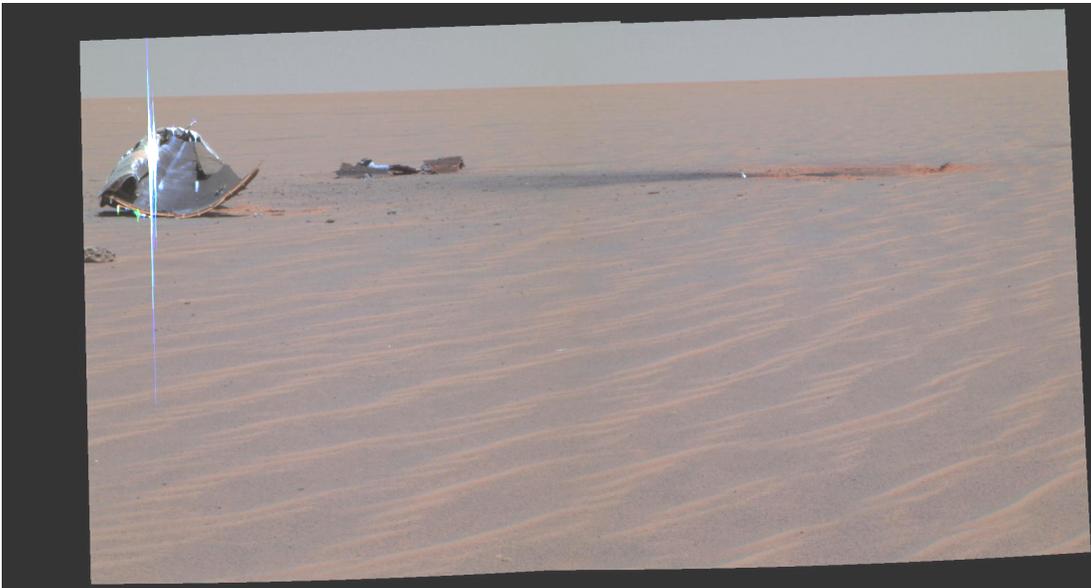
Figure 7: Images of the heatshield debris field taken on Sol 324

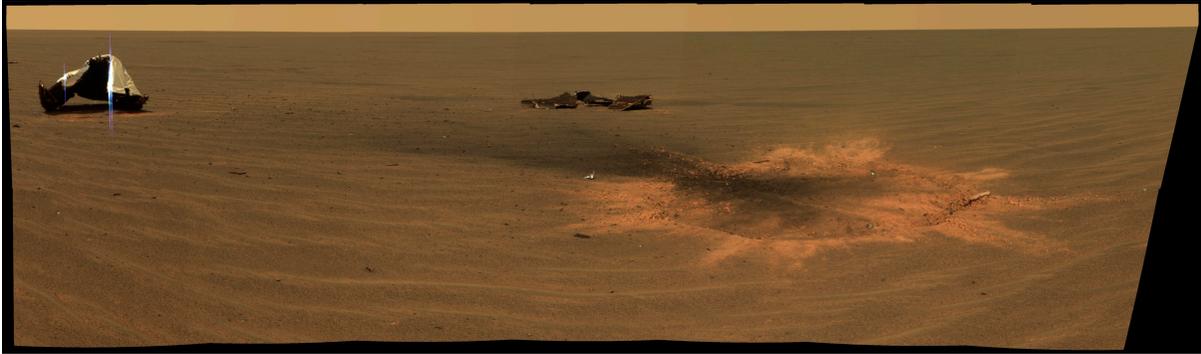
Figure 8: Main heatshield, “flank piece”, and impact divot

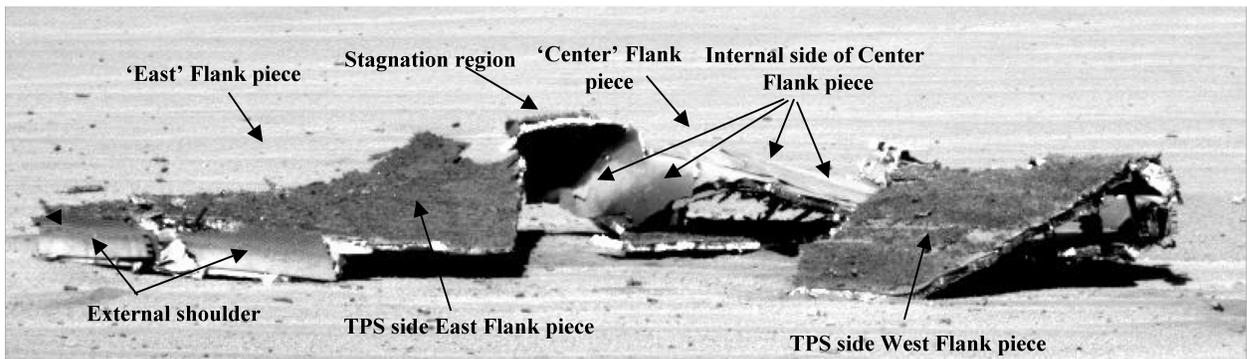
Sol 329 and 330 imaging of the “flank” piece provided a survey of the broken heatshield and structure at this location, and Figure 9 identifies these pieces. Circling around the flank piece gave intriguing vantage points and color images of the debris by utilizing the PanCam (shown in Figures 10 and 11). MI data was obtained on a couple of areas, including the stagnation piece, as seen in Figures 12 and 13. At the stagnation piece, the IDD was not able to position the MI to obtain a true cross-sectional view of the exposed edge. Therefore char depth could not be evaluated at this location on the heatshield. None of the “flank” piece debris offered areas where char depth evaluation could easily be obtained, so it was decided to move to the main heatshield.

Figure 9: Identification of the “flank” pieces

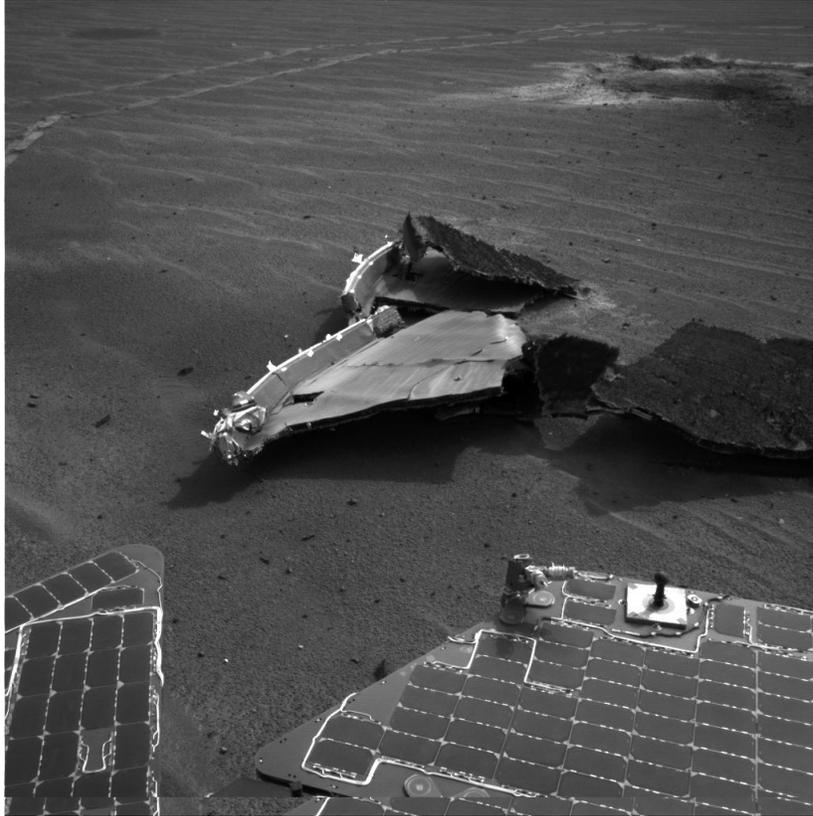
Figure 10: Sol 331 image of “flank” piece from the South (the rover’s solar panels can be seen in the foreground)

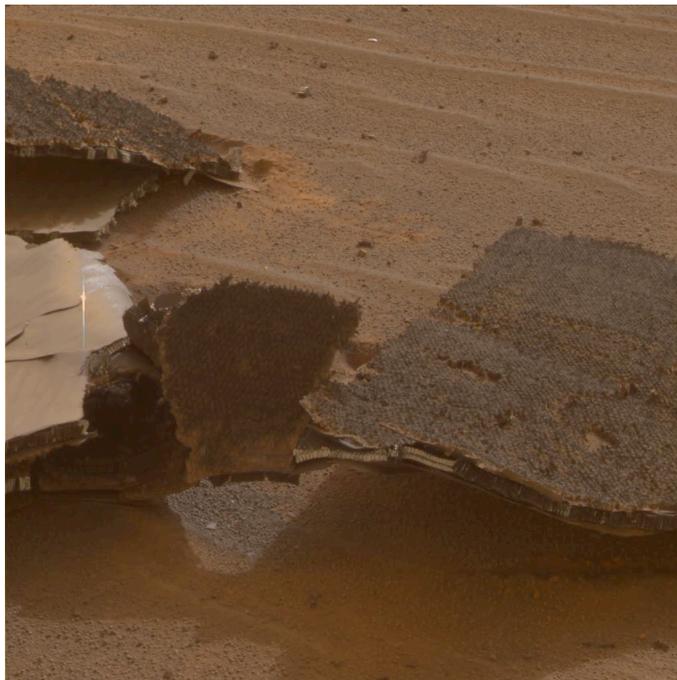
Figure 11: Color PanCam Image of the heatshield stagnation area

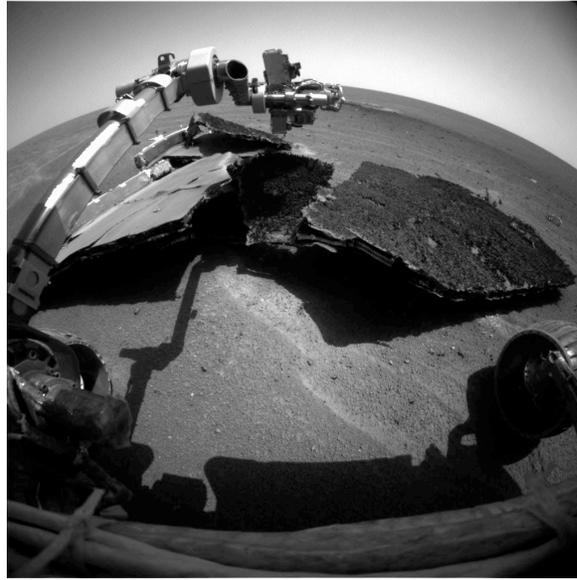
Figure 12: *Opportunity*'s Instrument Deployment Device positioning the MI for close-up images

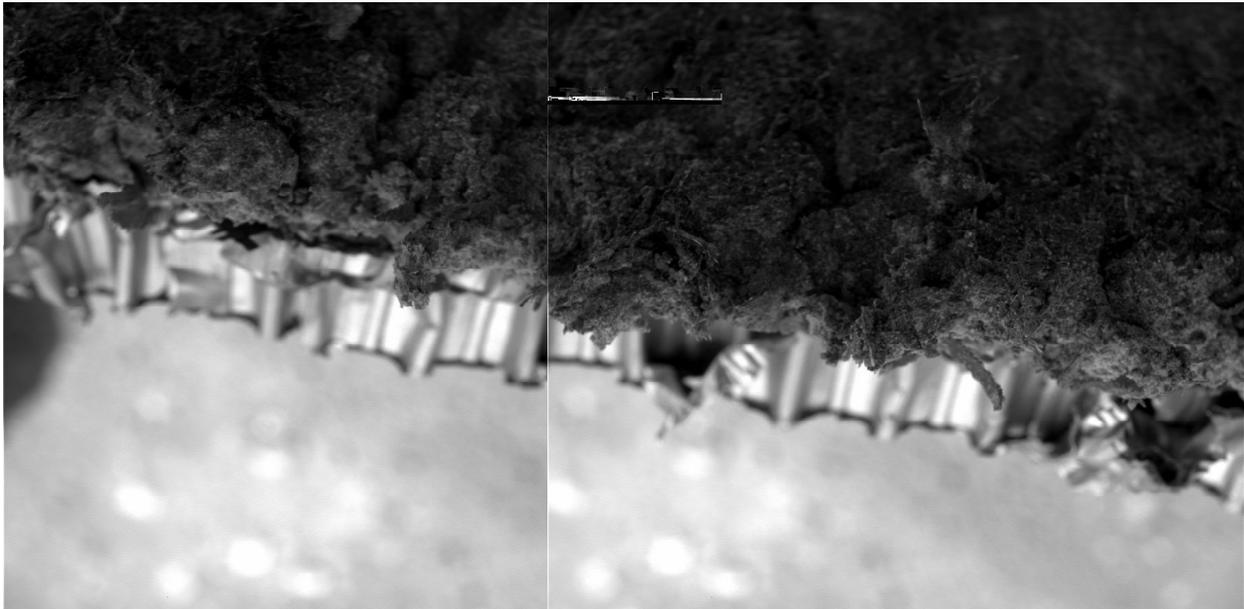
Figure 13: MI images of the "flank" piece stagnation area

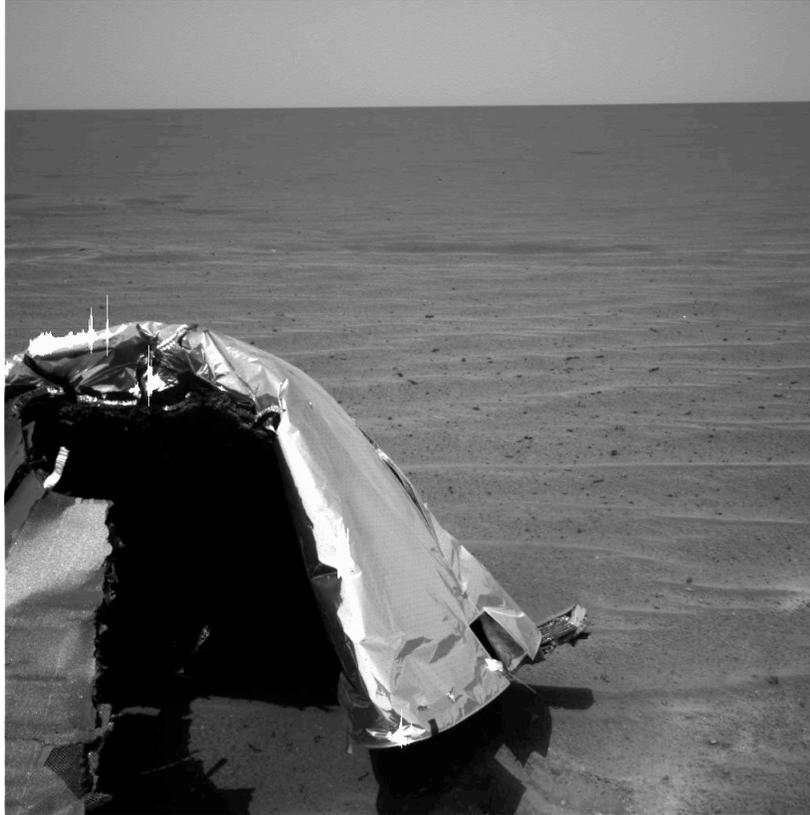
Before it was determined that the heatshield was inverted, it was hoped that observation of the global charring pattern on the exterior surface of the TPS would offer insight into heating gradients and transition to turbulence. Images were taken from various angles around the main heatshield, and at different times of the Martian day, to attempt to distinguish color patterns on the TPS. Unfortunately because of the inversion and the fact that the interior was always shadowed, clear images of the TPS exterior could not be obtained, as seen in Figure 14. However, this side of the main heatshield offered excellent cross section targets to obtain char depth measurements.

Figure 14: Main heatshield image in the attempt to view TPS surface characteristics

2. Obtain imaging data to look at global charring patterns on heatshield. Objective not met – Due to the inversion of the main heatshield debris, images could not be obtained that would allow an assessment of global heating patterns.

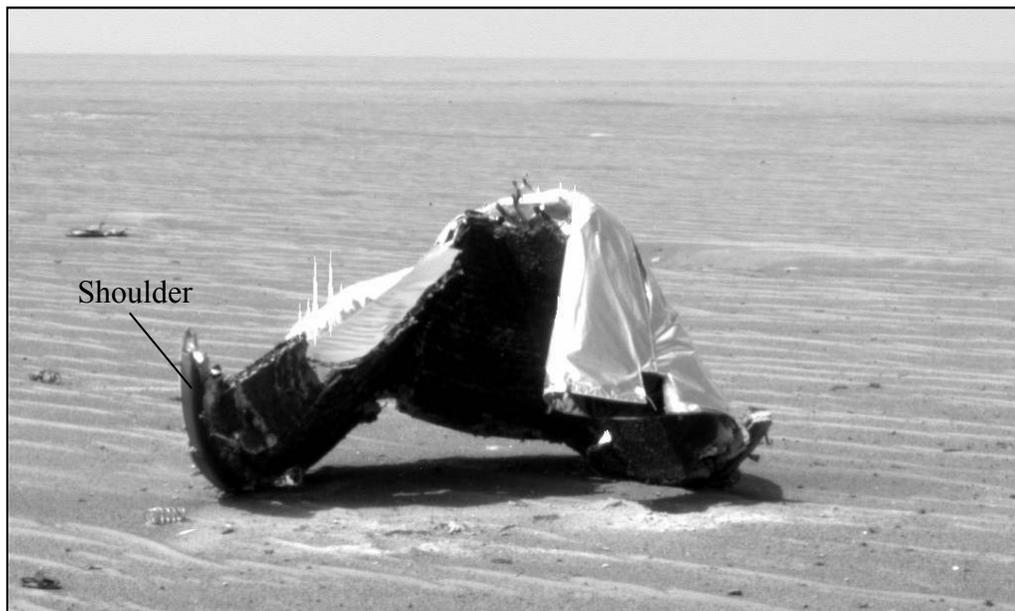
The heatshield shoulder is shown in Figure 15 and a close-up is shown in Figure 16. Figure 17 shows an intriguing view of the IDD and MI in position at the target location. This location turned out to be an excellent cross sectional view, and the image (Figure 18) was examined for the slight color difference between the char and the virgin material. Estimated char depth from the image was consistent with pre-flight predictions, yielding confidence in the ability of the computational material response model to predict the material's ablative response. This data allowed engineers to achieve one of the main objectives of the heatshield observation plan. An interesting view and color image of the shoulder area is shown in Figure 19.

Figure 15: Sol 329 image of the main heatshield from the west

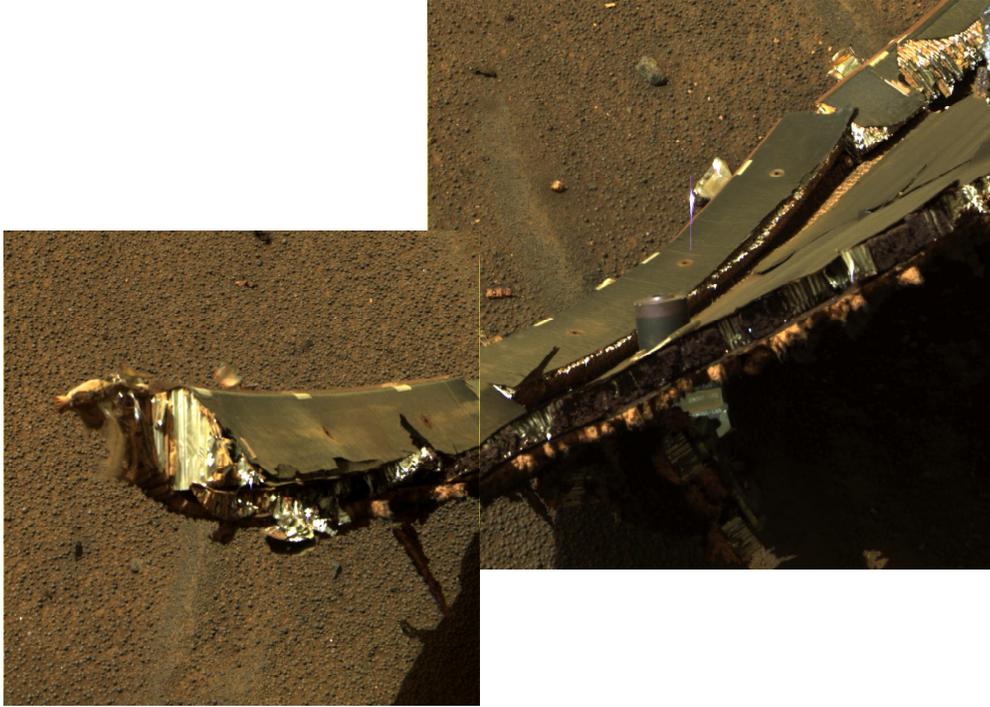
Figure 16: Mosaic close-up image of the heatshield shoulder

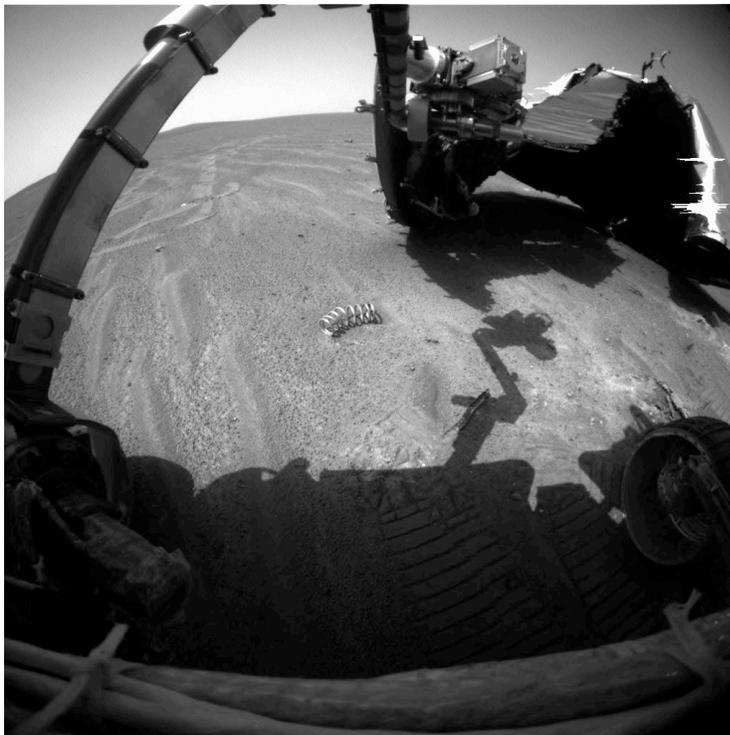
Figure 17: Rover IDD placement of MI on heatshield shoulder target (heatshield separation spring can be seen in foreground)

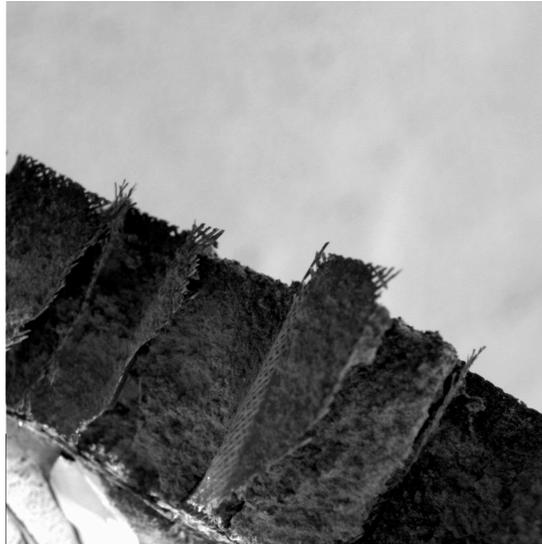
Figure 18: MI image of heatshield shoulder cross-section

1. Obtain imaging data to determine char depth of localized area of material. Objective met - MI imaging at the shoulder allowed an assessment of char depth that compared well to pre-test predictions.

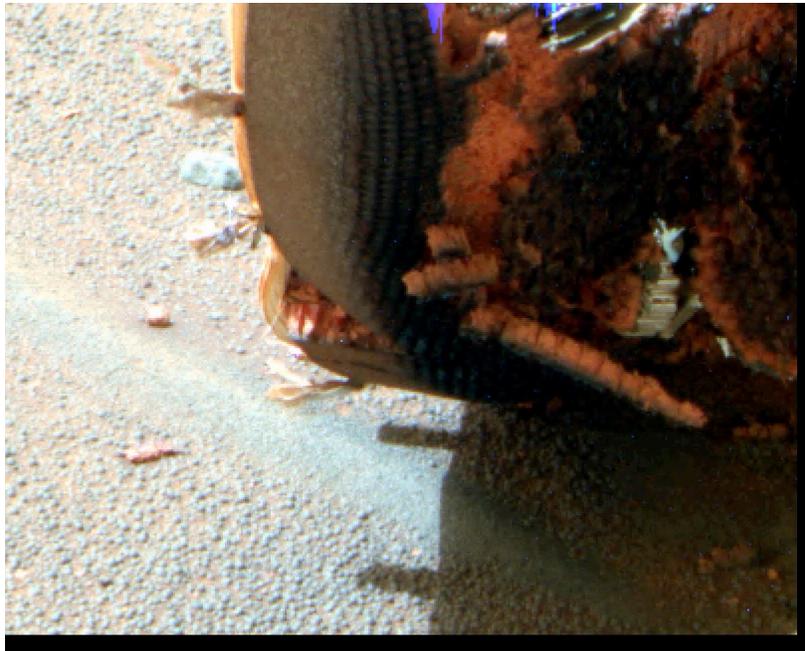
Figure 19: Color image of heatshield shoulder

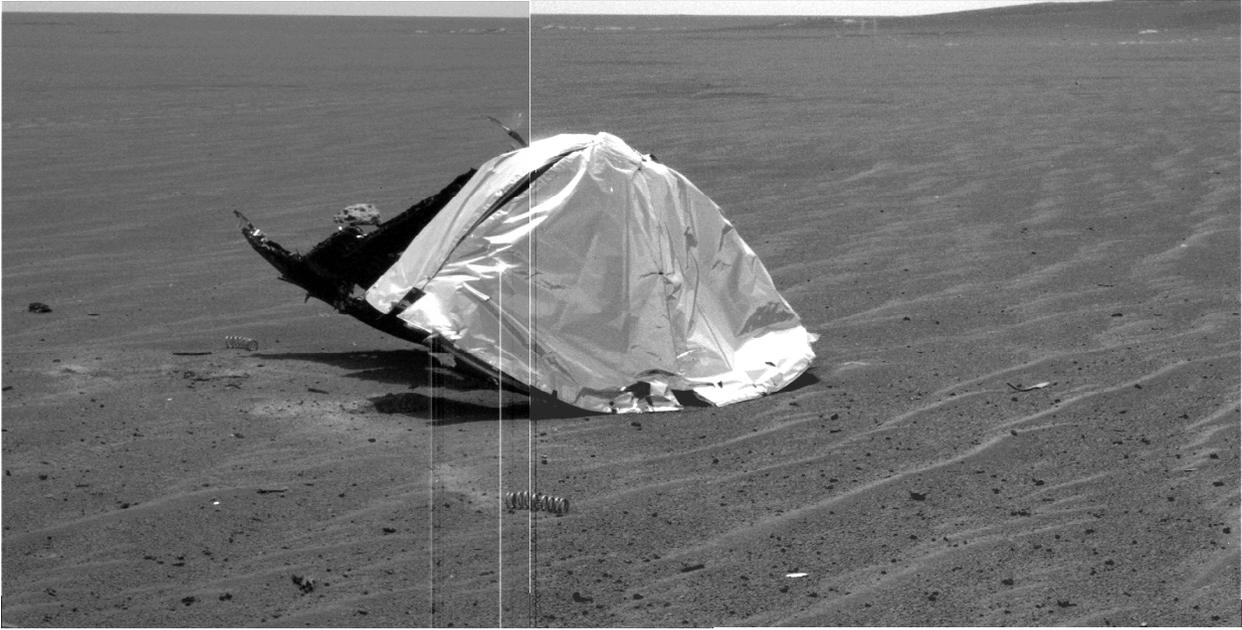
Figure 20 shows the internal MLI blanketing, a separation spring, and fortuitously, a rock that intrigued the MER scientists. An additional image of the impact divot (Figure 21) shows various aeroshell hardware, including separation springs and ballast mass that had been attached to the inside of the heatshield. A color image from Sol 357 (Figure 22) revealed the heatshield composite structure, fractured and rippled from the high-speed impact into the Martian surface. These color images showed no observable discolorations on the structure or internal MLI blanketing that would indicate overheating. This result achieved the fourth main objective of the observation plan.

Figure 20: Sol 335 image of the heatshield (“heatshield rock” can be seen just behind the heatshield)

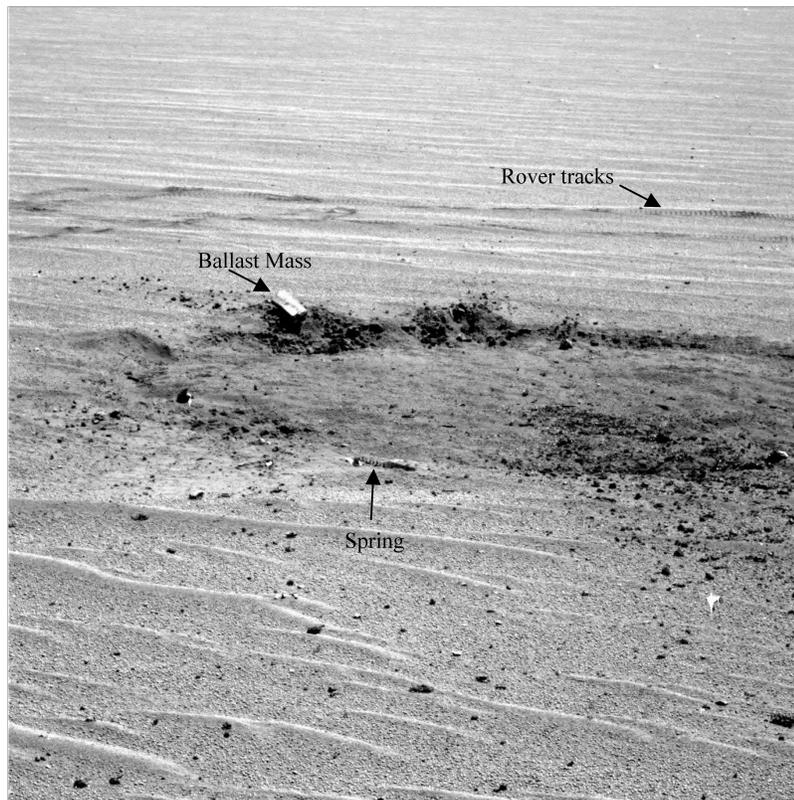
Figure 21: The impact divot and various heatshield hardware

4. Obtain imaging data of the internal structure. Objective met – Images of the internal structure, though fractured from impact, show no observable signs of discoloration that would indicate overheating.

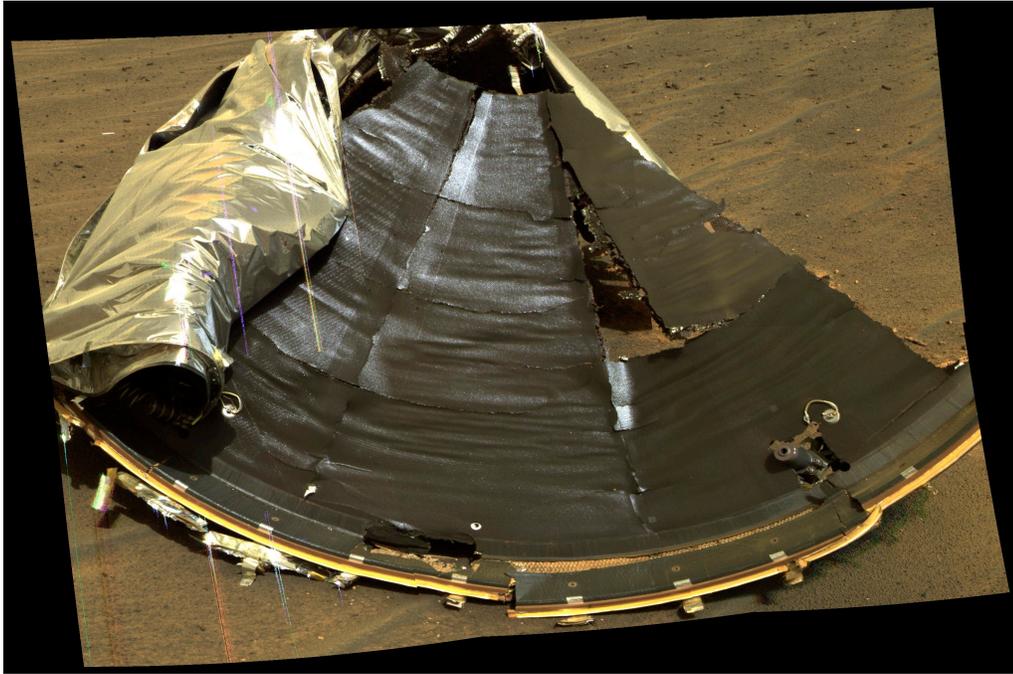
This vantage point and the same color image also show that the main seal appeared to be in pristine condition, with no observable sign of hot gas penetration through the seal. There were also no observable discolorations that would indicate overheating, and this observation achieved the third main objective of the observation. Further images taken on Sol 357 proved to be some of the most valuable images of the entire observation campaign.

Figure 22: Heatshield structure and main seal

3. Obtain imaging data to evaluate the performance of the main thermal seal. Objective met – Clear, color images of the main seal show no observable signs of overheating or gas penetration through the seal; seal appears to be in pristine condition and confirms adequacy of the seal design.

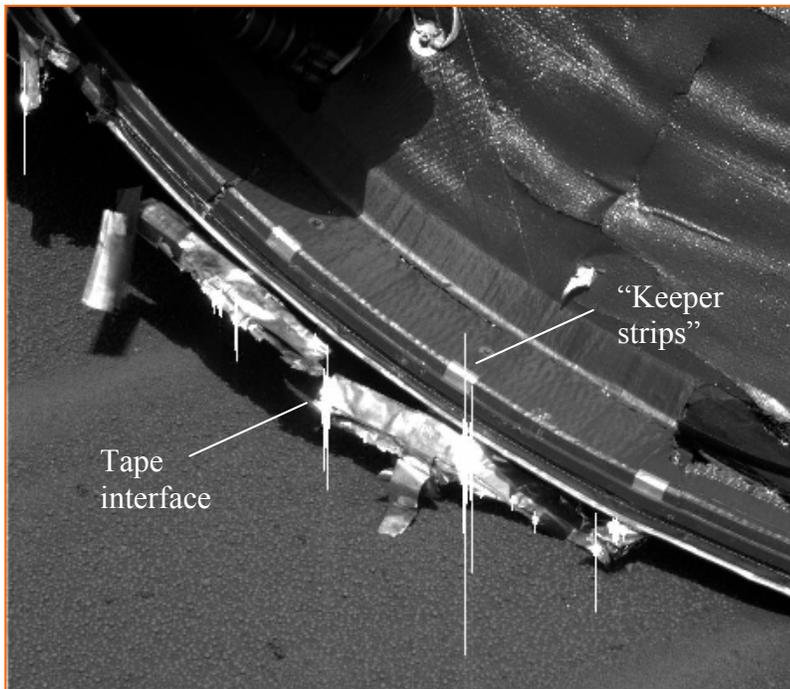
Figure 23 shows a close-up of the main seal area, and clearly shows remnants of the aluminized mylar tape interface and thermal blanket “keeper strips” that were used to attach the external MLI blanket to the heatshield. This external MLI blanket was needed for thermal control of the spacecraft during cruise. The observation of these remnants led engineers to explore the possibility that this may be an explanation for a mystery that had plagued the MER flight reconstruction efforts.

Figure 23: Thermal blanket "keeper strips" and tape interface for external thermal blanket remnants

Figure 24 shows the entry attitude reconstruction for *Opportunity*. This plot shows angle of attack oscillations much earlier, and at magnitudes far in excess of what was expected. This behavior was not seen in the post-flight reconstruction of the Mars Pathfinder spacecraft. Thus this unexplained behavior was causing consternation for design engineers who were designing the EDL system for the next Mars mission, Phoenix. Aerodynamicists studied the effect that this tape strip could have had on the entry dynamics. This work is detailed in Reference 6, and it was concluded that this tape strip remnant could have been enough of a disturbance in the flow field to explain the anomalous angle of attack oscillations during entry. This discovery has thus drawn attention to the design of external MLI blanket attachment schemes for future Mars missions. Fortunately, the Phoenix spacecraft did not need an external thermal blanket for thermal control during the cruise phase. It is now clear that the blanket attachment design must ensure complete burn-off during atmospheric entry, or mechanical removal, of the blanket and any attachment strips to avoid any possible flow field disturbance that would adversely affect entry dynamics.

The critical discovery of external thermal blanket remnants on the heatshield can directly feed-forward to future mission designs. Aerodynamic analyses have shown that these remnants could have been enough of a disturbance in the flow field to explain the previously unsolved mystery of unexpected angle of attack oscillations during entry. It is clear that external thermal blanket attachment designs need to ensure complete removal so as not to adversely affect entry dynamics.

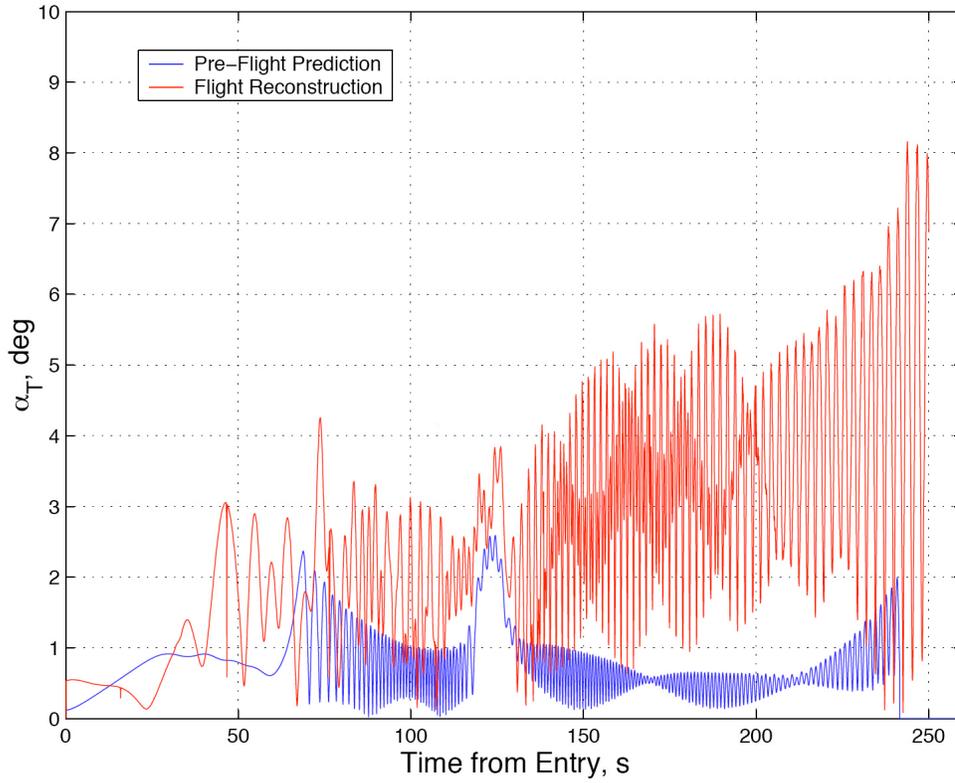
Figure 24: *Opportunity* entry attitude reconstruction (NASA Langley Research Center)

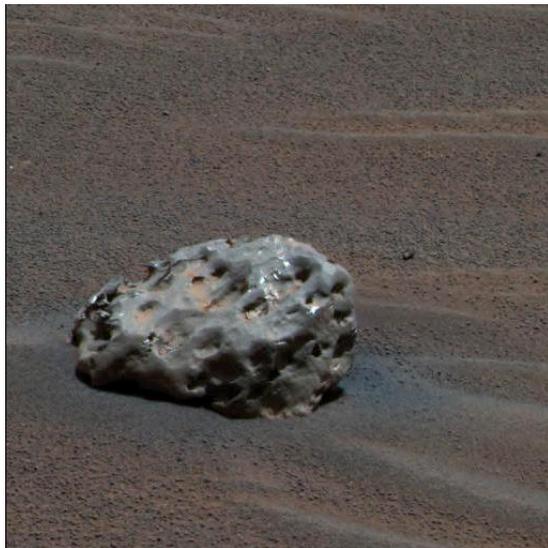
Figure 25: “Heatshield Rock”; the first ever meteorite identified on another planet

Opportunity's heatshield fortuitously landed near a unique, basketball-sized rock (Figure 25), aptly named “heatshield rock” by MER scientists (and affectionately nicknamed “SpongeBob” by the MER operations team). During the heatshield observation campaign, the scientists took a detour around the heatshield to gather spectroscopic data on the rock to aid in its identification. Surprisingly, it was determined to be an iron-rich
