Mars Balloon Flight Test Results

This paper describes a set of four Earth atmosphere flight test experiments on prototype helium superpressure balloons designed for Mars. Three of the experiments explored the problem of aerial deployment and inflation, using the cold, low density environment of the Earth's stratosphere at an altitude of 30-32 km as a proxy for the Martian atmosphere. Auxiliary carrier balloons were used in three of these test flights to lift the Mars balloon prototype and its supporting system from the ground to the stratosphere where the experiment was conducted. In each case, deployment and helium inflation was initiated after starting a parachute descent of the payload at 5 Pa dynamic pressure, thereby mimicking the conditions expected at Mars after atmospheric entry and high speed parachute deceleration. Upward and downward looking video cameras provided real time images from the flights, with additional data provided by onboard temperature, pressure and GPS sensors. One test of a 660 m³ pumpkin balloon was highly successful, achieving deployment, inflation and separation of the balloon from the flight train at the end of inflation; however, some damage was in

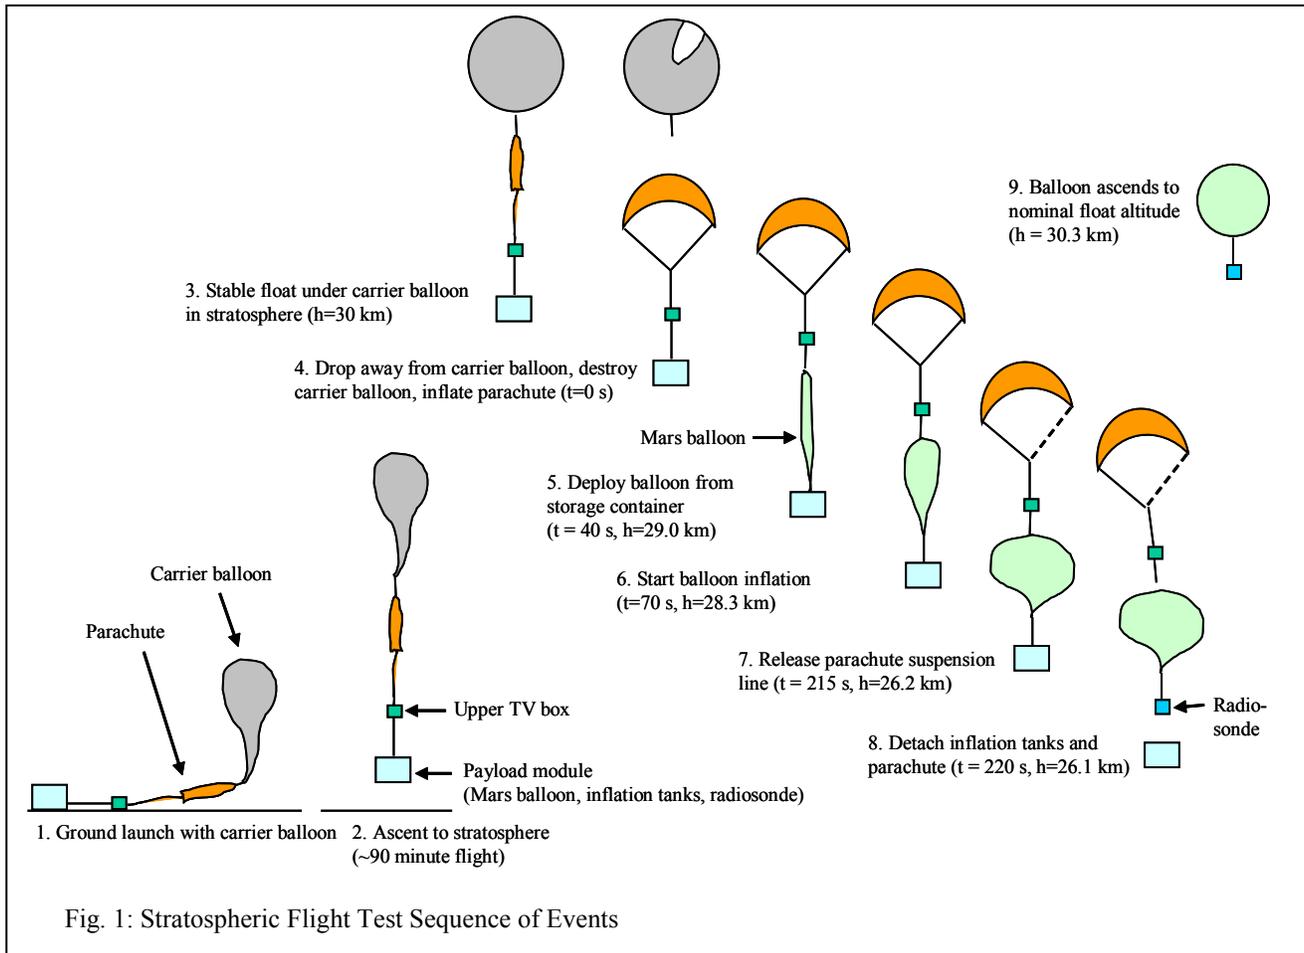
Fig. 1: Stratospheric Flight Test Sequence of Events

Stratospheric flight testing is required to evaluate the performance of the Mars balloon designs at the system level. The Earth’s stratosphere provides the best proxy environment for Mars because of the importance of matching the atmospheric density for the aerodynamic behavior of the system. Such testing is actually more severe than what would be experienced at Mars because the higher Earth gravitational acceleration ($9.8 \text{ vs } 3.7 \text{ m/s}^2$) results in a much higher balloon deployment speed and attendant deployment shock load. These flight experiments use a carrier balloon to lift the Mars prototype balloon and flight train from the ground to the stratospheric altitude. The flight test sequence of events is illustrated in Fig. 1. The aerial deployment and inflation experiment begins when the flight train is detached from the carrier balloon and commences parachute descent at a dynamic pressure equivalent to that which will be experienced at Mars (Step 4 in Fig. 1). Balloon inflation with helium gas occurs over a short period (150 s in this example) and completes at Step 8. Note that at Step 7 a pyrotechnical cable cutter is used to cut one of the four parachute suspension lines, which in turn engages a secondary suspension line that is 2 meters longer. This event makes the parachute geometrically asymmetrical and causes a lateral drift in the descent velocity vector. This lateral motion ensures that the parachute does not fall on top of the Mars balloon when the parachute-balloon separation event occurs in Step 8. The helium tanks are jettisoned simultaneously with the parachute. The Mars balloon is a free-floating vehicle at this point and will rise to its design altitude and stabilize there (Step 9).

Fig. 3 is a schematic diagram that shows the flight train arrangement at Step 5 (from Fig. 1) for the three aerial deployment tests, namely during parachute descent with a deployed but not yet inflated Mars balloon. The three main

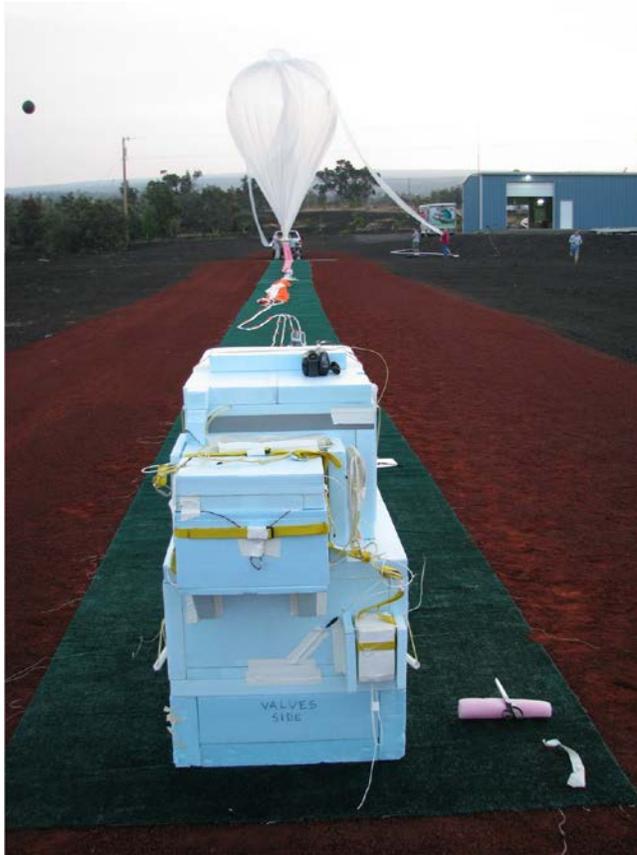
Fig. 2: Aerial Deployment Test Flight Train Prior to Launch (STRA-15).

The current set of four flight experiments were all launched from the Near Space Corporation facility in Ocean View, Hawaii. Table 2 lists the flight dates and other basic information. Figure 2 shows the arrangement of the flight train prior to launch for aerial deployment test STRA-15. The blue Styrofoam box-like structure in the foreground contains the rolled up prototype Mars balloon, the helium tanks and inflation plumbing, avionics for receiving radio

commands from the ground, a radiosonde, and an upwards-looking TV camera, transmitter electronics and wheel antenna. Laid out on the carpet behind that is the cross parachute with an orange canopy, and finally the zero-pressure polyethylene carrier balloon that is being inflated. The blue payload box was light enough ($<65 \text{ kg}$) that a hand-carried launch procedure was used to ensure that it and the other the flight train components did not drag across the ground when the carrier balloon was launched and began to ascend. This flight train arrangement was essentially the same for tests STRA-13 and STRA-14 also.

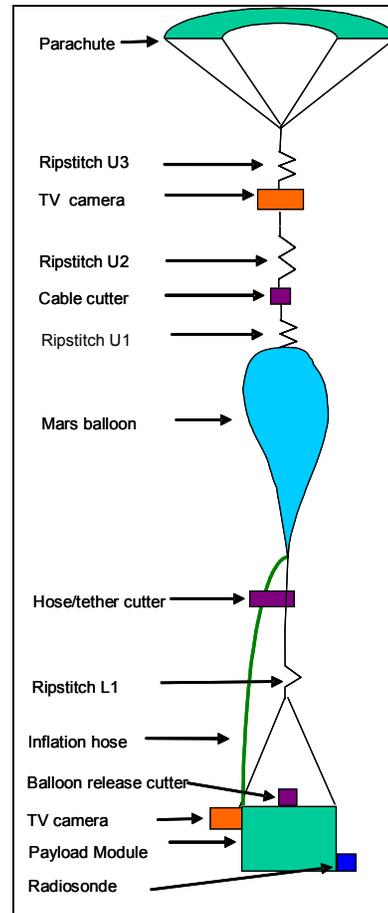
Fig. 3: Aerial Deployment Test Flight Train Schematic (Step 5 of Fig. 1.)

components (payload module, Mars balloon, parachute) are connected with Kevlar rope and carabiners to a number of secondary components to form the overall flight train. Three of the four ripstitch elements are used to mitigate deployment shock loads caused by acceleration of flight train components: L1 for the payload module, U3 for the upper cable cutter, and U2 for the upper TV box containing the camera, transmitter and antenna. The fourth ripstitch, U1, is designed to rip at the moment of balloon deployment and add 50 m of length between the balloon and parachute. We use a ripstitch for this purpose to avoid adding 50 m of flight train length on the ground and the increased difficulty of launching such a long experimental package. This long separation distance between the parachute and the balloon reduces oscillations in the parachute from vortices shed from the balloon. All ripstitches were constructed from MIL-W-4088K Type IV webbing and Nylon thread. Black marks were made at regular intervals on the ripstitch to assist with the post-flight video determination of how much ripping actually occurred.

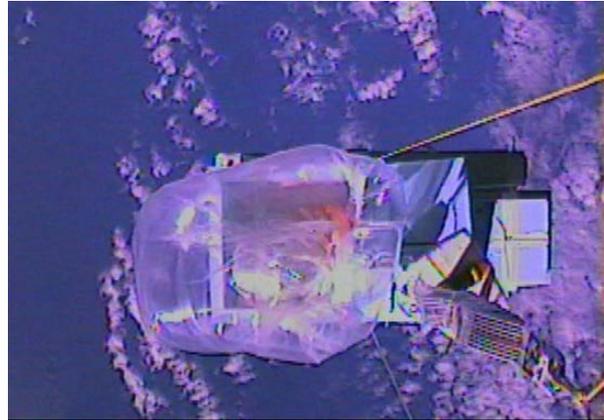
Fig. 4: STRA-13 extruded balloon problem.

The STRA-13 sphere balloon flight occurred on the morning of June 27, 2007. Following a successful launch of the carrier balloon and flight train, a problem occurred during ascent to the stratosphere. This problem was revealed by the downward-looking video camera that showed the top of the payload module (Fig. 4). Despite being rolled up inside the payload module, the Mars balloon expanded in the low density upper atmosphere due to trapped residual air inside the balloon. The balloon expansion eventually grew to the point that it pushed up on the lid on the balloon storage box until it broke. As the flight train continued its ascent, the balloon continued to grow until it reached an approximately 1 m diameter size just prior to deployment as shown in Fig. 4. The flight video showed this bubble quickly bursting during deployment due to mechanical interference with the remnants of the balloon box lid that pushed up from below during opening. This failure ended the experiment and no other useful data was collected during this flight test.

Post-flight analysis suggested a combination of factors that contributed to the residual gas problem and consequent structural failure. No previous flight test had shown this kind of behavior in which the balloon expanded and broke the payload module lid from below. However, some minor deflections of the balloon box lid could be seen in old flight videos, which is suggestive of a less serious residual gas problem. For STRA-13 and previous flight tests, the top of the Mars balloon was not capped so as to provide a direct vent path for residual gas to escape out of the top of the balloon during ascent to the stratosphere. It appears that this venting was greatly hindered on STRA-13 by two subtle changes from previous flights. The first change was that the internal porous fabric inflation tube was extended all the way to the top fitting, in contrast to previous years for which the tube was connected with a short length of fabric ribbon leaving the top fitting uncovered. This tube is intended to serve as an additional diffuser element that prevents direct impingement of high speed helium gas onto the balloon envelope during inflation. The second change was that the STRA-13 sphere balloon was packed more efficiently than any previous test in the sense that it was very tight and occupied a smaller volume. The combination of these two changes served to effectively block the vent path for residual gas to escape through the top fitting, with the porous inflation tube

A post-flight volumetric analysis revealed that approximately one-third of the residual gas was contributed from the inflation hose connecting the orifice valves and the balloon, and two-thirds was contributed from gas inside the balloon itself. One implication of this is that efforts to avoid the problem by completely evacuating the gas from inside the balloon will not work unless it is coupled with an evacuation of the tubing as well.

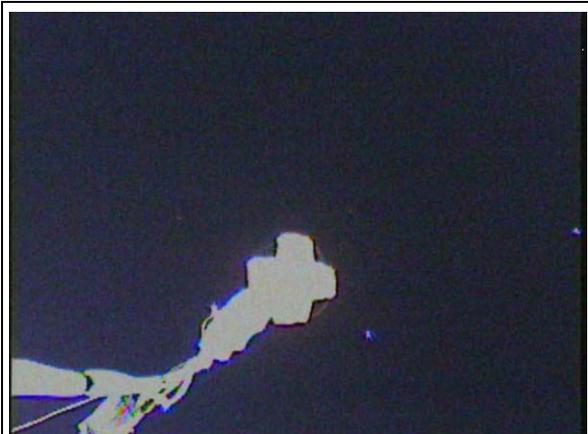
Fig. 5a: Pumpkin balloon and cross parachute just prior to inflation ($t = 0$ s). White flex hose visible at lower left.

Figure 5 shows a set of six images captured from the upward-looking video during the pumpkin balloon inflation process and subsequent parachute detachment. The full sequence was successfully executed with all pyrotechnic devices functioning properly and all separation events occurring. Helium tank pressure measurements confirmed that the helium gas was injected into the balloon in the planned 90 s period. However, the video evidence clearly shows that the balloon envelope was damaged in multiple places during the inflation. The first visible holes in the envelope are seen shortly after the peak helium flow rate time of 20 s after inflation start (Fig. 5c). The video shows that the internal porous inflation hose was thrashing about wildly during this time, undergoing whip-like motion around the time of peak inflation rate. Although the video evidence is not conclusive, the post-flight conclusion by the team was that the inflation hose smashed against the balloon envelope multiple times and broke the polyethylene film in multiple gores. This was an ironic result given the fact that the porous inflation tube's function was to protect the balloon envelope from direct helium impingement. Despite this damage, the pumpkin balloon almost completely fills out by the end of inflation, just like an undamaged balloon would (Fig. 5d). The experiment was sequenced through to completion with both parachute and payload module separation successfully occurring (Figs 5e and 5f). Unfortunately, the radiosonde that should have flown with and tracked the separated pumpkin balloon broke away from the balloon during the payload module separation event and so no data was obtained on the float behavior. Fig. 5f does show lateral separation of the parachute and balloon, indicating that the strategy of making the parachute glide just prior to separation worked to prevent it from falling on top of the balloon.

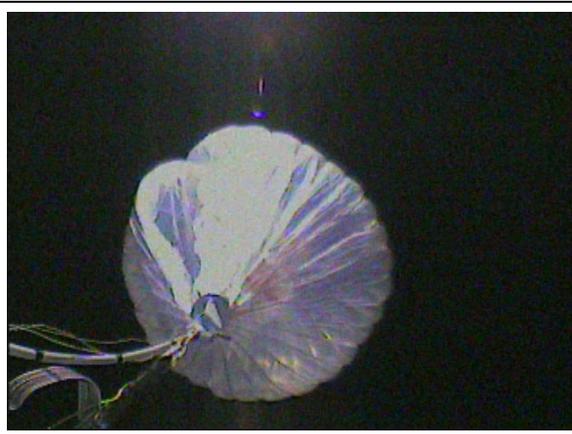
Fig. 5b: Early inflation is fine at $t = 10$ s, just prior to opening of the second orifice valve that initiates a high flow rate.

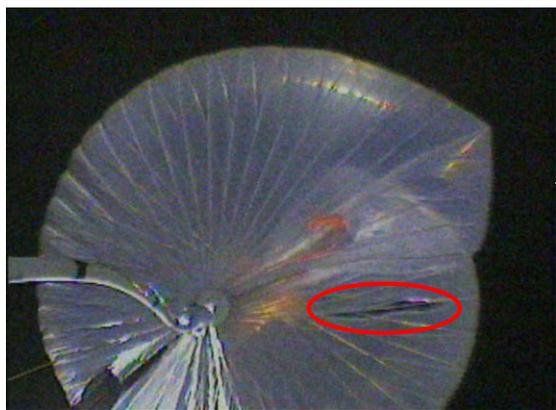
Fig. 5c: Tear/hole obvious at $t = 22.5$ s, just after third orifice valve opened.

The primary conclusion drawn from the STRA-14 flight is that the combination of a peak helium flow rate of 69 g/s and the use of a long, thin porous internal inflation tube results in violent, whip-like motion of the tube that impacts and damages the balloon. This was seen as a relatively tractable problem and design changes were made to the subsequent flight test, STRA-15, consisting of a new inflation tube design and a reduction in peak flow rate from 69 to 48 g/s. Although there were problems with the downwards-looking video camera and the radiosonde, all other core aspects of the Mars pumpkin balloon aerial deployment test were successful. In particular, the aeroelastic behavior of the partially inflated balloon during the parachute descent was quite benign, providing further evidence that very low dynamic pressures of approximately 5 Pa yield favorable conditions for Mars balloon aerial inflation. This benign behavior also allows for the use of lower helium flow rates that require longer inflation periods while descending under the parachute.

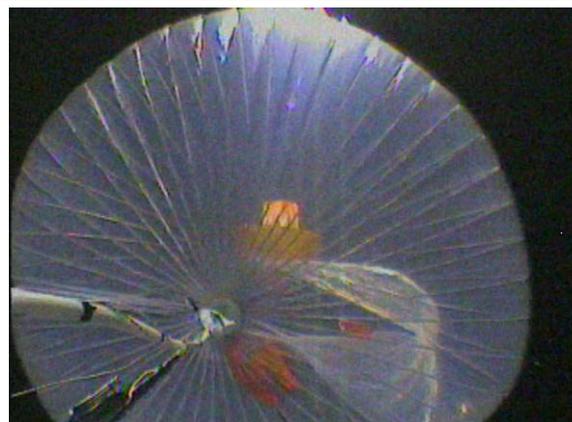
Fig. 5d: Balloon fills up despite tears ($t = 42.2$ s). Note orange cross parachute visible through balloon and orange inflation tube near bottom.

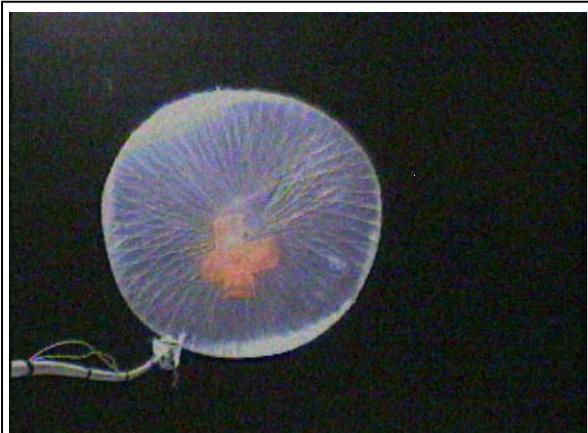
Fig. 5e: 1 sec after payload module and parachute separation ($t = 91.0$ s)

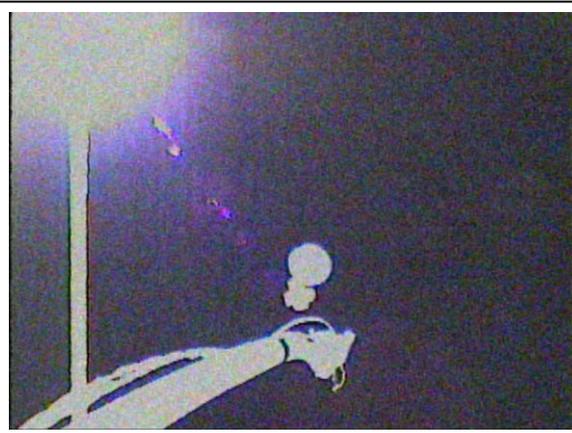
Fig. 5f: Balloon and cross parachute laterally displaced ($t = 93.9$ s)

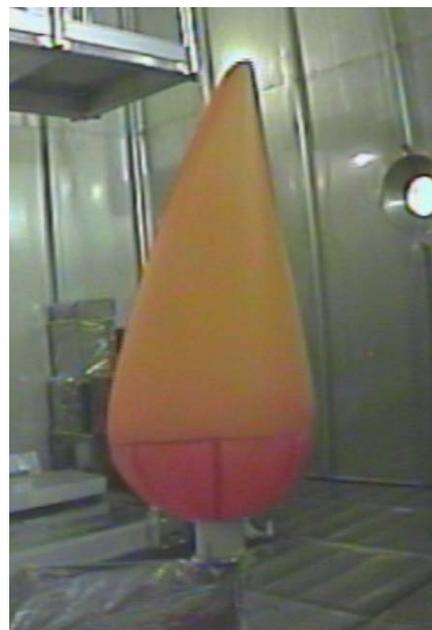
Fig. 6: STRA-15 Inflation Tube during laboratory flow test at low pressure.

The other major design change from the 2007 flight experiments was for the porous inflation tube. Instead of a long thin tube employed on every other Mars balloon stratospheric flight test, a new design was used that had the shape of a cone with the fat end on the bottom at the junction with the balloon end fitting (Fig. 6.) This actual flight tube was tested under full flow conditions (50 g/s) in a vacuum chamber to confirm absence of the whip-like motions seen in STRA-14. The new design behaved very stably in these laboratory tests while fulfilling the original design intent of diffusing the helium gas flow and preventing the direct impingement of a high speed helium jet on the balloon envelope. After laboratory testing, this inflation tube was used to build the STRA-15 Mars flight balloon.

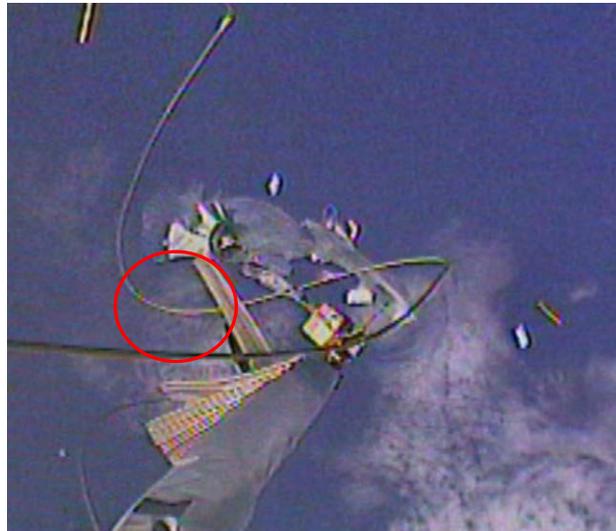
Fig. 7: STRA-15 sphere balloon at the moment of structural failure. Note broken circular edge of balloon highlighted in red.

The second clue can be seen in Fig. 7. The Mars balloon is displaced laterally to the upper left side to form an arc-like shape. This lateral displacement occurred despite no known lateral force acting on the system. Earlier frames from the video show a straight and vertical flight train with no lateral motion or apparent lateral wind loading. This kind of lateral movement must correspond to unequal stress loading of the balloon gores, with the gores on the outside of the arc gores loaded and the gores on the inside of the arc basically unloaded. The photograph clearly shows that the outside edge is where the balloon broke. Therefore, this suggests that the lateral motion and resultant balloon shape caused the transient shock loads to be borne by only a subset of the balloon gores, which became overstressed and failed. This large lateral motion was not observed in prior stratospheric flight tests, although much lesser deviations from vertical can be seen in the old flight videos.

The cause for the lateral motion is not known. The fact that the balloon can deviate from a strictly vertical line indicates that the top of the payload module and the bottom of the parachute must move towards each other and reduce their separation distance, otherwise the Mars balloon could not take on the arc shape seen in Fig. 7. It is plausible that there is a recoil in the balloon as it reaches its maximum deployed length, a recoil that pulls down on the parachute and slightly decreases the separation distance to the payload module. A natural consequence of this decreased separation distance will be for the balloon to laterally displace in an arc-like shape as seen. This is perhaps analogous to a guitar string that is quickly pulled taut and then vibrates perpendicular to the direction of the string. A review of upward-looking flight video from the prior STRA-11 sphere balloon test is consistent with this transient parachute pull-down hypothesis. However, the upward-looking video camera on STRA-15 failed during ascent and corroboration of the parachute motion could not be assessed for this flight.

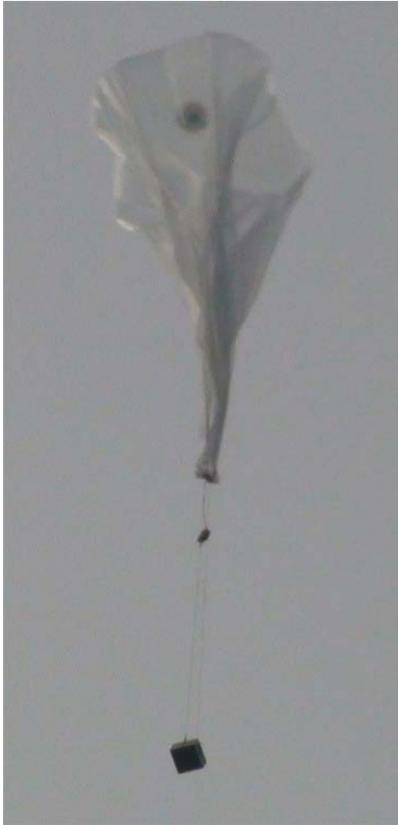
Fig. 8: Mars balloon shortly after ground launch for test GRND-1.

The ground-launched flight test was very successful. The Mars balloon safely ascended to a 30,275 m altitude just before local noon and maintained this altitude for the next 8.5 hours with a variation of only ± 75 m. Fig. 8 shows the Mars balloon shortly after launch, Fig. 9 shows the balloon soon after reaching its stratospheric float altitude, and Fig. 10 shows the altitude plot for the flight. Note that the balloon was stable in altitude despite going from the full noontime sun to sunset. Maintaining altitude stability under this full range of solar heating is highly indicative of a leak-free balloon. The helium fill of this balloon was 2.509 kg, designed to provide a surface free lift of 14% and a maximum superpressure of 260 Pa under the noontime sun. This compares to an expected burst superpressure of 820 Pa based on membrane theory for a perfect sphere. This gives a safety factor of 3.1, comparable to what is expected for an actual flight mission at Mars. The corresponding nighttime superpressure is 180 Pa, or an excess of 350 g of helium compared to neutral buoyancy. Note that the batteries on the telemetry system failed after 8.5 hours of flight at altitude, after which balloon tracking was lost. The balloon was 440 km from the launch site at that time. It is unknown how much longer the balloon continued to fly.

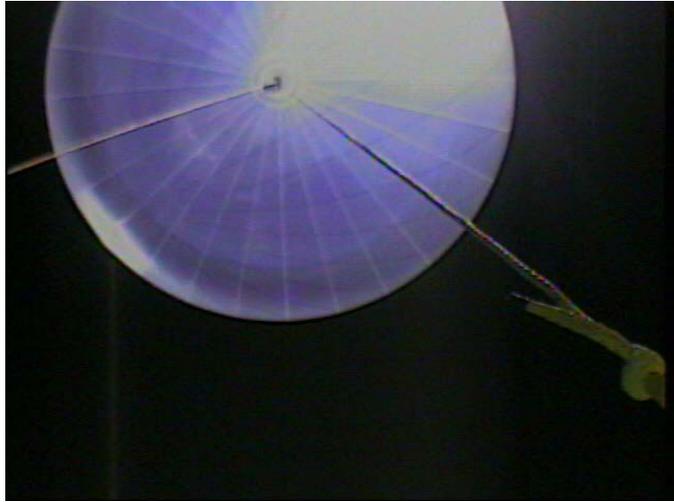
Fig. 9: GRND-1 balloon shortly after reaching the stable float altitude of 30.275 km.

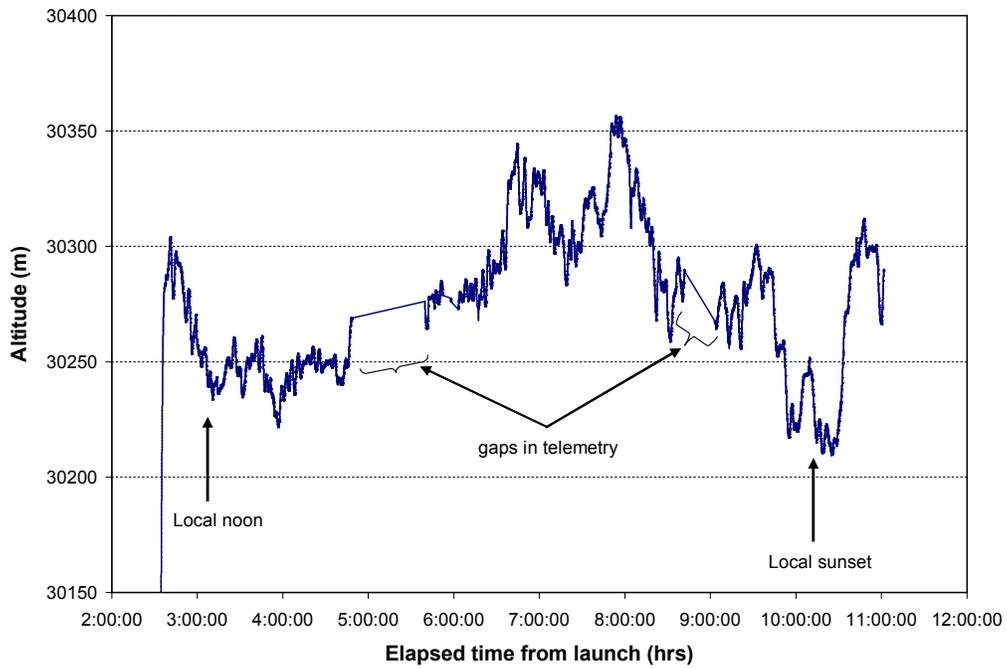
Fig. 8: Altitude Plot for GRND-1.
