Driving ATHLETE: Analysis of Operational Efficiency

Julie Townsend, David Mittman
Jet Propulsion Laboratory, California Institute of Technology
4800 Oak Grove Dr.
Pasadena, CA 91109
818-393-4713, 818-393-0037
julie.a.townsend@jpl.nasa.gov, david.s.mittman@jpl.nasa.gov

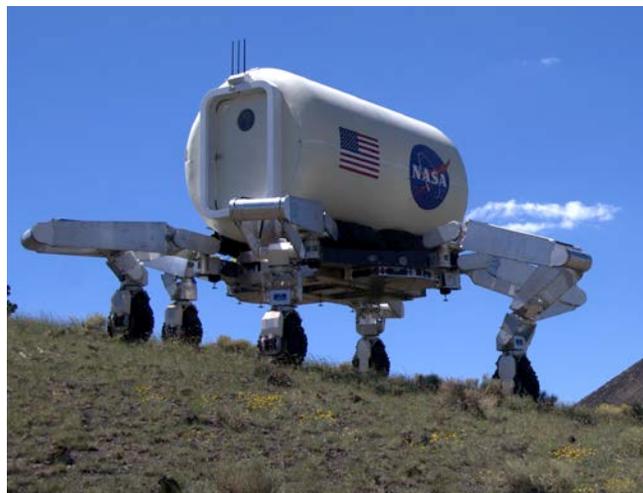
Figure 1 - ATHLETE prototype carrying a microhab simulated cargo element during traverse testing at Black Point Lava Flow, AZ, September 2010.

SDM-T12 consists of a pair of triangular three-limbed platforms called Tri-ATHLETES which, when joined by a cargo pallet, form the hexagonal six-limbed system shown in Figure 1. Sized to perform demonstrations at approximately ½ lunar scale, it stands to a maximum height of just over 4 m and carries a payload of up to 450 kg in Earth gravity. Each limb has 7 degrees of freedom (DOF), six for precise positioning and one redundant pitch actuator to enable each limb to stow compactly.

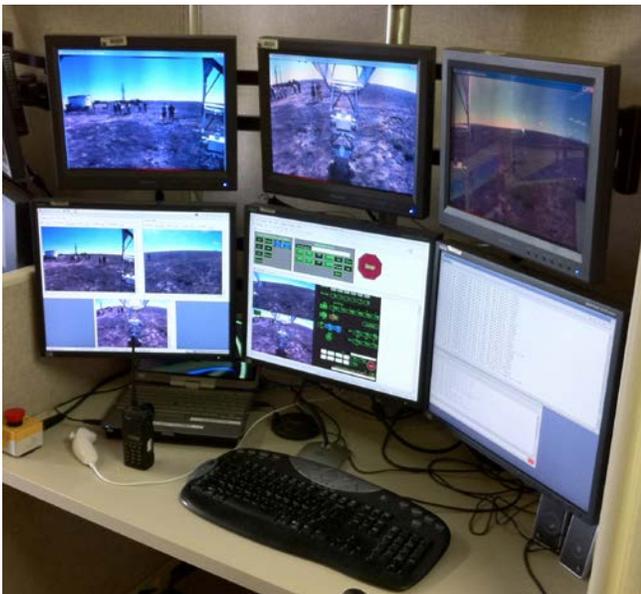
Figure 2 – The Operator Control Workstation provides the displays and controls required to remotely operate the ATHLETE rover.

When controlling ATHLETE from a remote location, the operator communicates with ATHLETE through a radio link, but has no direct visual contact with the vehicle. An operations safety officer accompanies the robot with a safety kill switch, but voice communication between the remote operator and the safety officer may or may not be present. The remote operator's workstation, shown in Figure 2, may be located at the field site or another remote

location and is composed of a general-purpose computer workstation with multiple displays used for tracking the performance of the vehicle. The robot acquires stereo images of its environment and those images are displayed to the remote operator as an aid in determining the distance to obstacles and general environmental conditions. Remote operators drive the vehicle through the direct input of textual commands or through a variety of directional input devices such as joysticks. In response to predictions of improved vehicle reliability and performance in 2010, the operations team developed a simplified driving joystick based upon the Nintendo Wii Nunchuk Controller, which can be operated with one hand. The Controller features a joystick for directional control, roll-axis control for turning and a dead-man style kill switch.

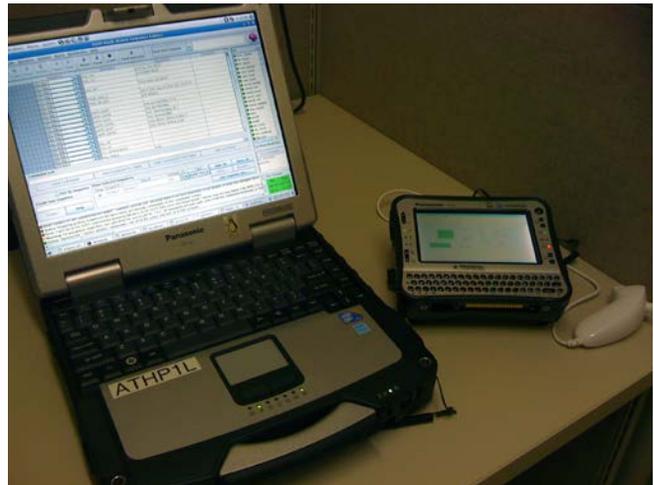
Figure 3 – The robot-mounted Portable Operations (PortOps) Laptop and local operator's PortOps Handheld provide a complete operations system independent of the field-deployable operations facility situated at base camp.

Because of the long traverses planned during the 2010 field test, the operations team was not guaranteed to have a working radio link between their field-deployable operations facility (a converted 40-foot cargo container), or OpsBox, and the vehicle. Safe vehicle operations require a low-latency link between the vehicle and its ground-based command and monitoring computer, which prior to 2010 were solely located within the OpsBox during field-testing. To accommodate this change in operating paradigm, the operations team developed a portable version of the ground-based command and monitoring computer that can be mounted on the vehicle itself. The portable operations workstation, or PortOps, shown in Figure 3, was developed in two parts, a vehicle-mounted Linux laptop that provided nearly all the functionality of the ground-based operations computer, and a handheld version that supported Wii Nunchuk driving and simple command and monitoring displays. Under normal operating conditions, an operator with the PortOps Handheld can drive the vehicle from anywhere within sight and wireless range of the vehicle. The operator uses the PortOps Handheld command and

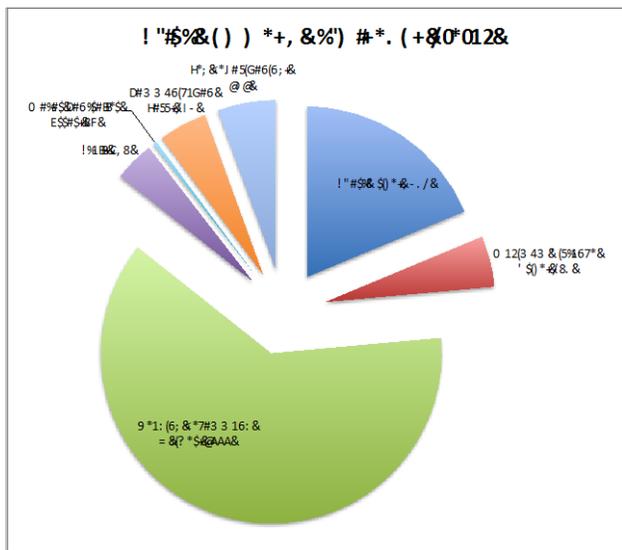
Figure 5 – Early termination of ATHLETE drive commands caused frequent stops, resulting in inefficient traverse operations.

As Figure 5 shows, the vast majority of commanded drives ended in some off-nominal condition that stopped the vehicle and required initiation of a new command. The errors originate from idiosyncrasies distributed throughout the operational system, including ATHLETE hardware, ATHLETE software, the PortOps controller.

Some commanding difficulties are unique to remote operations and since remote operation was infrequent at Black Point Lava Flow, Figure 5 does not accurately represent their potential effects on long-range traverse operations. Remote operation primarily affects driving efficiency by increasing the time spent between mobility commands while the remote operator attempts to determine a safe and effective course of action. Remote driving can also decrease the population of medium- and long-duration mobility commands as the remote operator stops more often to assess the safety and trafficability of the terrain.

The chart in Figure 5 reveals that heading recommendation and jitter accounted for more than half of all drive terminations. Drive commands included in this set traveled less than one meter before being interrupted by a new command or stopped by the operator. We attribute these very short drives to the difficulties of operating using PortOps, in particular the Wii Nunchuk.

ATHLETE’s control software includes a current limit for each actuator to prevent overheating of the motor if the joint is stalled. As shown in Figure 5, this stall protection stopped more than 400 drive attempts at Black Point Lava Flow. The stalls had multiple sources, the most prominent of which were stalls in the steering actuators and stalls in the thigh pitch actuators. The contribution of each of these particular stall errors to the total number of stall errors is shown in Figure 6.

incidence of motor controller errors was drastically reduced, from dozens of errors per kilometer during early testing to consistently fewer than five errors per kilometer at BPLF. At Black Point Lava Flow, the effect of motor controller errors on drive efficiency was insignificant, accounting for less than 0.5% of all stops as shown in Figure 5.

Figure 5 shows that communication loss between the PortOps laptop and handheld accounted for over 500 halts in traverse progress. Some small percentage of these halts were valid safety reactions caused by depletion of the handheld battery or the operator wandering too far away from the vehicle. Most, however, were due to performance issues on the PortOps handheld or laptop.

One prominent source of inefficiency arose from the drive behavior implementation in ATHLETE's onboard software. A characteristic of this behavior limits commanded drives to no more than 50 meters in length. In the absence of difficult terrain and other system errors, ATHLETE paused at least 20 times per kilometer as a result of this distance limit. Figure 5 shows that 537 pauses during traverse were due to the maximum drive distance limit.

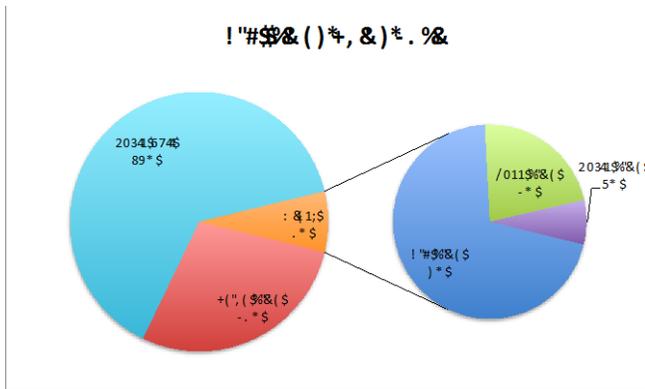
Figure 6 – The ankle roll (steering) and thigh pitch actuators were the cause of the majority of stalls during drives at Black Point Lava Flow.

Stalled Steering Actuators—As Figure 6 illustrates, stalls of the steering actuators were a common occurrence, making up 64% of the errors due to stalled actuators. The reason these errors were so common is that they occurred in reaction to an idiosyncrasy of normal ATHLETE traverse operations.

Stalled Pitch Actuators—Another significant source of stalled joint errors are the limb pitch joints, in particular the thigh pitch joints which are responsible for 28% of all stall errors, and the hip pitch joints, which are responsible for 5% of all stall errors, as shown in Figure 6.

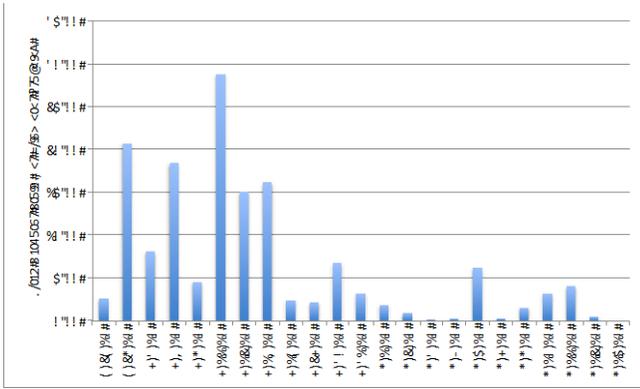
Figure 7 – Pitch actuator stall rates decreased after changes to vehicle pose strategies were implemented.

Figure 7 shows the number of pitch joint errors on each test day. Early tests, before the changes to active terrain compliance were implemented, had more stalls than were seen in later test days, after implementation of the changes. The changes to active compliance were effective in reducing pitch errors from an average of 15.44 stalls per kilometer traveled before BPLF to 2.26 stalls per kilometer traveled during BPLF for an effective reduction of 85%. At this point, there are probably no additional measures to be taken short of redesigning the joints to handle greater load or reducing the cargo weight of the prototype.

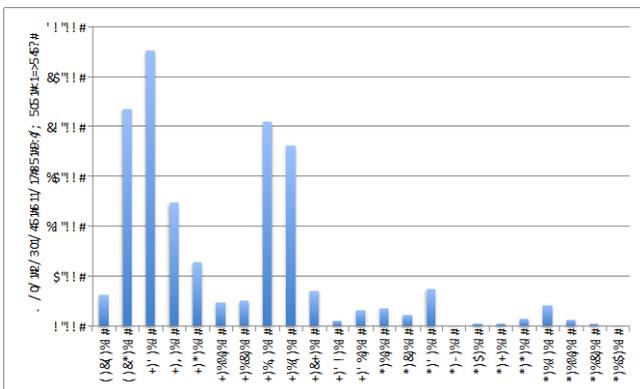
Figure 8 – Motor controller errors per kilometer decreased after changes to controller parameters were implemented.

Figure 8 illustrates the improvement in drive performance following the motor controller firmware upgrade. The

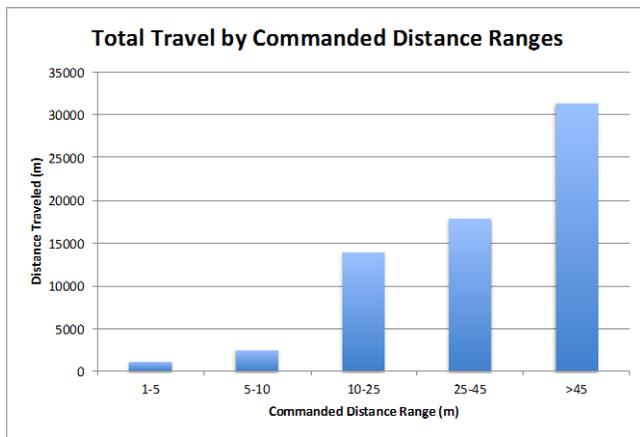
Figure 9 – Traverse distance covered by drive segments of various lengths.

Figure 9 illustrates the contribution of drive segments of different lengths to the overall traverse distance. Short drives of 1 to 10 meters were used when navigating difficult terrain, slopes, or the crowded conditions in the base camp. On benign, open terrain, ATHLETE traveled longer distances. Drives of 10 to 45 meters typically represent operator navigation, heading changes, and curving paths, while drives over 45 meters represent long, straight traverses.

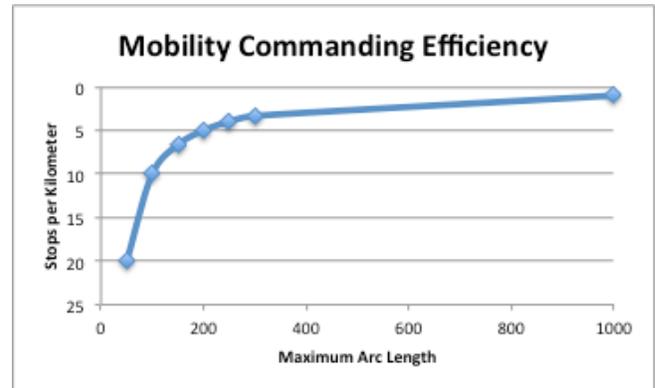
Figure 10 – Mobility command efficiency improves with increased maximum arc length by reducing the number of stops per kilometer.

While increasing this distance limit would improve drive performance by significantly reducing the number of stops per kilometer, as shown in Figure 10, changing the command philosophy for long traverse operations could be even more effective. Particularly when operated by a remote operator, it is probably more efficient to set a waypoint in ATHLETE imagery and have the robot work out the direction and distance to the waypoint and break the drive up into its own manageable chunks. This paves the way for more autonomous onboard capability in obstacle avoidance and path planning. It also brings the operator up to a more strategic level in which an operator can evaluate a future strategic waypoint and update the vehicle's path seamlessly.
