JPL Publication 16-2

Mars Exploration Rover Spirit End of Mission Report

*John L. Callas
Mars Exploration Rover Project
Jet Propulsion Laboratory*

December 2015

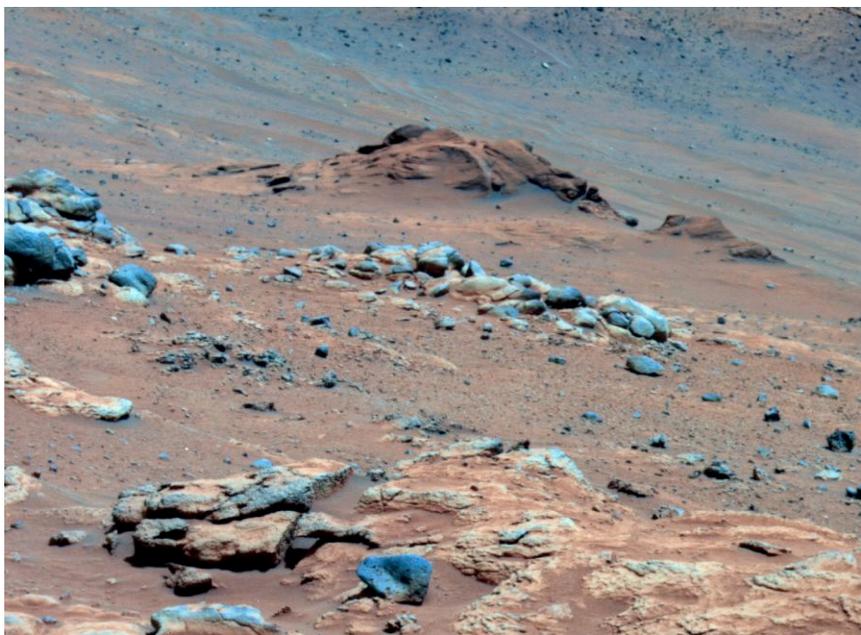
Figure 1.3 Color Pancam image from Sol 689 of the “Comanche” outcrop.

A detailed and painstaking joint analysis of Mössbauer, APXS, and Mini-TES data acquired on the Comanche outcrop near the top of Husband Hill (see Figure 1.3) revealed the presence of significant amounts of iron and magnesium carbonate minerals in these rocks. Previously, carbonates were found in ALH-84001 and CRISM spectra of Nili Fossae, but this is the first positive identification of this important mineral in its geologic context. The

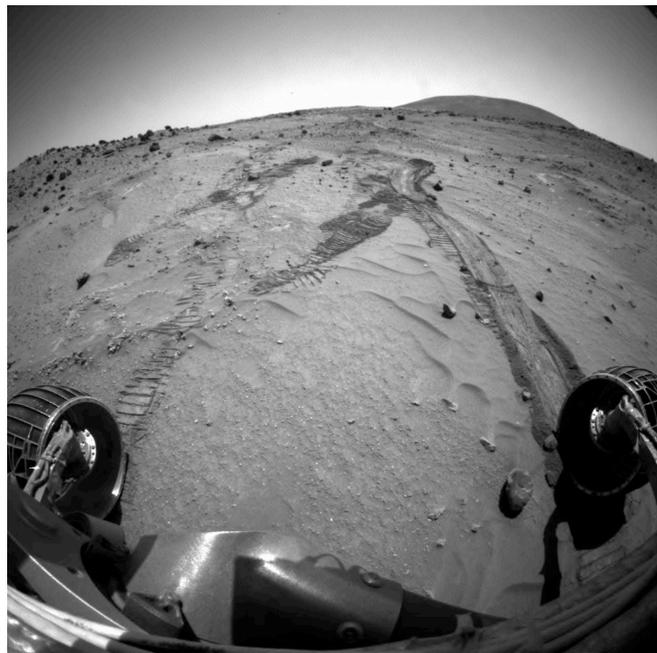
Figure 3.1 *Sol 781 front Hazcam image.*

On Sol 779, after operating for more than two Earth years, the right-front drive wheel actuator on Spirit failed. Because of the design of the motor, which utilized magnetic detents and a large-reduction (1500:1) gearbox, a failed wheel will not freely spin. Spirit's wheel would remain locked, greatly compromising further mobility. Figure 3.1 shows the Sol 781 front Hazard Avoidance Camera (Hazcam) image capturing the effects of the failed wheel on the local terrain. No explanation has been established for the wheel failure, although a motor brush failure is one possibility. Also, the actuators were operational well past their design life. Spirit had driven over 6.5 kilometers at the time of the wheel failure, greatly exceeding the design requirement of only 1 kilometer for the rover mobility system.

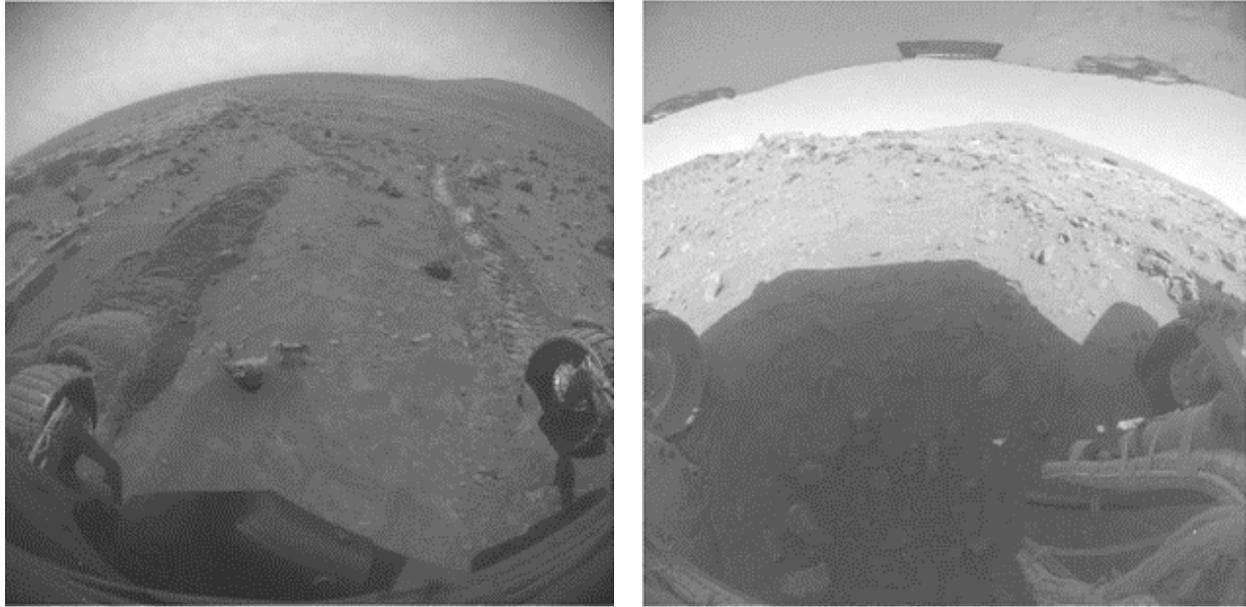
Figure 6.1 *Sol 1818 Hazcam images showing the embedding of the rover wheels.*

After Sol 1800, Spirit began the move along Route 1, the traverse up onto Home Plate. Soon the rover began to experience difficulty negotiating terrain with moderate slopes. Figure 6.1 shows the Sol 1818 Hazcam images of the embedding that was occurring. After making extensive efforts, the project abandoned Route 1 on Sol 1829 and made the decision to pursue Route 2.

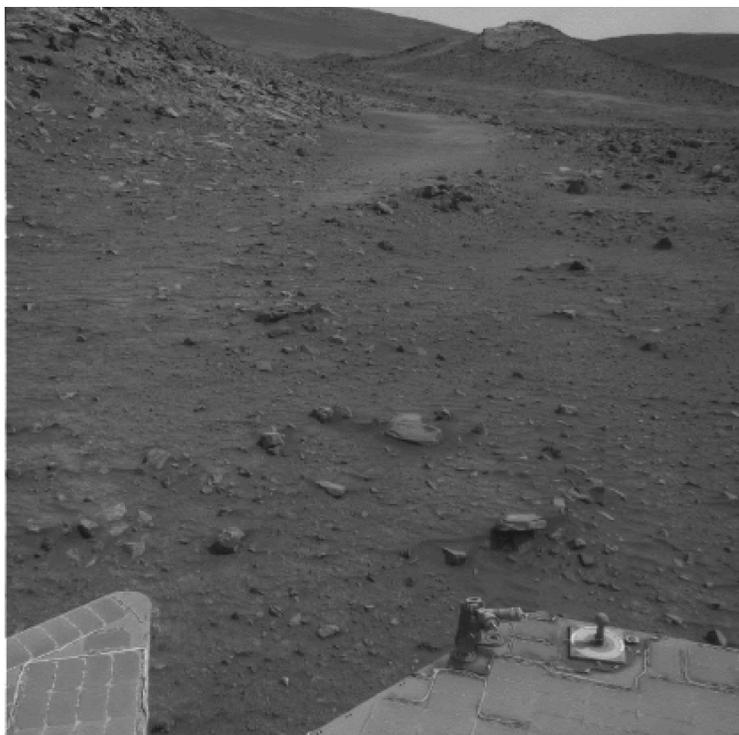
Figure 6.5 *The Sol 1870 Navcam just prior to embedding at Troy. The embedding location is approximately dead-center of the image.*

Spirit initially made good westward progress along Route 3. Figure 6.5 is a Sol 1870 Navcam image showing an apparently hazard-free traverse path. But on Sol 1886, Spirit began to become embedded in a location on the west side of Home Plate, now called “Troy.” Realizing the onset of embedding, the project, just as it had done for the embedding on Routes 1 and 2, made several tactical attempts to extricate the rover. But after several unsuccessful tries, on Sol 1899 a stall of the left middle wheel occurred. Upon investigation of the wheel stall and an assessment of the terrain, the project stood down from mobility operations. Figure 6.6 shows the Sol 1899 Hazcam images of the embedded rover wheels. Figure 6.7 summarizes the events leading up to and including the embedding at Troy.

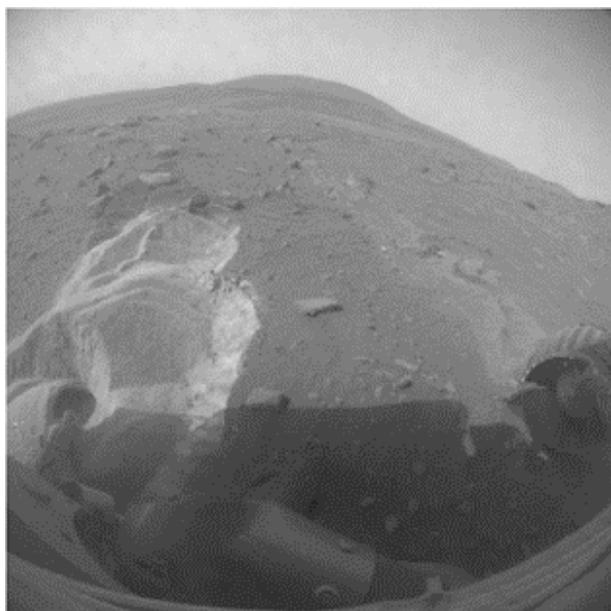
Figure 6.6 *Sol 1899 Front and Rear Hazcam images following the embedding at Troy.*

The proximate cause of the embedding is attributed to the rover breaking through an indurated crust into a hidden hazard of unconsolidated fines. The path south to the features Goddard and von Braun, which was dictated by the systematic exhaustion of all viable route options, led the rover to the unforeseen hazard at Troy. This was a contributing cause. The root cause was that Spirit had degraded mobility (failed right-front wheel), which generated greater terrain shear forces that compromised the terrain's structural integrity, particularly on slopes. An undetected environmental hazard also existed along Spirit's inevitable route. Details of the embedding, including a root cause analysis, can be found in the JPL document "Report on the Spirit Embedding at Troy", dated June 17, 2010.
