# First Test Flight Thermal Performance of the Low Density Supersonic Decelerator (LDSD) Supersonic Flight Dynamics Test (SFDT) Vehicle

A. J. Mastropietro<sup>1</sup>, Jason Kempenaar<sup>1</sup>, Matthew Redmond<sup>1</sup>, and Michael Pauken<sup>2</sup>  
*Jet Propulsion Laboratory, California Institute of Technology, Pasadena, California, 91109*

The first of three planned experimental flights of the Low Density Supersonic Decelerator (LDSD) Supersonic Flight Dynamics Test (SFDT) vehicle took place on the morning of June 28<sup>th</sup>, 2014 off the coast of Kauai, Hawaii. The goal of the first flight was to determine if the vehicle could reach the altitudes and airspeeds needed to test new technologies for decelerating supersonic vehicles destined for Mars. SFDT-1 was launched from the Navy's Pacific Missile Range Facility (PMRF) on a 960,000 cubic meter helium carrier balloon provided by NASA's Columbia Scientific Balloon Facility (CSBF). Once lifted to a stable float altitude of 36.4 km over the Pacific Ocean, the vehicle was dropped and a series of automated maneuvers began. First, the vehicle was spun up via small rocket motors to provide trajectory stability and then a

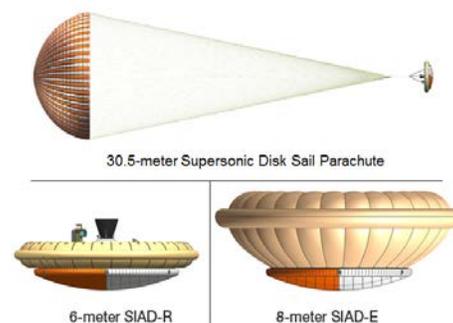
**Figure 1.** The LDSD project will develop and test two sizes of inflatable aerodynamic drag devices and a large new supersonic disk sail parachute using the SFDT vehicle in a series of high altitude flight tests<sup>6</sup>.

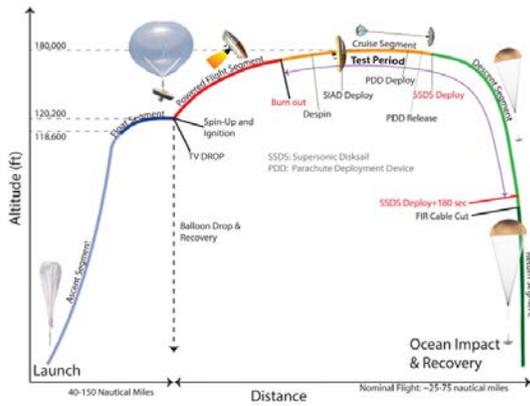
**Figure 2. Flight profile for high altitude LDS test in Earth's stratosphere using the SFDT vehicle.**

Figure 2 shows the intended flight profile for this stratospheric test which is supposed to briefly simulate a Mars-like entry environment while the decelerators are implemented. A large helium carrier balloon provided by NASA's Columbia Scientific Balloon Facility (CSBF) lifts the SFDT vehicle to a stable float altitude of about 118,000 ft (36 km) where it is then dropped, spun up for inertial stability using small rocket motors, then boosted up to an altitude of about 180,000 ft (55 km) and a speed of approximately Mach 4 using a Star 48 rocket motor, and finally despin, ready to deploy the technologies under development. The SIAD is inflated around the aeroshell to dramatically increase the drag surface area and reduce the vehicle speed to approximately Mach 2. Afterwards, a Parachute Deployment Device (PDD), comprised of a mortar and a ballute, subsequently pulls the 30.5 m SSDS parachute out of the vehicle to complete the vehicle deceleration sequence and ultimately return the vehicle back to the ocean where recovery operations can begin.

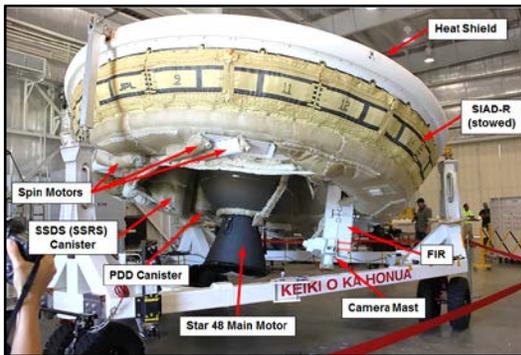
**Figure 3. Flight ready Test Vehicle #1 at PMRF.**

The ready-for-flight SFDT-1 vehicle is shown in Fig. 3. The primary elements of the vehicle are a Composite Core Structure Assembly (CSA), a Heat Shield, a Camera Mast, a Star 48 Main Motor, Spin Motors, and the stowed decelerator technologies to be tested – a SIAD-R, and a combined PDD/SSDS system. The Wallops Flight Facility (WFF) provided avionics pallet and the GLNMAC Inertial Measuring Unit (IMU) which are embedded in one of the 6 internal bays of the vehicle are best seen in Figs. 9-11.

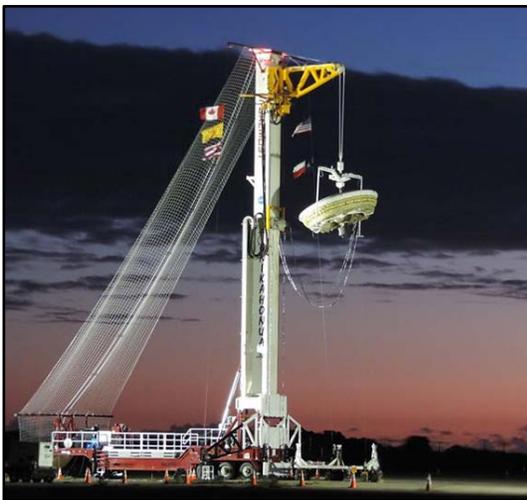
**Figure 4. SFDT vehicle suspended from the launch tower.**

At 08:00 HST on June 28, 2014, SFDT-1 was powered on for launch. Figure 4 depicts the vehicle on the launch tower ready for balloon launch. During this time, the carrier balloon was being inflated off to the side of the tower, and once it was ready, it was released and allowed to float over the top of the tower at which time the tower then released the vehicle initiating launch at 08:40 HST. Table 1 summarizes the time stamps for the critical events of the mission which followed with an emphasis towards those that have thermal performance ramifications while Fig. 5 displays the corresponding ground track of the entire test flight which occurred off the west coast of Kauai.

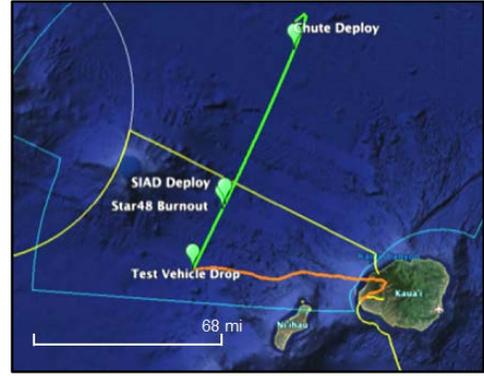
Figure 5. Balloon and test vehicle ground tracks after launch from PMRF in Kauai.

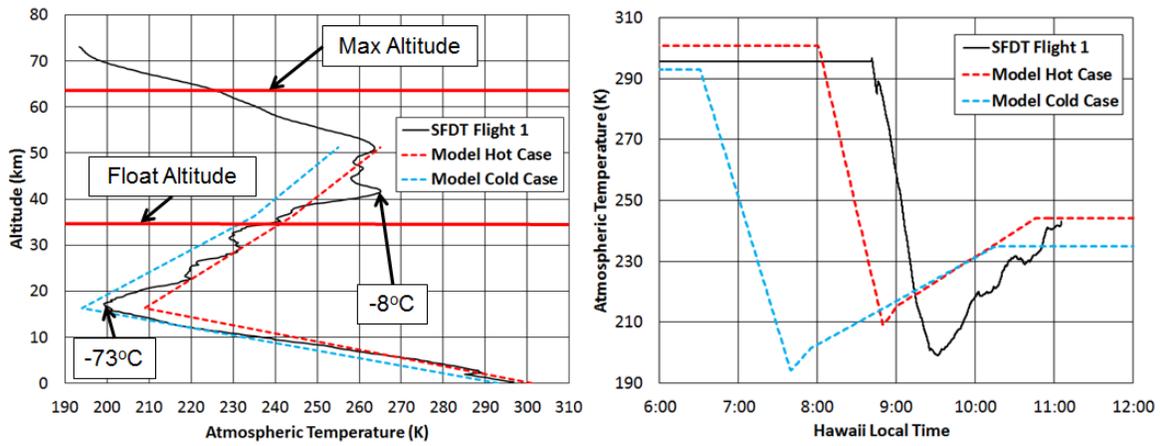
Figure 6. Reconstructed atmospheric temperature profile for SFDT-1 on June 28, 2014 with comparison to thermal model bounding cases.

In order to understand the aerodynamic behavior of the test vehicle, knowledge of the atmospheric density and speed of sound throughout the anticipated flight regime is required. For SFDT-1, various weather balloons and meteorological rockets were launched around the timeframe of actual SFDT operations in order to fully characterize the temperatures of the atmosphere at lower and upper altitudes. The left hand side of Fig. 6 displays the reconstructed as-measured temperature profile vs. altitude mostly bracketed by the worst case thermal analysis assumptions. It is apparent that the Model Hot Case assumptions were not entirely bounding between the altitudes of 40km and 45km. On the right hand side of Fig. 6, the interpolated mission time vs. atmospheric sink temperature is plotted. The Model Cold Case had assumed launch would occur in the dark before sunrise, whereas Flight 1 actually launched about 40 minutes later in the morning than was originally thought permissible. When all three curves are shifted to coincide with balloon launch, it can further be observed that the worst case cold ascent rate was also not thoroughly bounding. The earlier portion of the ascent was in reality much faster than assumed. This is important to capture correctly in the future so the maximum time spent within the coldest part of the troposphere is properly accounted for.

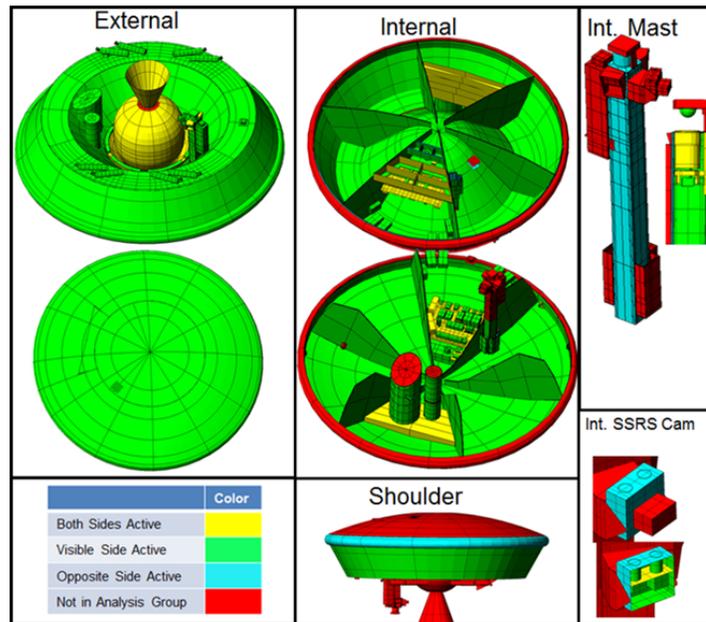
Figure 7. The SFDT Thermal Desktop Model<sup>®</sup> with various radiation analysis groups displayed.

Reference 14 provides details on the bounding LDS thermal analysis assumptions, environments, and the Thermal Desktop<sup>®</sup> model shown in Fig. 7 that was developed to support the thermal design of the SFDT vehicle. The thermal subsystem design passively protects the vehicle structure and its components from the cold temperatures experienced during the ascent phase of the mission as well as from the extreme heat fluxes imposed during the supersonic test phase by the Star 48 Main Motor, Spin Motors, and from aerothermal heating. Additionally, the thermal design safely rejects all of the onboard avionics power dissipation in order to maintain components within their allowable flight temperatures (AFTs). This passive thermal design approach for the SFDT vehicle relied upon careful and complex bounding analysis of all three modes of heat transfer – conduction, convection, and radiation – coupled with a tightly managed transient power dissipation timeline for the onboard electronics throughout all mission phases. Early on, the avionics pallet required considerable thermal redesign in order to enable the mission. The avionics had to be laid out carefully, high emittance coatings had to be used wherever possible to maximize the radiative heat rejection, and the individual component’s power on times had to be minimized whenever possible in the mission timeline. Figure 8 is intended to give the reader a flavor of the thermal model results which shows the worst case hot analysis temperature profiles for the avionics pallet. As mentioned, this was a very fast mission compared to what was thermally analyzed. During SFDT-1 the first drop attempt was successful vs. the three drop attempts modeled in the worst case hot profile. Descent to splash down should have nominally lasted about 35 minutes as well, but was expedited due to the chute failure. If the SSDS had remained intact, many components would have stayed on for a bit longer and reached higher temperatures than the flight telemetry shows.

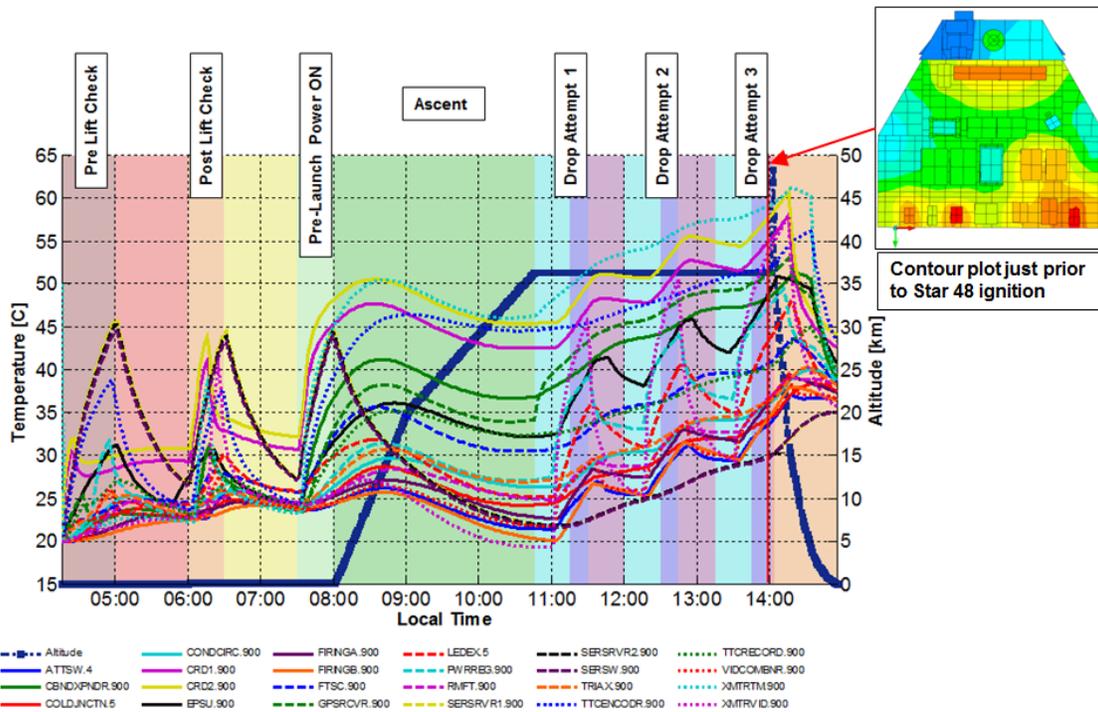
Figure 8. Avionics pallet worst case hot analysis results with 3 drop attempts assumed (refer to Fig. 11)

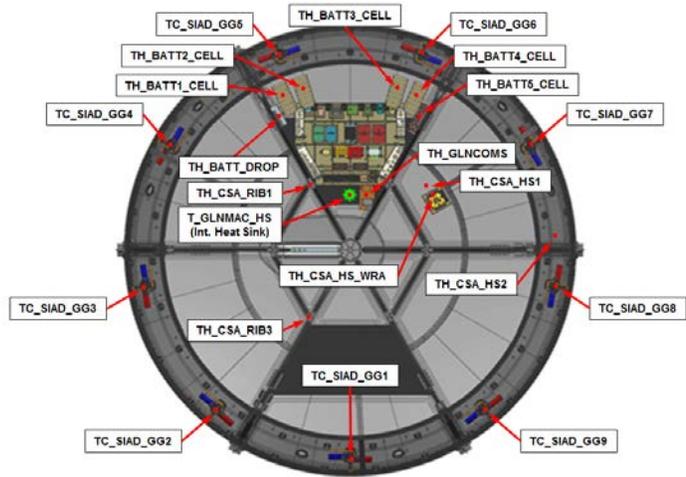
**Figure 9.** Temperature sensor locations for main and drop batteries, GLNMAC and GLN-Coms, core structure Heat Shield and ribs, and SIAD gas generators. Avionics pallet is also shown in the same bay that batteries and GLNMAC reside in.

There are 6 thermal sensors for measuring the cell temperatures of the 5 main batteries (Li-MnO<sub>2</sub>) and 1 drop battery (NiCd) as shown in Fig. 9. Additionally, there were 5 battery fuse temperature sensors for each of the main batteries as shown in Fig. 10. Note that the fuses were located in separate compartments attached to the side of each battery pack. Unfortunately, the *TH\_BATT2\_CELL* channel was not functional for SFDT-1. The main battery cells AFTs were +10°C to +60°C and despite their large mass, they were actually predicted to get too cold if they were simply mounted within the SFDT vehicle without any consideration for thermal control. Thus, the packs that the cells were contained in were eventually wrapped with a low emittance tape to more effectively isolate them from the surrounding environment. Figures 16 and 17 show the benign thermal telemetry that was collected for the batteries and their fuses. Note the fuses had much wider AFTs of -25°C to +75°C, although they all remained between +23°C and +37°C.

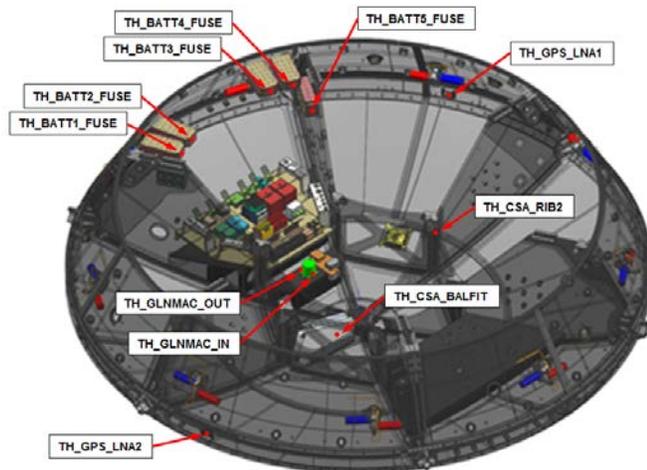
**Figure 10.** Temperature sensor locations for main batteries fuses, GPS LNAs, GLNMAC, and core structure balloon fitting and rib.

Thus, the GLNMAC temperature telemetry collected consists of a total of 2 external thermistors as shown in Fig. 10, and 12 internal temperature sensors that were only available when GLNMAC was powered on. In addition, because the telemetry from the 12 internal temperature channels was not directly piped to the thermal operator in real time, 1 more internal channel ( $T_{GLNMAC\_HS}$ ) was implemented as a real time proxy for the internal *Gimbal Heatsink* channel.

There is 1 temperature sensor for each GPS LNA on the SFDT vehicle as shown in Fig. 10. The LNAs are mounted on metal brackets on the interior perimeter of the core structure in the vicinity of the L-band antenna patches. The temperatures observed during SFDT-1 are presented in Fig. 26. Initially, while powered off, the LNAs cooled down during the ascent to about +6°C. After the Sensor Bus was powered on, they warmed up to at a rate of approximately 0.3C/min but remained well within their AFTs of -30°C to +61°C.

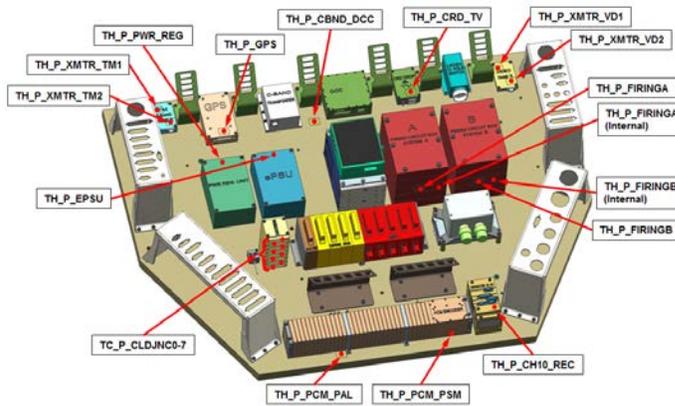
**Figure 11. Avionics pallet temperature sensor locations.**

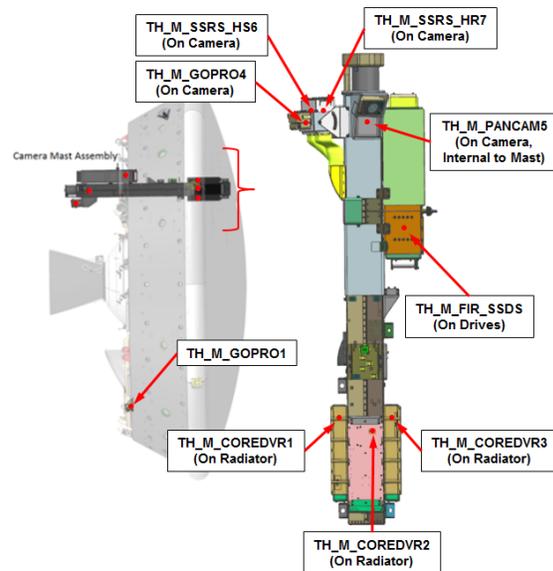
Figure 12. Camera system temperature sensor locations.

The camera mast as shown in Figs. 3 and 12 contains 3 situational video cameras which monitor the Spin Motor firings, as well as the SIAD, PDD, and SSDS deployments, 1 high speed panoramic machine vision camera for viewing the SIAD deployment, and 2 more machine vision cameras – 1 high speed and 1 high resolution – solely for viewing the PDD and SSDS deployments. The machine vision cameras recorded their data utilizing a 3 unit CoreDVR system positioned at the bottom of the mast which collected and stored the data on 12 Solid State Disks (SSDs) mounted within a shock resistant, detachable buoyant housing positioned further up the mast called the Flight Image Recorder (FIR).

There are 8 available thermistors in total on the camera mast, 1 each for the CoreDVRs, 3 for only the cameras which view the PDD and SSDS deployments, 1 for the panoramic SIAD viewing camera, and 1 for the SSDs. In addition, there is one more situational video on the top deck that has a thermistor. This camera overlooks the Main Motor firing as well as the very early portion of the PDD and SSDS deployments. All of the cameras were packaged within insulated housings that were designed to provide sufficient thermal mass to ride out the intense plume heating from the Main Motor burn while simultaneously conducting away internally dissipated heat via metallic mounting interfaces from the camera bodies. Each camera also had a retractable protective lens cover to shield the detectors during the Main Motor firing and to mitigate any soot build up that might otherwise obstruct their views.

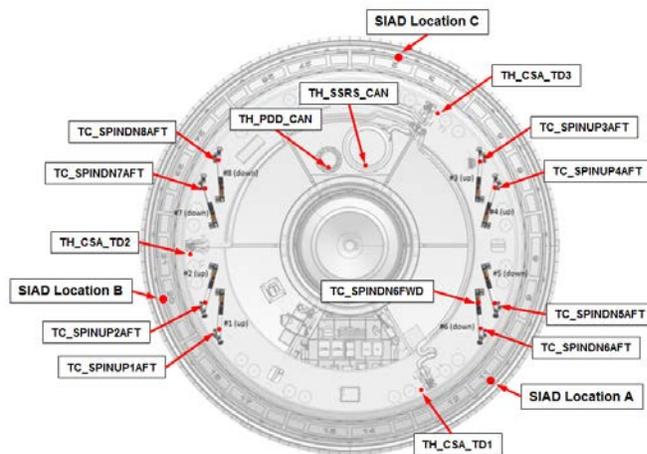
**Figure 13. Spin Motor, parachute system, top deck, and SIAD (reference next figure) temperature sensor locations.**

The SSDs (SSRS) and PDD canisters sit side by side on the vehicle as shown in Figs. 3 and 13. One thermistor is on each of the cans underneath the TPS. The PDD is deployed first followed by the SSDs. The PDD relies on an internal Inflation Aid to assist with the initial ballute pressurization. After the mortar firing event and once the PDD bag is at line stretch, a pyrotechnic initiator causes a rupture disk to burst and expel an aqueous methanol mixture from the Inflation Aid canister into the attached ballute vessel. The mixture immediately vaporizes and provides the initial pressure boost needed to puff up the ballute and allow its ram air inlets to complete the inflation process.

As shown in Fig. 13, each Spin Motor had a Type K thermocouple near its nozzle precisely located on the motor wall where one edge of the solid propellant grain was in close proximity. Only Spin Down Motor #6 had two thermocouples bonded to it in an attempt to capture the axial gradient between opposite ends of the fired motor. It's important to mention that the numbering of the Spin Motors was unrelated to their actual firing order. In fact, the firing Spin Up pair order was #1& #3 simultaneously, then #2 & #4, followed by Spin Down Motors #6 and #8, and finally #5 & #7. Figure 34 shows that Spin Motor temperature gradients between firing pairs prior to drop were on the order of 2°C, well under the allowable 19°C total dispersion (beyond which it was feared that uneven Spin Motor thrusting was more likely to develop undesirable nutation). Figure 35 shows all Spin Motors experienced a mild rise in temperature after they were fired with initial temperatures between +7°C and +15°C, and the soakback into the core structure was likely insignificant despite the preliminarily concerning estimates.

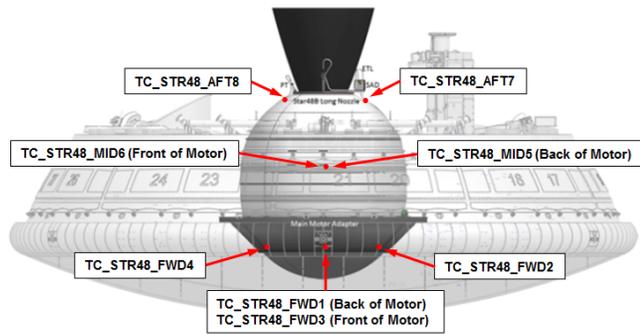
Figure 15. Star 48 Main Motor temperature sensor locations.

Figure 15 shows the position of all 8 thermocouples on the Star 48 Main Motor. 4 thermocouples were on the forward dome, 2 were on the mid-section, and 2 thermocouples were on the aft end of the Star 48 Main Motor near the nozzle. Figure 36 shows that the 2 aft sensors reached about +1°C which was slightly colder than the minimum solid propellant AFT of 7°C and remained below this limit for about an hour while ascending through the cold portion of the troposphere before naturally warming back up to within limits prior to Main Motor firing. It's not likely that the propellant actually experienced this cold temperature excursion because an insulation liner exists between the titanium motor casing and the propellant which would produce a significant temperature gradient. Furthermore, there is not any solid propellant in the immediate vicinity of the aft sensors. There was an additional concern that the nearby Star 48 Safe and Arm Device might have gotten too cold, but real time discussions during operations confirmed that it was qualified to -51°C and it too turned out to be a non-issue. Immediately after the Main Motor burnout, the forward dome experienced significant soakback heating as shown in Figure 37 with temperatures peaking at 282°C. As was mentioned previously, the heat pulse to the supporting core structure underneath appears to have largely been mitigated since no temperature rise was witnessed on the nearby ribs. Post-flight inspection also revealed that there was minimal slag in the forward dome, a finding which was again counter to prevailing thought prior to the first flight. The possibility of a considerable amount of hot slag in the forward dome did force the team to come up with a robust solution for thermally isolating the entire Star 48 from the rest of the vehicle with sturdy TPS blankets and a heavy steel motor adaptor mount.

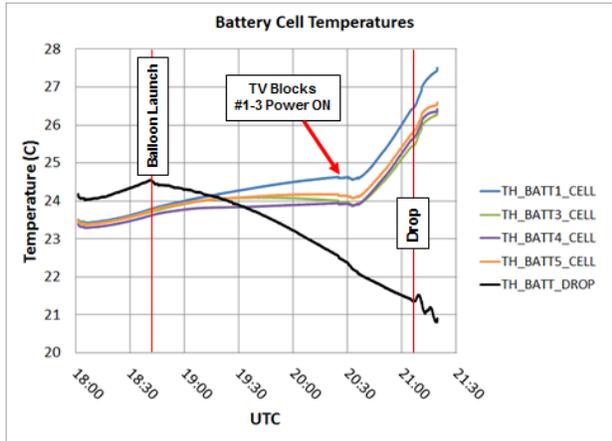
Figure 16. Main and drop batteries temperatures (Battery #2 thermistor was not functional for Flight #1).

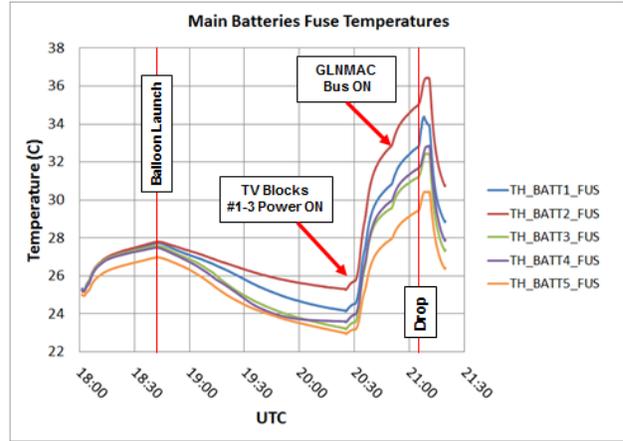
Figure 17. Main batteries fuse temperatures (fuses are located separately from cells within each battery pack).

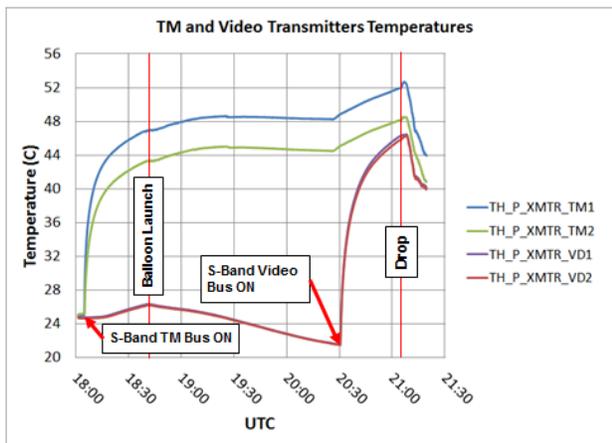
Figure 18. Telemetry (TM) and video transmitter temperatures. Vid xmtr turned on 35 min before drop.

The avionics pallet temperature sensors include 14 external thermistors, 8 cold junction stack thermocouples, and 15 internal board temperature sensors. Figure 18 shows that the Telemetry (TM) Transmitter which was left on continuously throughout the entire mission remained the hottest component on the pallet reaching a peak temperature of +53°C towards the end of the flight. This limit was well under its maximum worst case hot predict of +61°C as seen in Fig. 8 (refer to curve labeled *XMTRTM.900*). Before it was turned on later in the flight, the Video Transmitter was observed to be the coldest component on the pallet at +21°C. This result was good confirmation that the pallet thermal layout was optimal since the transmitters which were anticipated to be two of the hottest avionics components were purposely mounted on the part of the pallet that had the best radiative view to the colder Heat Shield in order to ensure maximum heat rejection. After it was turned on, the video transmitter indeed became the second hottest component on the pallet peaking at about +47°C. Despite its continuous operation, the third hottest component was the Pulse Command Modulator (PCM) Encoder which stayed just below +40°C as shown in Fig. 20. After the TV Blocks #1-4 power on, the Command Receiver Decoder (CRD), the Global Positioning System (GPS) unit, and the Power Regulator all peaked near +37°C. Note how the CRD was originally warmer than the PCM Encoder prior to balloon launch. After approximately 30 minutes into the ascent, the CRD cools off well below the PCM Encoder due to its more optimal position between the transmitters on the pallet where more effective radiative heat rejection occurs as previously mentioned.

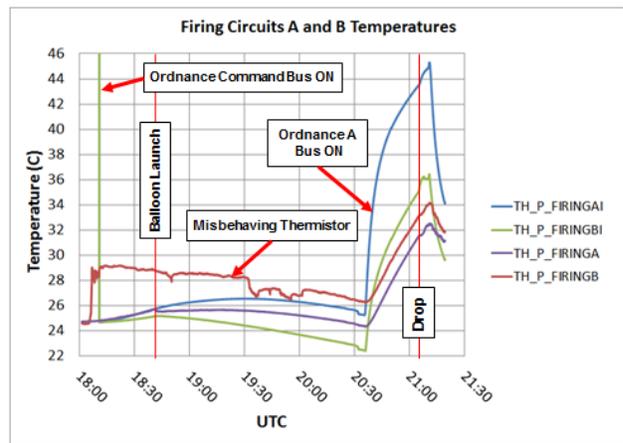
Figure 19. Firing circuits temperatures. Firing B sensor should have mimicked Firing A sensor more closely.

Figures 19, 22, and 23 depict several critical internal avionics board temperatures that were also recorded during Flight #1. After TV drop occurred, the EPSU, Power Regulator, Firing Circuit A, and Firing Circuit B internal

boards peaked at temperatures of +57°C, +53°C, +45°C, and +36°C, respectively. These temperatures were considered to be extremely benign. Figure 19 also shows that the externally box mounted Firing B thermistor was reporting suspect temperatures for most of the mission. It should have mimicked the Firing A thermistor much more closely. After the Ordnance A and B buses were powered on, it seems that the misbehaving thermistor started to sense more representative temperatures. When the vehicle was dropped, there was approximately a 23°C degree gradient observed across the components mounted on the pallet with the TM Transmitter being the hottest at +52°C, and the Thermocouple (TC) Cold Junction stack being

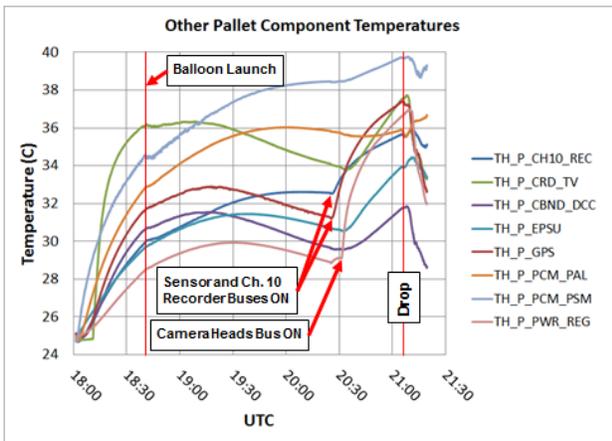
Figure 20. Temperatures of majority of components on pallet.

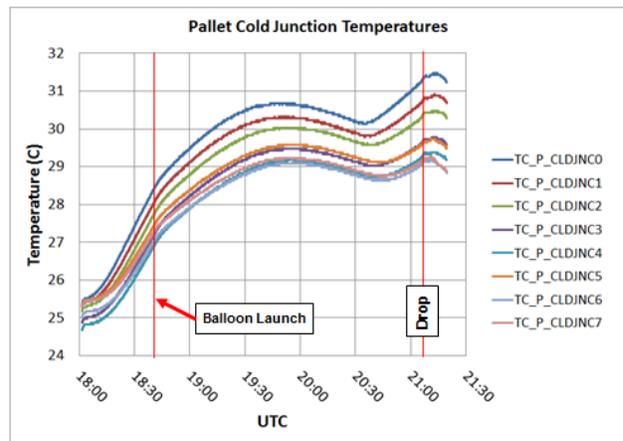
Figure 21. Cold junction thermocouple stack temperatures on pallet.

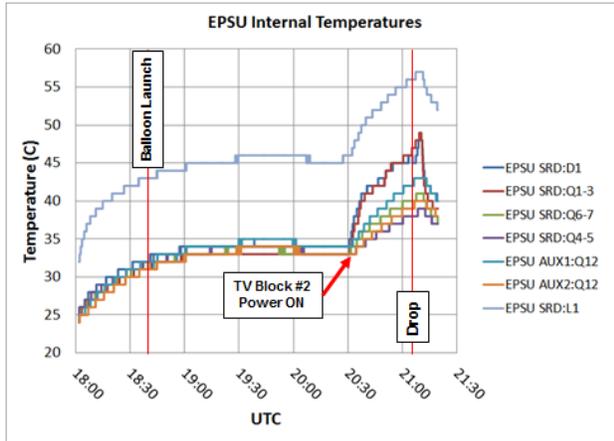
Figure 22. EPSU internal board temperature telemetry.

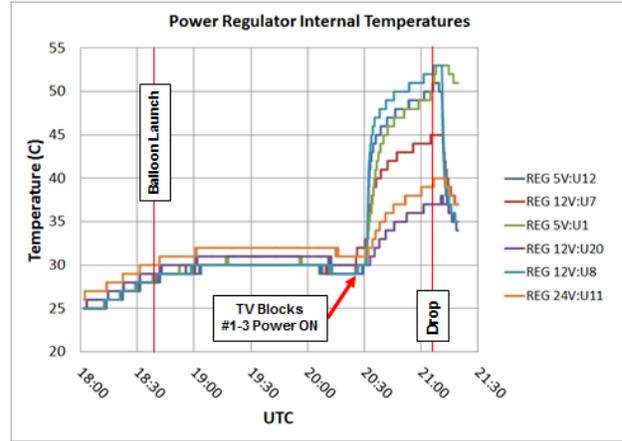
Figure 23. Power Regulator internal board temperature telemetry.

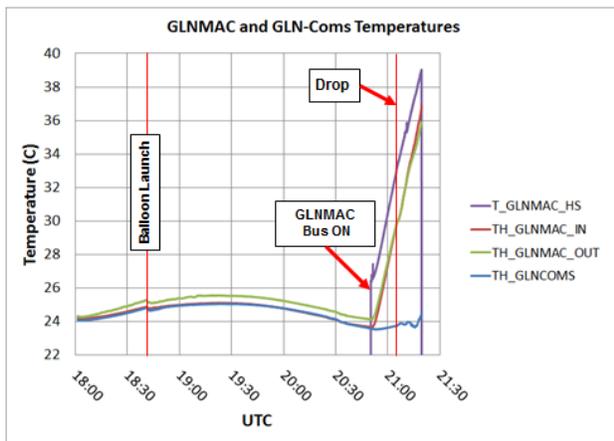
Figure 24. GLNMAC and GLN-Coms temperatures.

All 15 channels of the GLNMAC thermal telemetry are plotted in Figs. 24 and 25. The GLNMAC was powered on 15 minutes prior to drop in order to minimize its power on time. This decision reflected the appropriate balance of risk in terms of mitigating the GLNMAC from getting too hot during multiple drop attempts while still providing adequate time prior to drop to ensure that it was properly initialized for the powered flight.

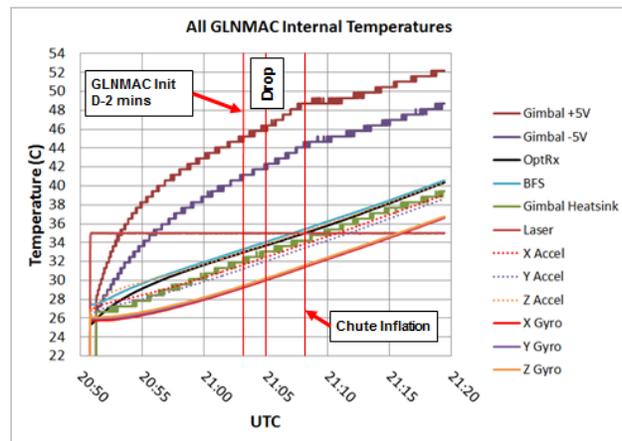
Figure 25. GLNMAC internal temperatures during operation. Optical Rx peaked at 40°C.

The internal limiting component, the *Optical Rx*, reached +40.4°C after approximately 30 minutes of continuous power on time and was increasing at a rate of 0.4°C/min prior to altitude shutdown. At this time, the external case temperature as shown in Fig. 24 peaked at +36.9°C and lagged behind the *Optical Rx* by only 3.5°C. In the worst case for Flight 1, the GLNMAC was expected to be on for 70 minutes continuously while accounting for a hold. Assuming the 0.4°C/min ramp rate had remained constant, the *Optical Rx* would have reached +57°C (safely under its +61°C qualification limit) had it remained on for the full 70 minutes. No increased temperatures were observed on any of the GLNMAC temperature channels due to the effect of the Main Motor plume heating followed by its soakback heating, affirming that the GLNMAC was effectively shielded from these events.

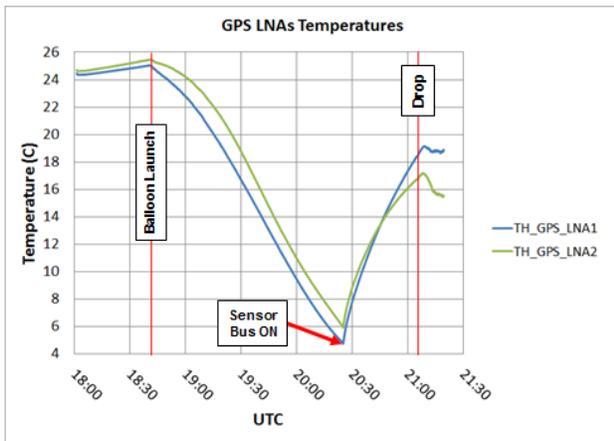
Figure 26. GPS Low Noise Amplifiers (LNAs) temperatures.

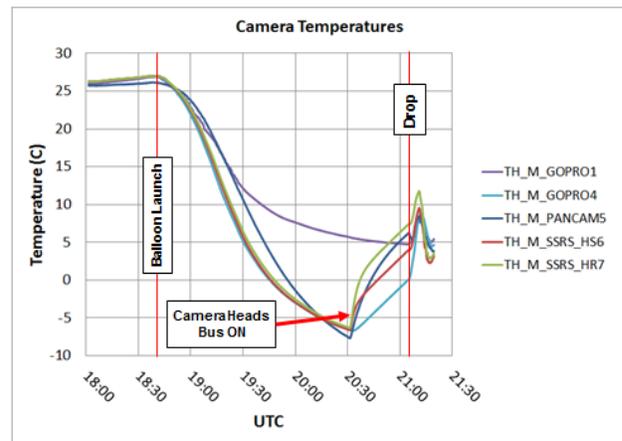
Figure 27. Machine Vision/Situational Video camera temperatures.

The temperatures for all of the camera equipment are plotted in Figs. 27-29. As shown in Fig. 27 the plume facing cameras did realize some increased temperatures due to the Main Motor plume heating, although not as much as was predicted. The most pronounced effect was observed on Situational Video Camera #4 which experienced about a 9°C increase in temperature due to the Main Motor plume heating event. While significant, the camera mast thermal design overall appears to have been very robust since all camera mast equipment remained well inside AFTs.

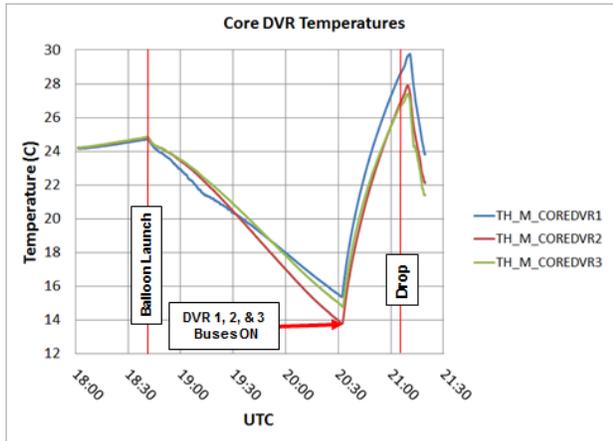
Figure 28. Core DVR temperatures.

Note the CoreDVRs had to be repackaged from their commercial off the shelf configurations since they were designed to be convectively cooled via fans in air at sea level. More thermally efficient voltage regulators were implemented, and all of the internal hot components were re-mounted so as to enable cooling by conduction and radiation only, thereby allowing them to function in a near vacuum environment. The CoreDVRs peaked at around 30°C after drop but remained within their AFTs of -10°C to +55°C.

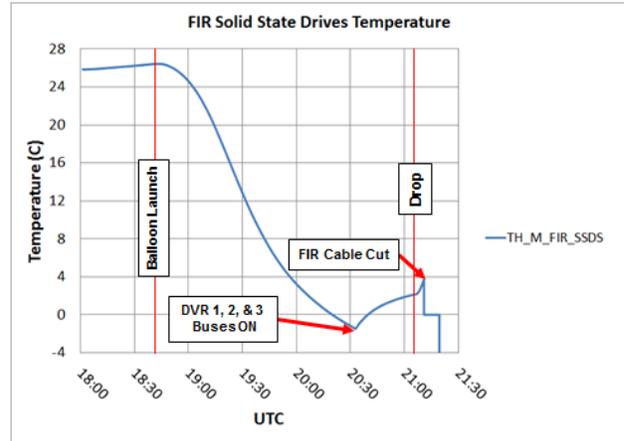
Figure 29. Flight Image Recorder (FIR) Solid State Disks temperatures. Cable cut after chute deployed.

firings with exterior layers of cork. The in-flight temperature of the FIR SSDs as shown in Fig. 29 remained quite benign and well inside its AFTs of  $-40^{\circ}\text{C}$  to  $+50^{\circ}\text{C}$ .

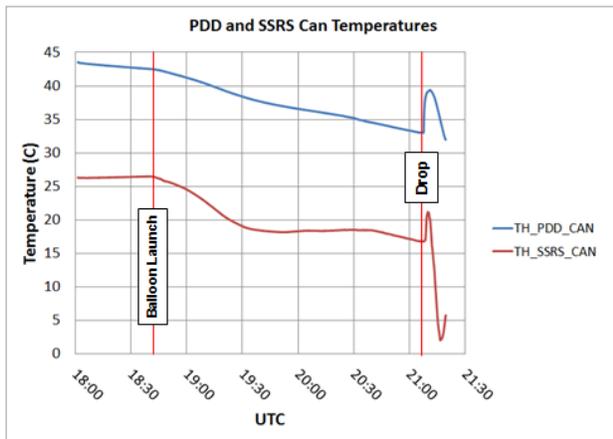
Figure 30. PDD and SSRS Canister temperatures. Inflation Aid within PDD canister likely at 44°C prior to deployment.

For SFDT-1, the PDD canister was heated for over 36 hours prior to heater disconnect in order to warm the Inflation Aid up to  $80^{\circ}\text{C}$ . Given the observed PDD canister flight temperatures in Fig. 30, the Inflation Aid was likely at  $43^{\circ}\text{C}$  when it was implemented after only 12 hours of cooling, leading to a highly successful ballute deployment.

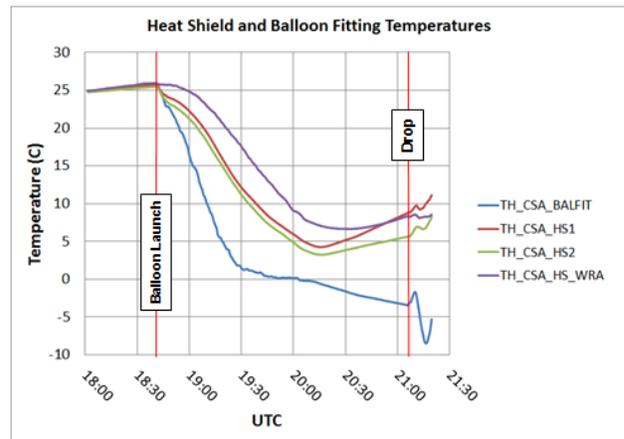
Figure 31. Heat Shield inner facesheet, Heat Shield Water Recovery Aid (WRA), and Balloon Fitting temperatures.

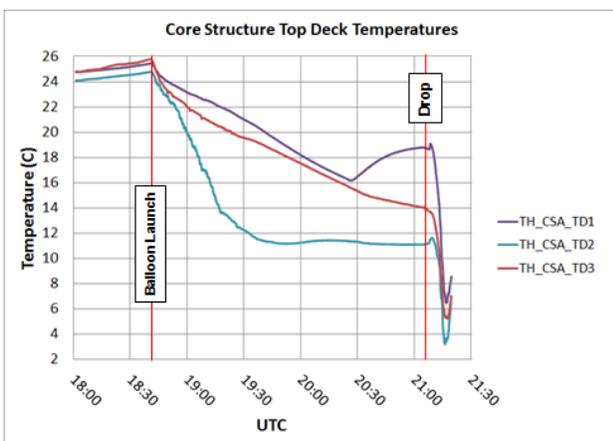
Figure 32. Core structure top deck outer facesheet temperatures.

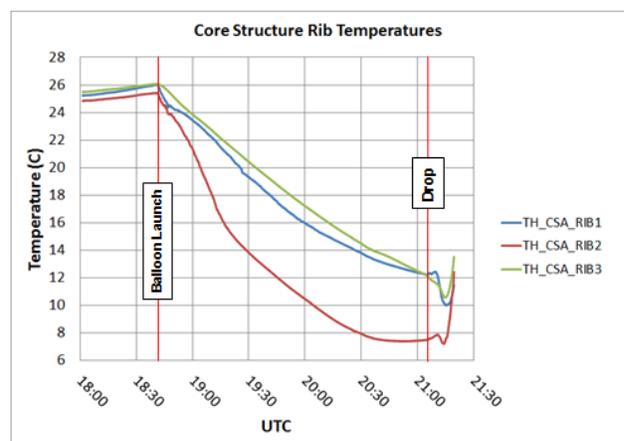
Figure 33. Core structure rib temperatures in vicinity of Star 48 Main Motor adaptor mounting ring.

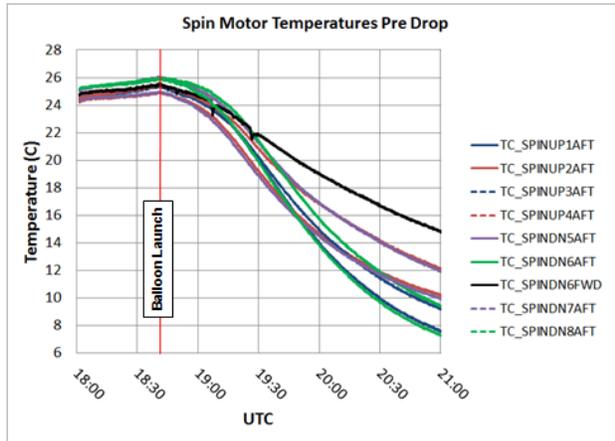
Figure 34. Spin Motor temperatures Pre Drop.

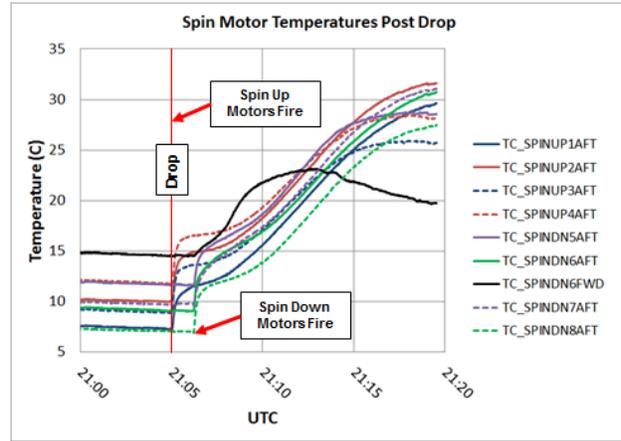
Figure 35. Spin Motor temperatures Post Drop.

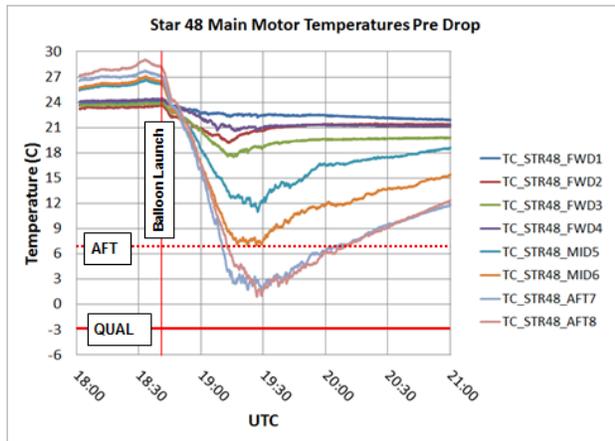
Figure 36. Star 48 Main Motor temperatures Pre Drop. AFT violation observed near nozzle during ascent.

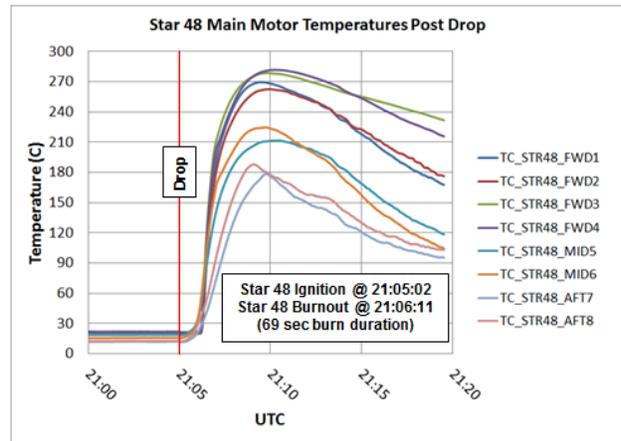
Figure 37. Star 48 Main Motor experienced soak back heating post engine burn up to a peak temp of 282°C.

The Main Motor soakback heating, however, appears to have been too conservatively estimated, and sufficient telemetry now exists to provide a more refined estimate of it.

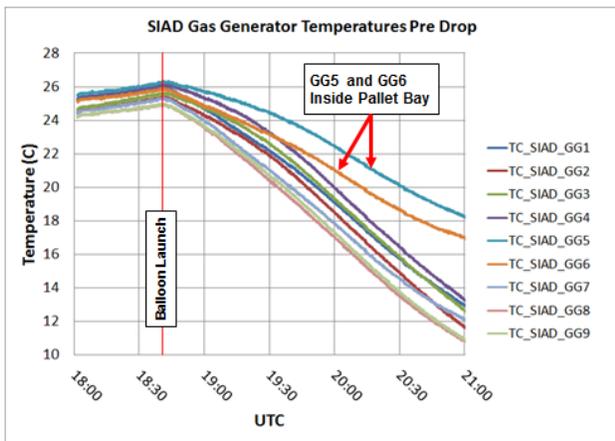
Figure 38. SIAD Gas Generator temperatures Pre Drop with GG5 and GG6 located inside the warmer pallet bay.

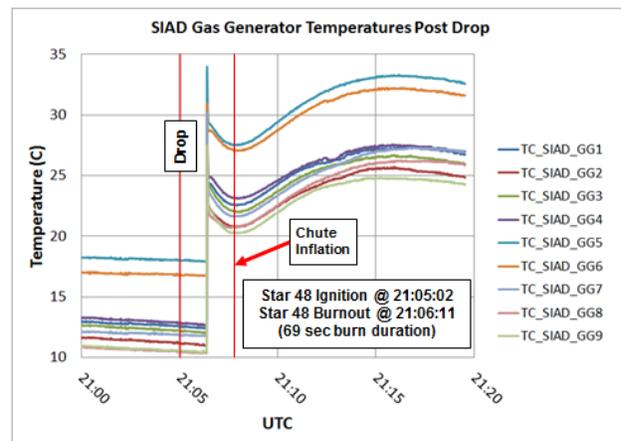
Figure 39. SIAD Gas Generator temperatures Post Drop.

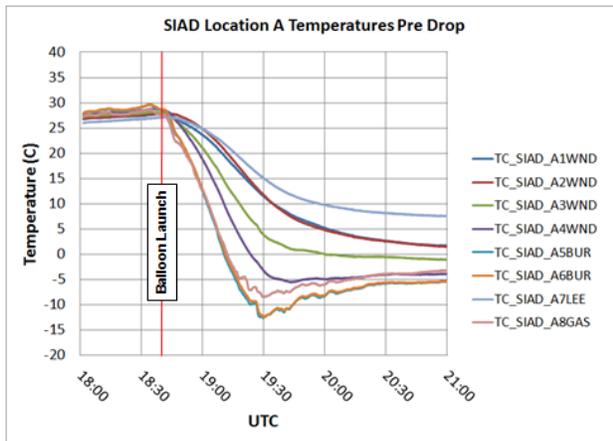
Figure 40. SIAD radial location A temperatures Pre Drop.

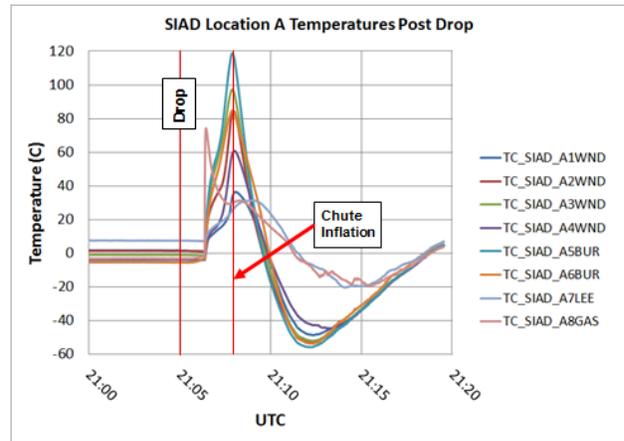
Figure 41. SIAD radial location A temperatures Post Drop.

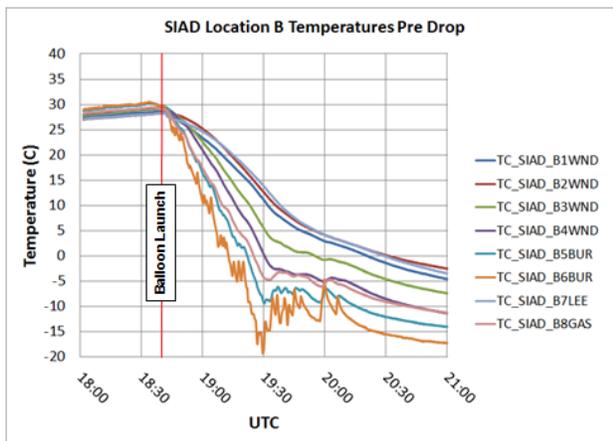
Figure 42. SIAD radial location B temperatures Pre Drop.

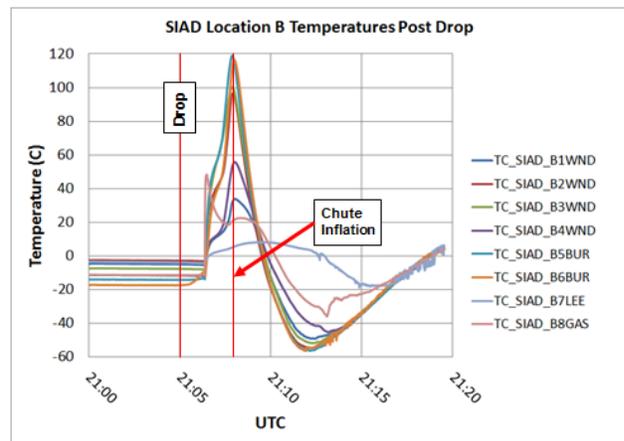
Figure 43. SIAD radial location B temperatures Post Drop.

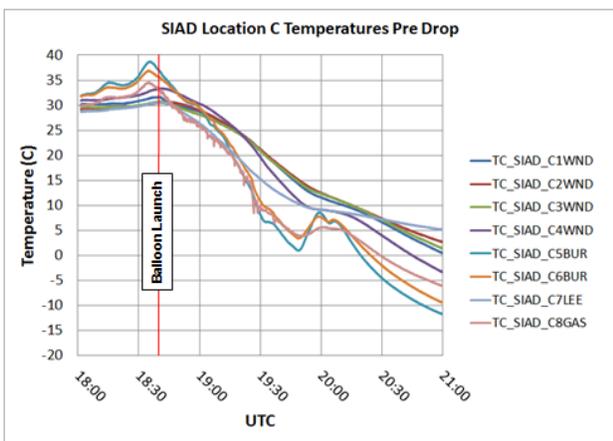
Figure 44. SIAD radial location C temperatures Pre Drop.

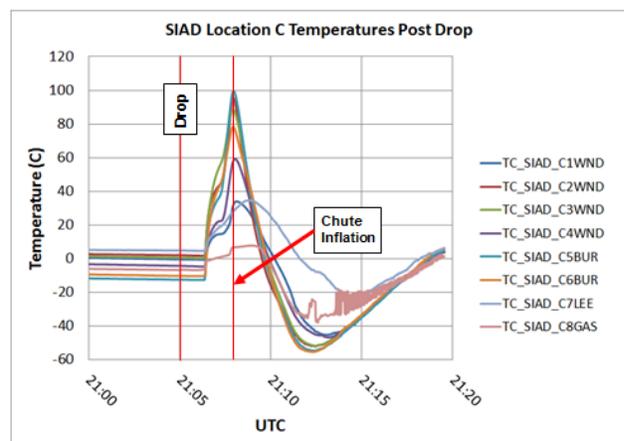
Figure 45. SIAD radial location C temperatures Post Drop.

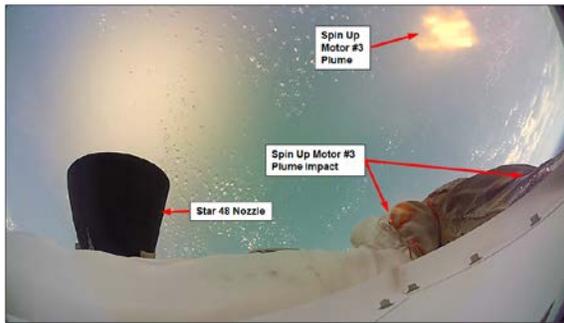
**Figure 46. Regions of backshell TPS glowing hot with small flames after firing of Spin Up Motor.**

Figures 46-51 show all the key events during the powered flight test in the order that they happened. Figures 52-54 shows some images taken of the recovered test vehicle post-flight and highlight the blackened areas of the TPS that likely experienced high heating either from Spin Motor or Main Motor plumes. The blast shields for the Spin Up Motors seemed to have markedly more blackened area and soot deposits than those for the Spin Down Motors. This can likely be attributed to the fact that Spin Down Motor plumes occurred at a much higher altitude where the plumes themselves were allowed to widen more and become less concentrated in the lower density environment. Furthermore, there was no particle erosion observed whatsoever. Fears of this concern led to thicker than necessary shields being implemented. The cork Heat Shield showed no signs of charring or ablation, nor did a Teflon WRA cover which protruded through the Heat Shield show any signs of melting confirming predictions. Not shown, however, is the TPS which was underneath the forward dome of the Main Motor. It did have considerable blackening but like the rest of the TPS, it did not exhibit any signs of burn through and only surface discoloration was observed. The camera mast was surprisingly uncovered in black soot except for the very top and no ablation from the Spin Motor plume impingement was observed on the cork that encapsulated the FIR as was feared.

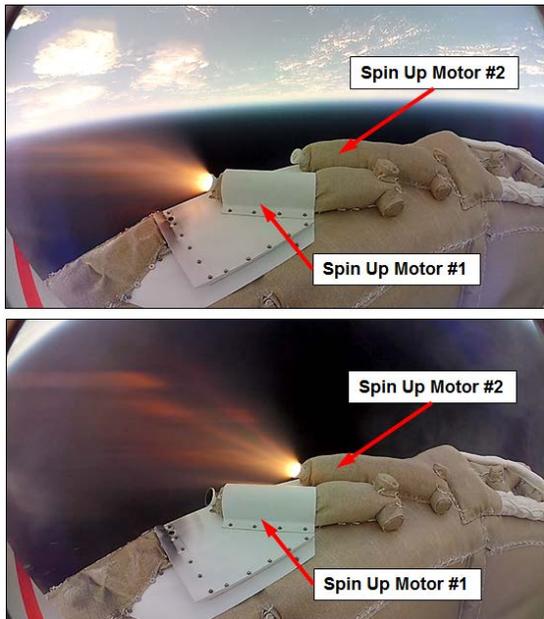
**Figure 47. Spin Up Motor #1 firing followed by Spin Up Motor #2 firing as viewed from Situational Video Camera #3.**

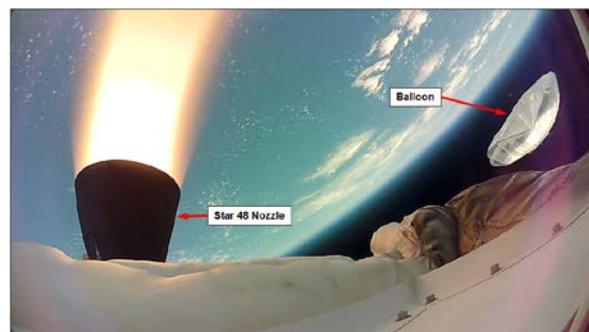
**Figure 48. Main Motor firing with detached carrier balloon in background.**

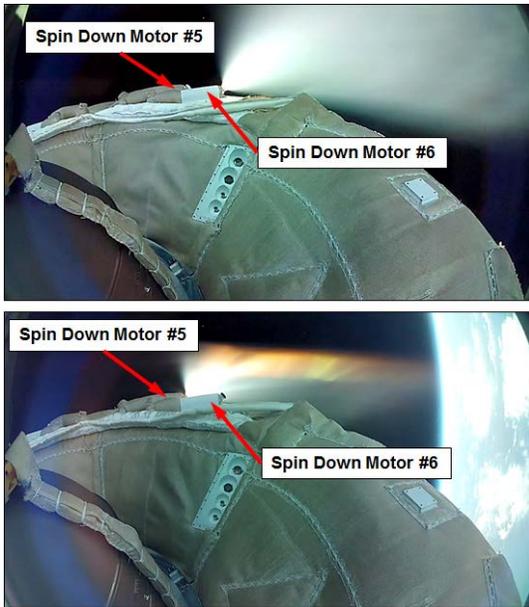
Figure 49. Spin Down Motor #6 firing followed by Spin Down Motor #5 firing as viewed from Situational Video Camera #2.

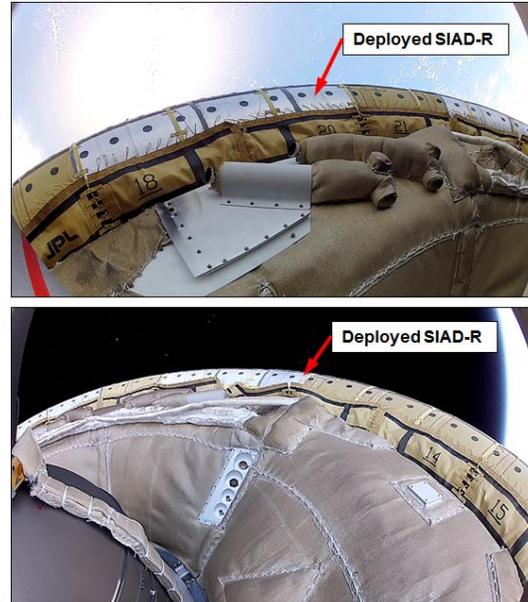
Figure 50. Successful SIAD-R deployment as viewed from the Situational Video Cameras.

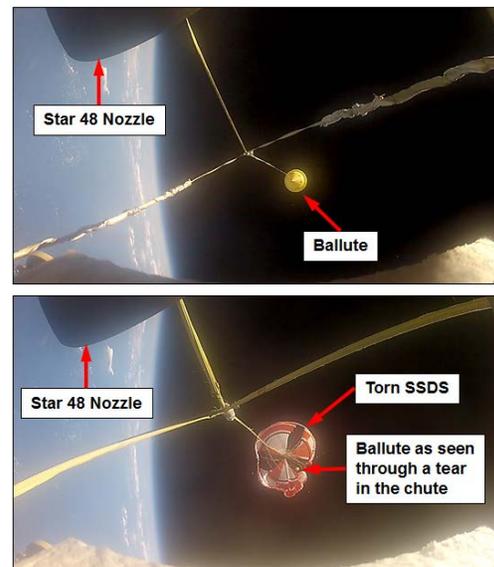
Figure 51. Successful ballute deployment followed by an unsuccessful chute deployment as viewed from the Situational Video Camera #4.

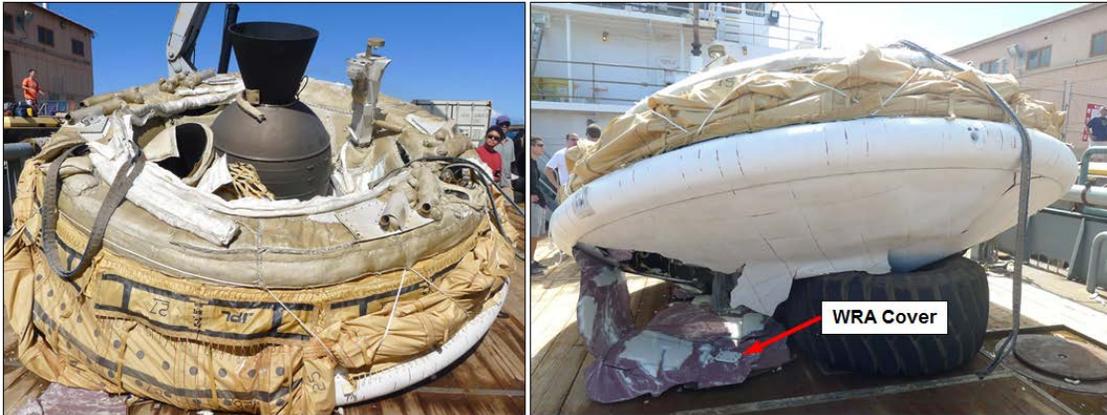
Figure 52. Recovered test vehicle showing Heat Shield (image on right) damaged from high speed water impact. Both the Heat Shield and the Teflon Water Recovery Aid (WRA) cover showed no signs of charring or melting.
