# First Test Flight Thermal Performance of the Low Density Supersonic Decelerator (LDSD) Supersonic Flight Dynamics Test (SFDT) Vehicle

A. J. Mastropietro<sup>1</sup>, Jason Kempenaar<sup>1</sup>, Matthew Redmond<sup>1</sup>, and Michael Pauken<sup>2</sup>  
*Jet Propulsion Laboratory, California Institute of Technology, Pasadena, California, 91109*

The first of three planned experimental flights of the Low Density Supersonic Decelerator (LDSD) Supersonic Flight Dynamics Test (SFDT) vehicle took place on the morning of June 28<sup>th</sup>, 2014 off the coast of Kauai, Hawaii. The goal of the first flight was to determine if the vehicle could reach the altitudes and airspeeds needed to test new technologies for decelerating supersonic vehicles destined for Mars. SFDT-1 was launched from the Navy's Pacific Missile Range Facility (PMRF) on a 960,000 cubic meter helium carrier balloon provided by NASA's Columbia Scientific Balloon Facility (CSBF). Once lifted to a stable float altitude of 36.4 km over the Pacific Ocean, the vehicle was dropped and a series of automated maneuvers began. First, the vehicle was spun up via small rocket motors to provide trajectory stability and then a

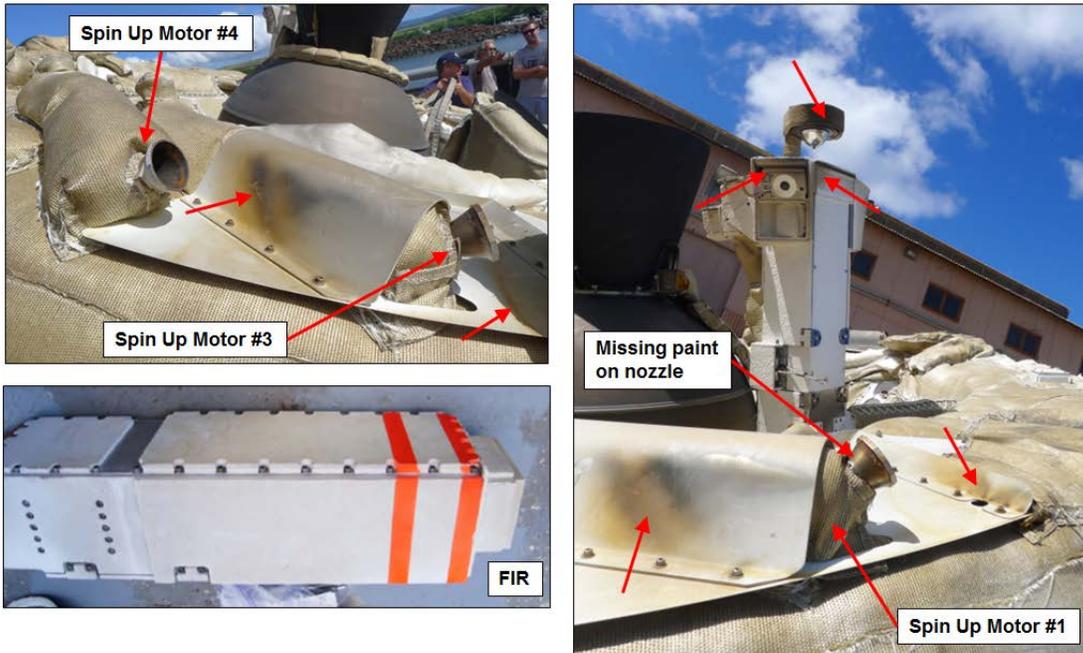
Figure 53. Unlabeled red arrows indicate areas where TPS was blackened due to plume heating. There was no significant particle erosion observed on the Spin Motor plume blast shields. While the FIR TPS had minor soot deposits, no ablation from the Spin Motor plumes was observed as was feared. The top of the camera mast had some noticeable soot deposits presumably from both the Spin Motor and Main Motor plumes.

Figures 46-51 show all the key events during the powered flight test in the order that they happened. Figures 52-54 shows some images taken of the recovered test vehicle post-flight and highlight the blackened areas of the TPS that likely experienced high heating either from Spin Motor or Main Motor plumes. The blast shields for the Spin Up Motors seemed to have markedly more blackened area and soot deposits than those for the Spin Down Motors. This can likely be attributed to the fact that Spin Down Motor plumes occurred at a much higher altitude where the plumes themselves were allowed to widen more and become less concentrated in the lower density environment. Furthermore, there was no particle erosion observed whatsoever. Fears of this concern led to thicker than necessary shields being implemented. The cork Heat Shield showed no signs of charring or ablation, nor did a Teflon WRA cover which protruded through the Heat Shield show any signs of melting confirming predictions. Not shown, however, is the TPS which was underneath the forward dome of the Main Motor. It did have considerable blackening but like the rest of the TPS, it did not exhibit any signs of burn through and only surface discoloration was observed. The camera mast was surprisingly uncovered in black soot except for the very top and no ablation from the Spin Motor plume impingement was observed on the cork that encapsulated the FIR as was feared.

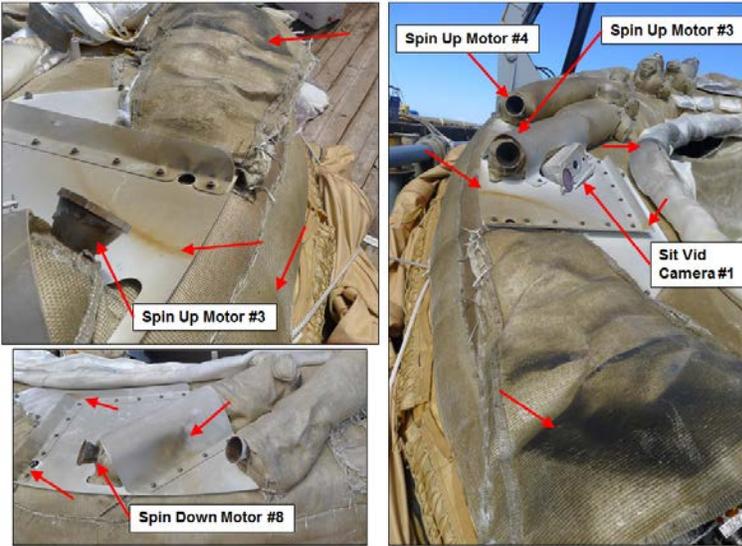
**Figure 54. Unlabeled red arrows indicate areas where TPS was blackened due to plume heating. Spin Down Motor blast shields showed markedly less evidence of a high heating event as compared to the Spin Up Motors.**
