# Radiation Test Results for Common CubeSat Microcontrollers and Microprocessors

Steven M. Guertin, Mehran Amrbar, and Sergeh Vartanian

SEL, SEU, and TID results are presented for microcontrollers and microprocessors of interest for small satellite systems such as TI MSP430 devices, Microchip PIC devices, the Atmel AT91SAM9G20, and the Intel Atom E620T.

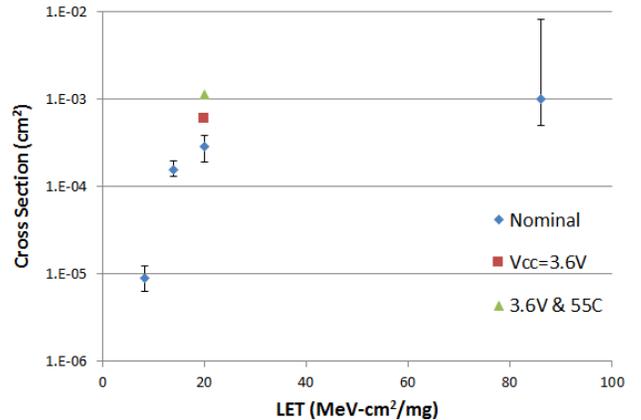
Fig. 1: SEL response of the MSP430F1612 test devices. All markers at LET 20 MeV-cm<sup>2</sup>/mg have the same 2- $\sigma$  error bars (some excluded for clarity). Large uncertainty at LET 85.6 is due to saturation of SEL counting.

MSP1612, devices tested for SEL, immediately showed 10 mA current increases upon exposure to the beam. These increases produce a stair-step type plot and never exhibited a reduction in current draw. Devices went from less than 1 mA of current to over 500 mA. We counted individual current steps as SEL because each step is believed to be caused by activation of another site. The resulting cross section curve is shown in Fig. 1. This also includes checks with increased bias and increased temperature resulting in increased event sensitivity. Difficulty with the rate at which steps accumulate

at high LET result in the very large error bars seen. After  $1.1 \times 10^{17}/\text{cm}^2$  Au testing (LET 85.6 MeV-cm<sup>2</sup>/mg), we observed that one device was no longer properly identified by the programming system. Instead of MSP430F1612, it was identified as MSP430F169 and the programming tools would not program the device in this configuration. Otherwise, all devices functioned nominally after their full exposures.

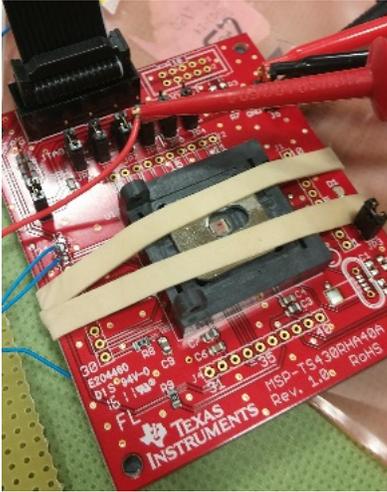
Fig. 2: MSP430FR5739 in MSP-TS430RHA40A evaluation board for SEE testing.

DUTs were mounted in the TI MSP-TS430RHA40A evaluation board. Test software operated at 1 MHz. The board was modified as follows. The socket was modified by removing the upper part of the clamshell and lowering the deck height of the lower portion. This allowed for using a metal plate to hold the DUT into the socket and make contact. Devices were acid etched to expose the die, with the outer lip left intact to contact the metal plate. The DUT's UART receive and transmit pins were connected to an added UART circuit to perform translation between logic levels and UART signal levels. The test setup used is shown in Fig. 2.

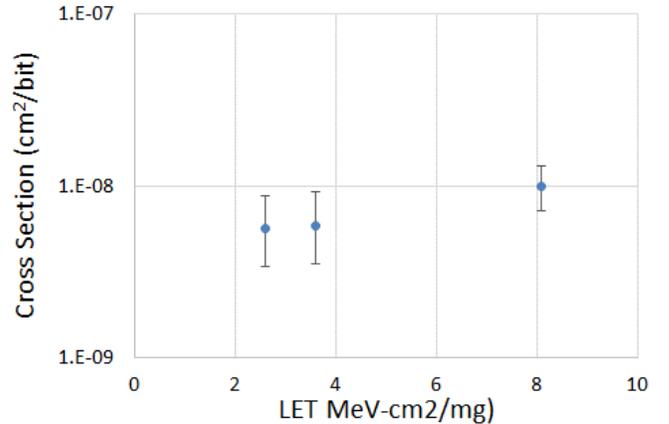
Fig. 3: SEE sensitivity of on chip SRAM cells in the MSP430FR5739. Error bars are  $2\sigma$ .

We were able to sensitize the on-chip SRAM for SEE testing during the SEL test effort. A limited amount of SEE data were collected and are presented in Fig. 3. Compare the apparent saturation cross section of around  $1 \times 10^{-8} \text{ cm}^2/\text{bit}$  to the MSP430F1611/1612 at around  $1.3 \times 10^{-7} \text{ cm}^2/\text{bit}$ .

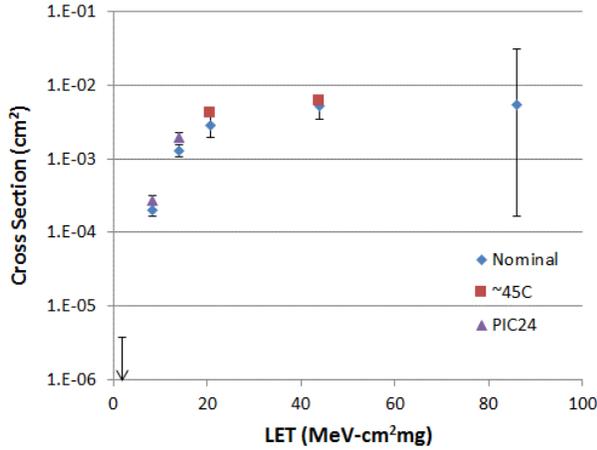
Fig. 4: SEL cross section of the dsPIC33 devices. Error bars are 2- $\sigma$ .

SEL was detected readily in the PIC devices. A plot of SEL cross section is presented in Fig. 4, below. Sensitivity of the device to SEL was also explored with increased temperature, which is shown on the figure. The error bars on LET 20 and 44 MeV-cm<sup>2</sup>/mg points with elevated temperature are about the same size as for the room temperature counterparts, as an example of temperature dependence expected in SEL. We could not increase the voltage with the Explorer 16 Board. Note that we could not run the DUTs at significantly elevated temperature because the thermal protection of the on-board power regulation would sometimes trip and actually recover SEL events creating questionable data. Significant issues with event counting while exposing devices to high fluence resulted in the large error bars for the LET 85.6 MeV-cm<sup>2</sup>/mg point.

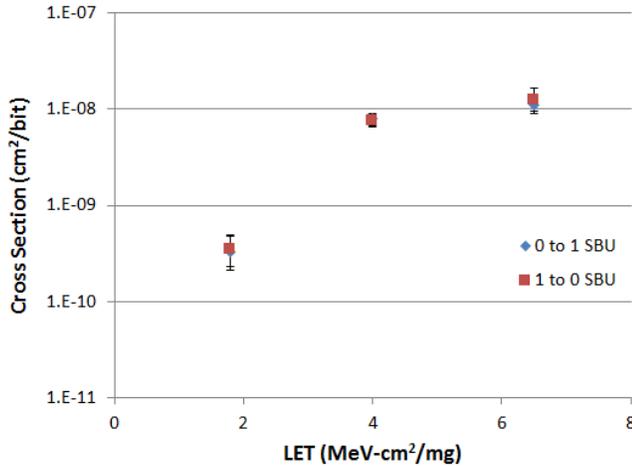
Fig. 5: The SRAM SEU sensitivity of the PIC24 DUTs. Error bars are 2- $\sigma$ .

Although the primary intent of our SEE testing was to determine the SEL sensitivity, we were able to collect upset data on the on-chip SRAM on the PIC24 devices. The observed cross section is shown in Fig. 5. Note that in this case we separate the 0 to 1 and 1 to 0 SEUs, but there is no significant difference between these.

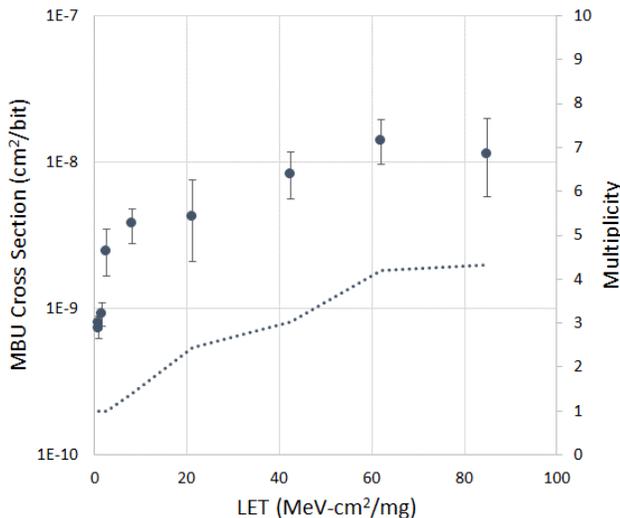
Fig. 6: Per bit cross section for MBUs in the AT91SAM9G20 OCM (data points). The dotted line shows the multiplicity of the average MBU event.

Using the method discussed above, DUTs 2 and 4 were tested for SEU in the OCM with heavy ions, and DUTs 1 and 3 were tested with neutrons. Events at higher LET were obviously higher multiplicity than at lower LET, with the multiplicity being about 1.5 for LET  $8.3 \text{ MeV}\cdot\text{cm}^2/\text{mg}$  and going up to about 4.5 for LET  $85.4$ . The MBU cross section results are shown in Fig. 6, along with the average event multiplicity (dotted line).

Neutron results included SBU, MBU and resets. Resets were isolated to only one test board. Since the resets were significantly different between the two test boards it is believed the resets were not due to the processor. Between both boards, an MBU cross section of  $1.10 \times 10^{-12} \text{ cm}^2/\text{bit}$  (1.02, 1.17) was observed. The multiplicity of MBU events with white neutrons was 1.19.

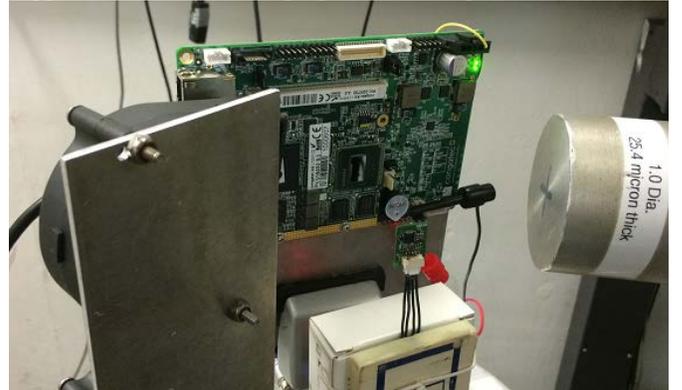
Fig. 7: The Conga QA6 - Intel E620 DUT board is shown mounted to the Conga MCB/Qseven board.

The Intel Atom E620T was tested on the conga QA6 module [17] which was mounted to a conga-MCB/Qseven carrier board which operates the processor at 600 MHz [18]. The combination of both elements produces essentially a full computer. The E620T processor features a Low-Power Intel Architecture Core with on-die 32 kB 4-way L1 instruction cache, and 24 kB 6-way L1 data cache. It also includes a 512 kB on-die L2 cache [19]. The test setup, at the end of the beamline, is shown in Fig. 5 below. In this setup, a thinned E620T DUT card is shown, mounted to the conga-MCB. Two fans, mounted to the aluminum plate, blow air across the thinned DUT. A thermal monitoring circuit is positioned facing the DUT to monitor the temperature. The board was connected to a monitor via the HDMI port and a USB keyboard. For SEE testing, a custom build of the GRUB boot-loader with test code embedded was used – this was booted using a USB memory stick. 12V power was delivered to the board by a generic power supply which was monitored and logged with an external laptop control computer.

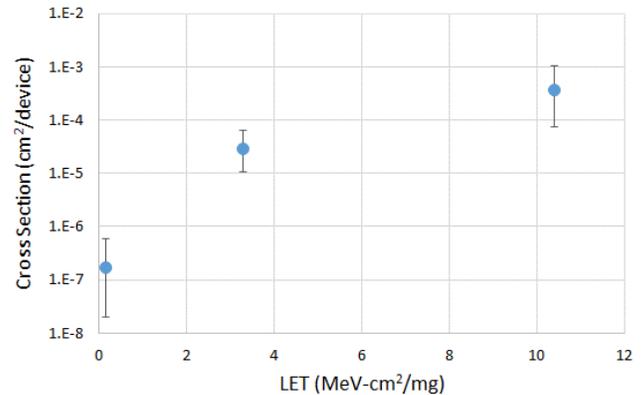
Fig. 8: Cross section for crashes during execution of memory test SW on the Intel E620T. Error bars are  $2\sigma$ .

For the memory test SW, the observed cross section for execution stop and crash/restart was characterized over a limited LET range and is given in Fig. 8.
