Summary of the First High-Altitude, Supersonic Flight Dynamics Test for the Low-Density Supersonic Decelerator Project

NASA's Low-Density Supersonic Decelerator Project is developing and testing the next generation of supersonic aerodynamic decelerators for planetary entry. A key element of that development is the testing of full-scale articles in conditions relevant to their intended use, primarily the tenuous Mars atmosphere. To achieve this testing, the LDSD project developed a test architecture similar to that used by the Viking Project in the early 1970's for the qualification of their supersonic parachute. A large, helium filled scientific balloon is used to hoist a 4.7 m blunt body test vehicle to an altitude of approximately 32 kilometers. The test vehicle is released from the balloon, spun up for gyroscopic stability, and accelerated to over four times the speed of sound and an altitude of 50 kilometers using a large solid rocket motor. Once at those conditions, the vehicle is despun and the test period begins.

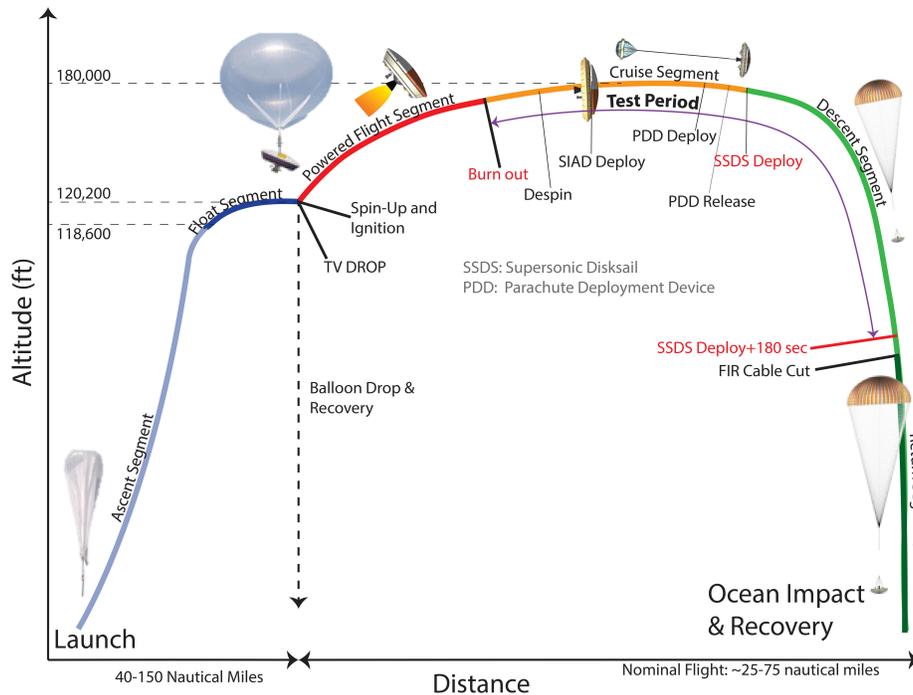
Figure 1. Overview of the LDSO Supersonic Flight Dynamics Test architecture

In 2012 NASA initiated the Low-Density Supersonic Decelerator (LDSD) project to develop a new generation of supersonic aerodynamic decelerators. As part of the LDSD project, several new ground-based test architectures were developed for performing structural testing of the decelerators. However, to fully evaluate deployment, inflation, and supersonic and subsonic aerodynamic behaviors, a full-scale flight test was required at conditions relevant to how the technologies would be utilized at Mars. This test series, referred to as the Supersonic Flight Dynamics Test (SFDT), utilizes a test architecture similar to the Viking Balloon Launched Decelerator Test (BLDT) series of 1972.¹ This architecture is outlined in Figure 1.

For a nominal mission, a large helium balloon is used to hoist a 4.7 m diameter blunt body test vehicle to an altitude of over 36 km. The test vehicle is released from the balloon, spun-up for stability, and a Star-48 solid rocket motor ignited. The motor accelerates the test vehicle to approximately Mach 4 and an altitude of 50 km. Upon burn-out, the vehicle is despun and the primary test phase begins. Shortly thereafter, the

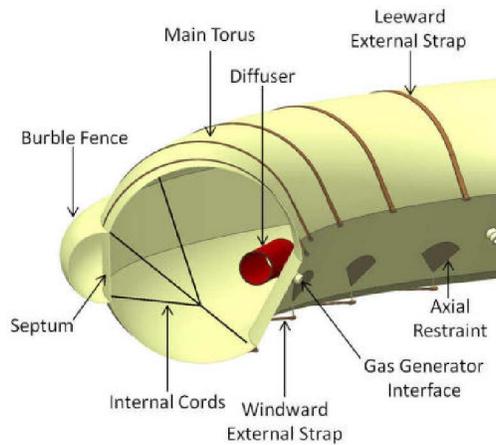
Figure 2. Design features of the robotic class SIAD flown on SFDT-1.

Though primarily an inflated torus, the SIAD-R design has a number of features, shown in Figure 2, designed to improve performance and rigidity. The burble fence on the periphery of the SIAD provides a location of uniform flow separation that improves the stability of the vehicle, particularly at lower supersonic and transonic conditions. The primary torus also contains a series of internal cords that provide additional preload and stiffness in the structure and help resist axial deflection and rotation of the torus under large aerodynamic loads.

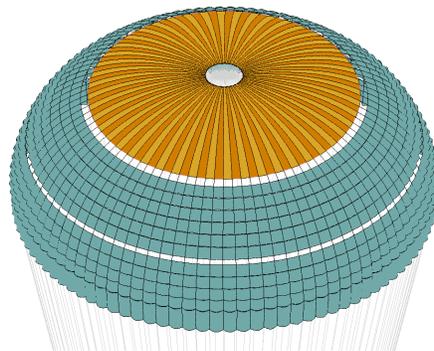
Figure 3. Supersonic Disksail parachute flown on SFDT-1.

The parachute tested on SFDT-1 is a 96 gore, 30.5 m D_0 Supersonic Disksail (SSDS), shown in Figure 3. The Disksail parachute merges design elements of both a Ringsail parachute and a Disk-Gap-Band (DGB) parachute. The design began with a 22 panel, 96-gore design for a 33.5 m D_0 Ringsail parachute tested as part of the 2005 Subsonic Parachute Technology Task (SPTT).^{6,7} The smaller Disksail design reduces the

base number of panels to 20 and subsequently replaces the upper 9 panels of the crown with a flat circular disk. The remaining 11 panels constitute sails of increasing fullness, with panels 10-12 having 6% fullness and panels 13-19 having 12% fullness. Panel 20 contains zero fullness, as per typical Ringsail design. Two gaps are present, one large gap at the edge of the disk and another shorter gap between the 15th and 16th panels. The parachute has an as designed geometric porosity of 13.69%, though the as-built geometric porosity of the canopy tested was estimated as 13.06%.

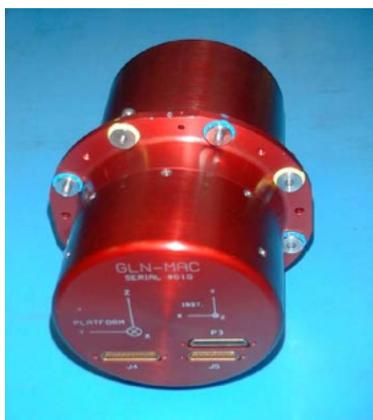
Figure 5. GLN-MAC Inertial Measurement Unit

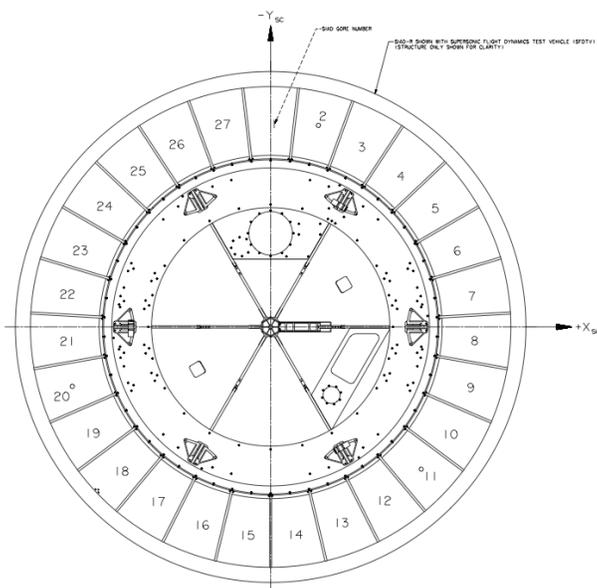
Figure 6. SIAD gore configuration

The 21 surface thermocouples were grouped in sets of 7 thermocouples, located at three circumferential locations on the SIAD, at gores 2, 11, and 20. See Figure 6 for the gore configuration and numbering scheme. At each gore, the thermocouples were installed in a consistent configuration, as shown in Figure 7.

SIAD INTERNAL GAS THERMOCOUPLES The 3 internal gas thermocouples were located at the same gores as the surface thermocouples, gores 2, 11, and 20, as shown in Figure 6. Due to construction of the SIAD and thermocouple mounting, these may not be reading the true gas temperature, and may have sensing some surface conductive heating.

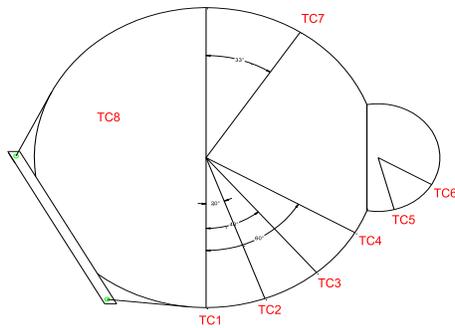
Figure 7. SIAD thermocouples in the same configuration at each gore

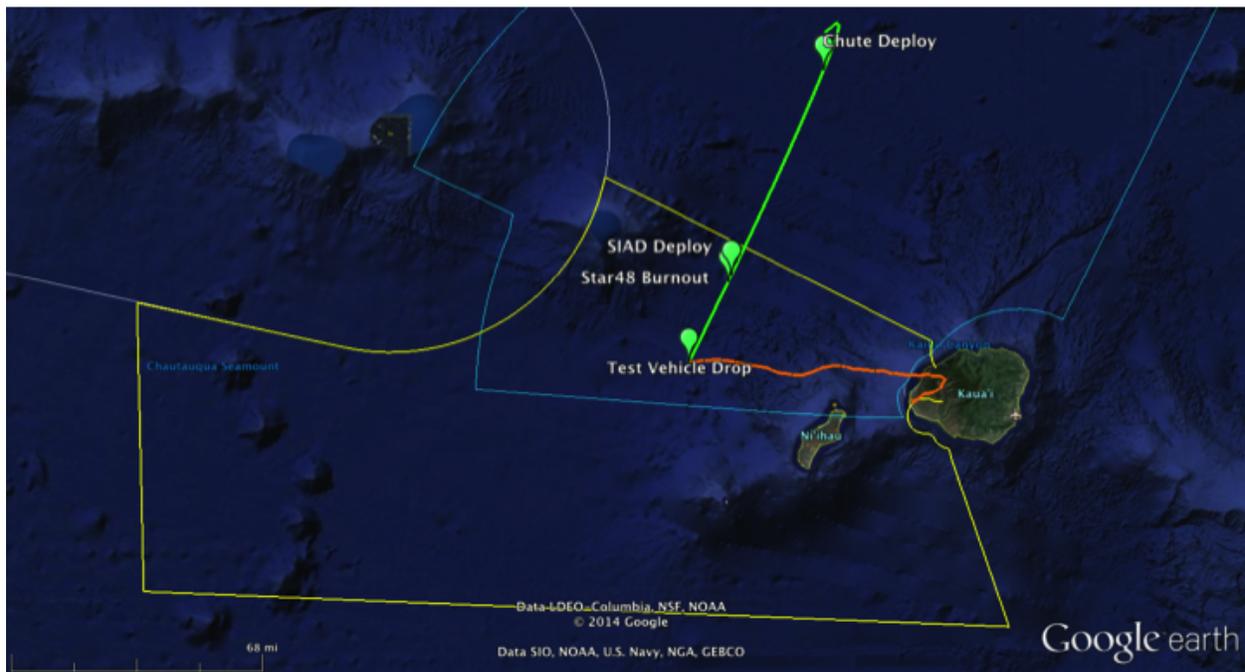
Figure 8. Balloon launch constraints and SFDT1 Ground Track

The trajectory of the balloon phase is determined by the balloon ascent rate as a function of time and the wind direction and speed as a function of altitude. The predicted trajectory must be shown to sufficiently avoid populated areas on and around the islands so that a possible balloon failure at any time during the ascent will not pose a safety hazard. In addition, the predicted balloon trajectory must permit enough time at float altitude and a set of selectable powered-flight azimuths so that the powered flight will be contained within the range boundaries for the test. These safety and operational boundaries are shown in Figure 8, where the balloon ascent must be contained in the yellow boundary.

The balloon ground track can be seen in red in the Figure 8, which very closely followed the predicted trajectory. The balloon crossed over the coast of Kauai about one hour after launch, at which time it was at an altitude of 18 km. A series of ballast drops were conducted shortly before and after crossing the coast, in order to assure a positive ascent rate through the tropopause. During ascent the predicted time at float altitude was updated in order to prepare for drop shortly after reaching float, and to select a time for drop and a pointing azimuth for the powered-flight trajectory. The drop time selected was 11:05 am HAST. During ascent, the gondola and test vehicle were commanded through UHF receivers on the gondola. The procedure to power up and arm the test vehicle systems for drop began at 40 minutes before drop, with all systems operating as expected.

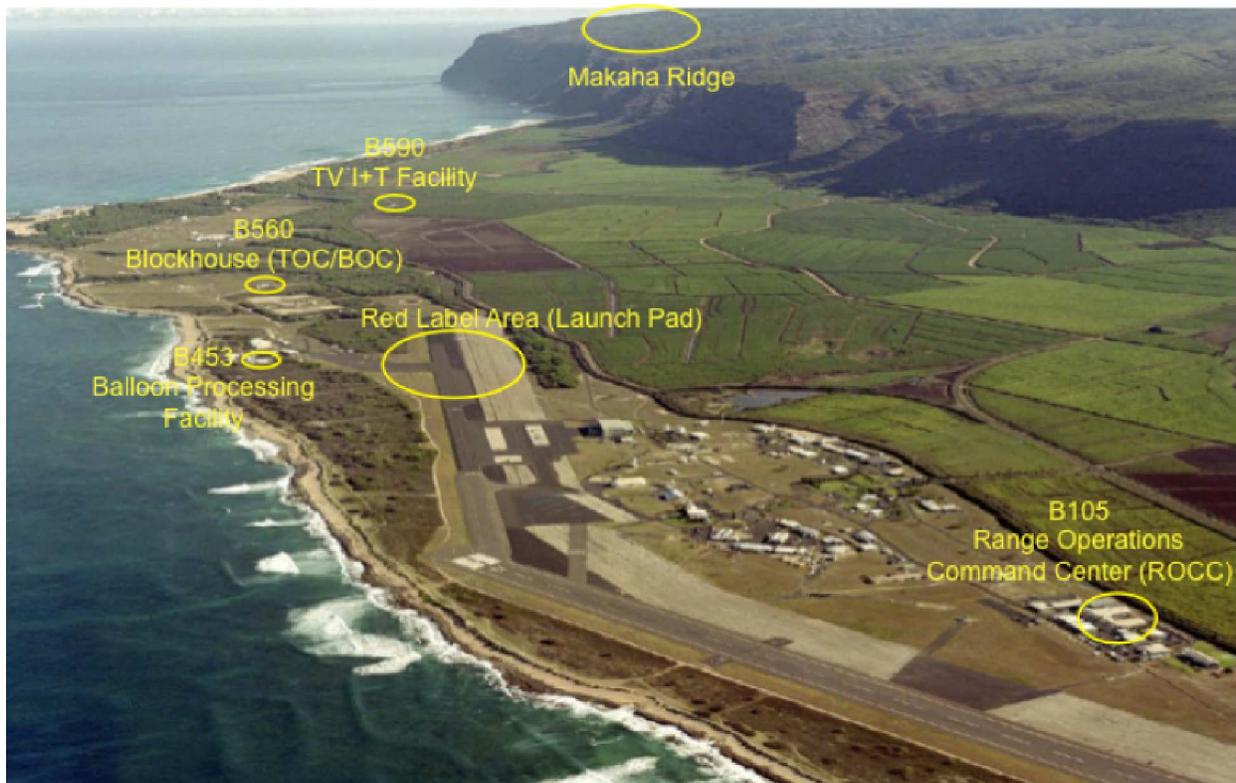
Figure 9. PMRF Facilities

Area), in the Range Operations Control Center (ROCC) for range systems, recovery, and overall mission direction, the Balloon Operations Center (BOC) for balloon control during ascent, and the Test-Vehicle Operations Center (TOC) for test vehicle commanding and telemetry assessment throughout the mission from pre-launch to splashdown. Figure 9 shows the locations of the facilities on the range. The range telemetry systems are on Makaha ridge.

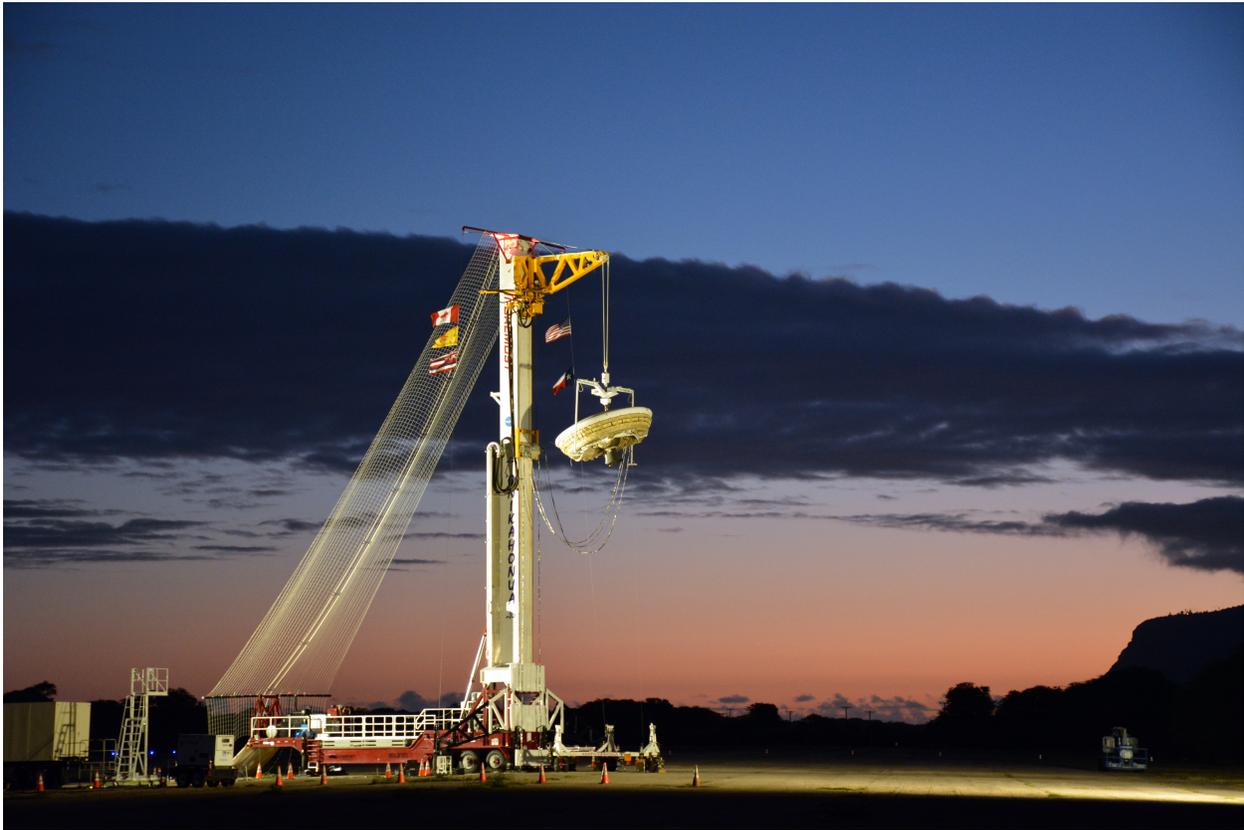
Figure 10. SFDT1 Test Vehicle and Balloon Gondola on Launch Tower

A series of checkout activities were conducted first with the test vehicle on its ground cart, and later with the vehicle lifted to the launch position. The test vehicle and gondola can be seen in the launch position in Figure 10, with the bottom of the balloon train draped behind the tower. The checkouts verified the operation of the test vehicle and gondola electrical systems, and exercised the radio frequency interfaces with the range. The checkouts were completed at 4:05 am HAST on launch day.

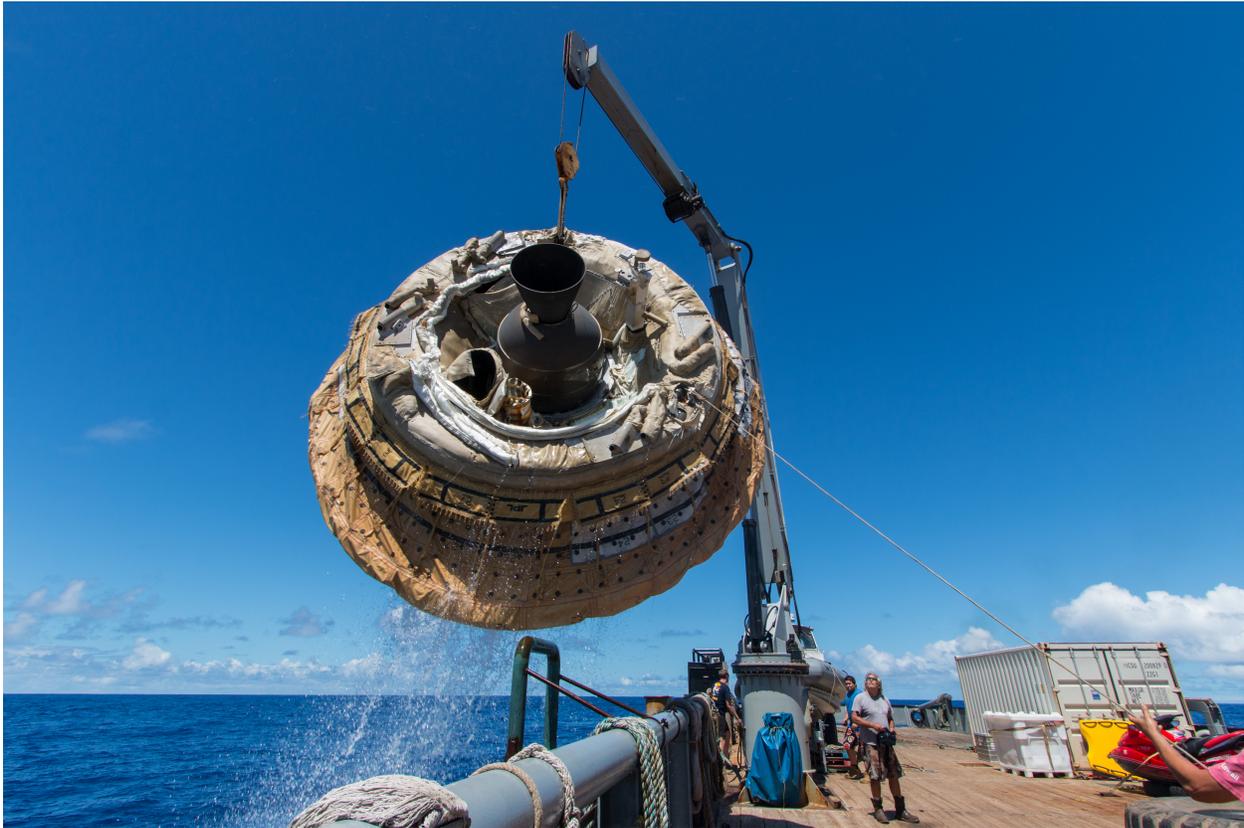
Figure 11. SFDT1 Test Vehicle Recovery on to the Kahana

In an unplanned operation, the Kahana recovered the ballute from the ocean at 1:14 pm and then proceeded to the test vehicle, arriving at 2:15 pm. The test vehicle was recovered and on the Kahana at 2:30 pm. The flight image recorder was transferred from the Manao II to the Kahana at that time. The Kahana delivered the recovered test vehicle and flight image recorder to Port Allen on Kauai at 7 am the following day, June 29, 2014. Figure 11 shows the test vehicle recovery.

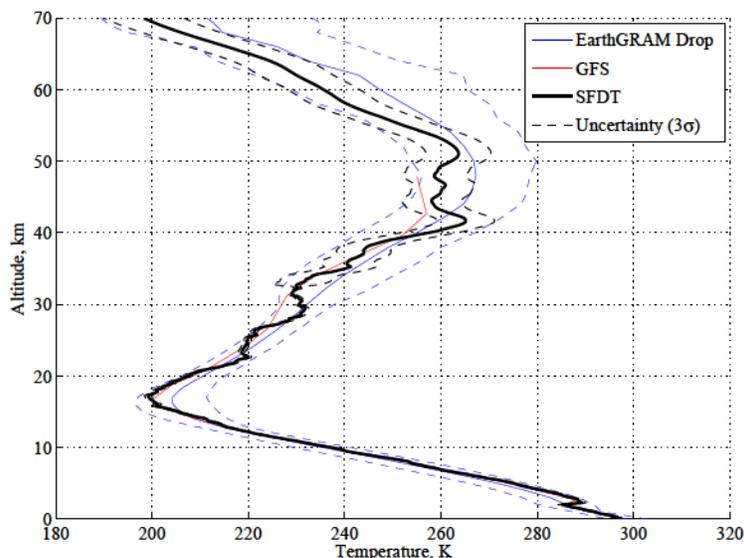
Figure 12. Reconstructed temperature profile with comparison to both EarthGRAM and Global Forecasting System models.

Reconstructed values of density, temperature, speed of sound, and wind are provided in the figures below.

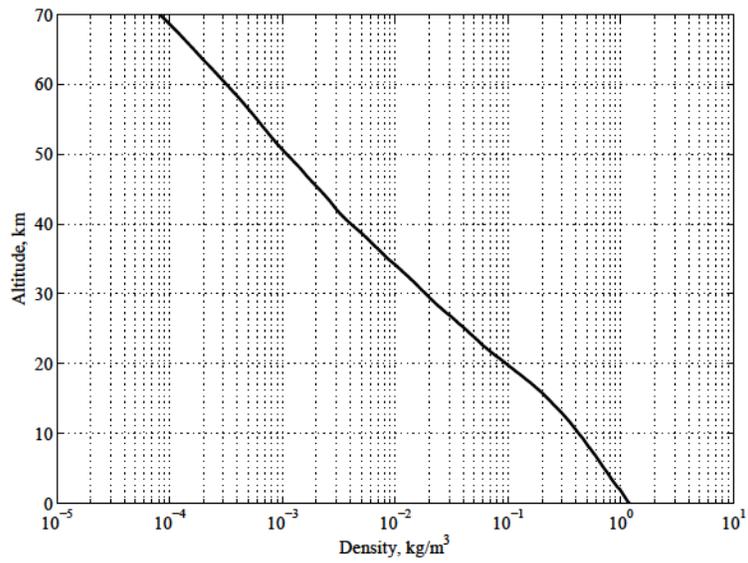
Figure 13. Reconstructed density profile.

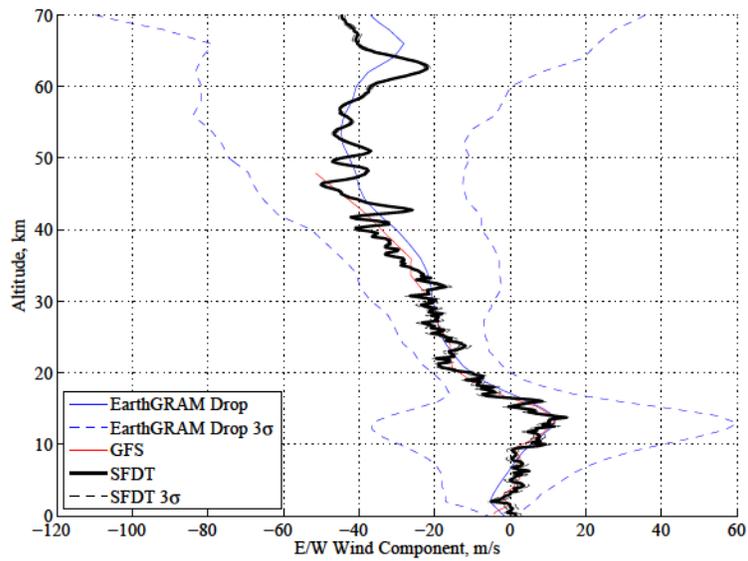
Figure 14. Reconstructed wind component in the east direction.

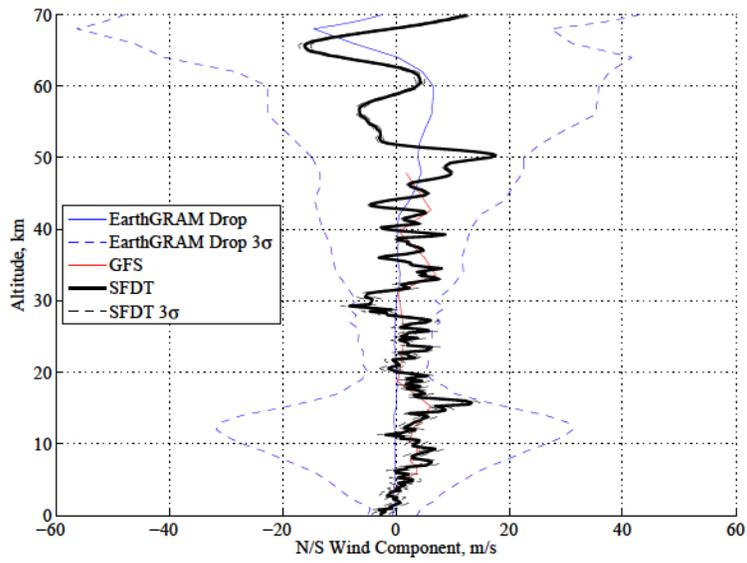
Figure 15. Reconstructed wind component in the north direction.

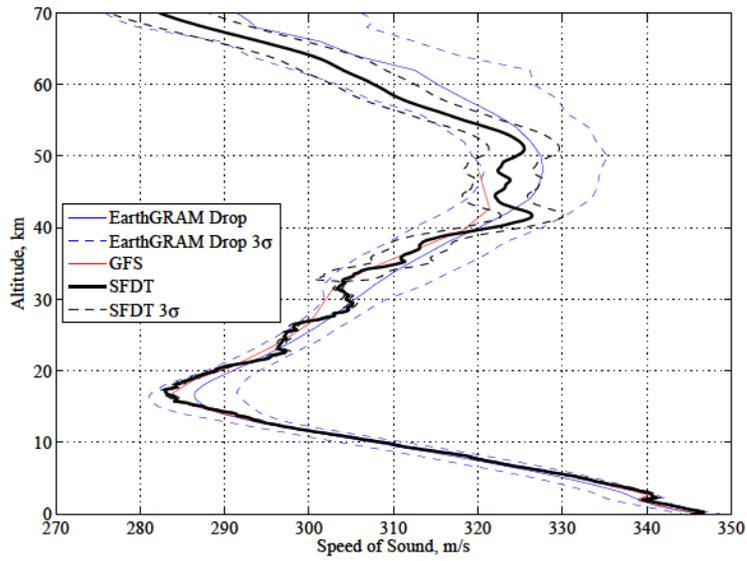
Figure 16. Reconstructed speed of sound profile.

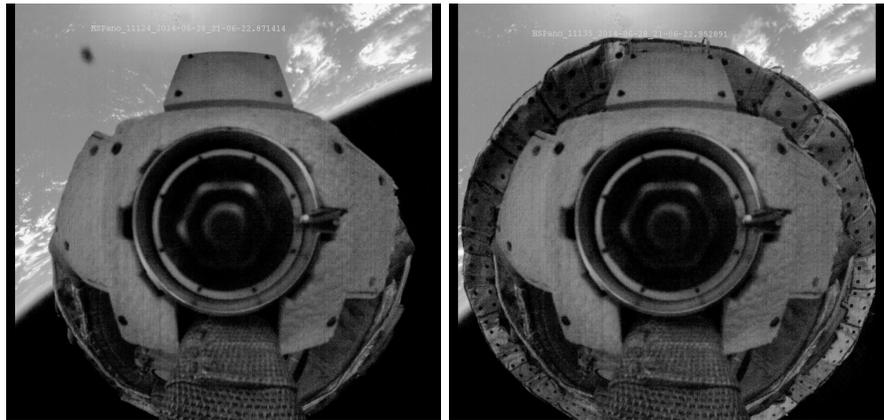
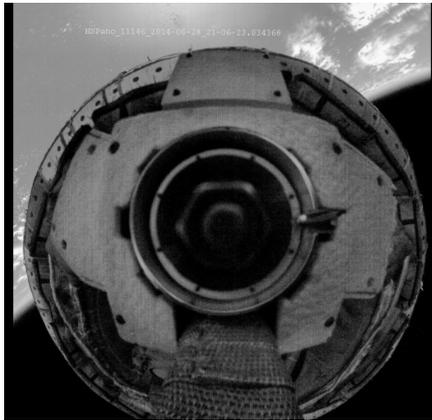
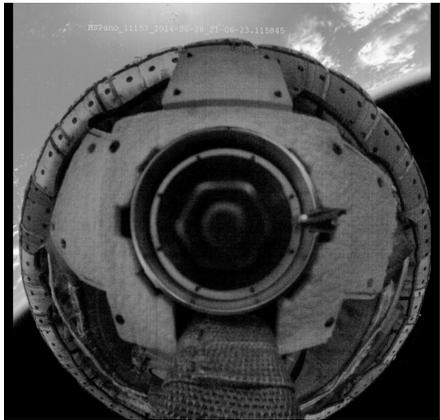
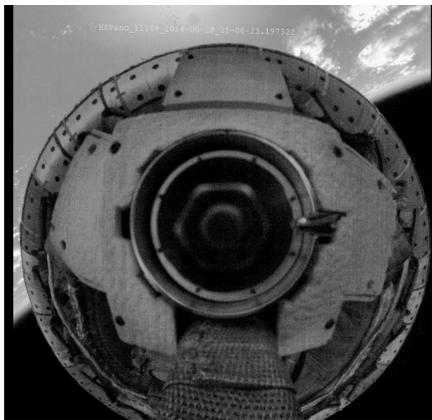
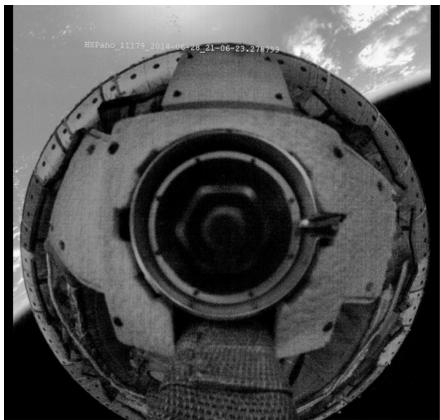
Figure 17. Progression of SIAD inflation from a complete stowed state (a) to a visibly rigid shape (f), progressing in 81.48 ms increments.

Initial emergence of the SIAD was observed to be relatively uniform with no significant asymmetries in geometry observed. Although some flagging of the SIAD is visible from the onboard cameras, it was not easily distinguishable from general inflation and it persisted only until the hot gas gg's were fired, at which point the SIAD appeared effectively rigid. Vehicle motions during deployment were also seen to be negligible, and post-SIAD inflation vehicle dynamics indicated that the SIAD had provided an overall reduction in vehicle oscillations. The progression of the SIAD from a stowed configuration to fully deployed is shown in Figure 17.

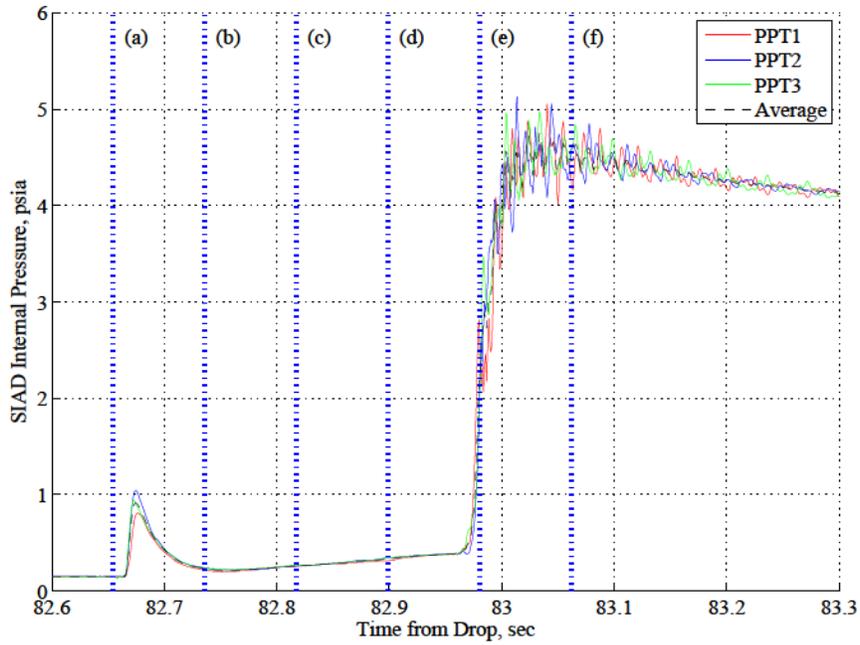
Figure 18. SIAD internal pressure history during initial moments of inflation. Vertical blue lines and associated letters correspond to subimages shown in Figure 17.

A trio of internal pressure transducers recorded the initial rise in pressure associated with the cold gas gg's to a value of approximately 1 psia and later rise from the hot gas gg's to a peak value of about 4.5 psia. Pressure traces from each are shown in Figure 18. After peaking, the inflation gas began cooling and subsequently the pressure decreased to a rough steady state value of around 3 psia. Pressure decay from that point was relatively minor with the SIAD losing less than 0.5 psia over the next three minutes.

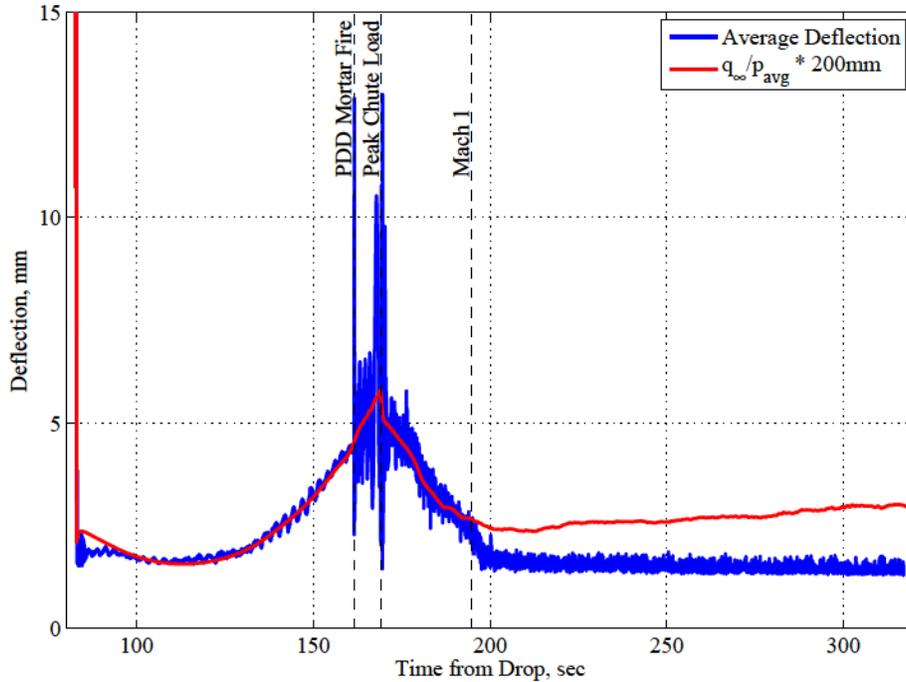
Figure 19. Average deflections of the three LEDs compared to a scaled ratio of freestream dynamic pressure and average internal pressure.

A summary of the deflections measured during SIAD flight is shown in Figure 19 along with a linear correlation with dynamic pressure. The linear correlation holds very well up until transonic and subsonic conditions, after which the deflection is nearly constant. This result is likely associated with a change in aftbody pressure on the SIAD that occurs as the vehicle goes subsonic and thus a differing aerodynamic torque on the SIAD.

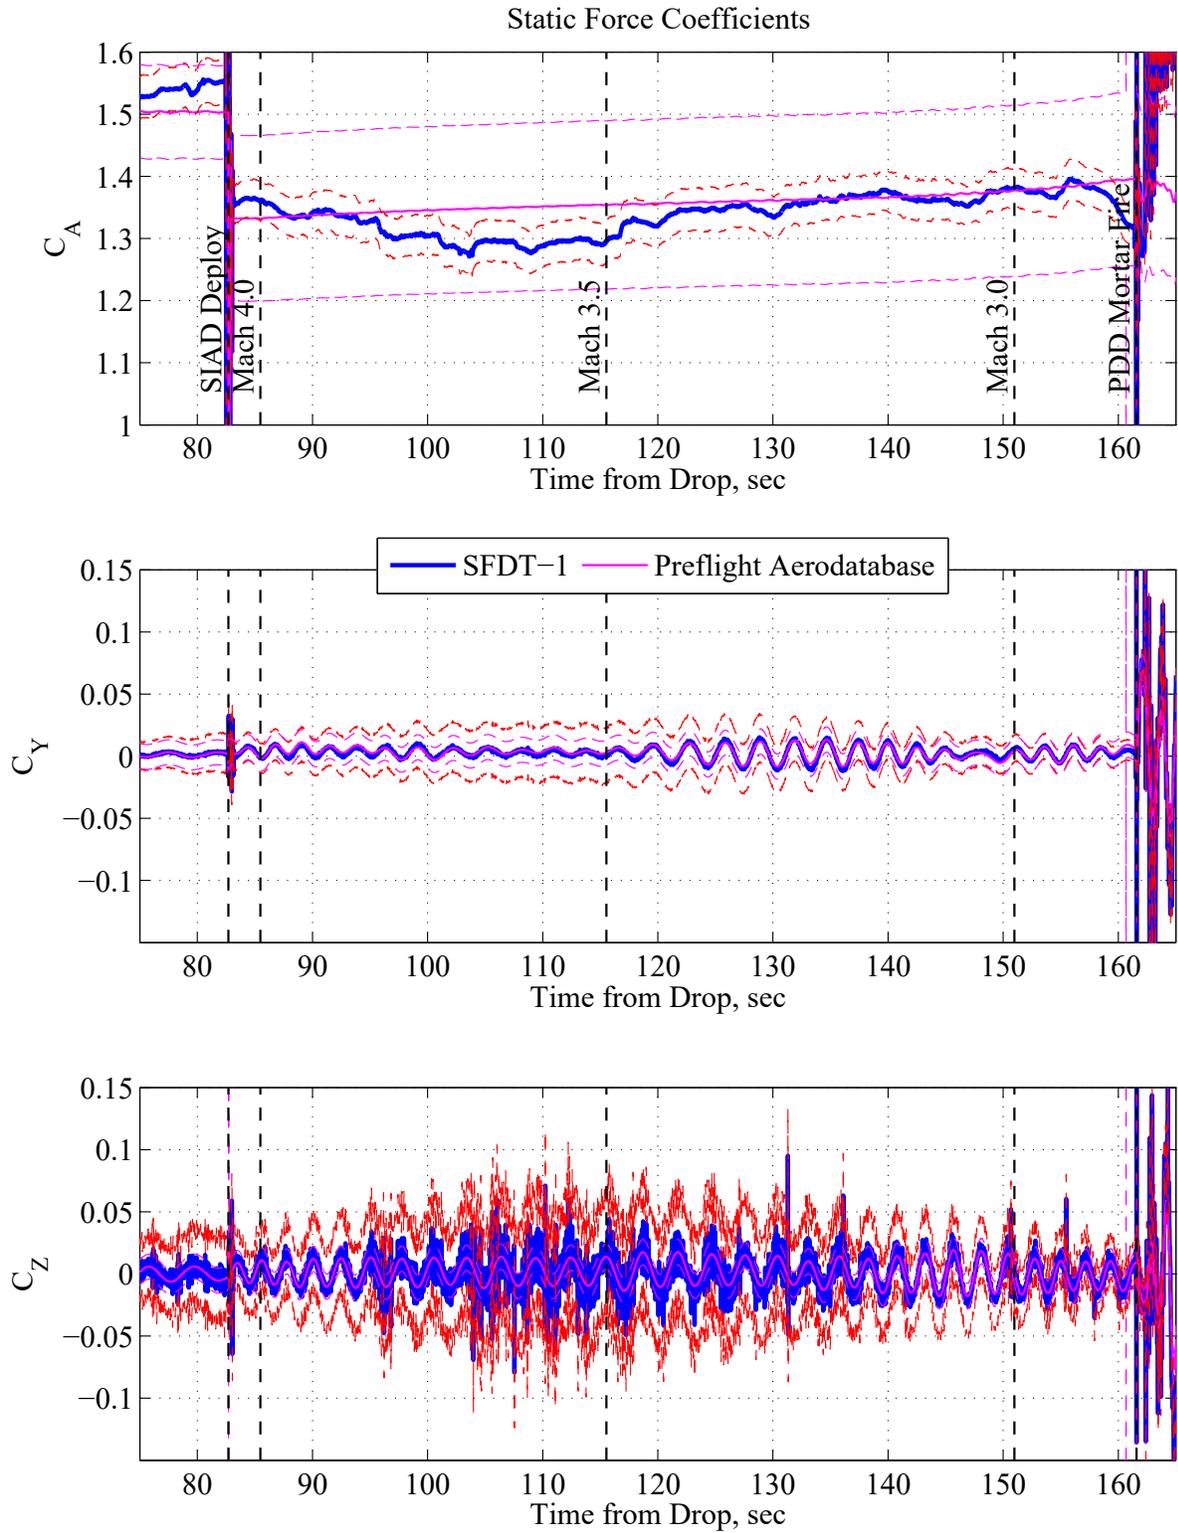
Figure 20. Reconstructed and preflight aerodatabase static force coefficients during SIAD flight. Dashed red lines correspond to the 3σ uncertainty values from reconstruction.

Overall agreement with axial force coefficient predictions is excellent and generally within a few percent. The largest deviations occur as the vehicle is reaching apogee and may be due to the aerodatabase generally being constructed from CFD analyses conducted for lower altitude conditions. The reconstructed side force coefficients also shows excellent agreement, however, the signal to noise ratio in vehicle accelerations in those axes is significantly lower than for axial forces and the uncertainties associated with the reconstructed values are relatively large. A similar situation is evident in the moment coefficients, where there is excellent agreement between nominals, though the reconstructed uncertainties are large percentages of the nominal value.

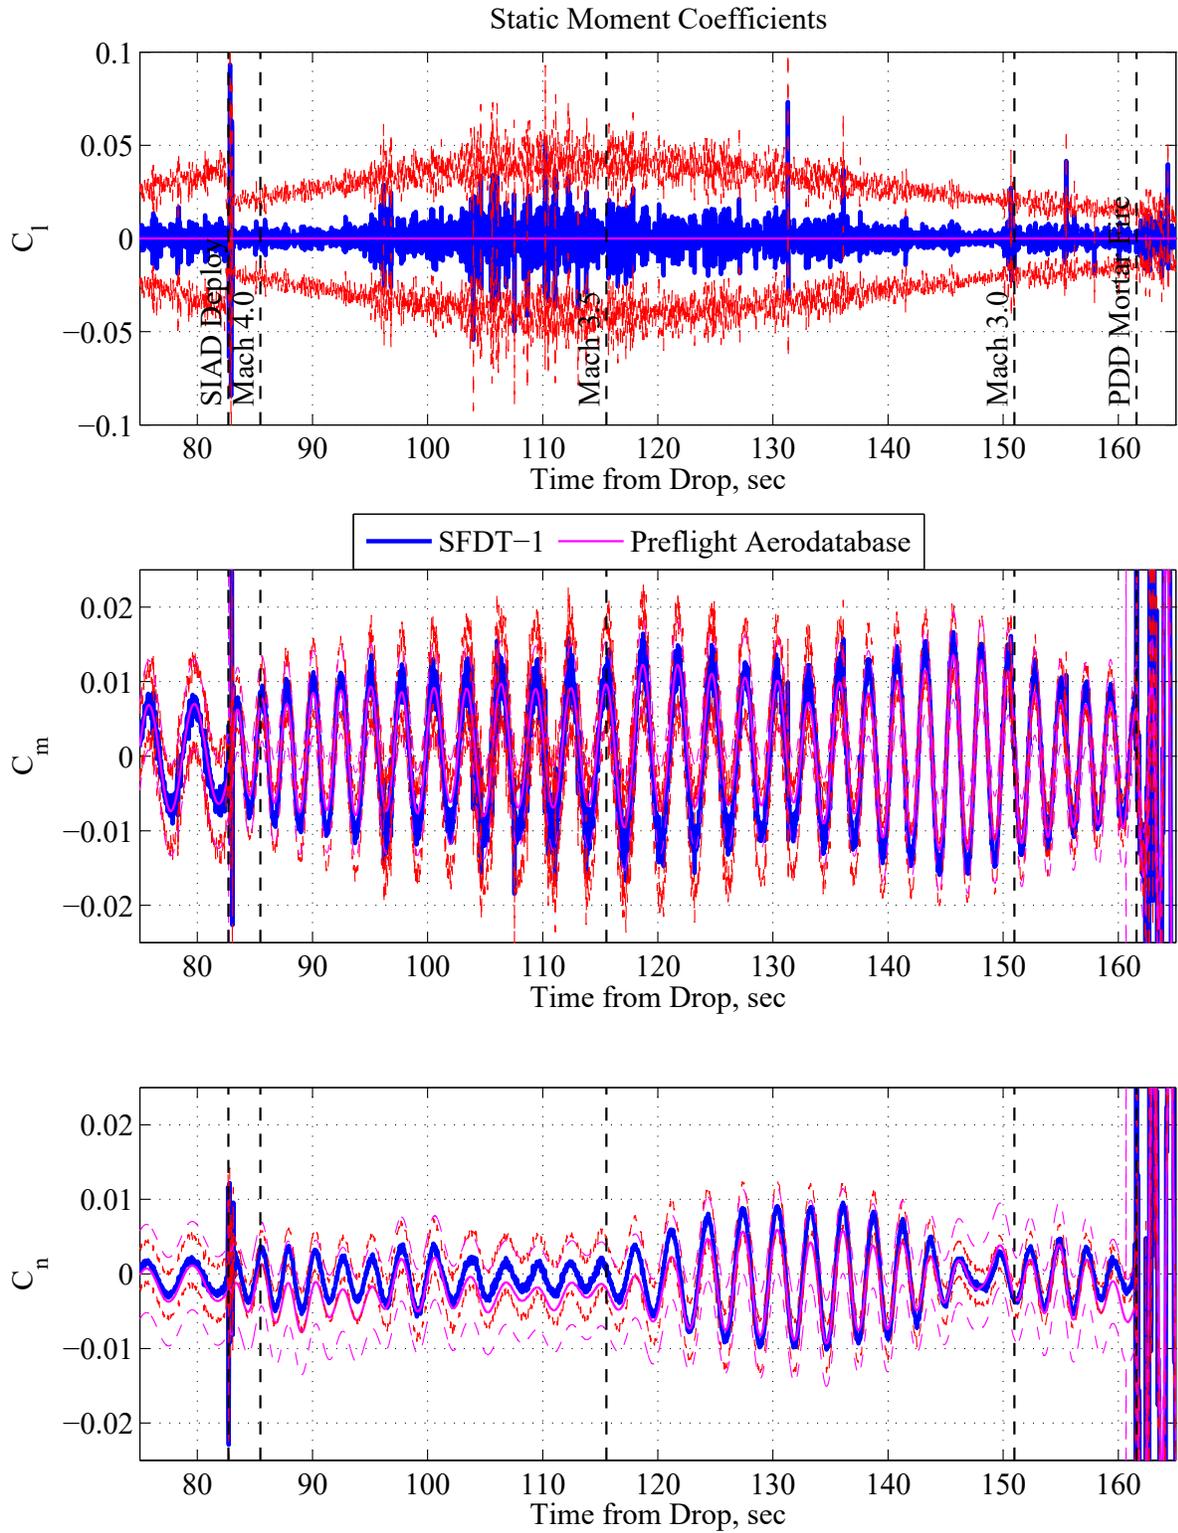
Figure 21. Reconstructed and preflight aerodatabase static moment coefficients during SIAD flight. Dashed red lines correspond to the 3σ uncertainty values from reconstruction.

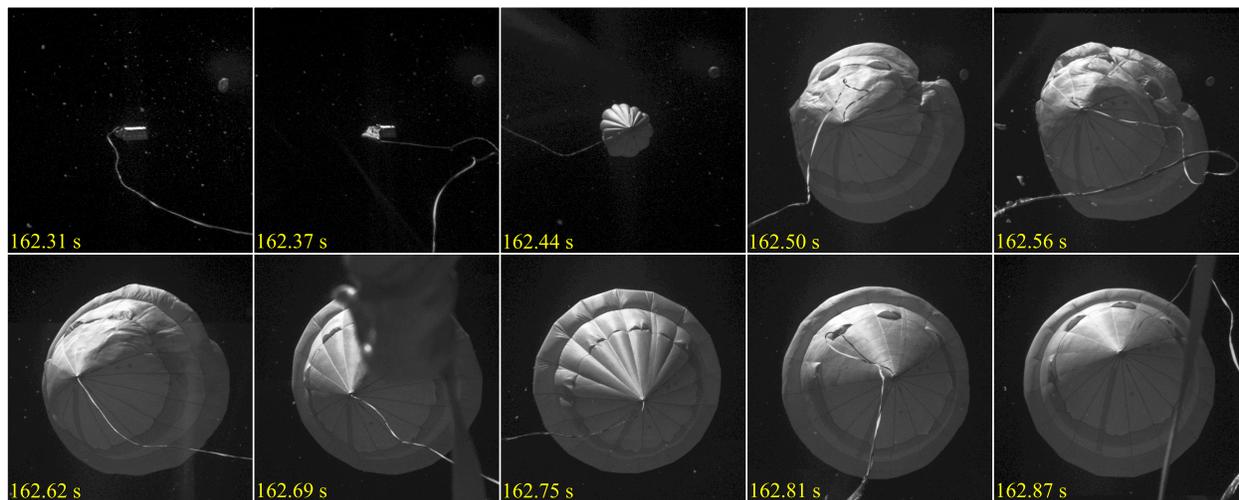
Figure 22. Ballute inflation sequence as shown from just prior to line stretch to full inflation. The reconstructed seconds from drop is indicated in each image.

As mentioned previously, ballute inflation was initiated at line stretch by the use of an inflation aid containing an aqueous water/alcohol mixture. After initial inflation, ram-air inlets are exposed to the oncoming flow to provide the remaining pressurization and to help maintain pressurization as dynamic pressure changes. The ballute inflation process is shown in Figure 22 from just prior to line stretch to full inflation. Post-test estimates of the inflation aid performance using known flight conditions calculated that the inflation aid provided nearly all of the initial pressure necessary to inflate the ballute. However, because the ballute stayed fully inflated during flight and was recovered inflated from the ocean, it is believed that the ram-air inlets were effective. Furthermore, imagery shows the eight raised inlets to be fully deployed and pressurized during ballute operation.

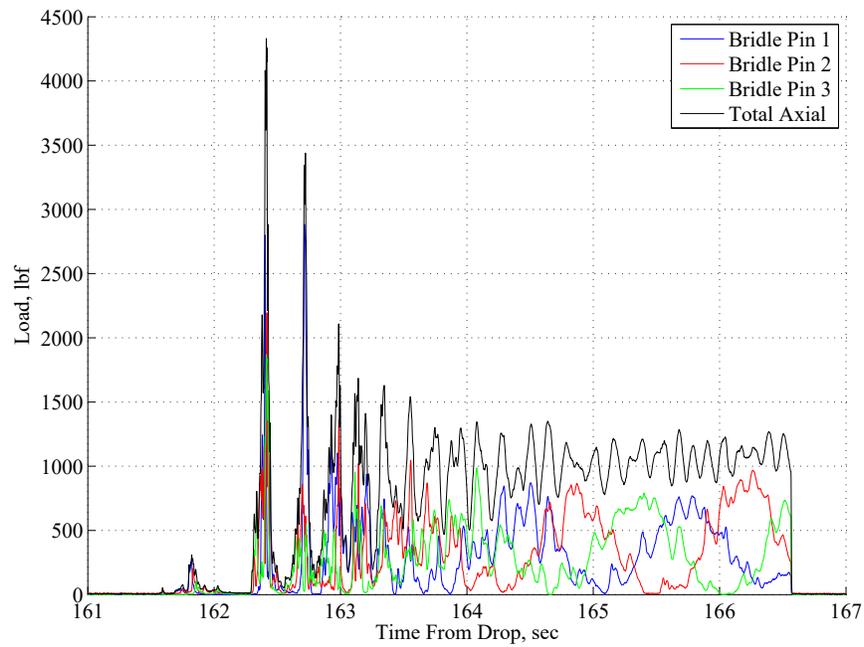
Figure 23. Ballute load history. The first force peak near 161.8 seconds is the triple bridle standup snatch.

The dynamics of the ballute after inflation were characterized by initially large pitch and yaw rotations of the ballute and oscillatory loads that damped out over a few seconds. The ballute trails the maximum diameter of the inflated SIAD by 42 m, or 7 forebody diameters, and the ballute resides in a highly turbulent, blunt body supersonic wake environment. Thus, some dynamic motion was expected from the ballute. Load cell data from the ballute, shown in Figure 23, shows several large initial peaks associated with high snatch forces as the ballute initially inflated and subsequently rebounded. These damped out and eventually an average ballute force of approximately 1000 lbf was measured.

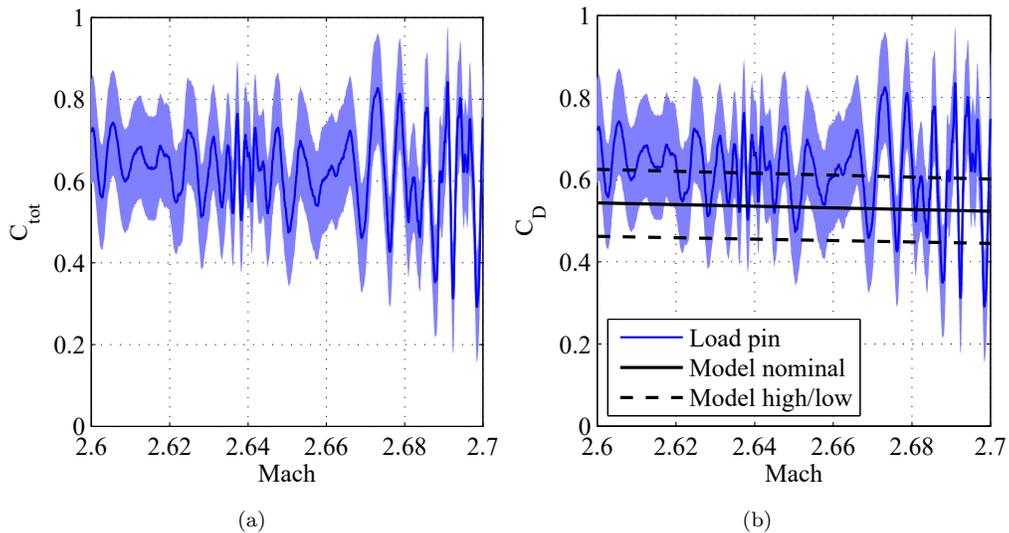
Figure 24. Ballute total force coefficient (C_{tot}) reconstructed from load pin measurements, and pre-flight predicted ballute drag coefficient (C_D) as a function of wind-relative Mach number for the last 3 seconds of ballute flight. The shaded regions indicate the 3σ confidence interval on C_{tot} , and the dashed lines indicate the high and low bounds in the preflight C_D prediction.

The load pin data was used to calculate a ballute total force coefficient and drag coefficient, where the former is the force acting along the pull direction of the ballute and the latter is the force in the wind relative direction. This data, as a function of Mach number, is shown in Figure 24. The calculated drag coefficient was generally higher than pre-flight CFD estimates. Early analysis of the data indicates that this is likely due to the stability of the ballute and its position in the wake of the test vehicle. Specifically, the pre-flight drag estimates were based on CFD of the ballute in the wake centerline, where the dynamic pressure deficit is largest. Analyses of the ballute at small angles of attack had been run and shown that the ballute would have a large restoring force to push it back to the centerline. During the flight the ballute did not fly precisely on the centerline and pull angles of between 5 and 10 degrees were measured. At those angles, the ballute would have seen a higher local dynamic pressure environment and thus provided more drag.

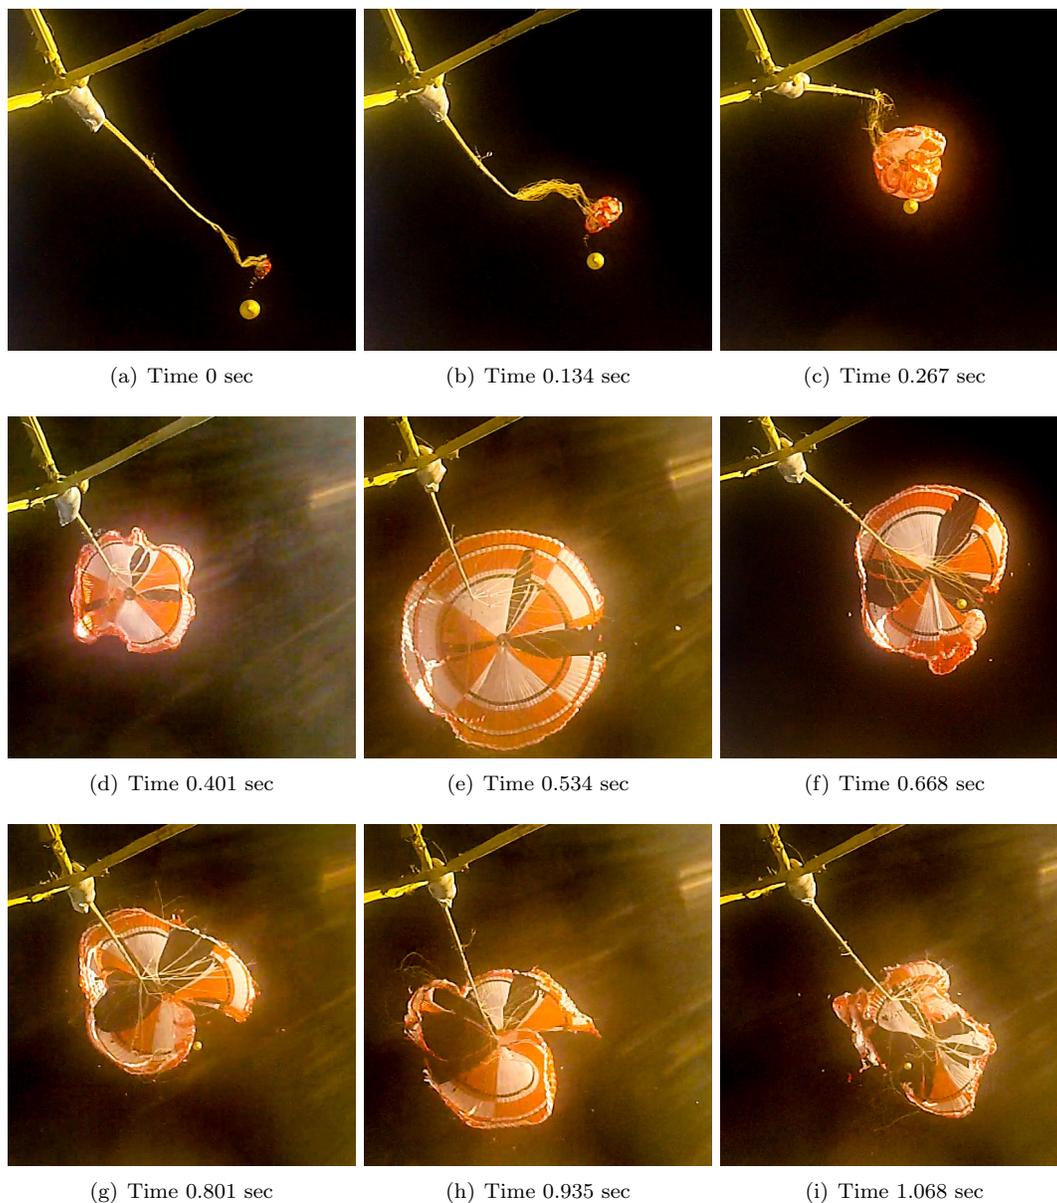
Figure 25. Image sequence during canopy inflation. Note that the time reference is arbitrary.

Initial inflation of the parachute, shown in Figure 25 appeared to proceed in a manner typical of low-density supersonic inflation with very fast initial motions, significant line dynamics, and elements of asymmetrical inflation visible. However, very early on in the inflation process canopy damage is visible and the tears propagate further until at peak inflation the canopy has significant damage throughout. The canopy continued to destroy itself over the next second.

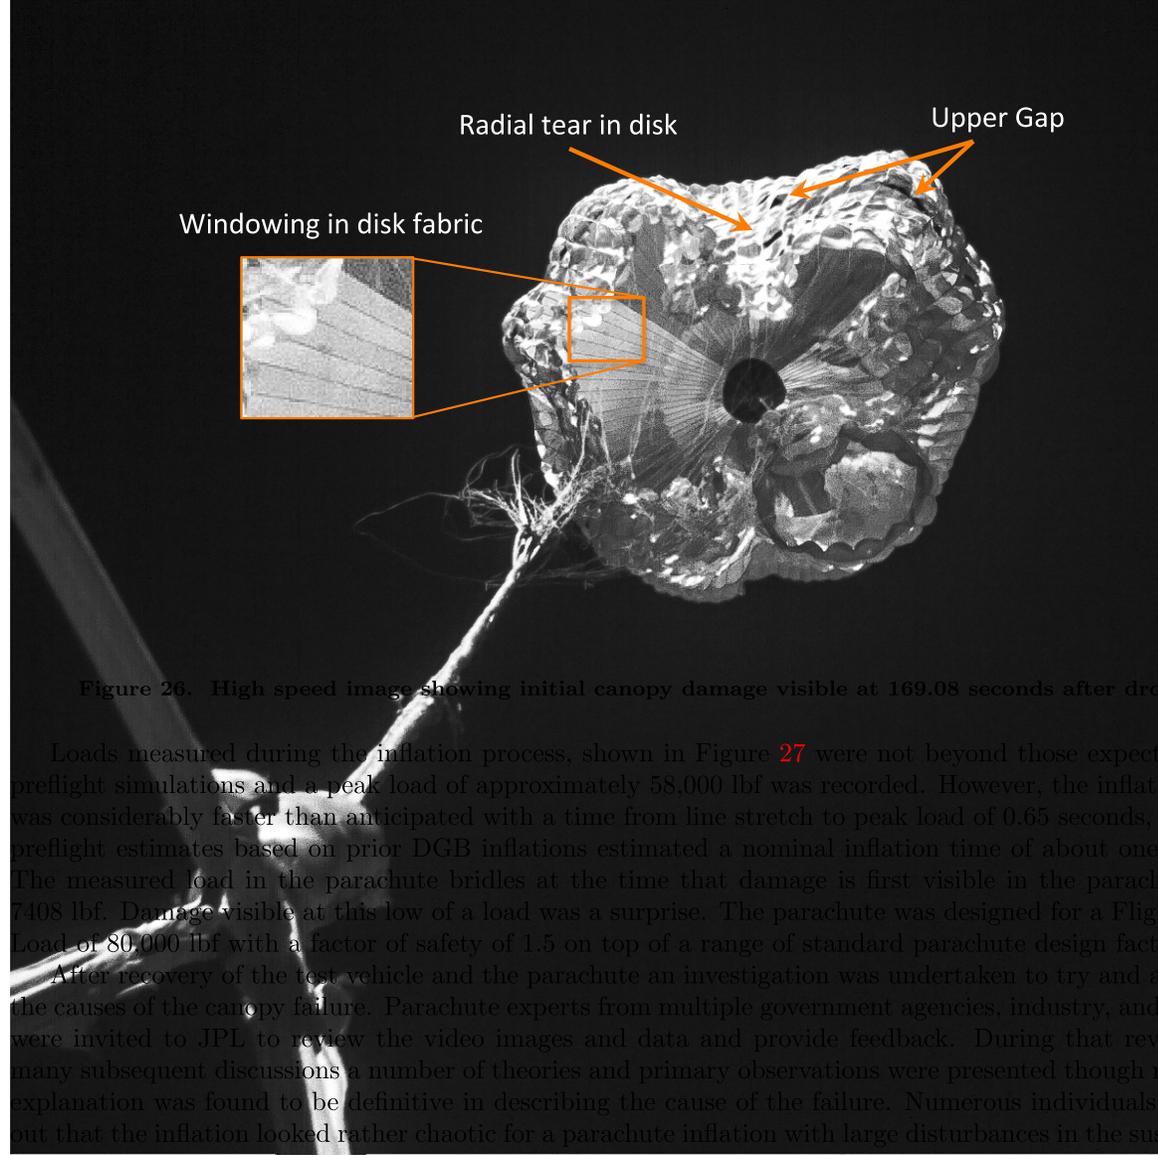
Figure 26. High speed image showing initial canopy damage visible at 169.08 seconds after drop.

Closer inspection of the high speed imagery captured during flight indicated that the initial location of damage appeared in the disk region of the parachute (see Figure 26) and quickly propagated radially towards the vent and to the edge of disk. At the time of initial damage visibility, windowing in the disk fabric can also be identified and later frames showed the windowing transitioning to more significant radial tears. By the time of the final frame, the damage had propagated to the edge of the disk, with

- **Line Entanglement:** During the inflation of the parachute some hesitation in the skirt of the canopy was observed and is visible in the lower right of Figure 26. From the video, it appeared that there have been a momentary snag in either the leading edge of the skirt or in the suspension lines in that region. The canopy would eventually recover and inflate fully in that region, but the possibility remains that the snag helped contribute to asymmetry and augmentation of stresses within the canopy.
