Summary of the First High-Altitude, Supersonic Flight Dynamics Test for the Low-Density Supersonic Decelerator Project

NASA's Low-Density Supersonic Decelerator Project is developing and testing the next generation of supersonic aerodynamic decelerators for planetary entry. A key element of that development is the testing of full-scale articles in conditions relevant to their intended use, primarily the tenuous Mars atmosphere. To achieve this testing, the LDSD project developed a test architecture similar to that used by the Viking Project in the early 1970's for the qualification of their supersonic parachute. A large, helium filled scientific balloon is used to hoist a 4.7 m blunt body test vehicle to an altitude of approximately 32 kilometers. The test vehicle is released from the balloon, spun up for gyroscopic stability, and accelerated to over four times the speed of sound and an altitude of 50 kilometers using a large solid rocket motor. Once at those conditions, the vehicle is despun and the test period begins.

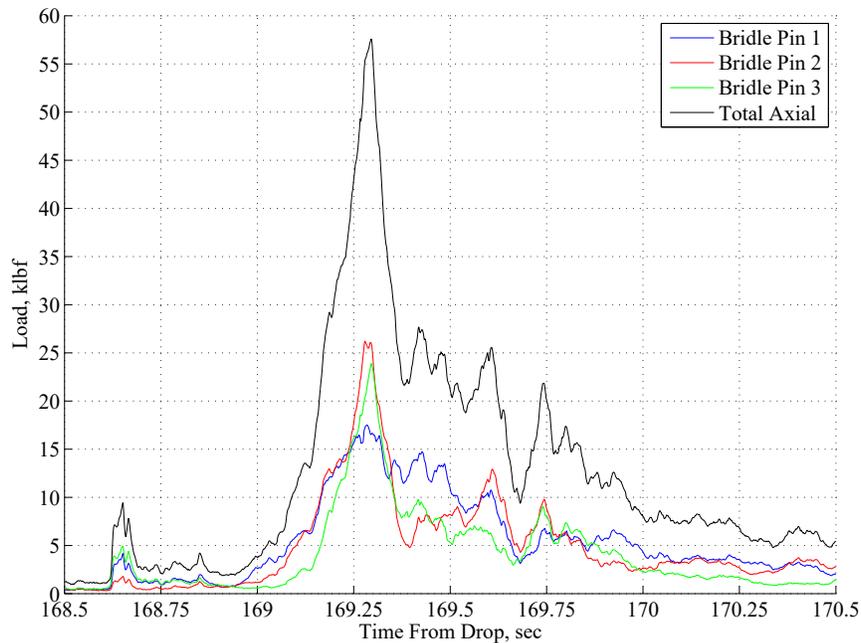
Figure 27. Measured parachute bridle loads during inflation.

Loads measured during the inflation process, shown in Figure 27 were not beyond those expected from preflight simulations and a peak load of approximately 58,000 lbf was recorded. However, the inflation time was considerably faster than anticipated with a time from line stretch to peak load of 0.65 seconds, whereas preflight estimates based on prior DGB inflations estimated a nominal inflation time of about one second. The measured load in the parachute bridles at the time that damage is first visible in the parachute was 7408 lbf. Damage visible at this low of a load was a surprise. The parachute was designed for a Flight Limit Load of 80,000 lbf with a factor of safety of 1.5 on top of a range of standard parachute design factors.
