Soil Moisture Active and Passive (SMAP) White-Painted Expanded Polystyrene (EPS) Radome Survivability Test

Rebecca Mikhaylov¹, Eug Kwack², Matthew Stegman³, Douglas Dawson⁴, and Pamela Hoffman⁵
Jet Propulsion Laboratory, California Institute of Technology, Pasadena, California, 91109

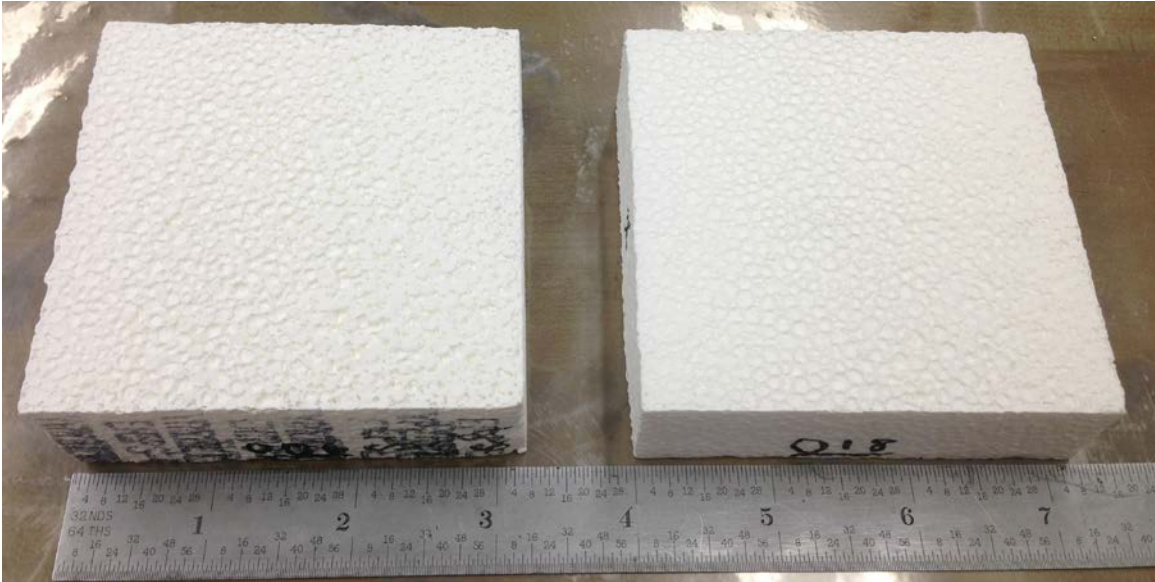
Figure 2. EPS Test Article (two coupons)

The test article was two coupons from the flight radome paint process (Figure 2). Each coupon was 3.25”L x 3.25”W x 1” D. White paint was applied at the same time as the flight radome unit. The coupons had not been subjected to any additional thermal tests.

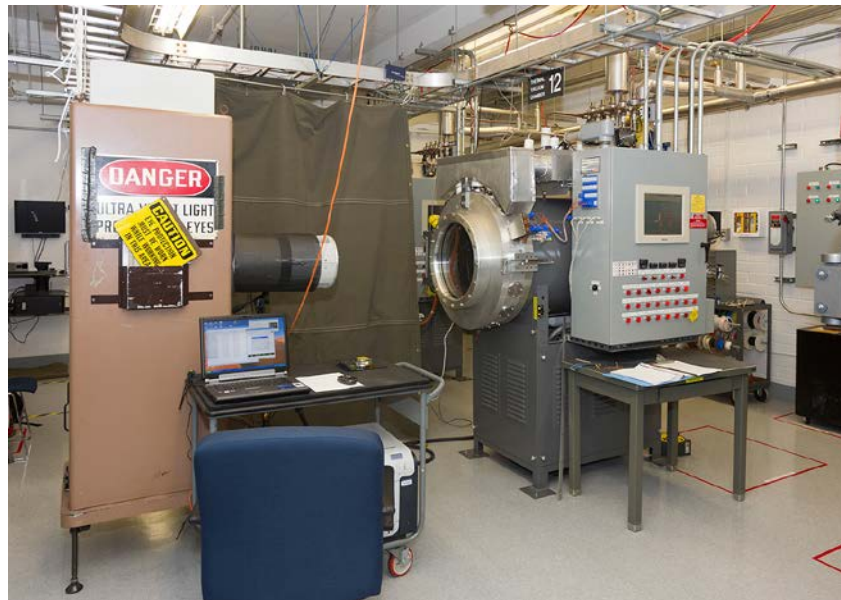
Figure 3. Side view of solar simulator and thermal vacuum chamber

A portable solar simulator illuminated the test article through the quartz window of the vacuum chamber (Figure 3). The Spectrolab X-25 Solar Simulator beam is capable of producing up to 2.5 solar constants and includes a filter that produces a square illumination of approximately 9” x 9” at the 17.75” diameter Quartz window cover location. The beam irradiance was kept nearly constant (near 1725 W/m² at the center of beam) during the entire 50 hour test except during the first hour which simulated the expected 79 °C on-orbit surface temperature of the radome.

Thermocouples were utilized to monitor temperature throughout the test. Additionally, a Nikon D2X DSLR camera running on a power supply captured time-lapse photographs at one frame per minute for documentation purposes using a laptop PC as the intervalometer (Figure 3). The images were used to examine any color and dimensional changes during the test and to produce a Quicktime movie which plays back in 100 seconds at the standard rate of 30 frames per second.

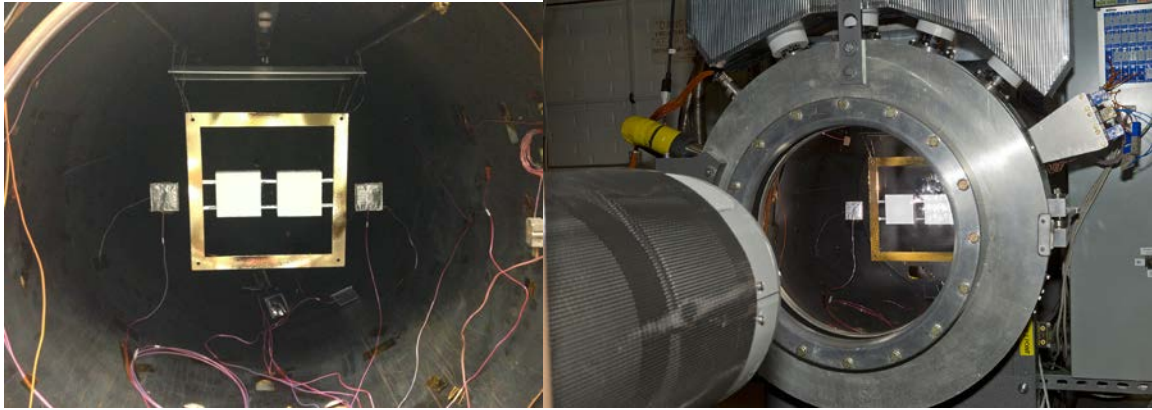
Figure 4. Test Article set-up within thermal vacuum chamber

The test article was mounted within a frame. The frame was then hung from the chamber rail using fixed length wire along with two calibration targets positioned at the same depth from the chamber door (Figure 4). The radome
