45th International Conference on
Environmental Systems

Soil Moisture Active and Passive (SMAP) White Painted Expanded Polystyrene (EPS) Radome Survivability Test

Rebecca Mikhaylov, Dr. Eug-Yun Kwack,
Matthew Stegman, Douglas Dawson, and
Pamela Hoffman

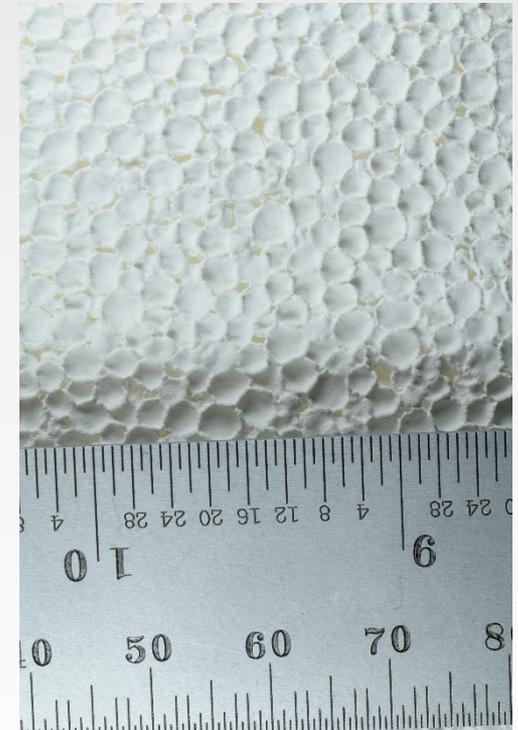
SMAP Radome Background

- Radome (50cm diameter, 10cm thick) at the mouth of feedhorn to prevent solar entrapment
- EPS (Expanded Polystyrene) was used because light weight and transparent to RF signal (or low RF absorptivity)
- White paint (S13GP:6N/LO-1) was baselined due to the fast degradation of bare EPS solar absorptance
- Large surface irregularities (wells, pinholes) were produced during paint application due to the rough surface of bare EPS caused by mechanical cutting (instead of laser cutting)
- These surface irregularities may result in localized hot spots which could exceed the EPS glass transition temperature (starts at 96°C) under the worst-case scenario of a no-spin fault condition at the end of mission

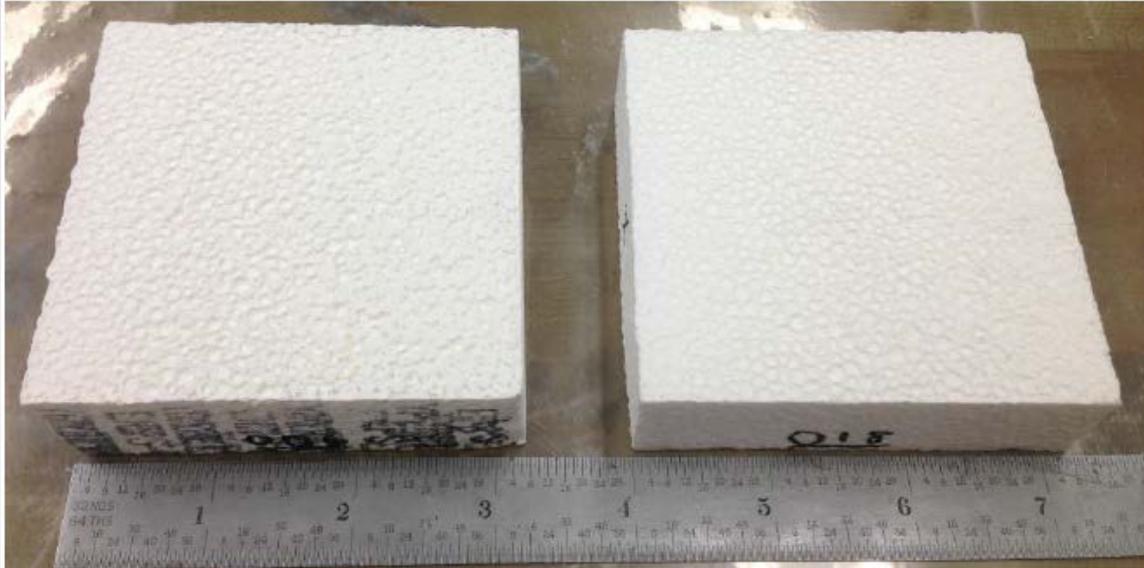
Test Article

- Two coupons from the flight radome paint process
 - White paint was applied at the same time as the flight radome unit
 - The coupons had not been subjected to any additional thermal tests
- Each coupon was 3.25”L x 3.25”W x 1”D

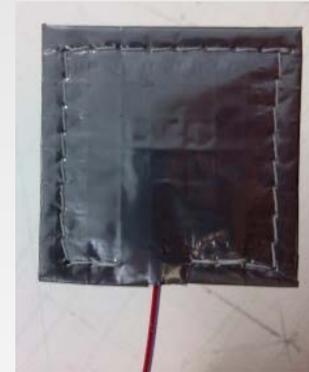
Calorimeter
(Germanium Kapton)

- Calorimeter
 - Front Face: Germanium Kapton
 - Thermocouple attached at the back of the front sheet
 - MLI on the back

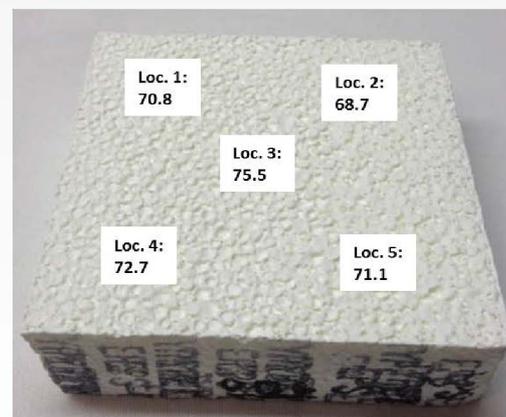
Test Results: Optical Property Measurements

- No optical property change
 - Minor changes may be attributed to measurement source error as well as the inability to repeat the exact measurement location with the source sensor (and size differences in the pinhole/well/cavity seen by the sensor at those two slightly different locations)

- No EPS color or dimensional changes were visible in the 100 second movie created from photos taken at 1 frame/minute throughout the entire test
- A 2% net decrease in the average solar absorptance of each coupon based on five measurements per coupon

- The suspected cause for this is the location variation of the measurement source sensor in the pre- and post-test measurements
- If any hot spots exist locally, they did not cause any observable permanent deformation when comparing scaled coupon photographs before and after the test

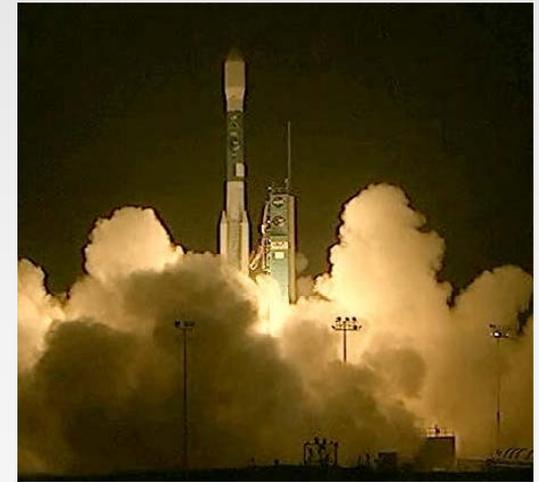
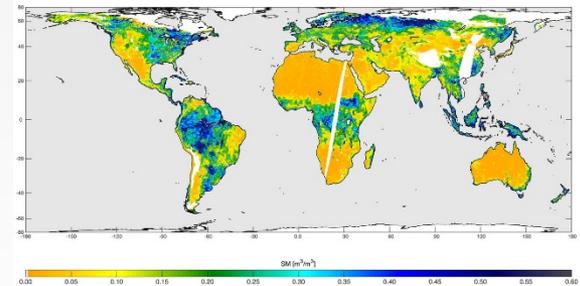
- Launched on Jan 31, 2015
- Spin-up to 14.6 RPM on March 26, 2015
- Completed Commissioning Phase successfully
 - PLAR (Post Launch Assessment Review) on May 6
- 3 safing events but kept spinning
- Good science data and stable temperatures

Radome (and the rest of the observatory) healthy!
