**JPL Publication 17-6**

# **Pisgah Lava Cave Communication Test**

*Science Case Study for the  
Networked Constellations Initiative*

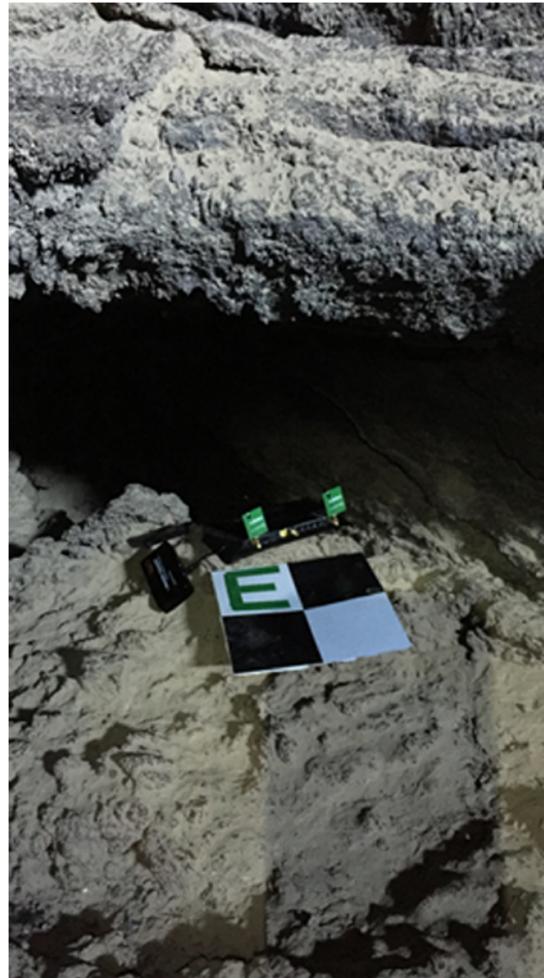
Figure 1. Router location for Test 1.

The router was placed at Checkpoint E, under the cave ceiling between the first and second room (see Figure 1). Two 5 GHz chip antennas were connected. Since only two such antennas were available, the router's third antennas input was terminated by a 50 Ohm plug. The laptop was located 4 m from the router in direct field of view. The communication was established initially at 5 GHz, but then the connection was lost.

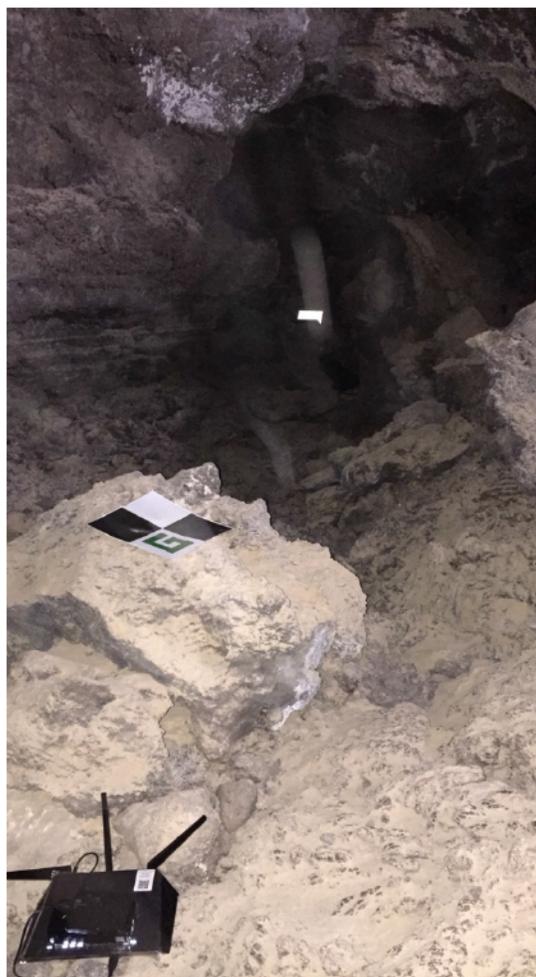
**Figure 2.** Test 10 setup.

The router was placed behind a boulder at Checkpoint G. The laptop was on the rock next to Checkpoint F with no direct FOV to the router. See Figure 2.

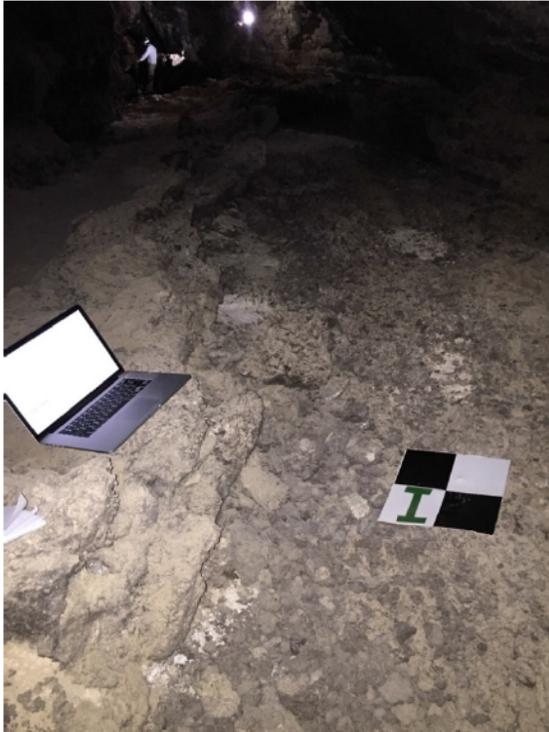
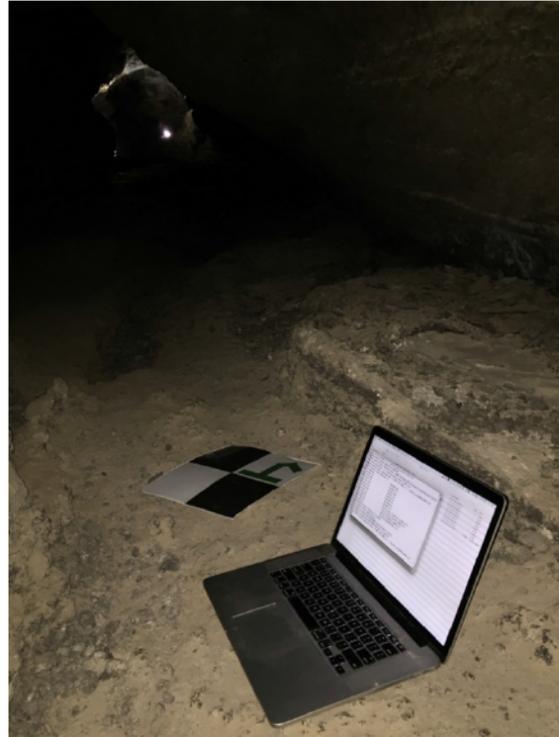
Figure 3. Laptop location for Test 11 (left) and Test 12 (right).

For Tests 11 and 12, the router was placed in the next room inside the cave. In both tests, the router was not in the field of view of the laptop. Test 12 goes deeper into the cave behind the turn. See Figure 3. The results of the tests are in Table 1.

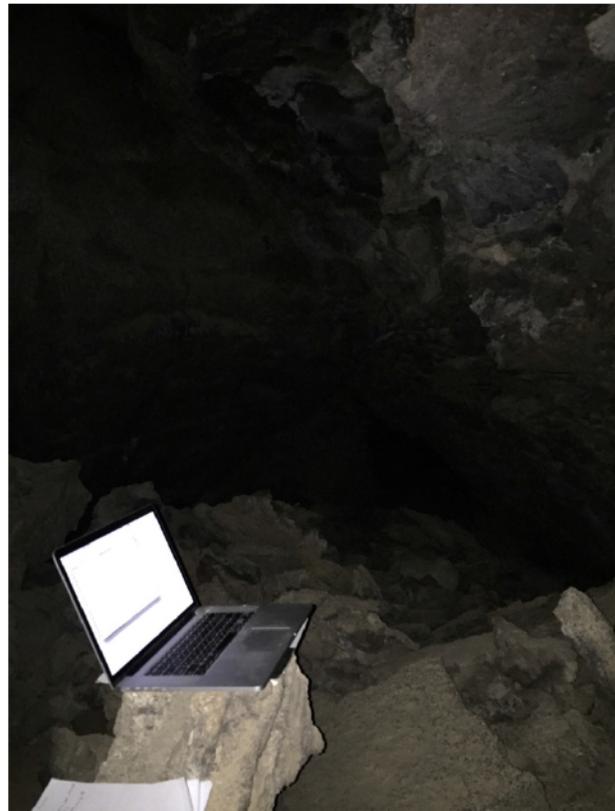
Figure 4. Laptop location for Tests 13 and 14.

These tests were conducted with the router in the same location as in Tests 11 and 12, but the laptop was placed in the last room of the cave, Room 4. In addition to the previous obstruction by the turn and the elevation change, the narrow passage into the room created an additional obstacle for the signal. For Test 14, the router was moved closer to the laptop, to Checkpoint H, but the wall obstruction was still present.

The results of the test are provided in the Table 1, while the laptop location is shown in Figure 4.
