# Creating a Voyager Thermal Model 39 Years Into the Flight Mission, Along With Model Correlation and Application

William C. Ledebor<sup>1</sup>

*Jet Propulsion Laboratory, California Institute of Technology, Pasadena, CA, 91109-8099*

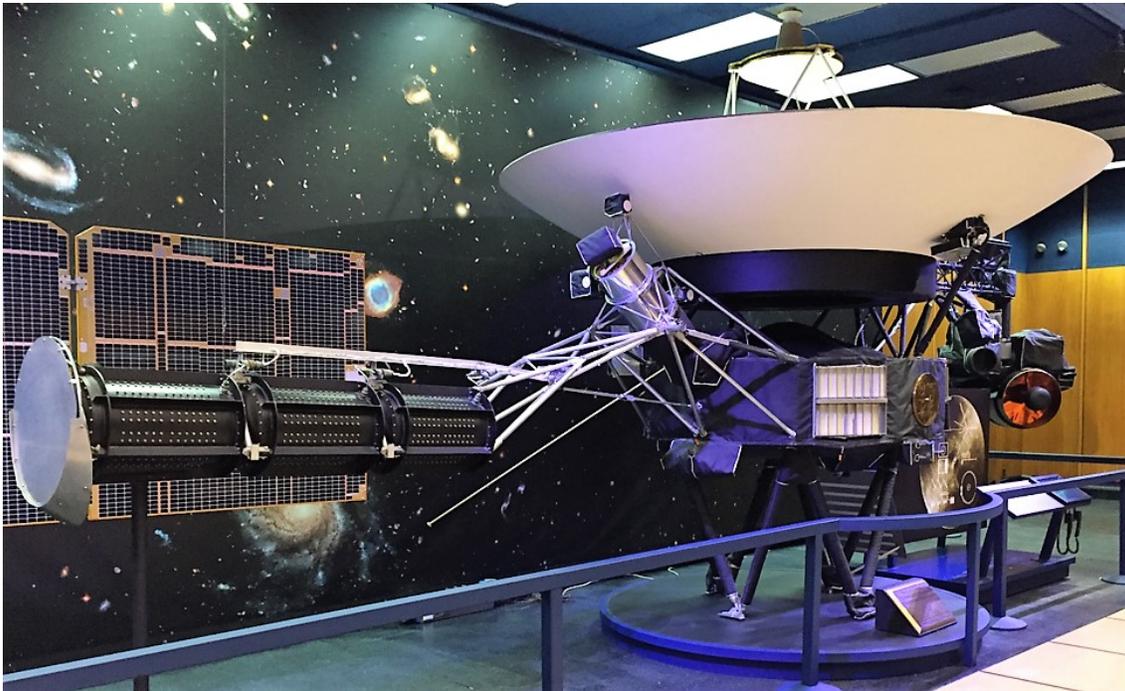
**Figure 1. Full Size Model of Voyager Spacecraft in von Karman Auditorium at JPL. (Photo by author)**

**F**ORTY-ONE years ago, two Voyager spacecraft (see Figure 1) were launched on trajectories to explore the outer planets Jupiter and Saturn. After successful encounters with their primary targets, Voyager 1 was targeted toward the edge of the Solar System, while Voyager 2 was navigated to encounters with the other gas giants, Uranus (1986) and Neptune (1989) before heading for interstellar space.

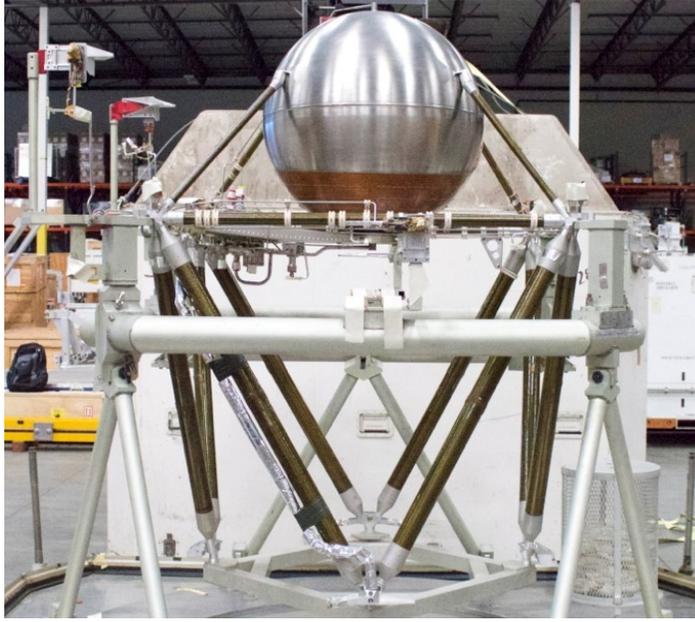
**Figure 9. Voyager TCAPU Flight Spare.**

On 17 March 2015, the Voyager Project Administrator received e-mail stating, “This image is of an old container that is in storage and has been there for about 30 years” (See Figure 8). A trip was arranged to the storage facility to open the container and inspect its contents. It turned out to be an assembly of Voyager TCAPU flight spare hardware (See Figure 9).
