# Regolith Particle Erosion of Material in Aerospace Environments

**Abstract**— This paper studies the effect of exposing thermal control S13GP:6N/LO-I white paint, Kapton flex cable, fiber optic cable, HEPA filter, and M55J graphite composite to high-velocity regolith environment that spacecraft landing on Mars are commonly exposed to. Due to the similarity between the Mars 2020 Rover design and Mars Science Laboratory design, it is expected that the Mars 2020 rover will be exposed to a similar high-speed regolith environment that the Mars Science Laboratory was exposed to. This environment is replicated to test the survivability of susceptible materials. The testing is performed at the University of Dayton Research Institute in Dayton, Ohio. The experiments expose different materials to basaltic-like particles ranging in size from approximately 40  $\mu\text{m}$  to 2 cm, at velocities ranging from 19 m/s to 250 m/s, with varied particle fluxes (measured in  $\text{mg}/\text{cm}^2$ ). Depending on the size of the particle used, the particles can either embed in or erode the material. Post-test analysis shows that all materials tested will survive the expected environment observe

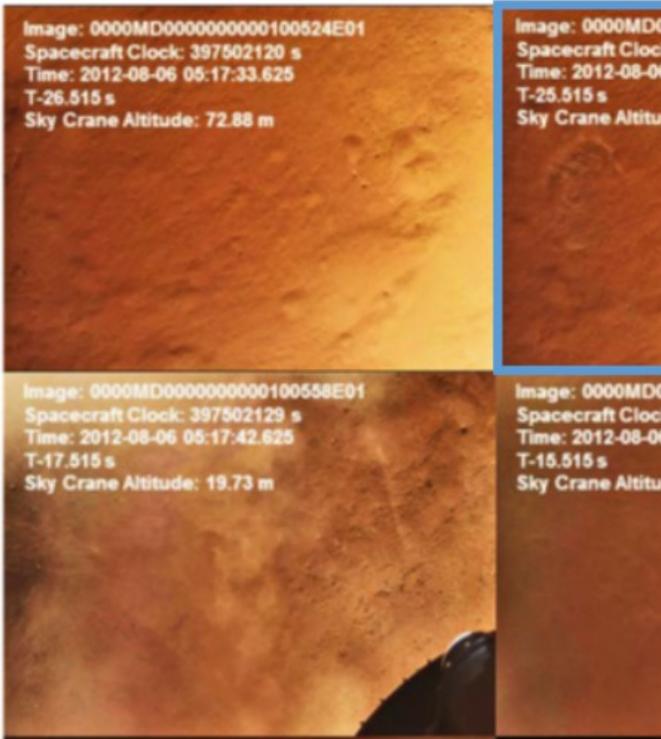
Fig. 1. MSL EDL Instrument (MEDLI) suite camera images showing the MLE plumes starting to erode Martian regolith at approximately 63 meters above the surface (blue square) [1].

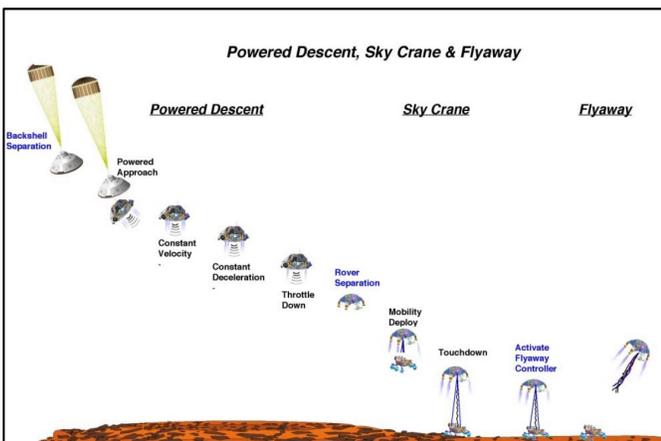
Fig. 2. The MSL Entry, Descent, and Landing (EDL) sequence [3].

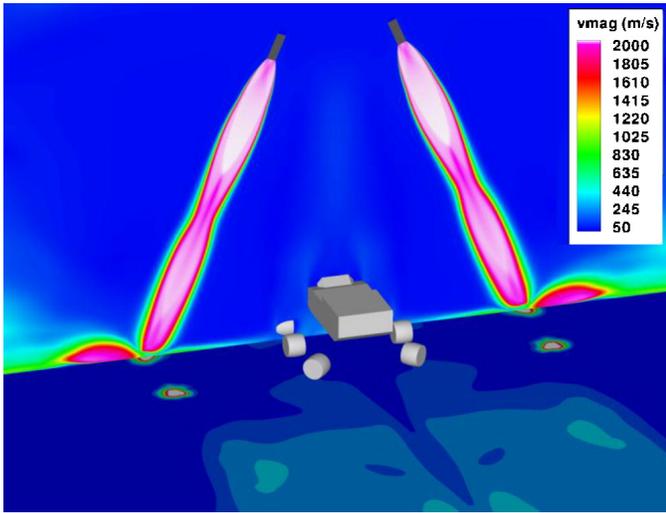
Fig. 3. CFD simulations demonstrating plume-plume interactions and plume-rover interaction [2]. The color scale represents gas velocity.

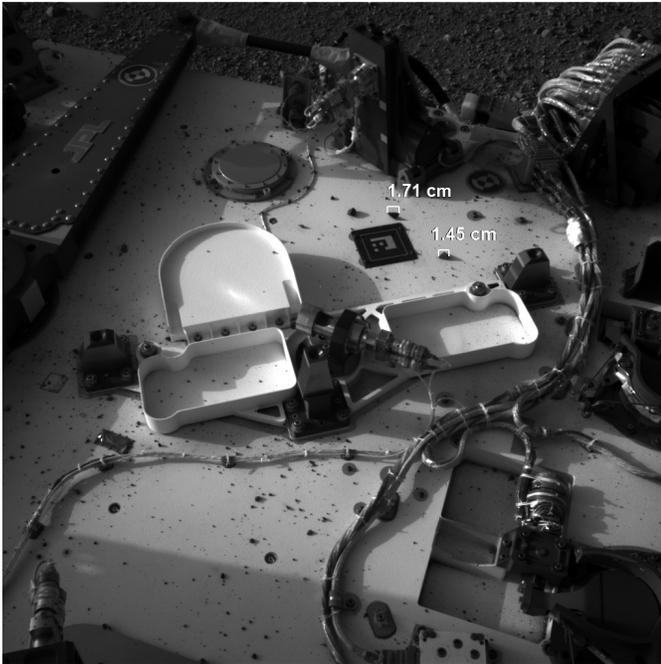
Fig. 4. Images taken by MSL on Sol 2 show the top deck scattered with particle debris after landing, some almost 2 cm in diameter [4].

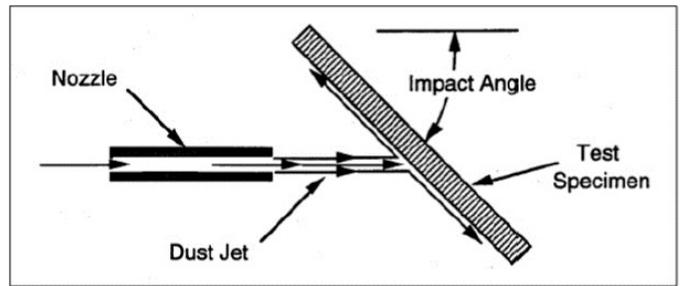
Fig. 5. Schematic for the Particle Erosion Rig [10].

The Particle Erosion Rig is used for testing helicopter rotor blades per MIL-STD-3033 [9], and the set up is modified for the M2020 test. The Particle Erosion Rig uses pressurized gas to accelerate a constant stream of particles through a nozzle towards a test sample (Fig. 5). A Laser Doppler Anemometer (LDA) setup is used to measure particle velocity. This test apparatus allows the particle velocity, particle size, impact angle, and mass loading to be varied as desired. Mass loading is defined to be the total mass of particles that impact a test article per unit area (which is a function of particle mass loading, velocity, and time), and has units of mass per unit area. In this work  $\text{mg}/\text{cm}^2$  are used for convenience [10]. The gravelometer is generally used for testing motor vehicle coatings per ASTM D1370 [11], and uses pressurized gas to accelerate a steady stream of particles up to speed before they impact samples (Fig. 6). However, for the M2020 test, the gravelometer equipment was altered from the ASTM standard and the LDA was used to measure the velocity of the particles. The Gas Gun uses pressurized air to launch one particle at a time at the sample, using a large barrel in order to launch larger particles (Fig. 7). The particles used in the Gas Gun are shown in Fig. 8. Velocity of the particles from the Gas Gun is measured with LDA as well. Table II compares the media type used for each test.

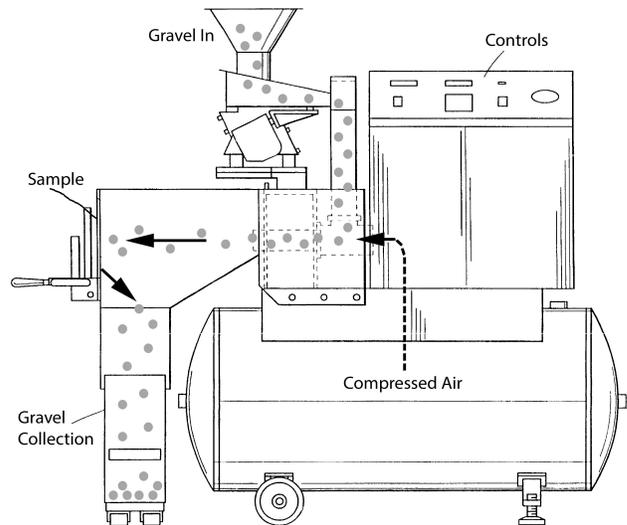
Fig. 6. Schematic for Gravelometer [12].

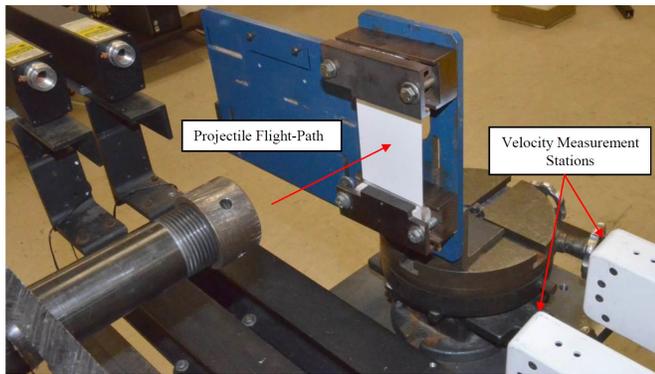
Fig. 7. Test configuration for the Gas Gun with 76.2 mm x 127mm samples.

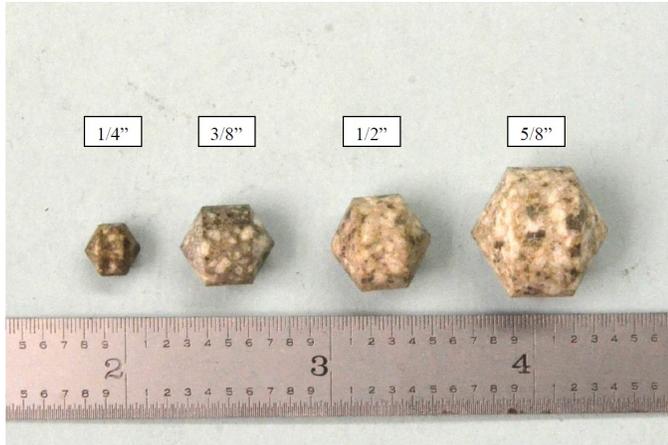
Fig. 8. An image of the various size Tonalite rocks used in the Gas Gun, both ends of the rock are formed to a 118° angle.

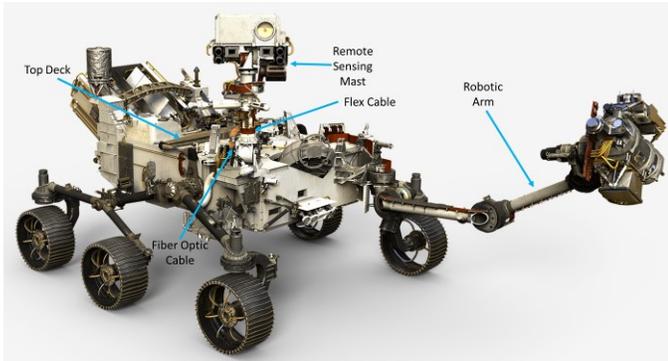
Fig. 9. Overall of the M2020 rover [14].

such as the Remote Sensing Mast (RSM) (Fig. 9), and the robotic arm. Damage to the trace, through either a short circuit or an open circuit, of the flex cable from particle impacts could cause electrical problems for the specific instrument of interest.

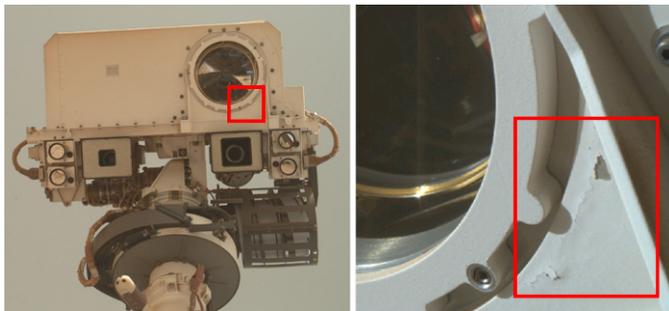
Fig. 10. Images taken MSL showing evidence of the ApteK 2711 chipping [4].

Aptek 2711 was tested along with the S13 in order to act as a control sample to compare current measurements to measurements previously taken in 2008 [3]. The Aptek 2711 samples tested in this campaign have consistent optical properties as the samples measured in 2008 (Fig. 22). However, the mass loss varied significantly between the MSL and current testing, and it is believed that this discrepancy is due to the difference in thickness of paint on the samples from 2008 compared to the current samples. When exposed to the same environment (177-250 micron sand with a velocity of 160 m/s and a 30° impact angle), the Aptek 2711 lost mass more rapidly than the S13. The Aptek 2711 failed cohesively, unlike the S13, leaving a thin layer of inorganic material behind. When exposed to enough mass loading, the Aptek 2711 was completely removed from the aluminum substrate (Fig. 23). On the MSL rover, there is only one documented location where there is evidence of paint damage (Fig. 10), and the cause of this damage is unknown.

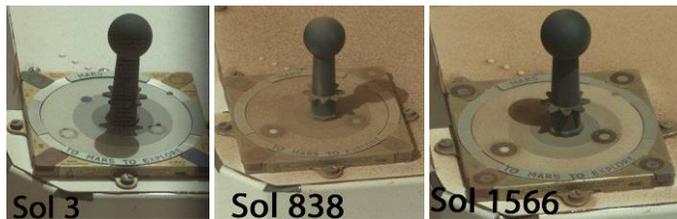
Fig. 11. This series of images taken by MSL of the sundial throughout the mission show particle migration, dust accumulates and then the wind causes the dust to dissipate and this cycle is repeated [4].

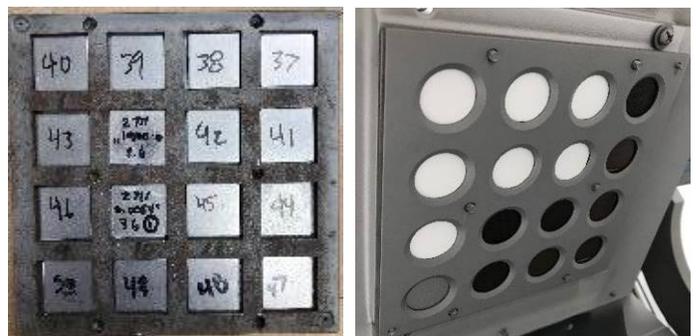
Fig. 12. Test configuration for the 1"x1" samples, front and back. The 1"x1" coupons were placed in a recessed box, with a <1" diameter hole on the bottom

side, which protected the edges of the coupons. Sixteen 1"x1" samples could be tested per run on the Particle Erosion Rig.

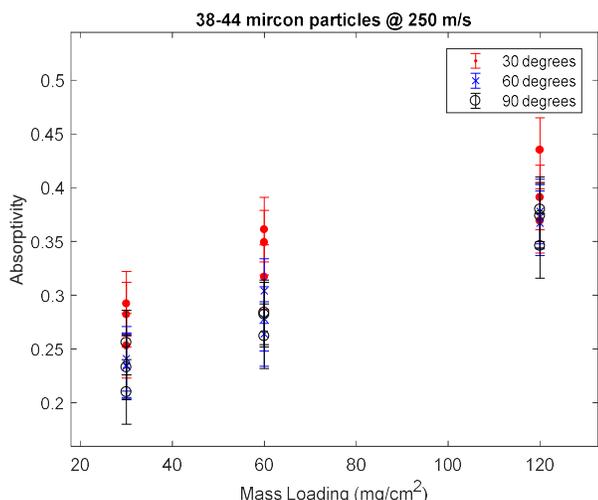
Fig. 13. Absorptivity vs. Mass Loading for 3-44 micron particles traveling at 250 m/s at different impact angles. The rate of change for absorptivity at 30° impact angle is higher than 60° and 90°. The error bars are the error margin of the instrument used, a TESA 2000 (AZ Technology).

Based on the results shown in Fig. 13, 30° was determined to be the worst impact angle, and all subsequent tests were conducted with this angle of impact. At a 30° impact angle, the sand is easily embedded into the soft silicone paint. The embedded particles darken the paint, thus increasing the absorption (Figs 14-15). Fig. 16 shows a graph of  $\alpha/\epsilon$  vs Mass Loading for 38-44 micron particles traveling at 250 m/s. As mass loading is increased, the  $\alpha/\epsilon$  values appear to converge towards a constant value of  $\alpha/\epsilon \approx 0.55$ .  $\alpha/\epsilon$  values in this range can decrease the efficiency at which the rover can reject heat to its surroundings. The  $\alpha/\epsilon$  value is mostly dependent on absorptivity because emissivity ( $\epsilon$ ) changes very little with mass loading (Fig. 17). The sand used in this erosion test is a white/brown sand; the sand on Mars is red, thus the expected absorption value of the paint on Mars after the landing event will differ from the results presented in this work. Mars simulant sand was not used for this test campaign due to facility concerns, though is an open area of investigation for future work.

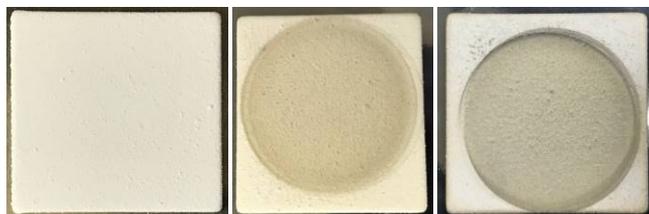
Fig. 14. S13 coupon discolored after exposure to 38-44 micron particles traveling at 250 m/s. The left image is a virgin paint sample, the middle image is taken after 120 mg/cm² of particle exposure, and the right image is taken after 2000 mg/cm² exposure. The exposed area is ~2 cm in diameter.

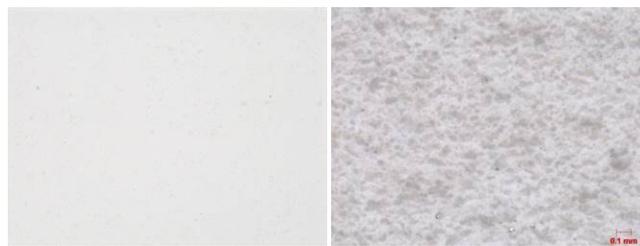
Fig. 15. High magnification image of a virgin S13 sample (left). High magnification image of S13 paint with 177-250 micron particles embedded (right).

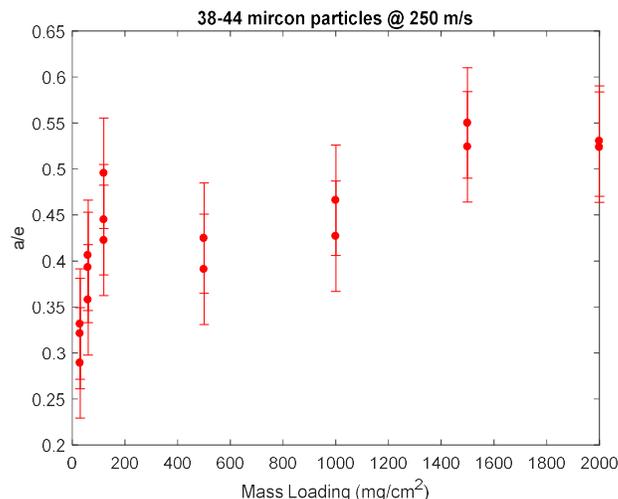
Fig. 16.  $\alpha/\epsilon$  vs Mass Loading for 38-44 micron particles traveling at 250 m/s. The  $\alpha/\epsilon$  values appear to reach a somewhat constant value at  $\alpha/\epsilon \approx 0.55$ .

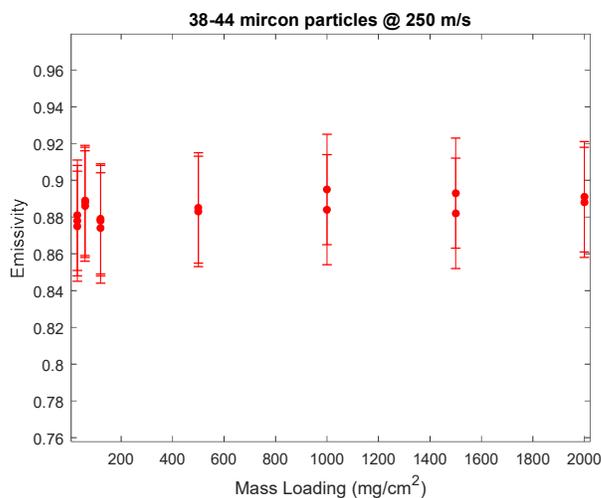
Fig. 17. Emissivity vs. Mass Loading for 38-44 micron particles at 250 m/s. Mass Loading has little effect on emissivity for all parameters.

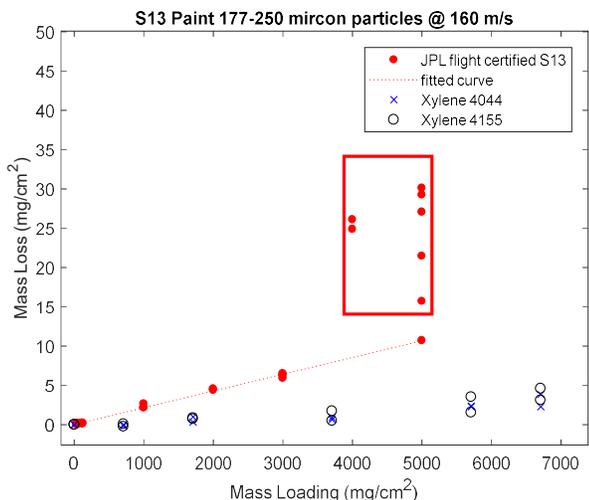
Fig. 18. The red box shows where the catastrophic failure occurred for the S13 paint. The xylene thinners did not fail.

177-250 micron sand with a velocity of 160 m/s is observed to cause linear erosion until a mass loss of ~18.5% of the initial weight (Fig. 18) is reached, at which point catastrophic adhesion failure occurs, resulting in exposure of bare aluminum (Fig. 19). The failure mode of the S13 paint is an adhesive failure to the aluminum substrate. After the paint fails, the paint chips are recovered and examined. The largest paint chip found is ~89.03 mm², which is ~24% of the exposed surface area. Before the paint failed, the  $\alpha/\epsilon$

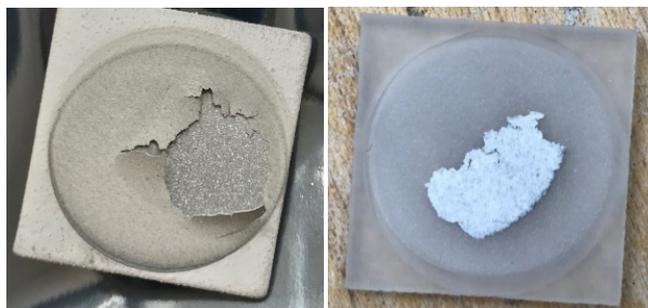
Fig. 19. The image on the left was taken after the S13 paint coupon exposed to 177-250 micron particles at 160 m/s after 5 g/cm<sup>2</sup> mass loading. The image on the right is a paint chip found in the sand after testing.

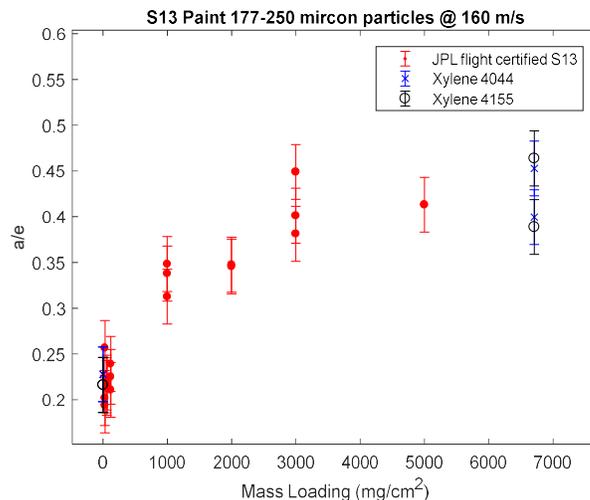
Fig. 20. The  $\alpha/\epsilon$  measurements leveled off, this data was fit with a curve. The new xylene thinner coupons had a higher  $\alpha/\epsilon$  value than the flight certified S13.

measurements appear to reach a constant value. The new xylene thinner coupons have a higher  $\alpha/\epsilon$  value than the flight certified S13 coupons (Fig. 20). Neither the paint with 4155-xylene nor the paint with 4044-xylene experience catastrophic failure (e.g. bare aluminum) when exposed to the same particle conditions, (177-250 micron sand with a velocity of 160 m/s), but the paint did start to blister. Fig. 21 shows the effect of particle velocity on mass loss, by showing results for two tests with the same sized particles yet different velocities. Increased kinetic energy of the impacting particles (higher velocity) increases the mass loss for a given mass loading.

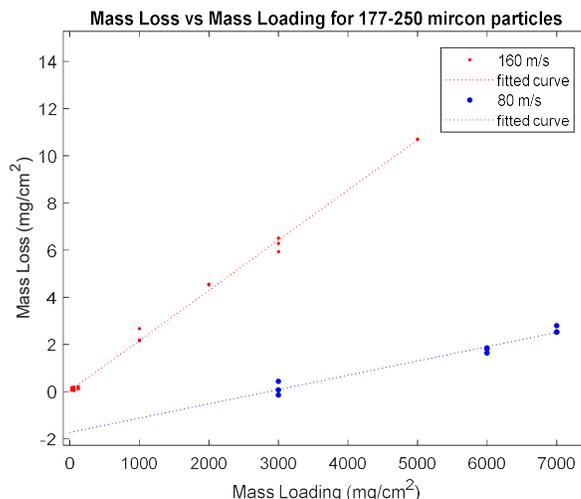
Fig. 21. This graph shows the difference in energy has on erosion. Increased velocity results in a significant increase in erosion rate for a constant particle size.

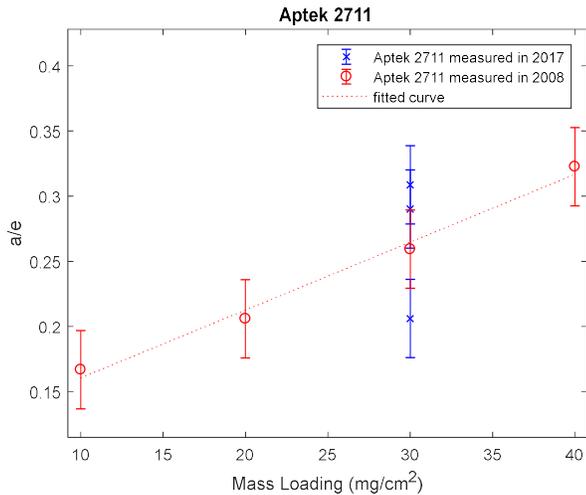
Fig. 22.  $\alpha/\epsilon$  ratio for the Aptek paint tested in 2008 for MSL compared to the Aptek paint tested in 2017 for M2020. The  $\alpha/\epsilon$  matches consistently with the margin of error from the optical instrument. Aptek 2711 was used as a control sample to confirm the M2020 paint was not over-tested and compare to the results from MSL testing [3].

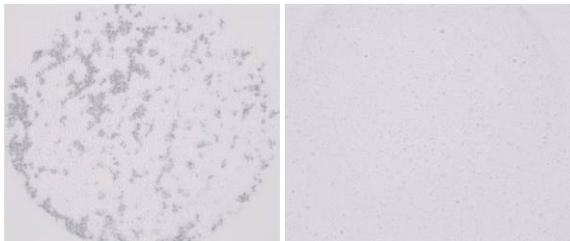
Fig. 23. Aptek 2711 coupon from MSL (left) and S-13 coupon (right) exposed to the same environment. The Aptek 2711 paint shows a cohesive failure early in testing and the S13 seems visually unaffected.

As there are no images taken by MSL's cameras that show similar paint erosion to that shown in Fig. 23, it is believed that the test environment is more severe than the particle environment that MSL experienced while landing on Mars.

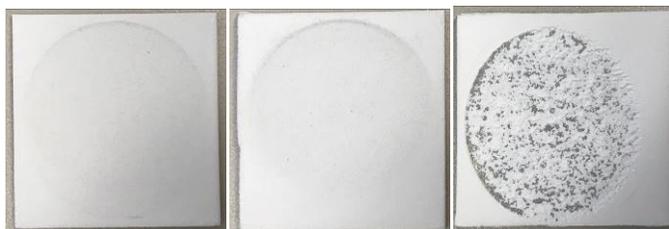
Fig. 24. Aptek paints 2706, 2719, and 2727 exposed to the same environment. 2706 had the lowest mass loss of all the Aptek samples.

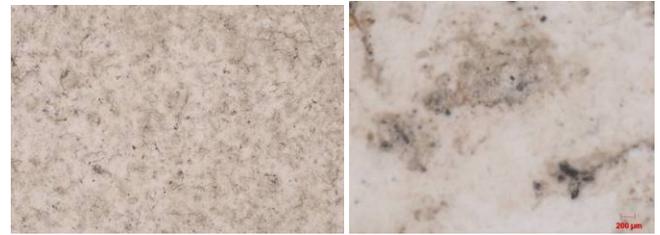
Fig. 25. Optical images (low and high magnification) of the S13 after exposure to the gravelometer. The paint also appears more red compared to the Particle Erosion Rig samples due to the red color of the MMS.

The S13 paint coupons exposed to gravel gain mass linearly, as the 1-10 mm gravel breaks upon impact and embeds into the paint (Fig. 25). This contrasts an erosion mechanism. The samples gain >1% mass, followed by catastrophic failure resulting in bare aluminum (Fig. 26). Neither the paint with 4155-xylene nor the paint with 4044-xylene show bare aluminum when exposed to the same environments, but the paint did start to blister. The 25 m/s gravelometer test is performed at the lowest possible particle velocity that the test equipment allows.  $\alpha/\epsilon$  values after

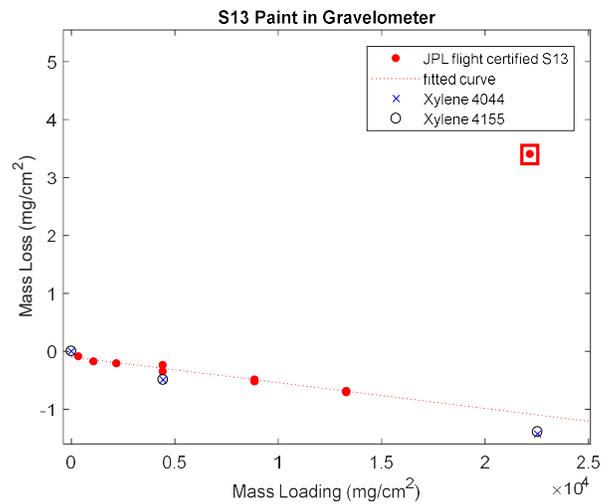
Fig. 26. In the gravelometer, the S13 gained mass linearly until catastrophic failure (red box),

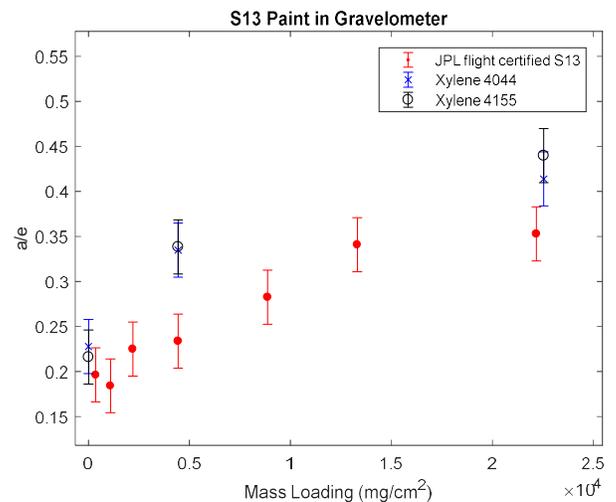
Fig. 27.  $\alpha/\epsilon$  levels off around 0.35 after exposure with the gravelometer. The samples with xylene thinners had a higher  $\alpha/\epsilon$  than the JPL certified paint.

gravel exposure reach a relatively constant value of  $\alpha/\epsilon \approx 0.35$ , which would only yield a modest temperature increase (Fig. 27). The impact angle of the gravelometer is fixed at 90°, but absorptivity is expected to be higher with lower impact angles (as discussed previously with respect to the Particle Erosion Rig).

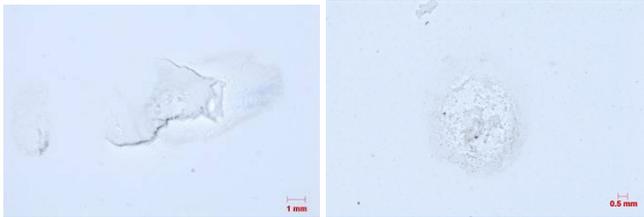
Fig. 28. Images post 15.8 mm particle impact with the Gas Gun. The impact angle of the left image is 30° and the impact angle of the right image is 90°.

The gas gun impact angle is variable and tests are performed at both 30° and 90°. Little damage is done to the S13 sample with a 90° impact angle. However, an impact angle of 30° causes the paint to peel away from the substrate (Fig. 28). Since the paint remains attached to the substrate in both experiments, and the color does not change significantly, there is no significant change to the emissivity and absorptivity of the paint.

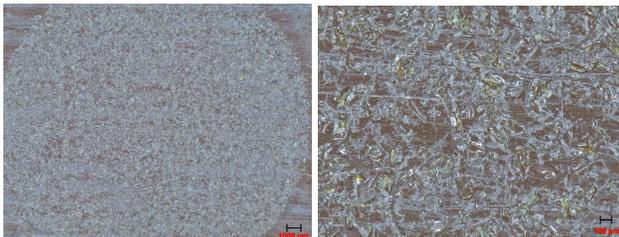
Fig. 29. When exposed to particles from 38-550 microns, in the Particle Erosion Rig, the outer layer of Kapton is abraded, but there is no damage to the traces. The left image is at low magnification and the right at high magnification.

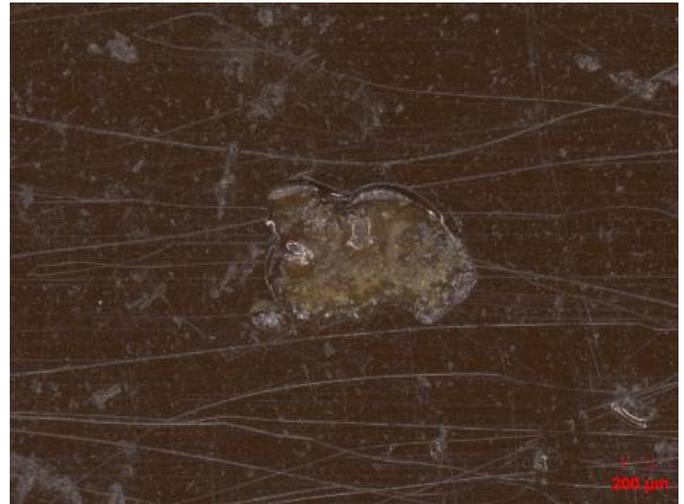
Fig. 30. Flex cable when exposed to 1-10 mm particles, in the gravelometer, the outer layer of Kapton is abraded; however, the copper traces were not exposed.

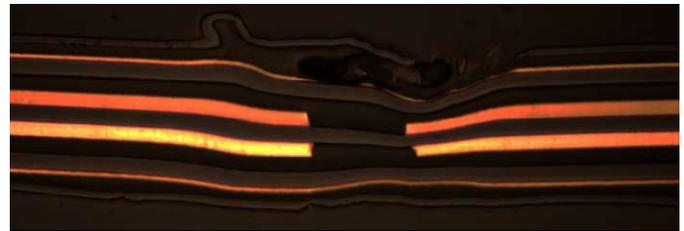
Fig. 31. Flex cable cross-section image at high magnification of the Fig. 30 location, the copper traces below the Kapton were deformed.

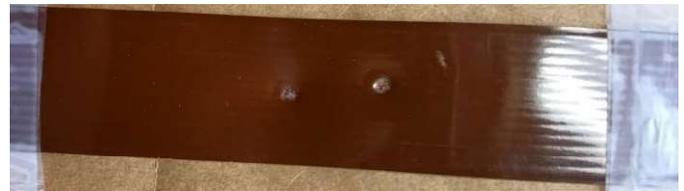
Fig. 32. This is an image of the flex cable after impacts from the Gas Gun. The indentation on the left is from impact with a cardboard backing and the indentation on the right is from impact with an aluminum backing.

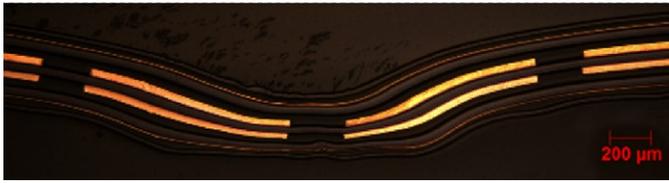
Fig. 34. Flex cable cross-section of the indentation that occurred with the same parameters but instead aluminum was behind the flex cable, right indentation in Fig. 32.

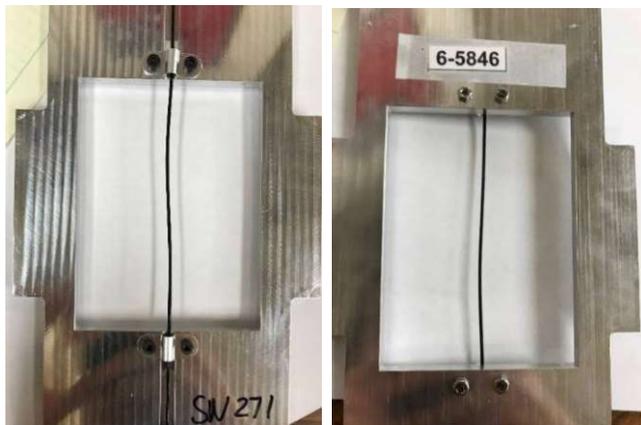
Fig. 35. Images of the back and front of the GSE with the FOC mounted to it prior to Gas Gun testing.

In order for the fiber optic cable (FOC) to be in a flight-like configuration (slack and without backing), ground support equipment (GSE) is designed to hold the FOC during testing (Fig. 35). Functional testing is performed after each particle exposure to verify that a laser can transmit light through the FOC. Videos are taken of the FOC during testing to monitor the FOC movement, and no anomalies were noted while in the Particle Erosion Rig. The FOCs that were exposed to sand passed the functional tests and no erosion was observed on the FOC. Videos taken during the Gas Gun impacts observed SN 271 deforming elastically approximately 5 cm (2 inches) after impact from a 15.8 mm particle traveling at 24.1 m/s. This level of deformation is commensurate with the acceptable bend radius of the fiber. After the deformation, the functional test had noticeably-reduced transmission through the FOC. The other FOC tested with particles smaller than 15.8 mm also deformed elastically, though less than SN 271. Post-testing attenuation measurements as a function of wavelength from 240-860 nm are also performed. In order to measure unsaturated data over the whole range of wavelengths considered, three measurements were taken: 0.8ms from 551-860 nm, 2.2ms 360-550 nm, and 5.6ms 240-395 nm. The test schematic for the attenuation measurements is shown in Fig. 36. All cables, except for SN 271 pass the requirement provided by the project. For SN 271 the attenuation was measured to be greater than the maximum allowed attenuation (Fig. 37). This FOC was tested to above the M2020 requirements.

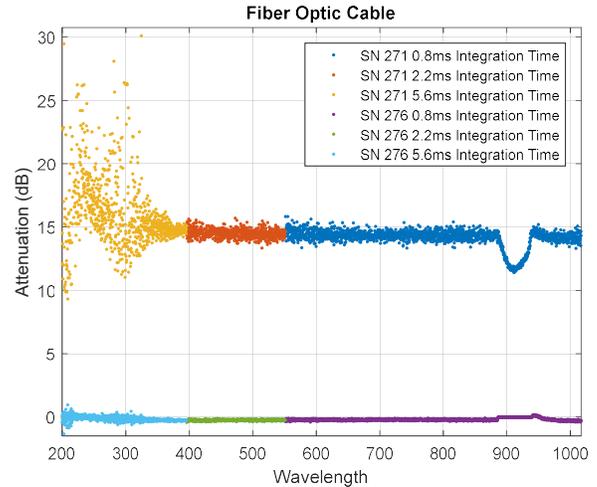
Fig. 37. The attenuation of SN 276 is an example of a FOC with acceptable attenuation and SN 271 is an example of a FOC with unacceptably high attenuation. Attenuation this high would lead to instrument failure.

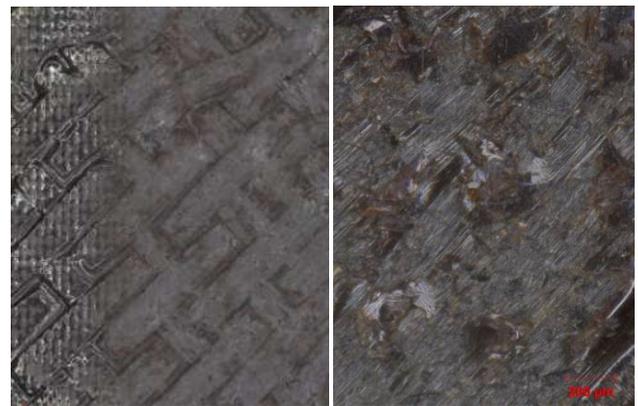
Fig. 38. Low and High magnification images of erosion of the M55J with sand. The resin has started to erode, but he fibers are still intact.

The resin in the M55J composite started to erode after exposure to sand, but no fiber damage was visible (Fig. 38). In the gravimeter, impacts resulted in fiber damage and through-thickness holes (Fig. 39). When the composite is exposed to rock impacts, plastic deformation is observed. The maximum deformation is about 1.27 cm (0.3 inch); this occurred after two impacts of a 15.8 mm particle with a 24 m/s impact velocity (Fig. 40).

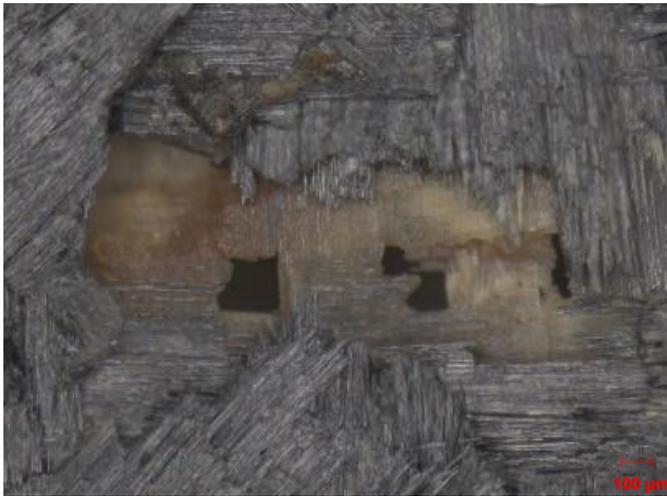
Fig. 39. Erosion of the M55J with gravel, after high mass loadings the fibers started to break and small holes were formed.

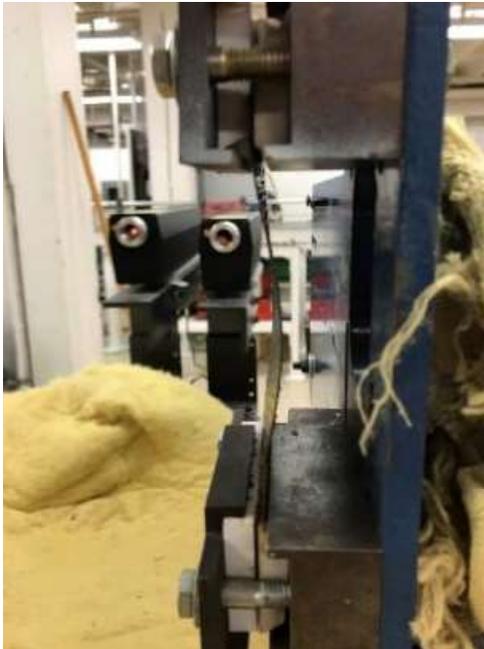
Fig. 40. Impact with two 15.8 mm particles caused the M55J to deform about 7.62 mm.

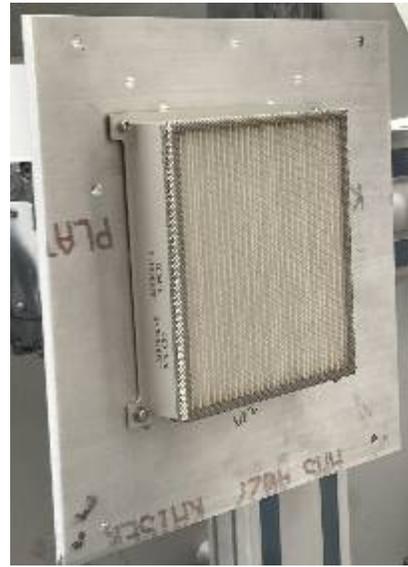
Fig. 41. The HEPA Rover Chassis mounted to a GSE plate testing with the Particle Erosion Rig.

Two flight HEPA filters are tested: 177.54 mm x 145.4 mm from the Rover Chassis (Fig. 41) and 30 mm x 32 mm from the RSM. Since there are a limited number of HEPA filters to test, the Rover Chassis is divided into 9 sections (Fig. 42). Each section is tested with different parameters, while the other sections are covered. The purpose of this configuration is to still be able to determine when a failure of a filter occurs, if one were to occur. After testing with the Particle Erosion Rig, the filters are inspected, and no sign of visible damage was noted. Some sand particles became trapped behind the screen, but none passed through the filter. The RSM HEPA filter is impacted with gravel traveling at 25 m/s. After an exposure of about 4700 mg/cm<sup>2</sup>, the screen over the filter showed visible

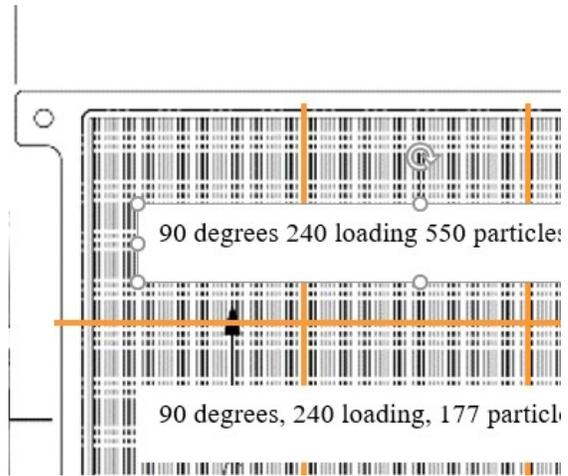
Fig. 42. Due to the limited amount of filters, the large filter was divided into 9 sections (in hopes that if the HEPA material failed the test parameter would be able to be determined based on the location of the failure.)

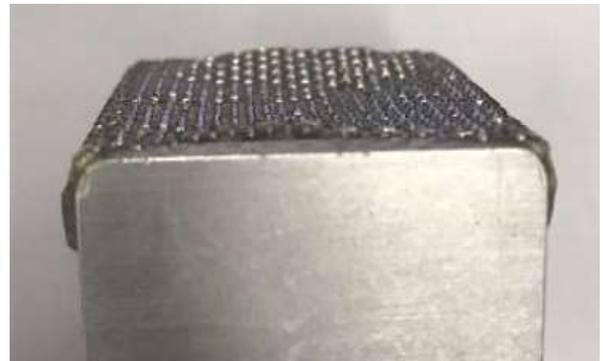
Fig. 43. Since the particles in the gravelometer ranged from 1-10 mm not all particles were able to pass through the 2 mm hole screen. These large particles deformed the screen on the RSM filter, but were unable to damage the filter.

damage to the screen but none to the HEPA material as the screen blocks most of the particles (Fig. 43).

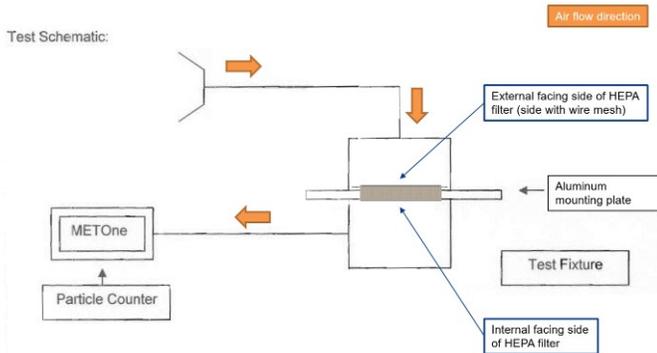
Fig. 44. HEPA filter leak check test schematic.

In order to quantify possible damage to the HEPA filters, post- and pre-testing for this hardware includes a particle count leak check, which determines how well the HEPA filters perform. The pre- and post-test values can be compared to determine if there is any degradation in performance. In order to measure this, first, the particle counter pulls a vacuum in “dirty air” and counts how many particles of a certain size make it to the detector, which is the baseline measurement. By placing the HEPA filter in front of the detector this should decrease the baseline measurement to significantly less than the original background measurement (Fig. 44). Both filters allowed less than 0.03% of the 0.3 micron size particles through, and these results are shown in Table VII.
