Thermally-resilient image sensor packaging approach for Mars2020 Enhanced Engineering Cameras

Abstract— Electronics designed for NASA planetary missions such as the Martian surface environment require wide-temperature survivable electronics packaging designs to ensure high-reliability avionics and instrumentation. Planetary surface temperature range of -135C to +40C dictate that electronics packaging solutions provide resiliency to large thermal excursions to counteract mismatches in the coefficient of thermal expansion in the myriad of materials found within space born electronics.

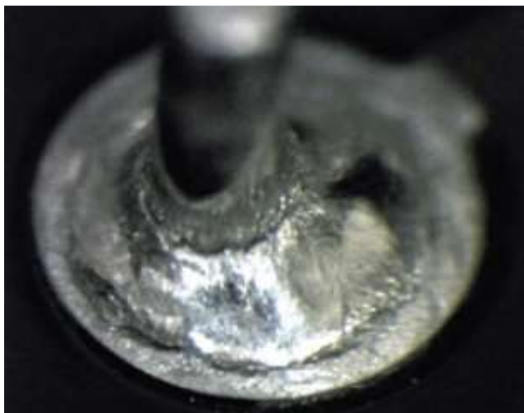
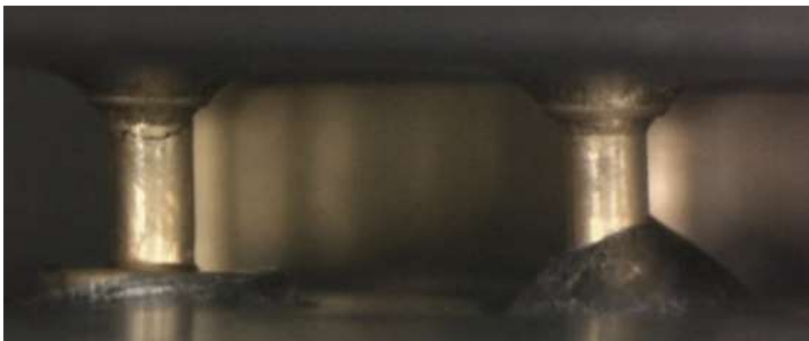
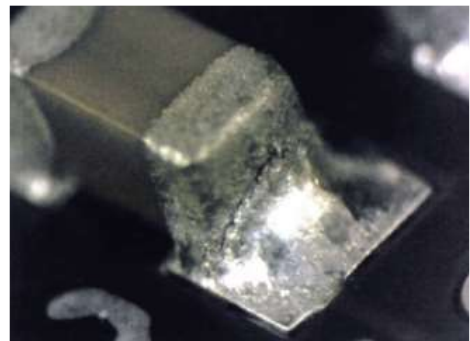
Figure 2. Various stress fractures on detector package pins (top left, top right), solder joints (bottom left), and passive components (bottom right)

During inspections at the equivalent of 2X mission life, stress fractures on the detector package were observed in two locations: a) between the pins and brazed join on the package ceramic and b) at the solder joints on the Printed Circuit Board (PCB). Further, electrical tests at this inspection point showed loss of detector function. This failure mode is due to fatigue from thermally

Figure 2 shows a number of pictures from the inspection

report detailing the various stress fractures on package pins and solder joints (on both pins and passive components).

A contributory factor in the original assembly package failures was the accelerated thermal profile used for the testing (using a 205°C temperature range). The extended

temperature range and greater extremes likely led to an overstress of the parts and exacerbated the stress-induced fatigue.

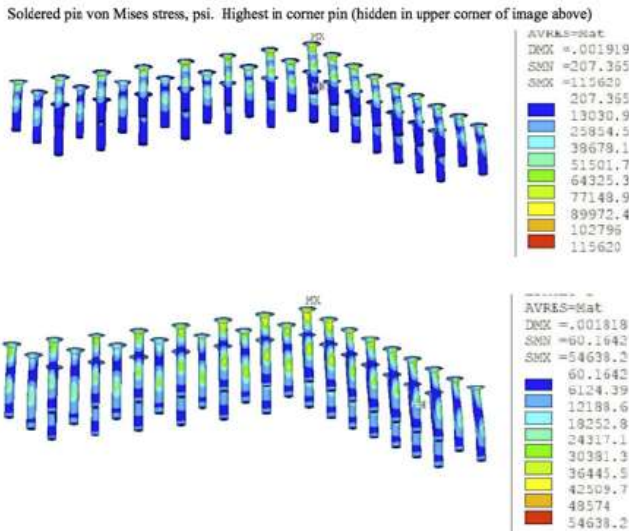
Figure 4. Top - ¼ FEA model of package and PCB assembly. Middle/bottom - 2X reduction in pin stresses from 0.05” to 0.1” height at +100°C from zero stress point.

Detailed data on the fatigue lifetime of the Kovar package pins was not available (let alone over the full thermal cycling temperature range) for modelling. An external company was contracted to perform fatigue measurements on the package pins to determine room temperature life and Kovar yield strength behavior. This would have been very beneficial in predicting the outcome of the thermal cycling test based on the FEA. Unfortunately, due to limitations in the test capability the measurements could not directly transfer to the current analysis (thermal cycling of bonded parts leads to reproducible displacement during thermal cycling rather than repeated stress levels. Typically, fatigue testing is designed to replicate the latter rather than the former). Nevertheless, the comparative predictions made it clear that maximizing the standoff height between detector package and PCB would reduce the chance of fatigue failure in the package pins. Increasing the standoff height beyond 0.100” with standard PCB thickness of 0.062” was not possible without having the package pins flush, or only partially inserted, into the PCB through-holes. Figure 4 shows results of ¼ FEA of the detector package at different standoff heights.

To add further to the standoff height, fabricating a thinner (0.047”) PCB would provide an additional 0.015” of standoff height over the already increased 0.100”. Rerunning the analysis with the thinner PCB showed a linear relationship between standoff height and maximum stress. Increasing the standoff distance by an additional 15% would reduce the chance of fatigue failure even further, and reduced the maximum predicted stresses below published values for Kovar yield stress. The nominal test assembly consisted of an 8-layer PCB fabricated with a thickness of 0.062” with 0.024” diameter through holes. A variant with 0.030” diameter through holes were manufactured as well to determine if there was an optimum solder wall thickness that provides for more compliancy without reducing the overall strength of the solder joint. Previous work had shown that a solder wall radial thickness of 0.003” provided the optimal joint strength. With a 0.018” diameter pin, a 0.024” thru-hole diameter would deliver the 0.003” radial solder thickness. However, to survive the thermally induced stresses there was some uncertainty whether a less stiff and more compliant solder joint would have a greater lifetime. An increased through-hole diameter of 0.030” was chosen to test this hypothesis.

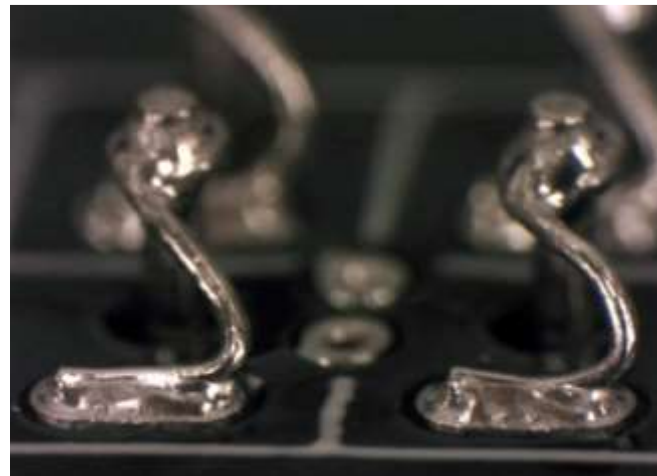
Figure 5. Jumper-wire soldered to floating package pin and soldered to a surface-mount pad on the PCB.

The Jumper Wire approach eliminates the through-hole solder joint and resembles a common ‘dead-bug’ electronic packaging approach common in the aerospace industry. Instead of soldering the pins into the plated thru-holes of the printed circuit board, the pin is allowed to float freely in the thru-hole and a loop of wire is soldered to the tip of the package pin and then bent around for attachment to a bond pad on the surface of the PCB. Figure 5 below shows close up photos of the PCB test article and the jumper wire solder joint (taken during inspections). This approach eliminates the stiff mechanical constraint between the pin and PCB. The pin is left floating inside the PCB thru-hole and instead the differential thermal motions are soaked up by the much more compliant jumper wire. In this configuration, the jumper wire is never subjected to stresses exceeding the yield stress of the wire material and the corresponding fatigue lifetime was expected to far exceed the 3X margin applied during thermal cycling. This approach has been used before on Mars Science Laboratory (MSL) [2] (e.g. Cold-Encoder) and has proved itself out in a Martian environment.

Within this configuration two styles of wire-loop were tested (with an approximately equal number on each test board), which can both be seen in the top panel of Figure 5. One is a simple U-shaped loop, the other a S-shaped loop. The purpose of two shapes was to test if there was any difference between the two at 3X life. Both solutions proved equally resilient to thermal cycle fatigue, and the S-shaped loop shall be used for future assemblies.

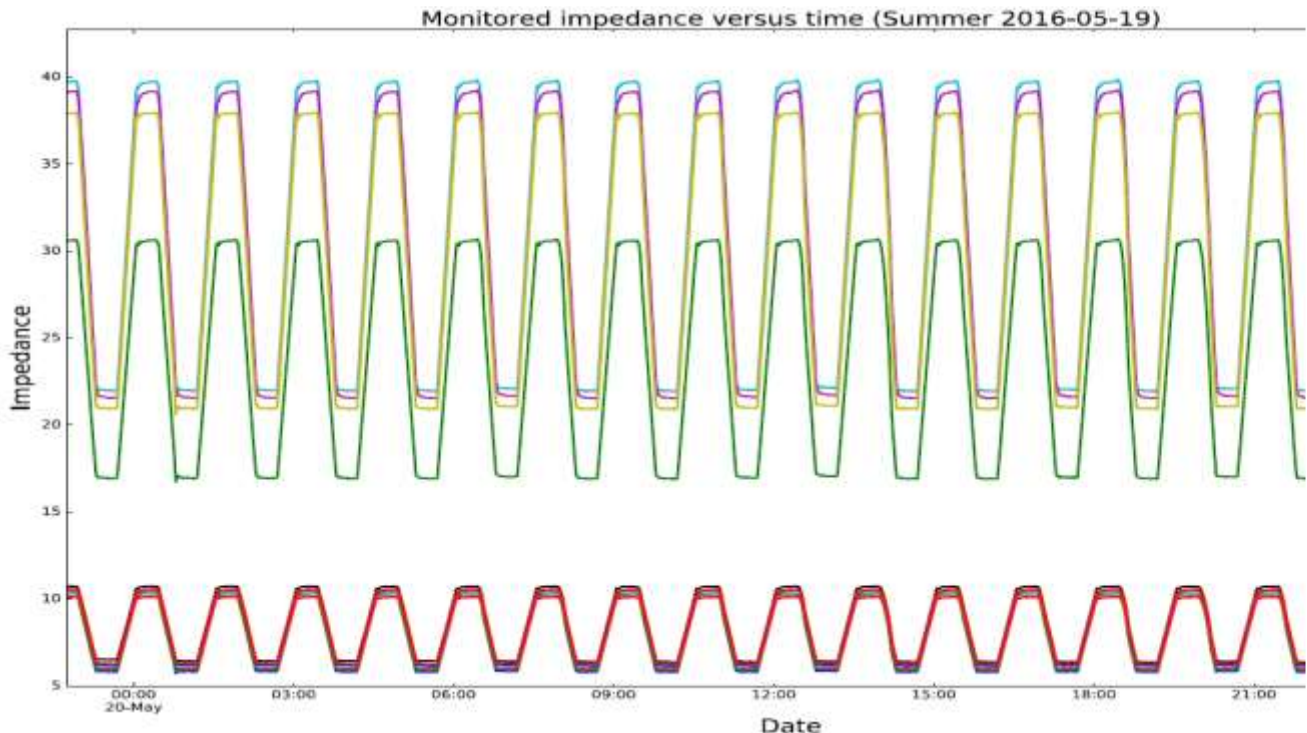
Figure 8. Plot of individual test assembly package daisy-chain resistance over temperature vs. time.

Figure 8 shows an example of continuous monitoring data from a sample of assemblies. The assemblies with mean resistance of around 10 Ohms have packages with the short described above. However, the short does not open or close as the temperature changes. The high mean value of around 40 Ohms corresponds to the expected series resistance without the short. One assembly is discrepant due to a short in a different location.

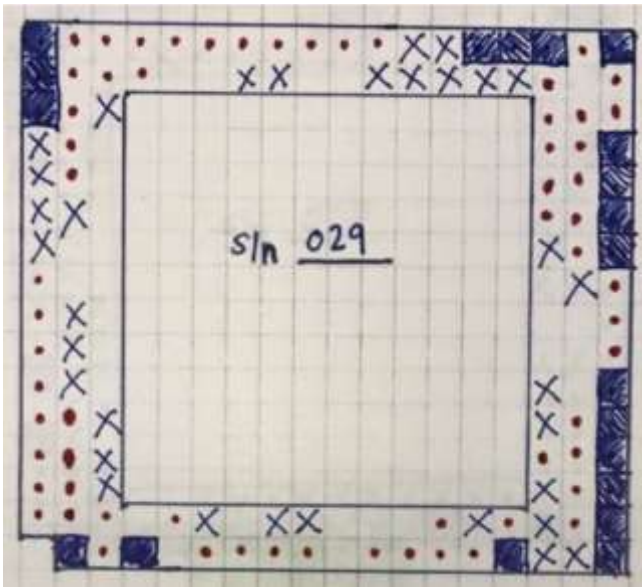
Figure 9. Solder joint fracture map. Squares = 1X life, circles = 2X life, and X = 3X life occurrence

At each inspection point the pins and solder joints for each test assembly were carefully assessed. Howard recorded his inspection results by drawing maps of fracturing in the package pins. These maps were updated at each inspection point to show the additional fractured solder joints observed. Figure 9 shows a fracture map for one test assembly. The shapes show the additional fractures that developed at each successive inspection point. It can clearly be seen that the initial fractures developed at the outer edges and corners of the assembly. As the number of thermal cycles accrued the inner pins began developing fractures. By 3X nearly all the pins on the assembly had developed a fracture in the solder joint.

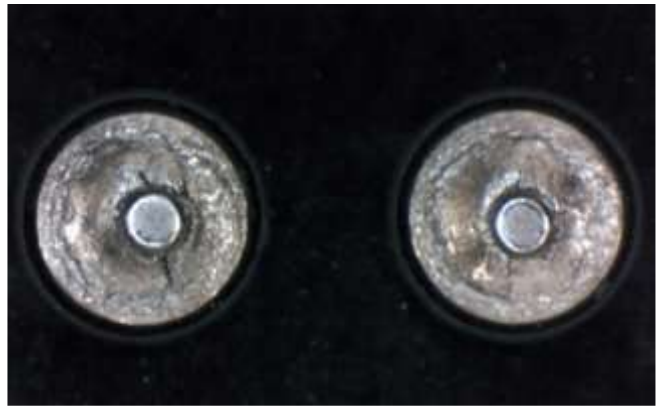
Figure 10. Radial and annular fracturing on the solder joint, bottom side of PCB

Figure 10 and Figure 11 show inspection photos (from the 3X report) of solder joint fracturing on the underside and topside of the assembly respectively.

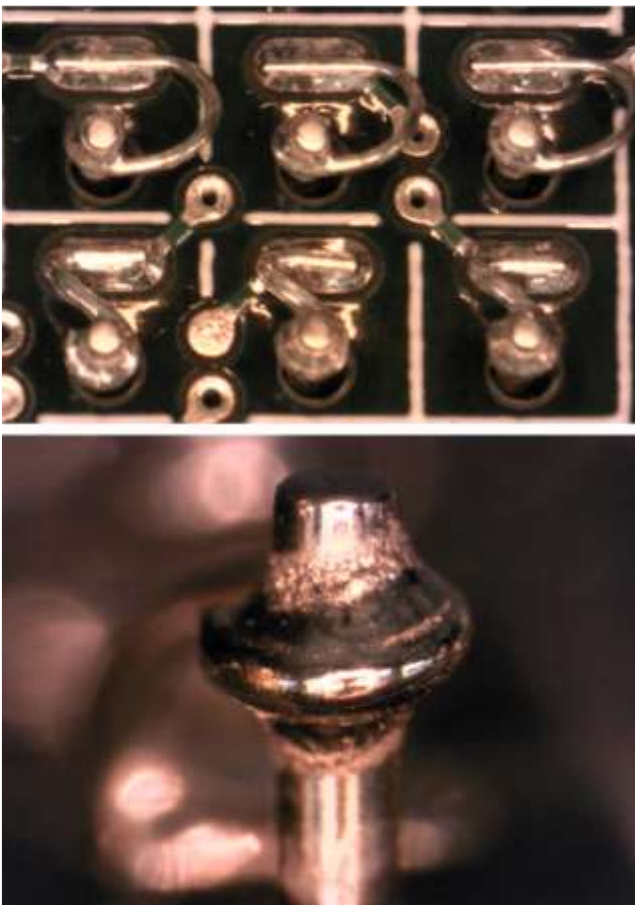
Figure 12. Jumper-wire solder joints after 3X life

At 3X the jumper wired assemblies showed only nominal signs of age seen via increased granularity in the solder joint at the tip of the package pins. This is illustrated in Figure 12. Otherwise the jumper wired boards looked in “as-new” condition at the end of 3000+ thermal cycles. The epoxy bonds between the PCB, ceramic shim and package sandwich showed no signs of damage from visual inspection.

All test samples of the increased-height soldered pin and jumper-wire configurations passed 3X life thermal cycles of the Mars2020 temperature cycle requirements. DPA results identified near-failure conditions of the package solder joints, and therefore the jumper-wire approach was chosen to be the baseline for the camera packaging design. The overall health and resiliency of the jumper-wire solder joints inspired confidence that this packaging approach would best serve the cameras well beyond their planned operational life on Mars.

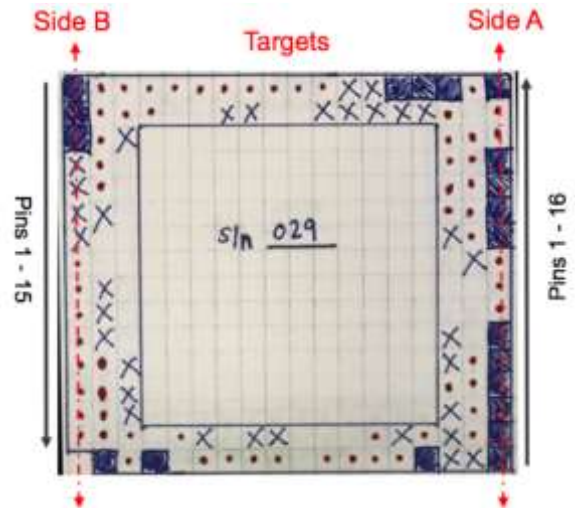
Figure 12. Cross-section analysis reference for soldered pin SN #29

Several destructive parts tests were carried out post 3X inspections for the soldered-pin assembly boards. Cross-sectioning of a sample of the soldered pin boards was performed to determine the extent of fracture propagation. After completion of 3X inspections two of the soldered pin boards (#29 and #43) were selected for cross-sectioning to determine the extent of the fracture propagation into the PCB through-hole. These cross-sections provide important

additional information as to the expected reliability of the solder joints. While the failure criteria had not been met during testing the visual inspections raised serious doubts about the reliability of the solder joints. Cross-section analysis of a sample of boards to determine the depth of fracture propagation into the solder through holes is necessary to provide a much better handle on the proximity to failure.
