Insight — The First Three Months (or 100 sols) on Mars

W. Bruce Banerdt, JPL/Caltech
And the InSight Science Team

18 March, 2019

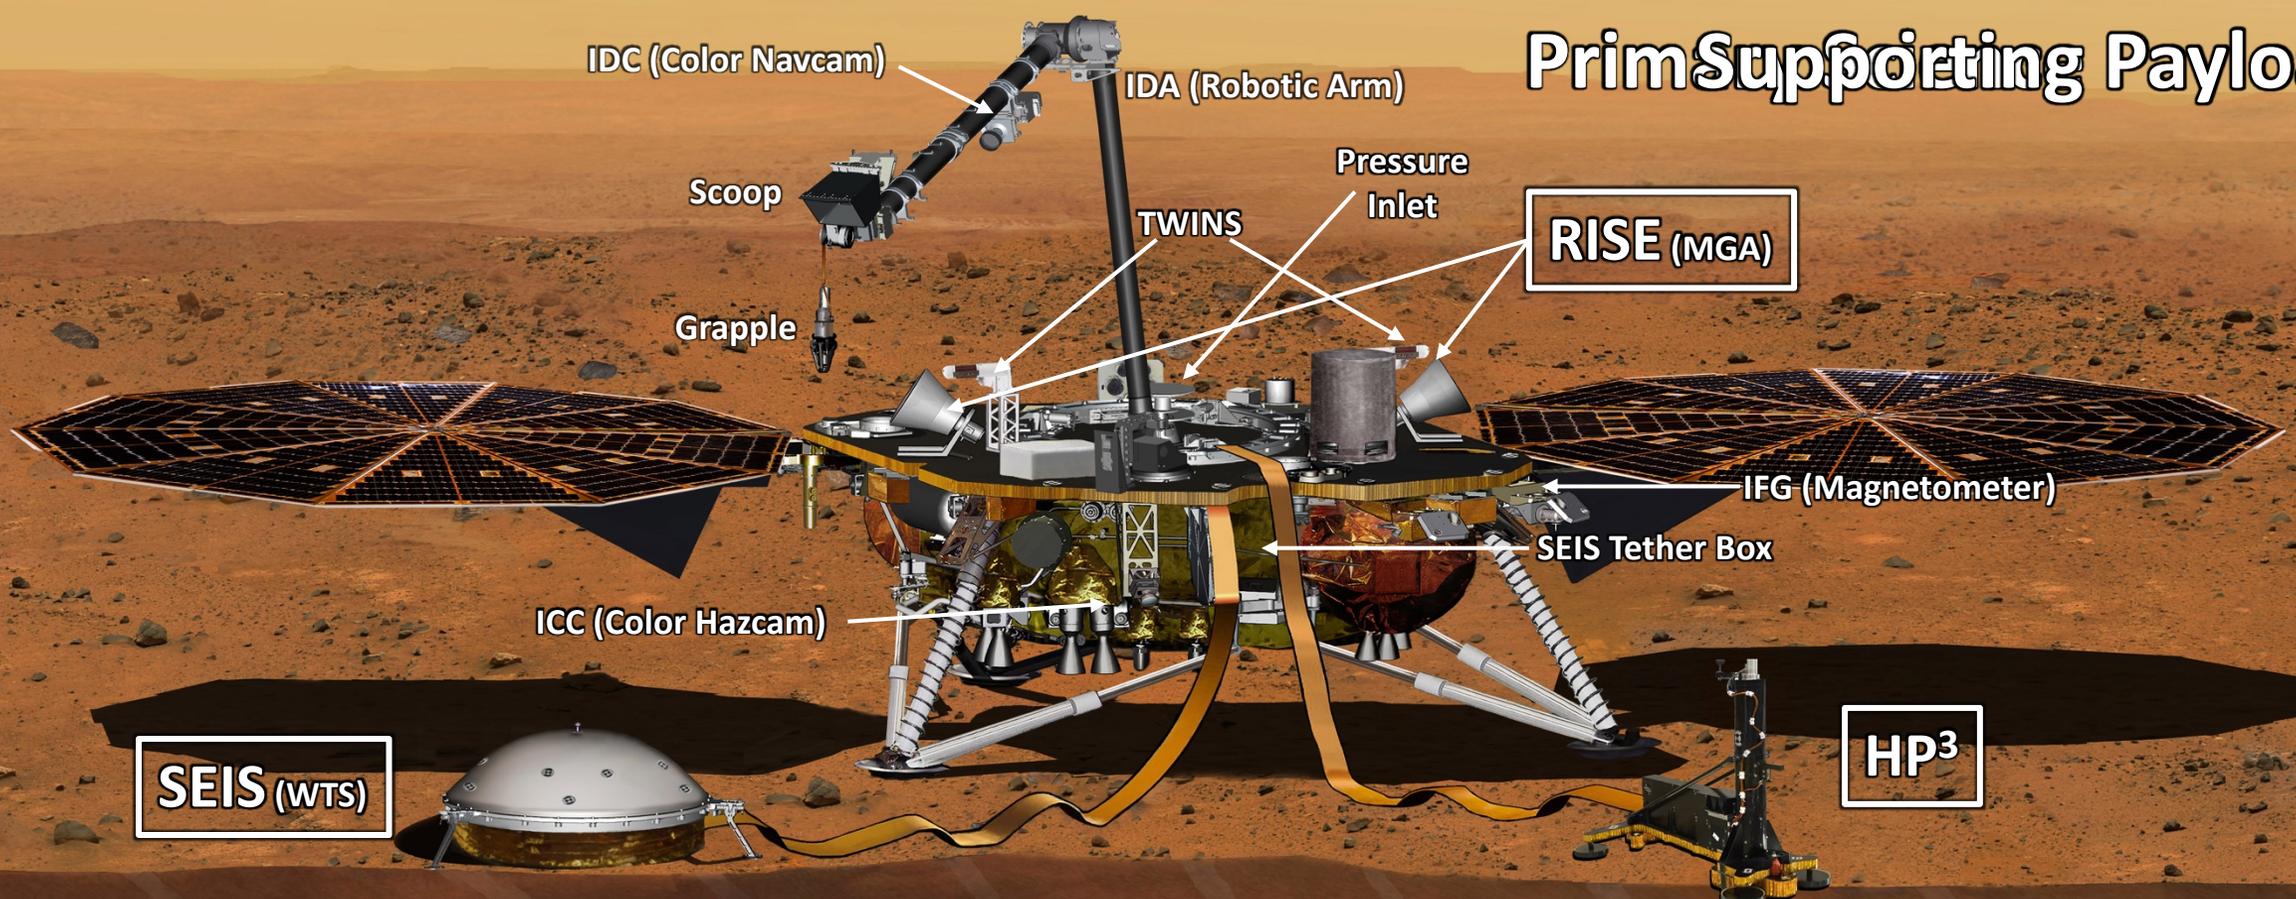
Primary Supporting Payload

SEIS (WTS)

HP3

- Instrument Electronics – Inside S/C
- Pressure Sensor – Inside S/C
- Radiometer – Other side of S/C
- Camera Calibration Target – Other side of deck
- LaRRI (Laser Retroreflector) – Other side of deck
- Names to Mars Chips – Other side of deck

Science Tether

Mole

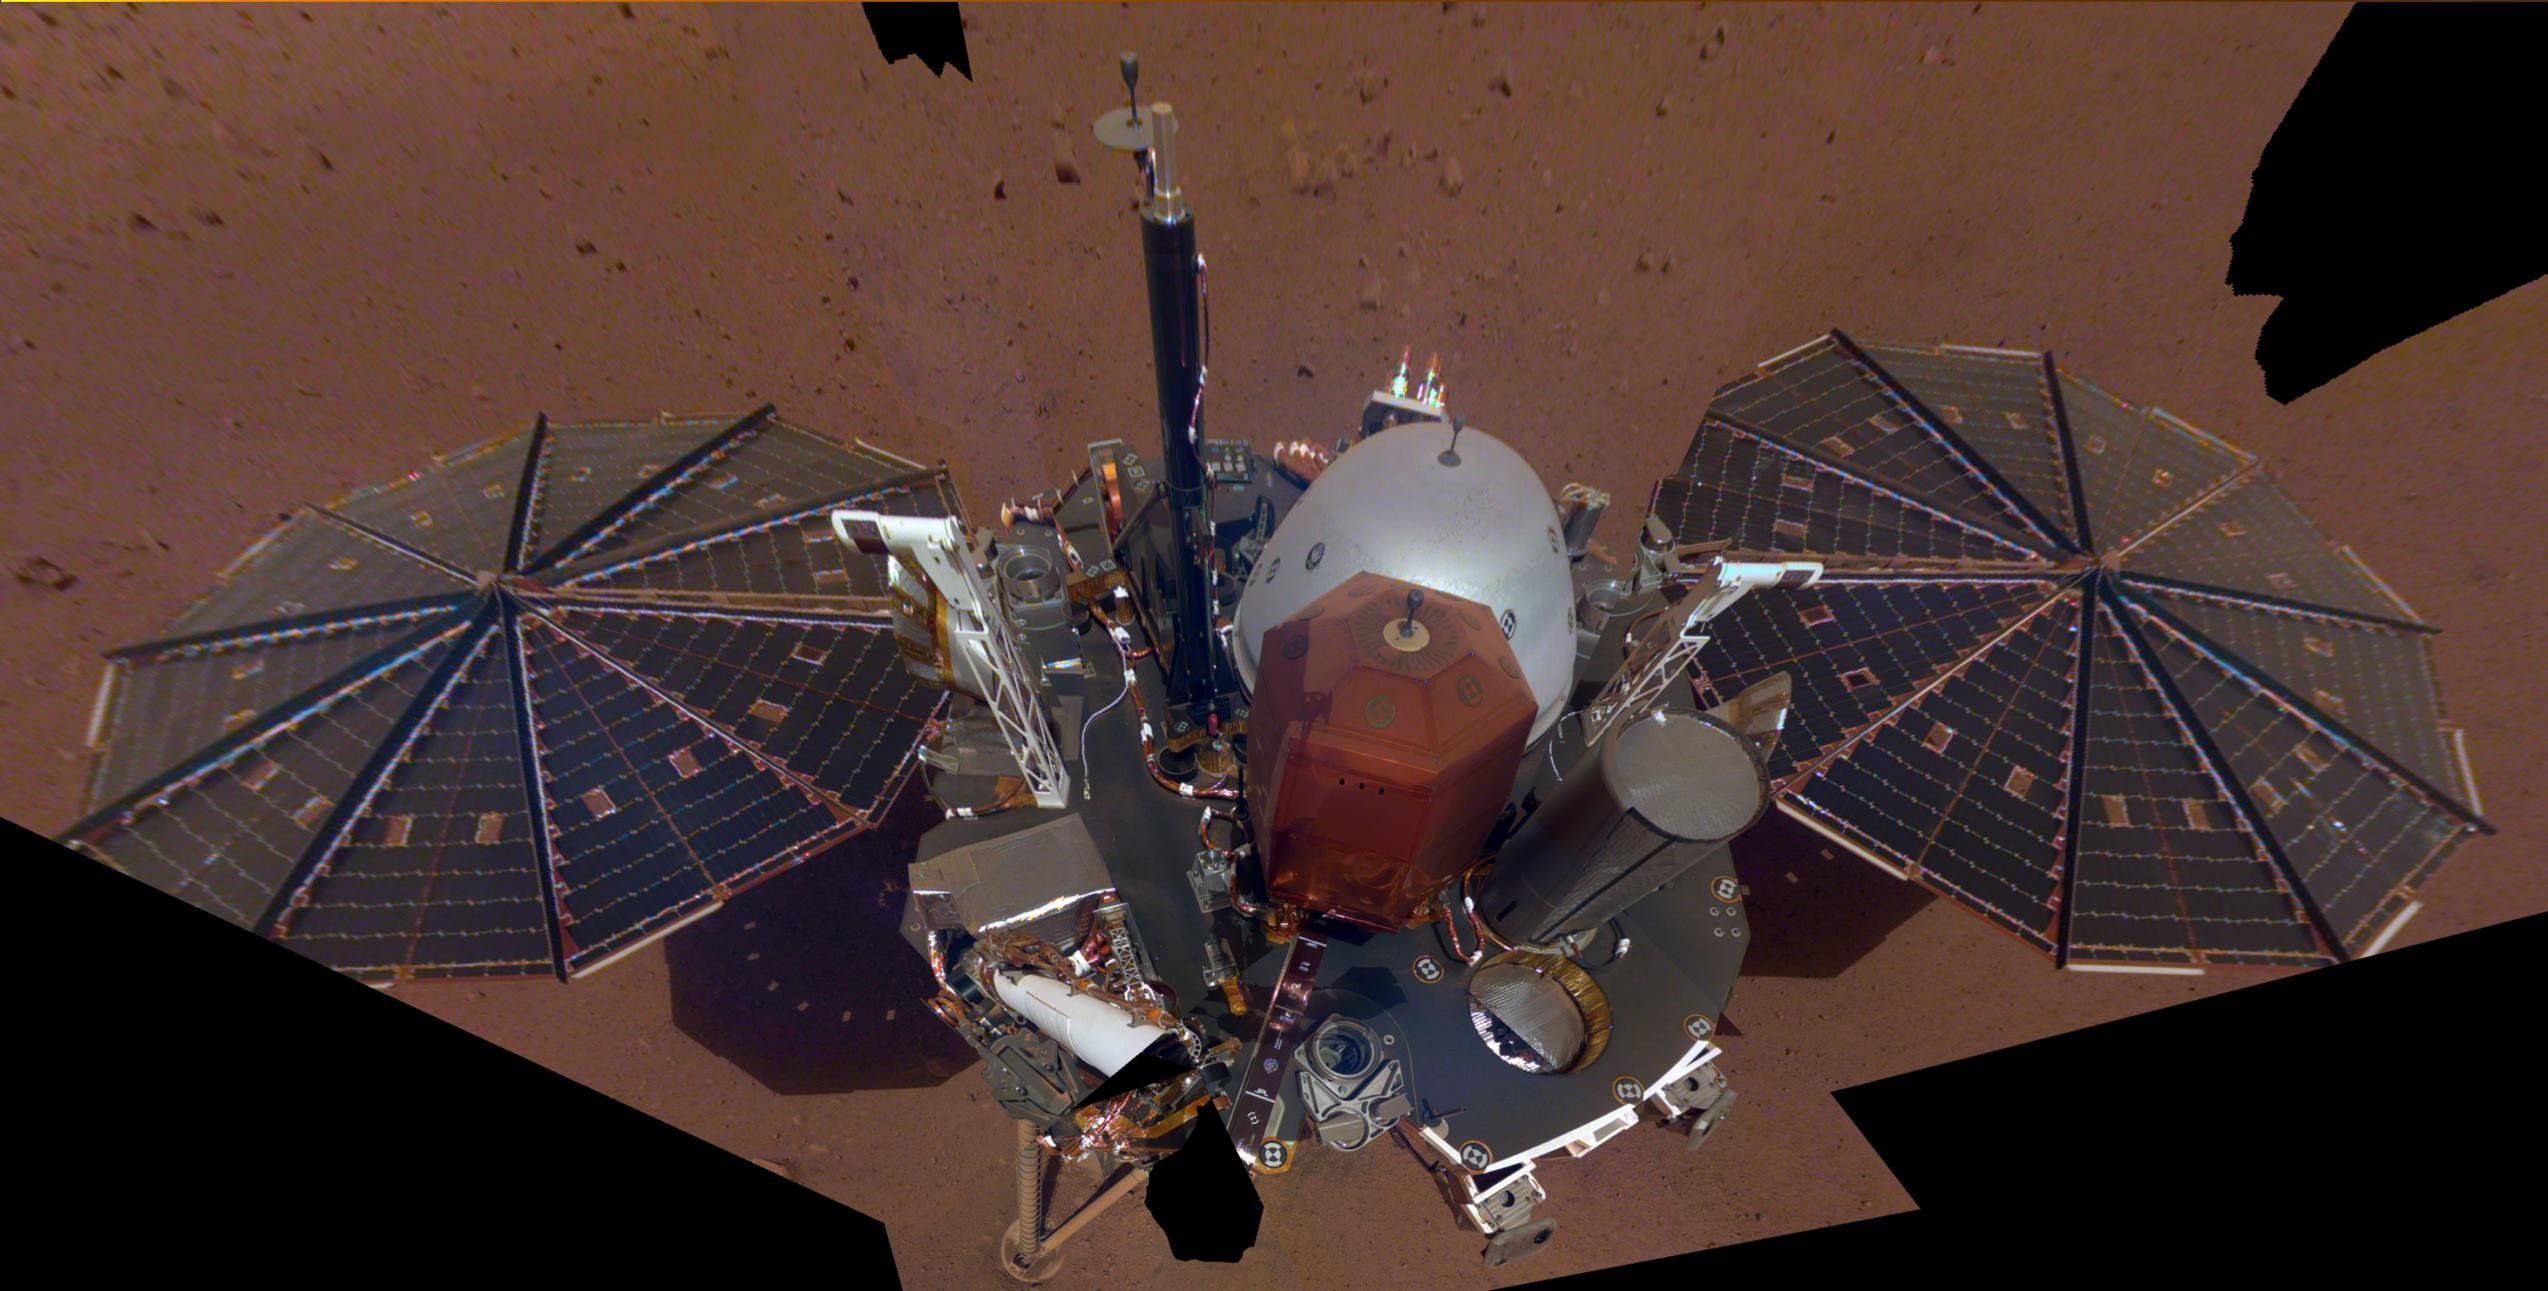
IDA (Instrument Deployment Arm) Workspace

1 meter

A vertical white scale bar representing 1 meter.

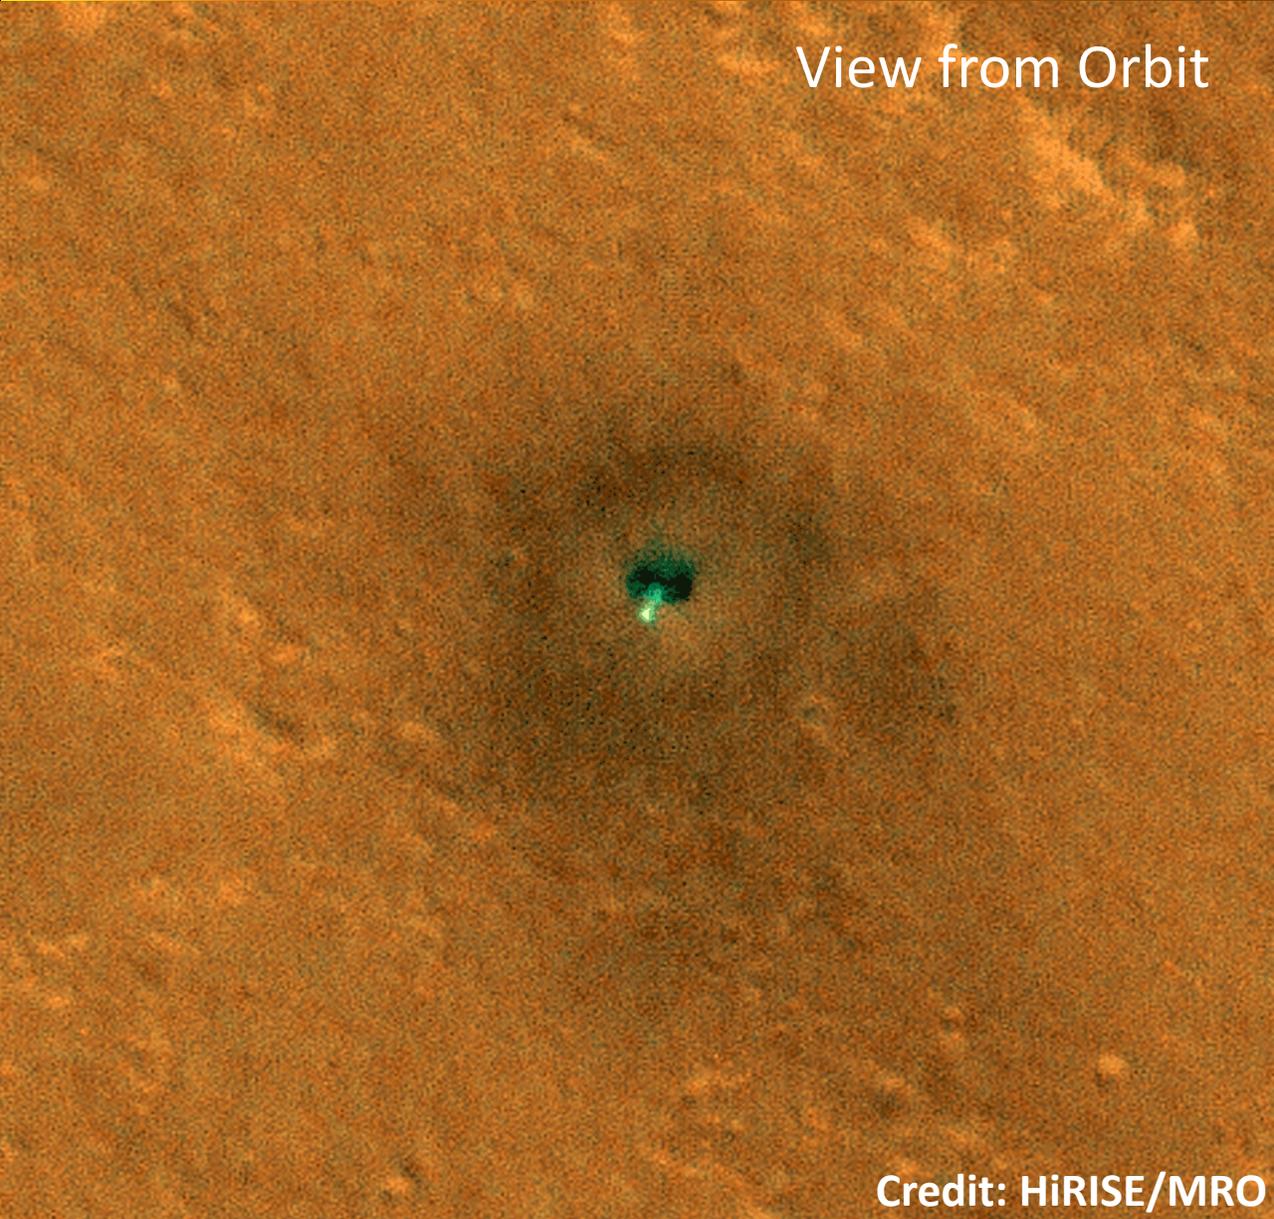
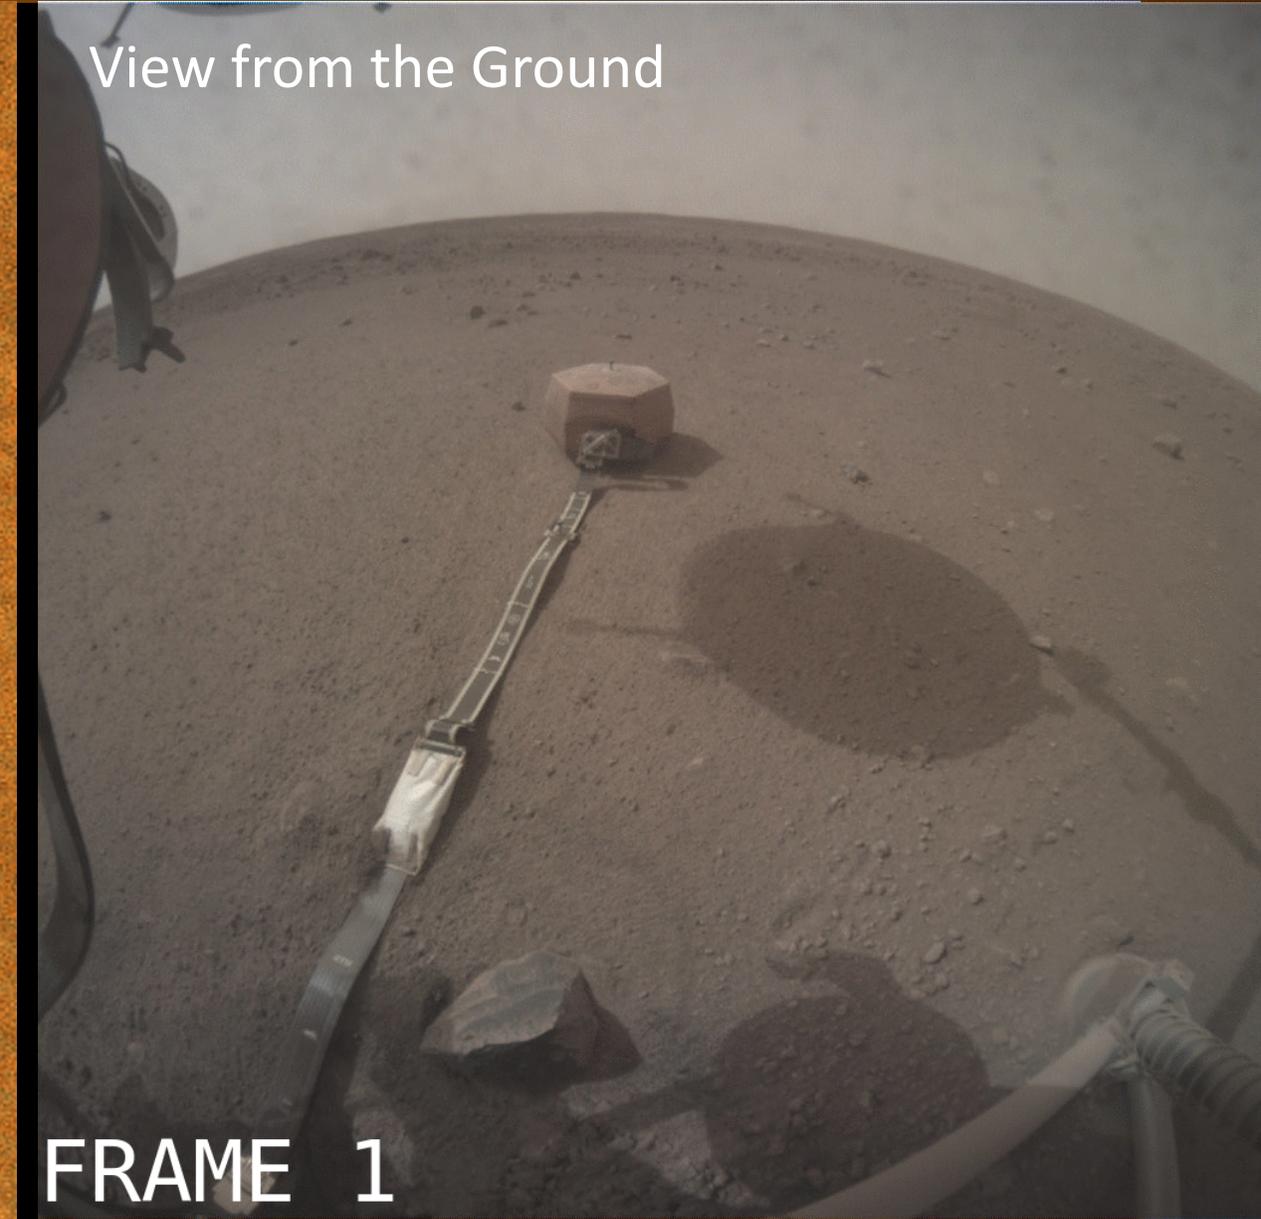
Sol 66 – Wind and Thermal Shield Deployment

View from Orbit

View from the Ground

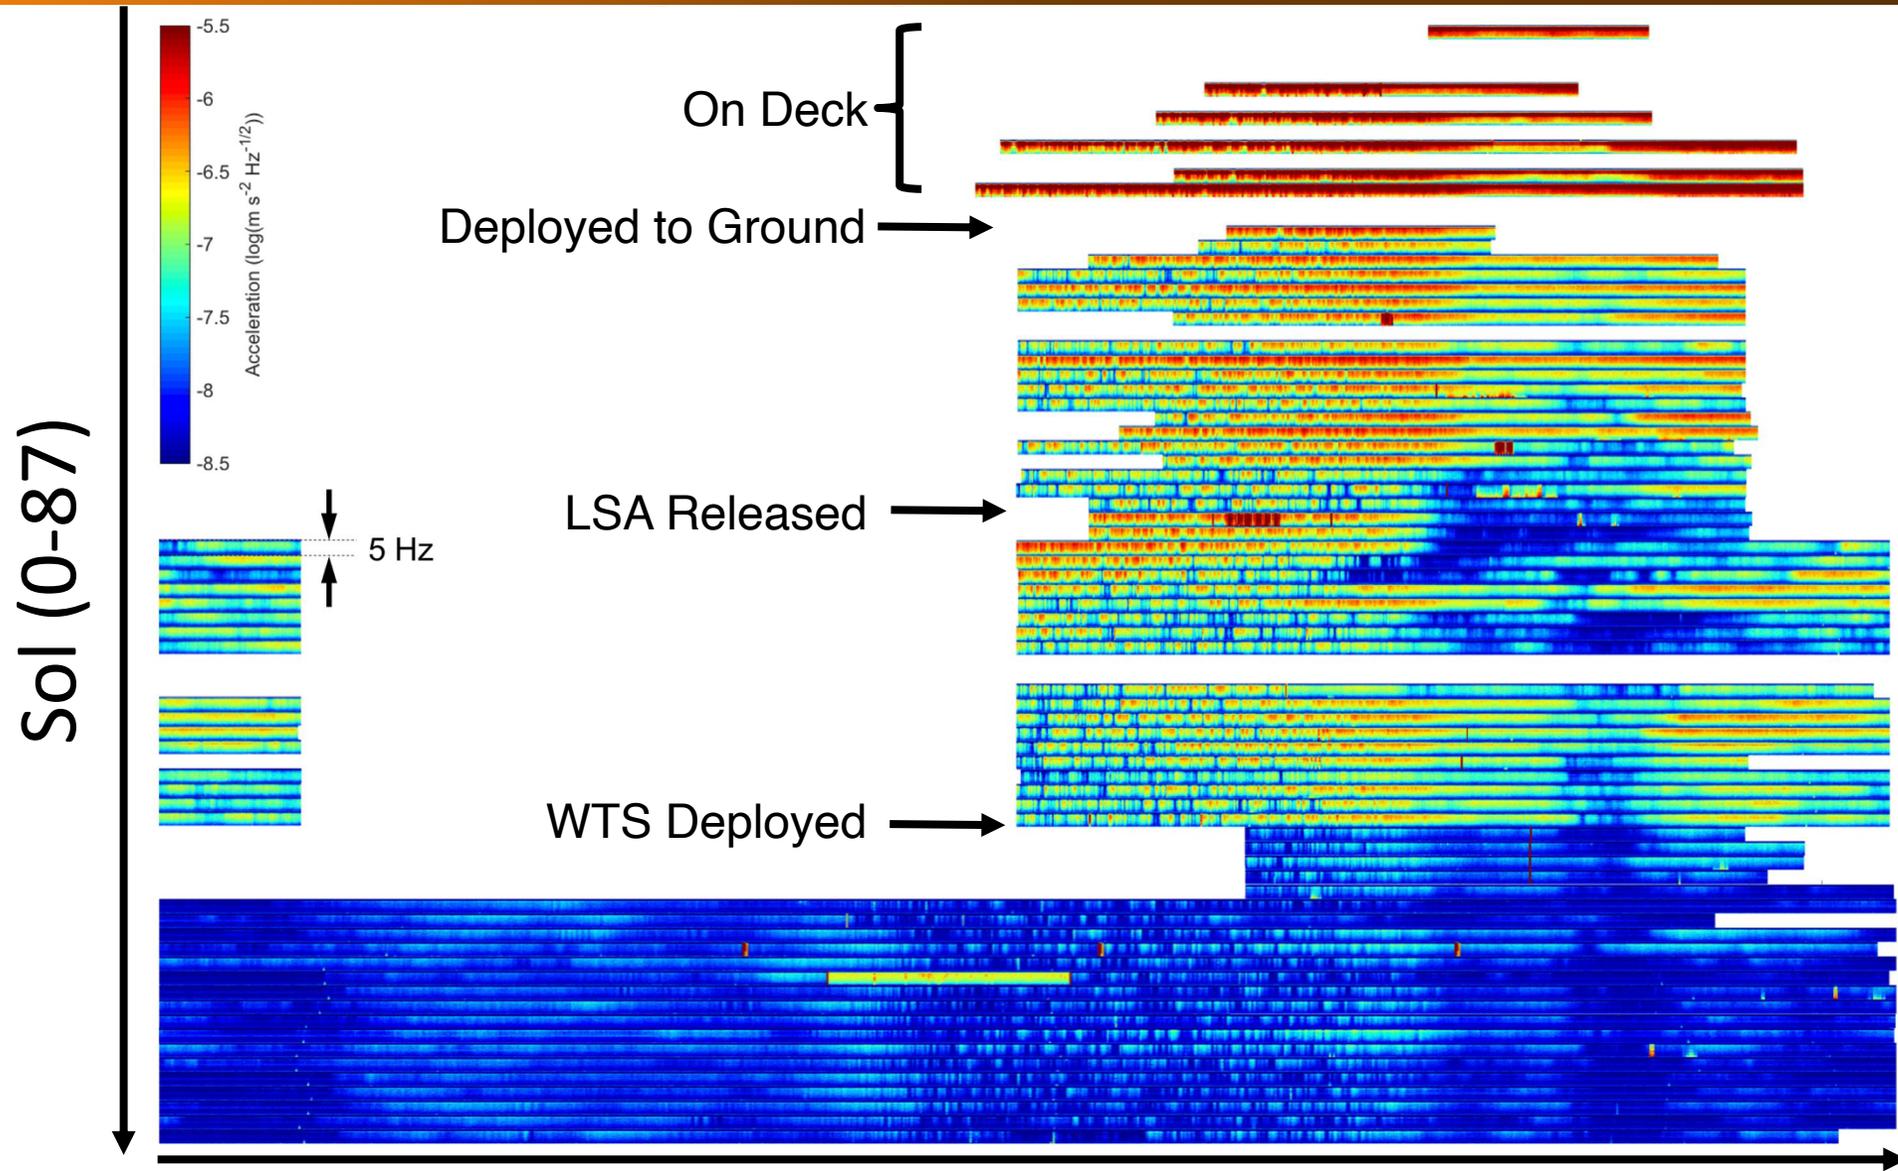
For scale, the inferred displacement sensitivity at the bottom of this plot is of order 25 pm, or ~20% the diameter of a hydrogen atom.

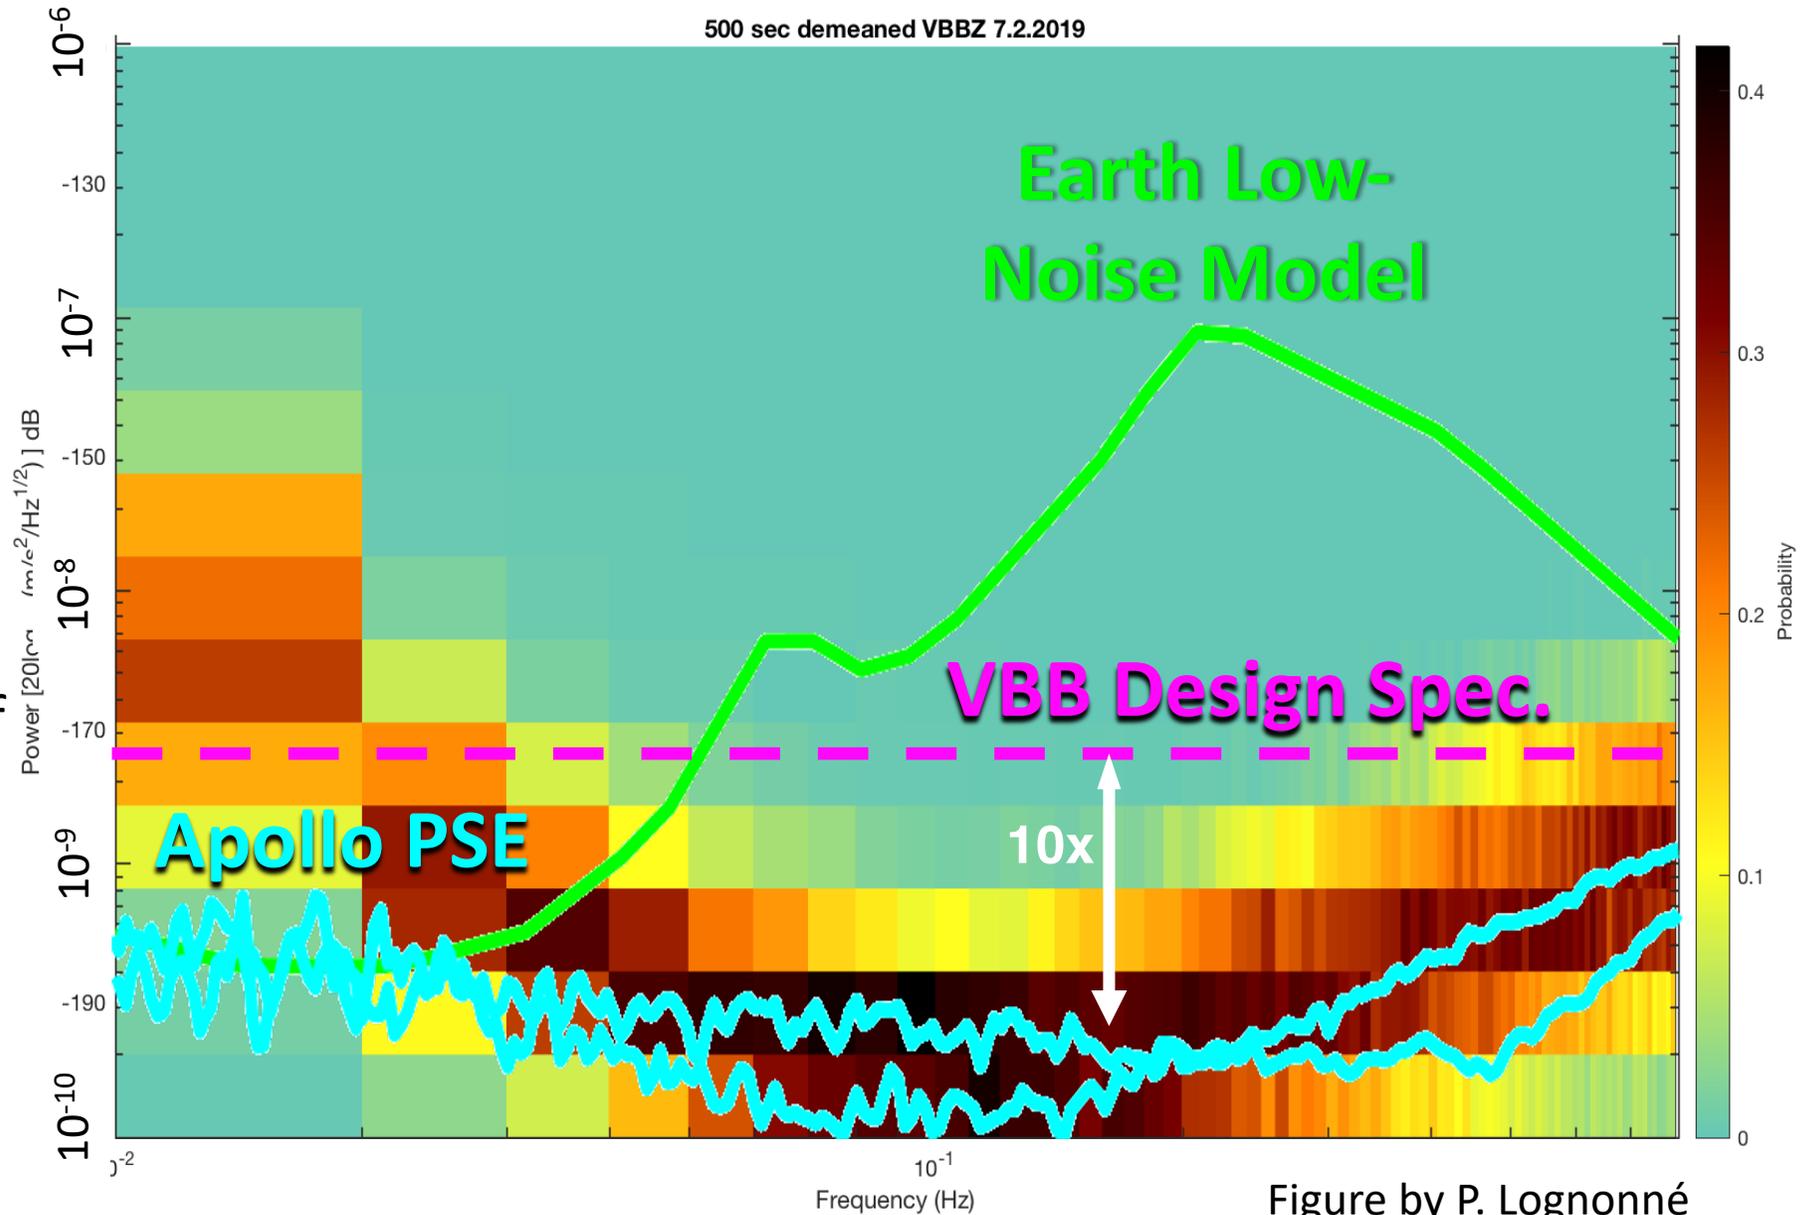
Out of 100 Sols on Mars, we have 40 sols with excellent SEIS data quality.

During this time we have observed NO clear signal identified as a marsquake.

This excludes Earth-like activity levels.

Pre-landing estimates (e.g. Golombek, 1992) are still within the allowed range of activity rates.

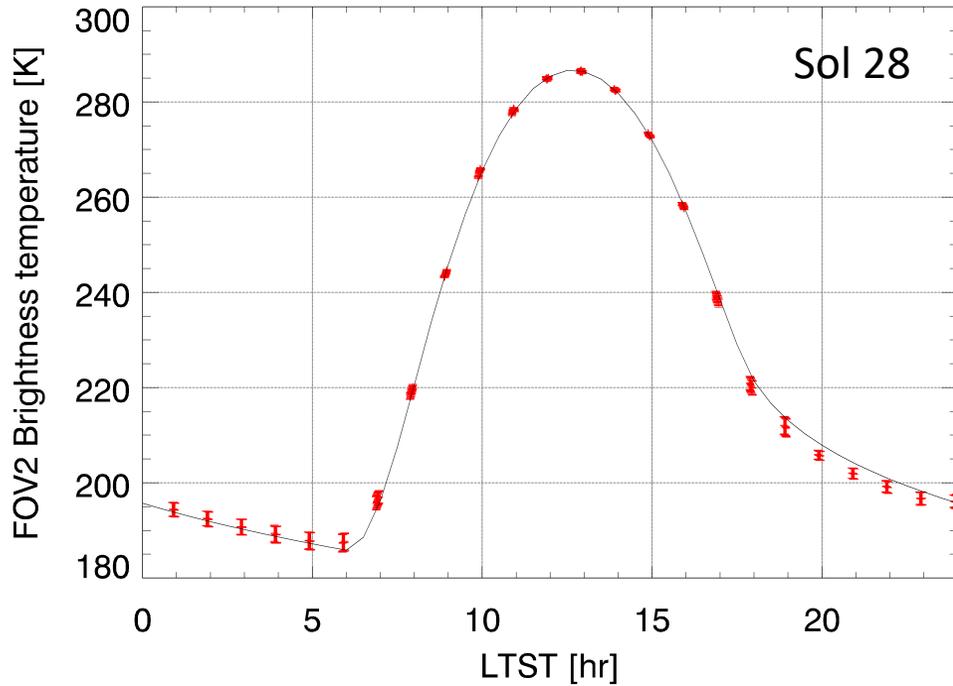
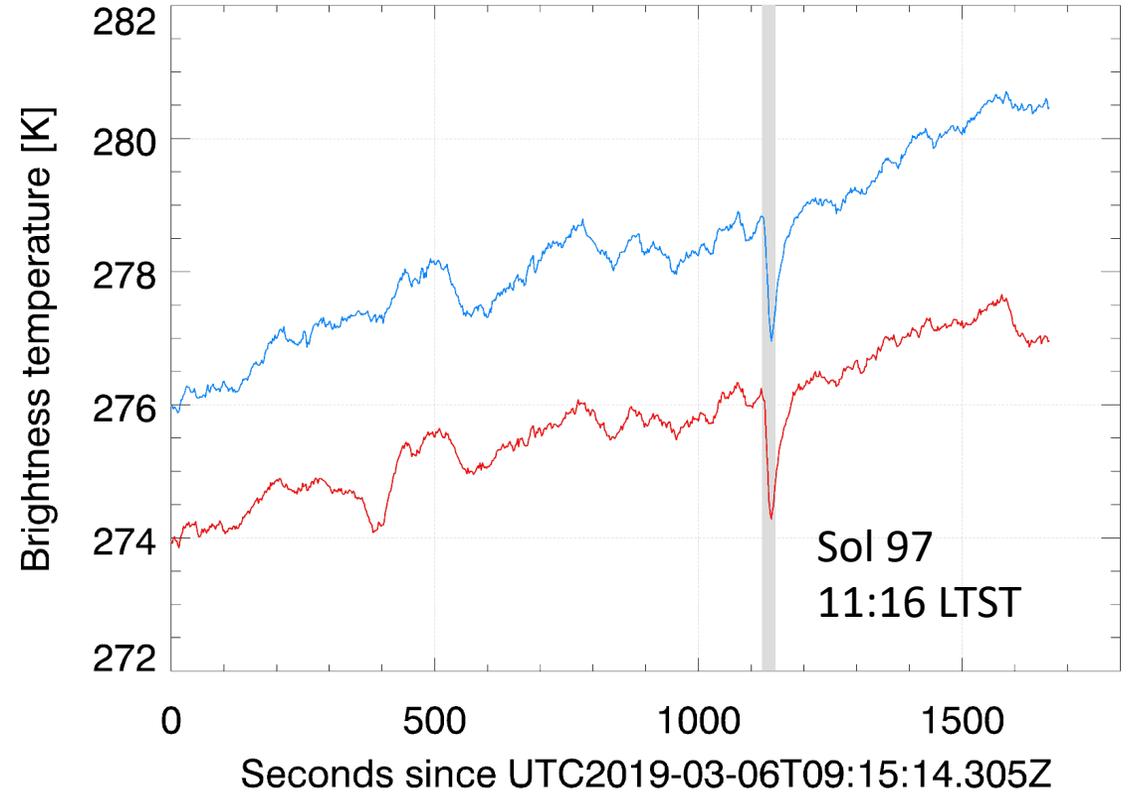
Both measurements are consistent with a thermal inertia of $190 \text{ J m}^{-2} \text{ s}^{-1/2} \text{ K}^{-1}$.
 This is also consistent with both orbiter observations and direct conductivity measurements by the mole in the regolith

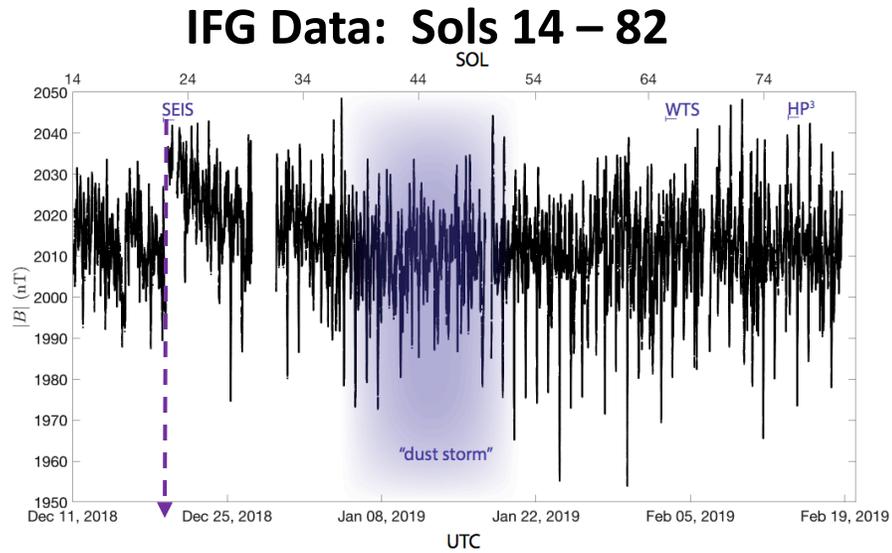
DC field → estimate of crustal field.

$$|B| = 2013 \pm 13 \text{ nT}$$

Declination = 138° , Inclination = -28°
 i.e., SE and upward pointing

Ground-based estimate ~ 10x satellite estimate
 → contributions from magnetizations with scale lengths $< \sim 150 \text{ km}$
