# Slow and fast motion of landslides along California Highway 1 from UAVSAR and Satellite SAR analysis

**Alexander Handwerger<sup>1\*</sup>, Mong-Han Huang<sup>2</sup>, Eric Fielding<sup>1</sup>, Adam Booth<sup>3</sup>,  
Roland Bürgmann<sup>4</sup>, David Bekaert<sup>1</sup>**

<sup>1</sup>Jet Propulsion Laboratory, California Institute of Technology.

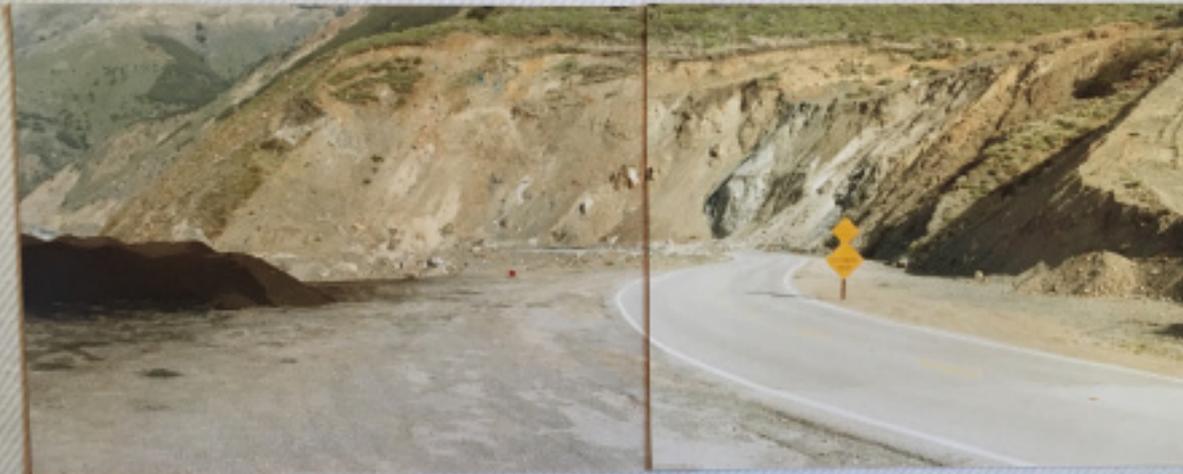
Figure 6. Aerial view of the McWay slide of 1983. Photo by Lynn Harrison, Caltrans

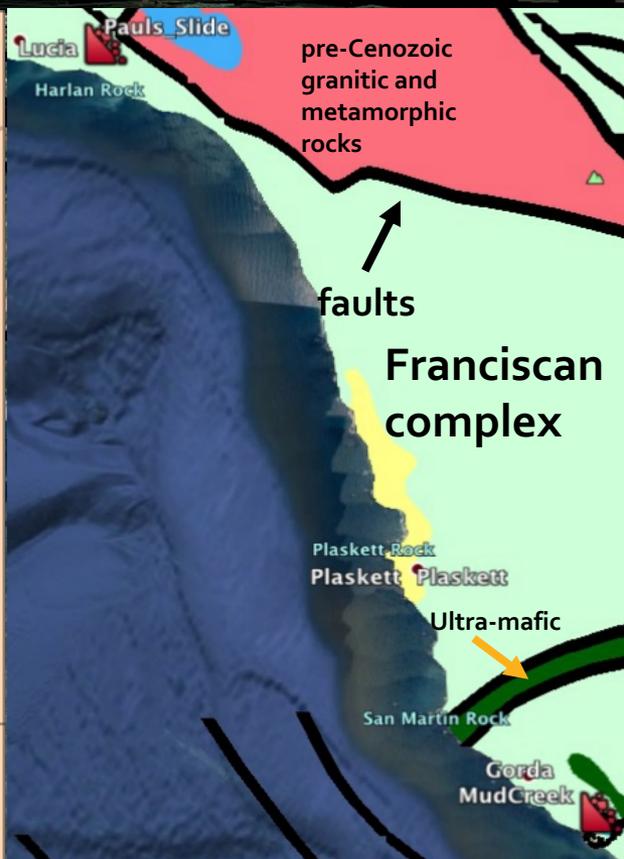
- Santa Lucia Mountains
- Compressional deformation related to San Andreas and San Gregorio
- Uplift rates ~ 0.8 mm/yr (Ducea et al., 2003; Johnson et al., 2018)

- Franciscan mélange
  - Accretionary prism complex
  - Argillaceous matrix

- Precip. = 1 m/year
- 80% between Oct & May
- Coastal retreat rates ~0.3 m/yr

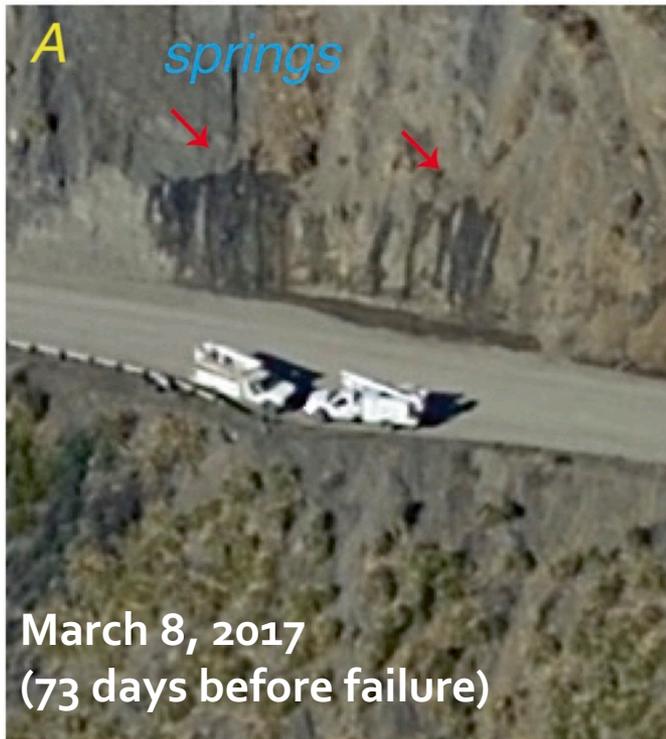
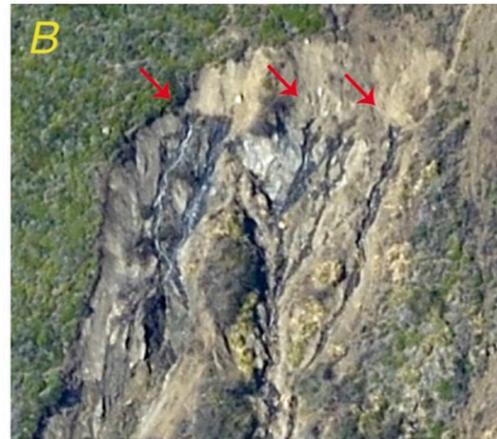
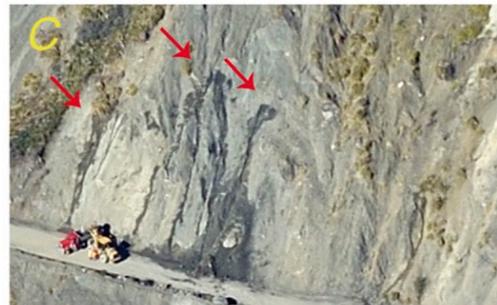
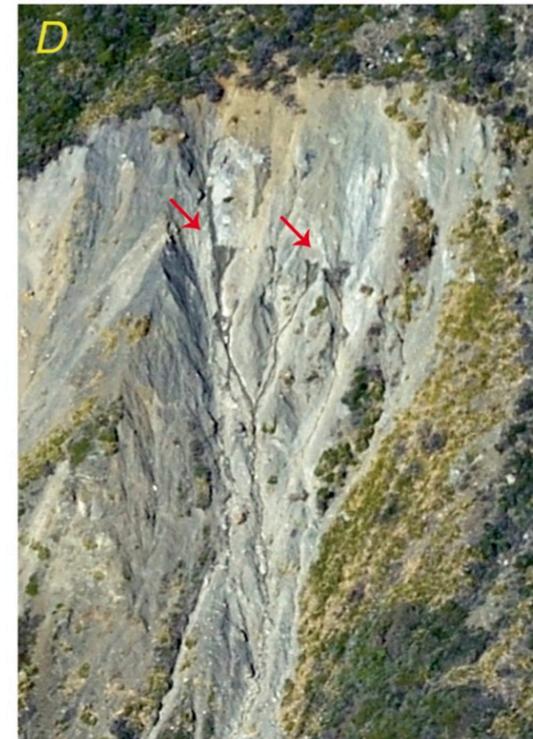
## High pore-water pressures

## Evidence of high pore-water pressure

- Springs produced darkened areas of soil with downslope seepage
- Water flowing down gullies
- Not caused by overland flow from recent rainfall, because no precipitation occurred at the site during the previous 2 weeks
