JPL Publication 2005-2

Genesis Failure Investigation Report

JPL Failure Review Board, Avionics Sub-team

July 2004

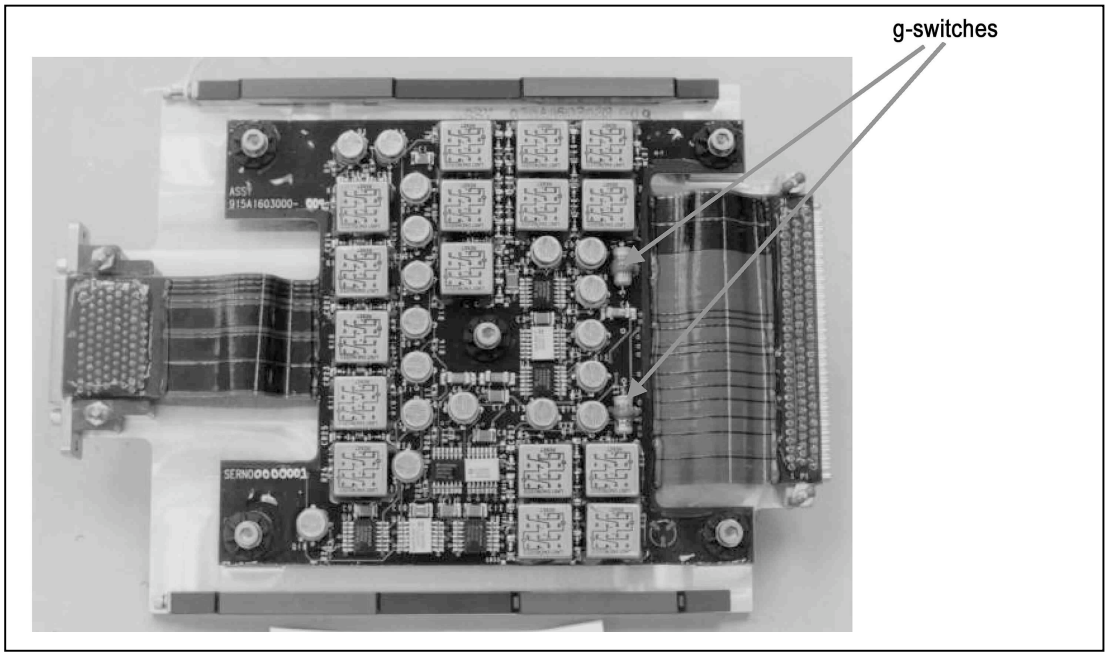
Figure 2-9. G-switch location in relay module

Shortly after the mishap, LMA engineers identified the proximate cause of the failure in less than a week. The forensic evidence indicated that the first pyro event had not occurred (i.e., the drogue chute had not deployed). The list of possible common mode failures that could affect both avionics units was small. LMA engineers quickly identified the improper orientation of the G-switch as a simple common fault in both redundant avionics units that could explain the entire failure. Examination of the as-built relay module indicated that this was indeed what had happened.

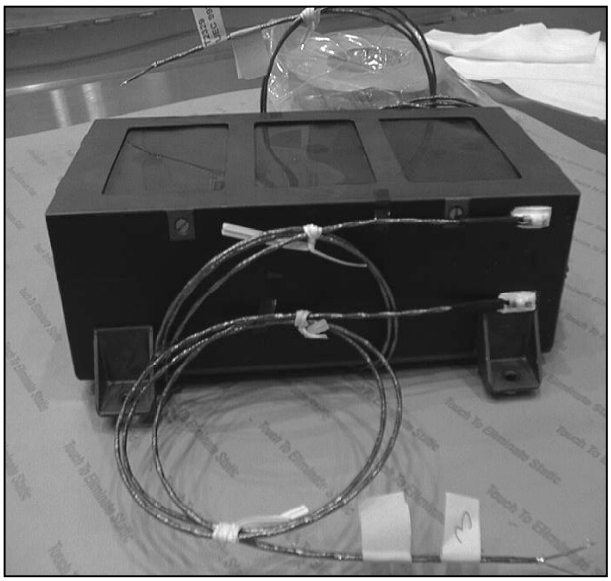
Figure B-1. Genesis battery with temperature sensors attached prior to installation of heaters and black Kapton top layer

After the hard landing of the SRC in the Utah desert, speculation abounded as to the batteries' contribution to the failure. SO_2 monitors at the impact site indicated presence of the gas, a main component of the battery cells, suggesting a possible battery leak. Initial battery voltage measurements (post-impact) indicated a totally depleted battery. However, the outer physical appearance of the battery after the impact did not show significant damage.

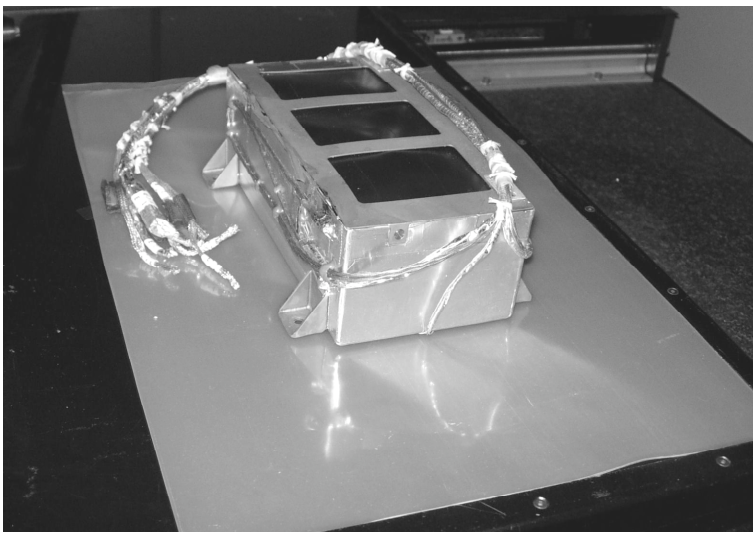
Figure B-2. SRC battery, pre-flight

A thorough inspection of the battery was performed at JPL, including dimensions, weight, and some electrical measurements at the battery level. Peripheral devices such as the four temperature sensors and the three heater strips were also measured. All measurements were also done on the ATLO battery for comparison. The outer appearance of the battery looked very clean and indicated minimal damage from the hard landing. Figure B-2 shows the battery during initial inspection at JPL.

With the exception of a bowed top cover and some discoloration/staining on the top cover and black Kapton (Figures B-3, B-4), the battery surprisingly escaped severe damage from the hard landing. Physical dimensions of the battery were measured and were found to be comparable to pre-flight measurements, with the exception of height. This discrepancy is due to the bowing of the top cover.

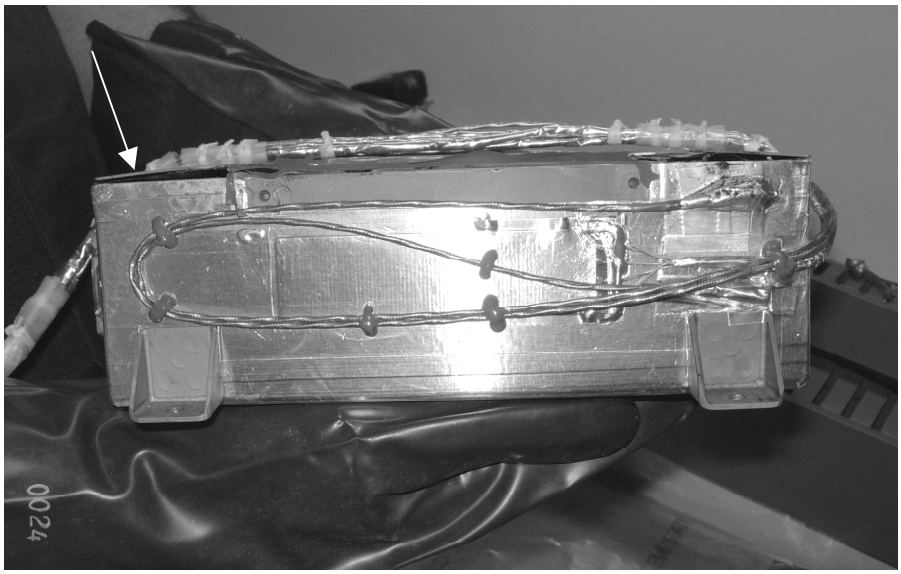
Figure B-3. Battery showing bowed cover

The post-flight battery weight of 1.810 kg indicated a decrease of about 250 grams compared to the as-built weight (ATLO battery weight was 2.060 kg). Later procedures would show that this was due to loss of active materials from the cells due to venting.

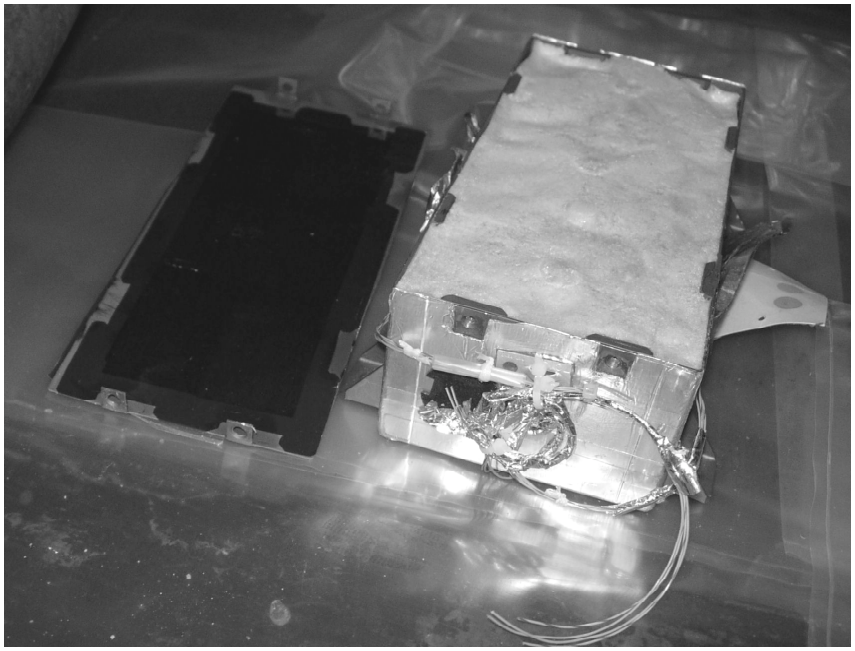
Figure B-6. ATLO battery showing pristine Eccofoam insulation

The ATLO battery (i.e., one that had not been exposed to a flight environment) was opened first for comparison purposes. Figure B-6 shows the top of the ATLO battery underneath the cover and Kapton layers. The Eccofoam insulation looks pristine and has a pinkish color. By contrast, when the SRC battery top cover was removed, there was significant discoloration of the Eccofoam insulation, indicating exposure to excessively high temperatures (Figure B-7). The worst discoloration, almost black, was localized over the nickel cell interconnect tabs. This condition is consistent with high-rate discharge over a significant duration.

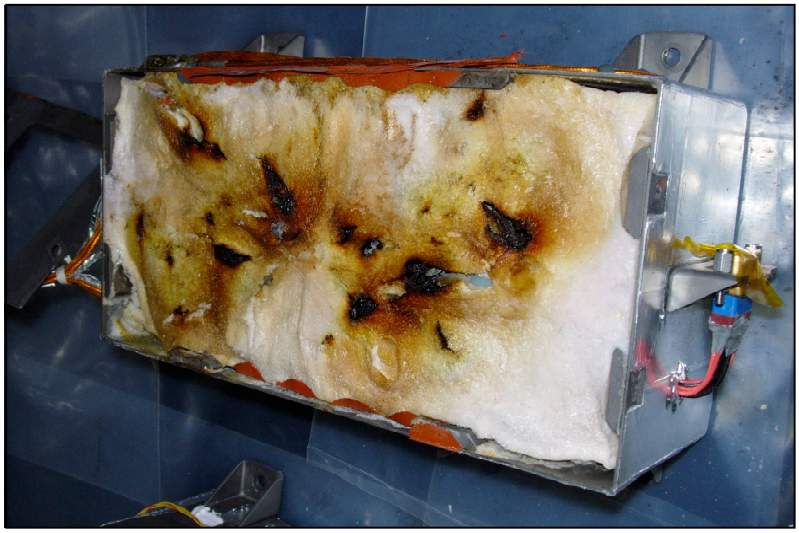
Figure B-7. SRC battery Eccofoam insulation

The likely cause for all cells to vent is external shorting. The observed "burning" of Eccofoam in the vicinity of the tabs and the blackened insulation under the tabs leads to the conclusion that the tabs were very hot. Eccofoam heated in air was observed to turn black at about 200°C. Calculations show that nickel tabs could reach 500°C within seconds at short-circuit currents. As built, the positive tab from the cell top was tightly strung over the edge of the negative case cell and attached to the sidewall of the adjacent cell in the string. The manufacturer reported that they pulled the tabs tight to make sure that any cell movement would cause a tab to break, thus effectively working as a mechanical fuse in the case of a severe impact. The battery did not include a fuse or any other device to limit short-circuit battery current.

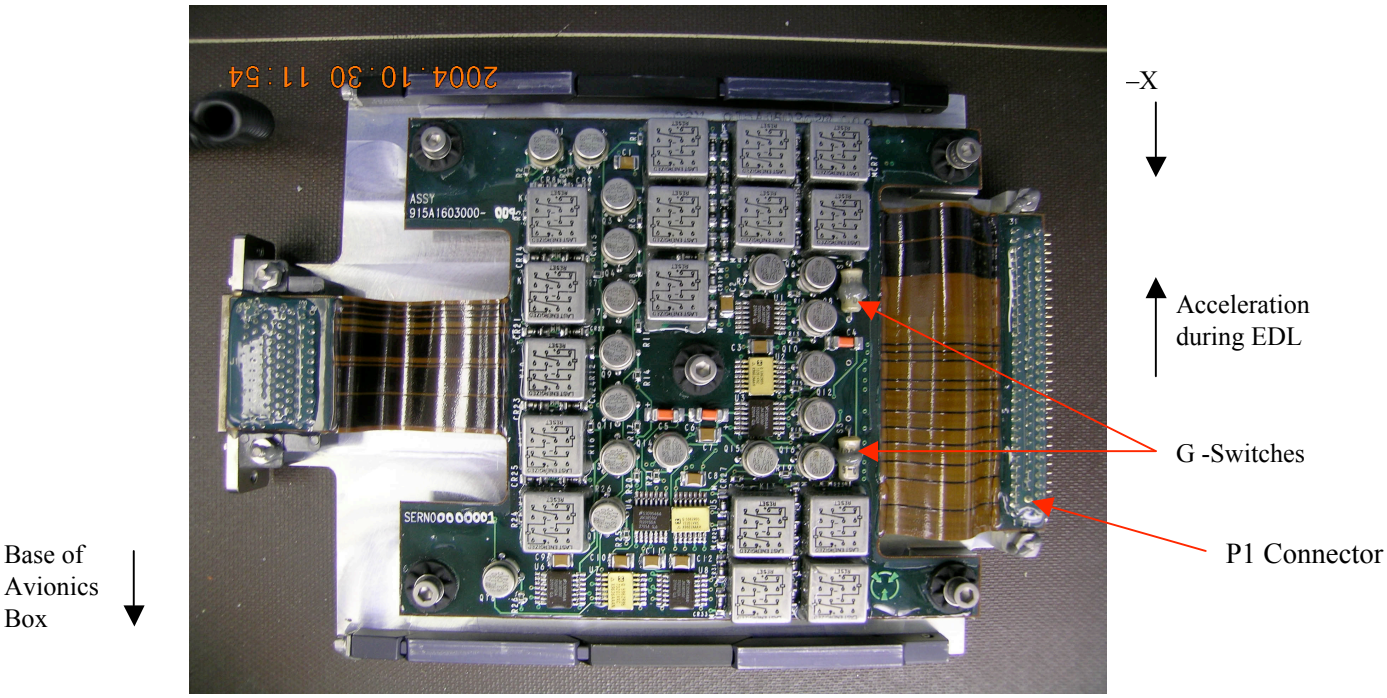
Figure G-1. Avionics Box A Relay Card SN 001

A card-level continuity test was performed. Continuity was measured from power-to-ground and power-to-power for each primary and secondary power net. There were no shorts.

Continuity was also measured at the card level from each separate pyro output-to-ground and from each separate pyro output-to-pyro output. There were no shorts.

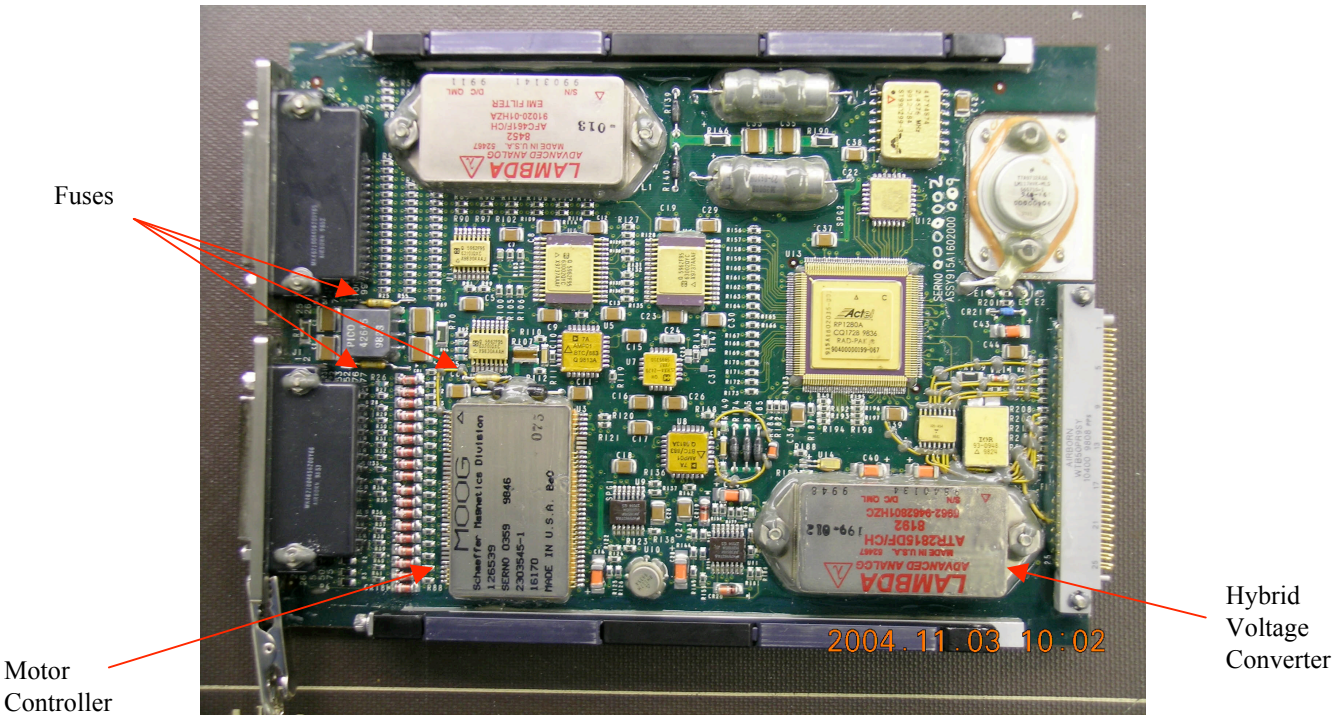
Figure G-4. Avionics Box A MDE Card SN 002

MDE Card S/N 002. The MDE card was in very good condition (Figure G-4). A slight deformation of the board was observed, less than the EST. The two 5-A 28-V spacecraft power fuses appeared normal with no visible evidence of damage or overstress. Continuity tests verified the integrity of the fuses. The hybrid DC/DC secondary voltage converter appeared normal with no evidence of damage or overstress.

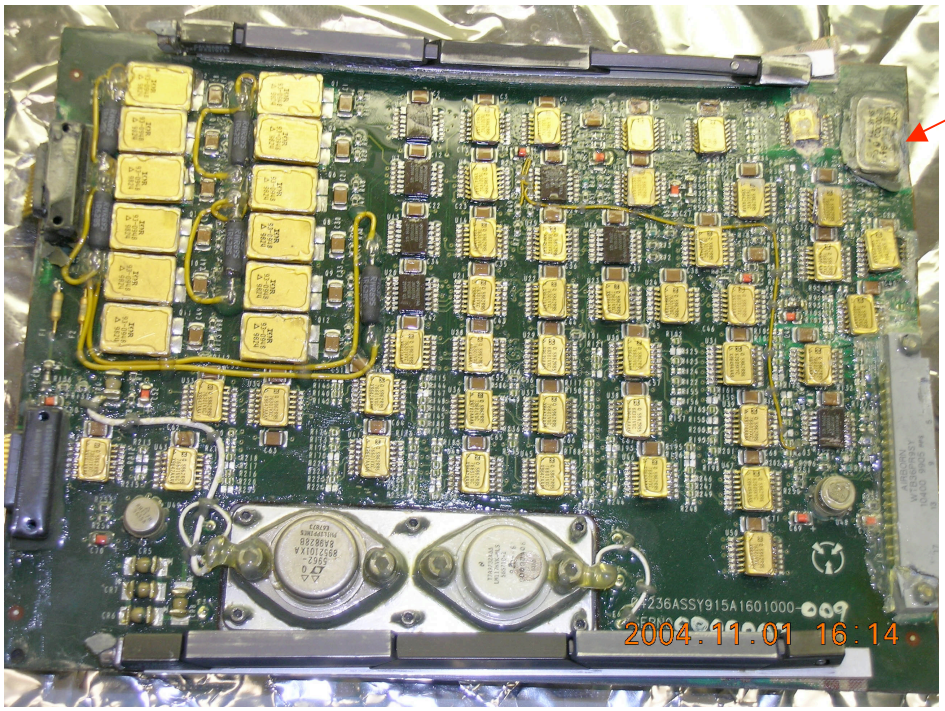
Figure G-6. Avionics Box B EST Card SN 002

EST Card S/N 002. The EST card was heavily damaged. The connectors were smashed and badly deformed; there was extensive damage to the PWB near one corner (see Figures G-6 and G-7). However, there was no visible sign of overstress that would indicate an EST card power-to-ground short, such as discoloration or burning of the PCB or conformal coating.

Note physical damage in this corner.

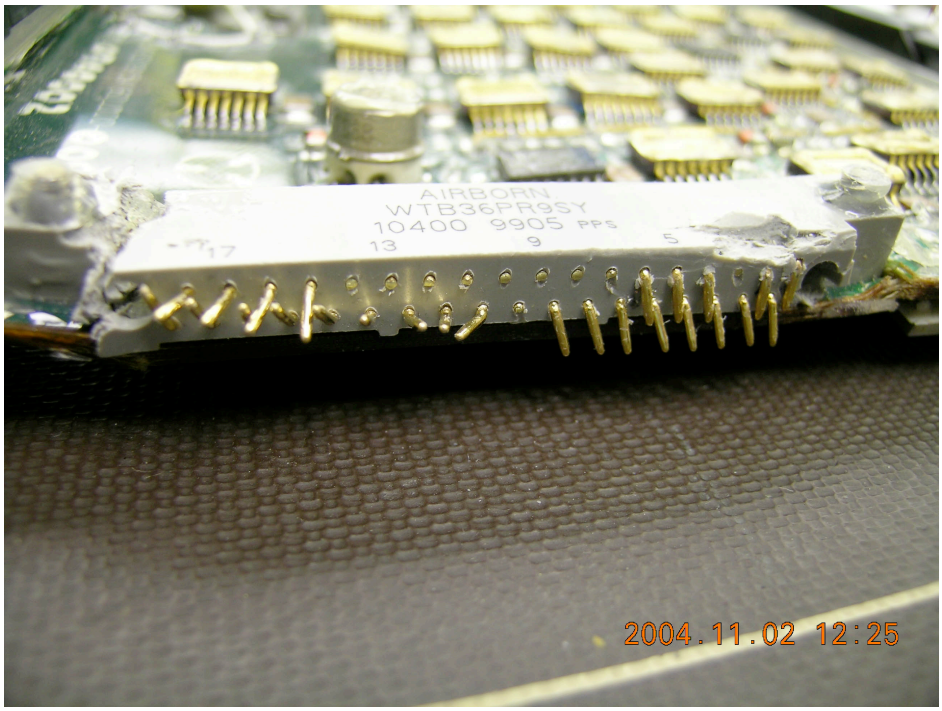
Figure G-7. EST SN002 P1 Connector

Damage to the connectors prevented their use for card-level continuity tests; therefore, testing was performed by probing board solder joints through the conformal coating. Primary and secondary ground nets were shorted to ground and to each other. Pins touching each other on the smashed connector may have been responsible for the shorts (Figure G-8). If these shorts had occurred while the circuit was powered, there would have been considerable heat generated. However, the lack of visual evidence such as discoloration, burning, or melting of the PCB suggests the power-to-ground shorting of the EST card was due to crash damage and not an in-flight failure.

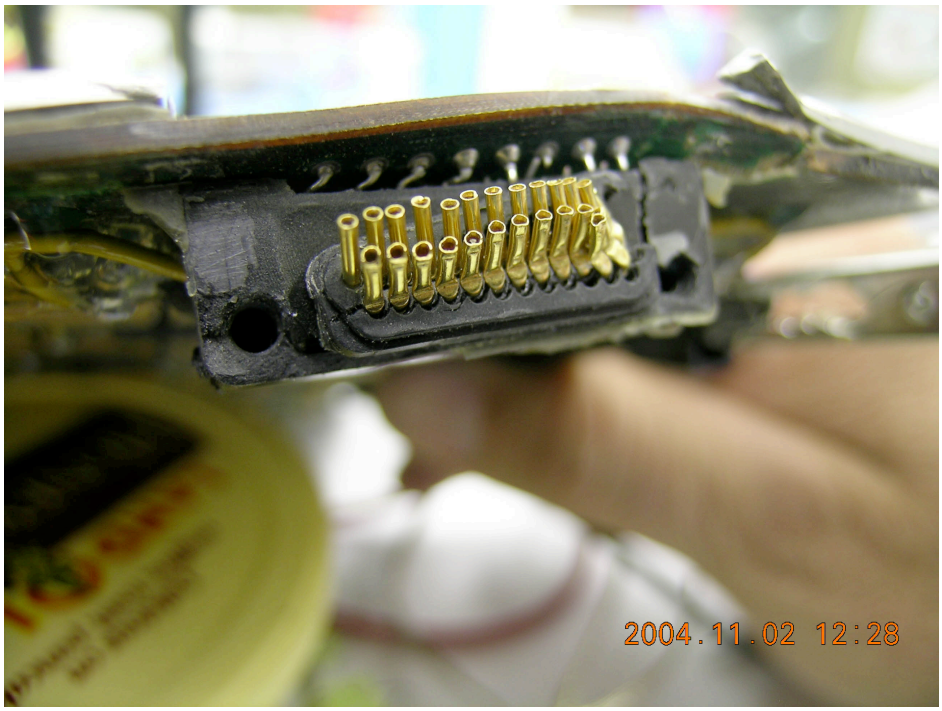
Figure G-8. EST SN 002 J2 Connector

Pyro output continuity testing could not be performed because of connector damage.

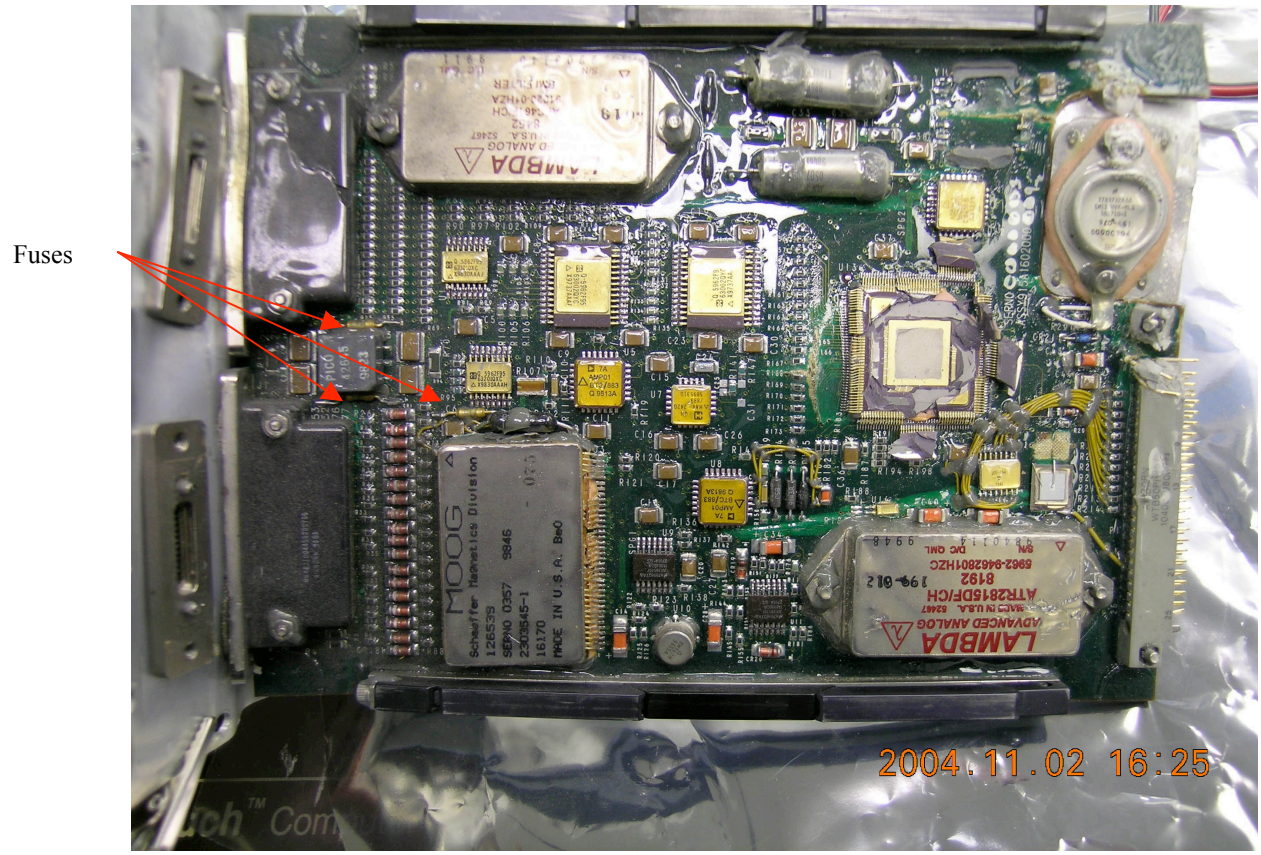
Figure 9. Avionics Box B MDE Card SN 003

MDE Card S/N 003. The MDE card was in bad condition, with extensive damage to the components and board near the P1 connector (Figure G-9). However, the two 5-A 28-V spacecraft power fuses escaped damage and appeared normal, with no visible evidence of damage or overstress. Continuity tests verified the integrity of the fuses.
