COLUMN GRID ARRAY REWORK FOR HIGH RELIABILITY

Atul C. Mehta and Charles C. Bodie Jet Propulsion Laboratories
California Institute of Technology

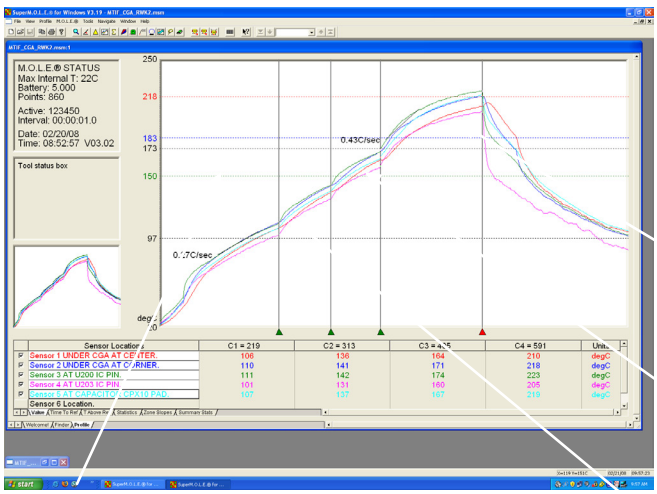
Figure 7 - Graphical representation of thermal profile

Since the assembly consisted of 0.125 inch thick board with several heavy ground and power planes the thermal profile was conducted in series of steps as recommended by the manufacturers. The steps are a) Preheat the nozzle b) Preheat the assembly c) Soak. the assembly and d) Heat the assembly to achieve final reflow
The maximum temperatures reached during the process are shown in the table 1. The parts on the top surface of the board all reached the temperatures to near 210 degrees C which would reflow the solder joints (183 degrees C is the reflow temperature). The underside of the PWB directly under the CGA reached 169 degrees C which is well under reflow temperature of the assemblies.

Figure 7 depicts the graphical representation of thermal profile.

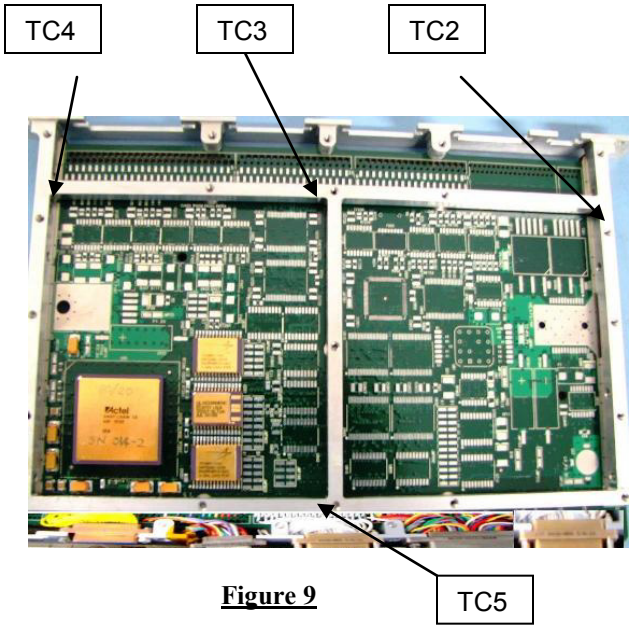
Figure 9

A question came up as to the temperatures experienced by the frame and the connectors mounted to the frame of the PWA slice during rework of the CGA package. Figures 9, 10, and 11 and tables underneath each provide the temperatures of the various locations on the frame and the connectors.

Thermo Couple Locations	Maximum Temperature Reached ºC
TC2	175.6
TC3	128.3
TC4	100
TC5	113.9

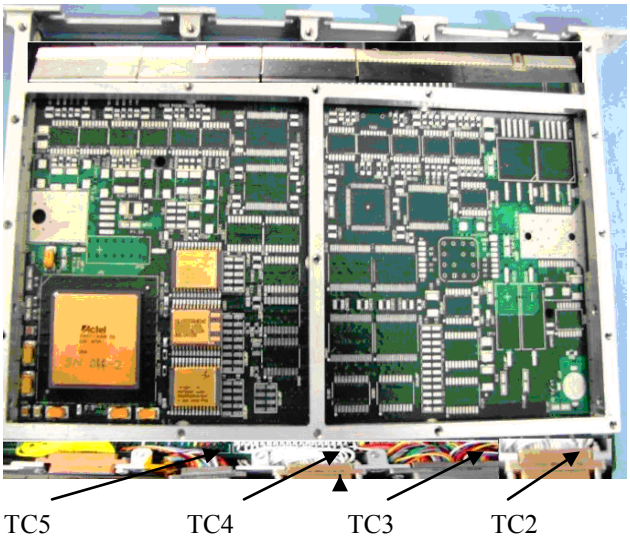
Figure 10

Thermo Couple Locations	Maximum Temperature Reached ºC
TC2	113.9
TC3	122.2
TC4	116.7
TC5	116.7

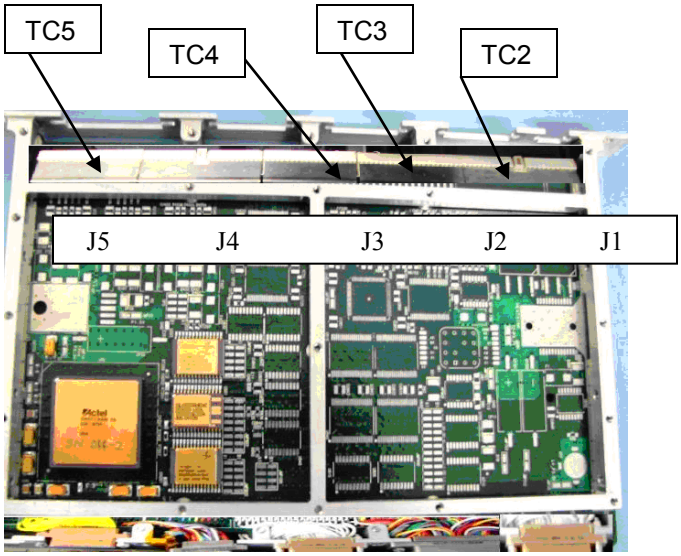
Figure 11

Thermo Couple Location	Maximum Temperature Reached ºC
TC2	155
TC3	137.2
TC4	103.9
TC5	93.9

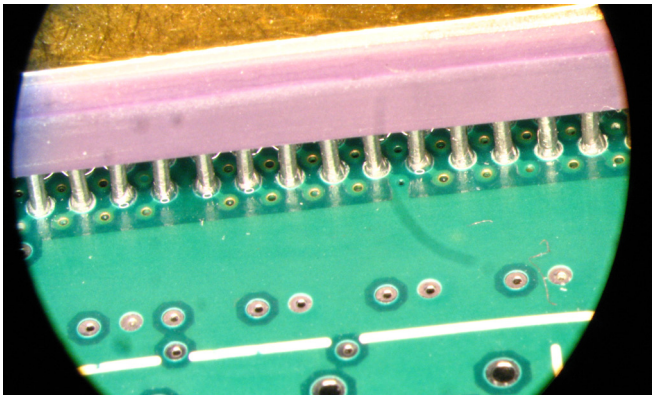
Figure 12 - CGA Columns Soldered to PWB

Figures 12 and 13 Shows a series of typical solder joints obtained after the vapor phase reflow.

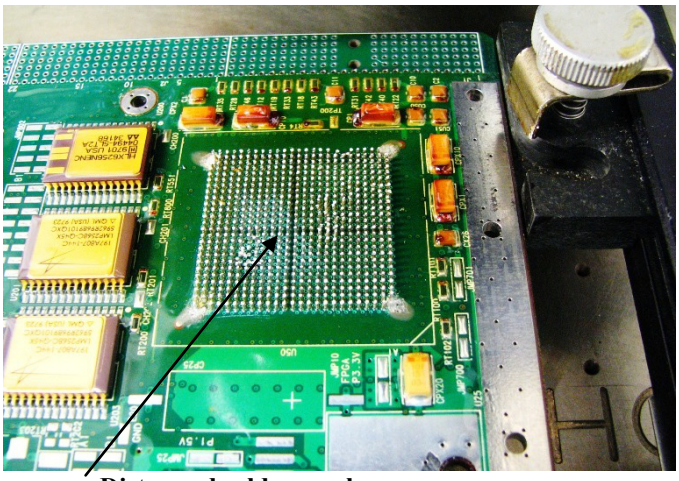
Figure 15 - Most Columns remain on PWB after part removal

Removal of the original CGA package from the conformal coated assembly was done using the Hot Gas Rework system. The removal process resulted in all of the columns separating from the ceramic package and remaining soldered to the printed wiring board pads. See Figures 15 and 16. Figure 16 shows columns under UV light reflecting the conformal coat. Each column is attached to the bottom of the ceramic package with Sn63 solder and reflows at the same time as the Sn63 on the pads. The coating adds an adhesive quality to the PWB and, hence, the columns have a greater tendency to stick to the PWB. Removal of the columns and cleaning of the pads of conformal coating residue required 8 full hours of work by a highly skilled technician using solder wick and cleaning solvents. The pad area was very noticeably distressed by the intensive cleaning action. See Figure 15. Further the solder mask between the pad and the associated via was destroyed at three locations. See figure 17. This damage, if not repaired, will result in the solder that is melted during reflow running down the via and, thereby, starving the solder joint between the column and the pad creating a questionable connection. The solder mask was repaired by the application of a tiny ribbon of epoxy isolating the pad from the via preventing the solder from following the trace to the via. From this experience it was recognized that conformal coating of the CGA should be delayed as late in the testing as possible to avoid the necessity of reworking conformal coated packages and to avoid the associated risk to the assembly. The CGA was replaced using the rework system in following sequence.

Distressed solder mask

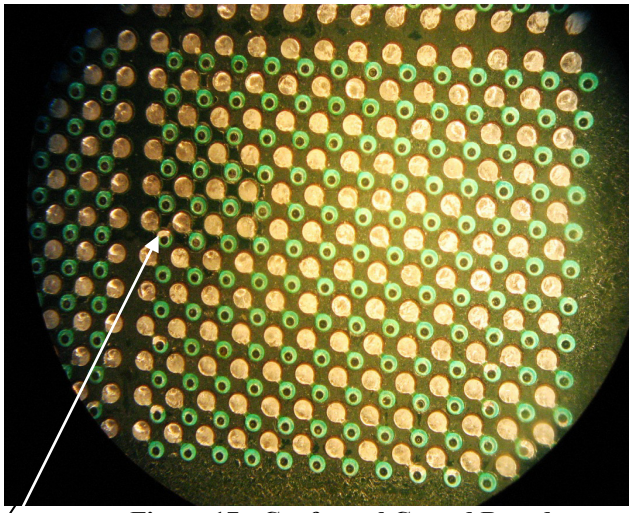
Figure 17 - Conformal Coated Board pads after removal and Clean-up of Columns

Solder mask damage

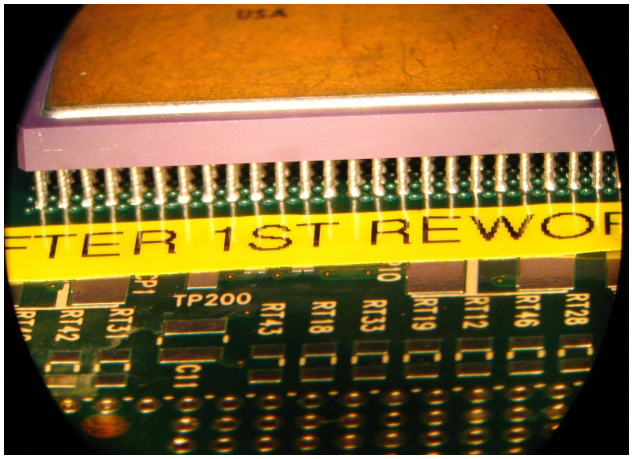
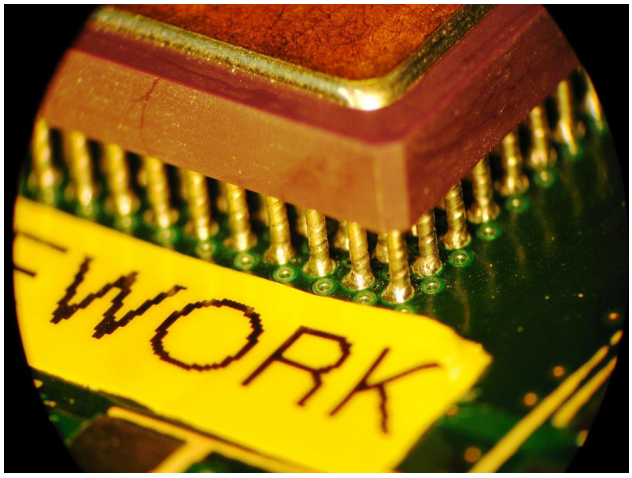
Figures 18 and 19 shows solder joints formed during the rework process whereas figures 20 and 21 shows the X-Ray views of CGA solder joints. The Joints as viewed in X-Ray image appear to be uniform and without any apparent anomalies.

Figure 18 - Solder joint generated by rework process

Figure 19 - Close up view of Solder joint generated by rework process

- Deposit Sn 63 solder paste on to the pads, using mini stencil.
- Place the device using split vision rework system
- Reflow the solder using the same rework system.

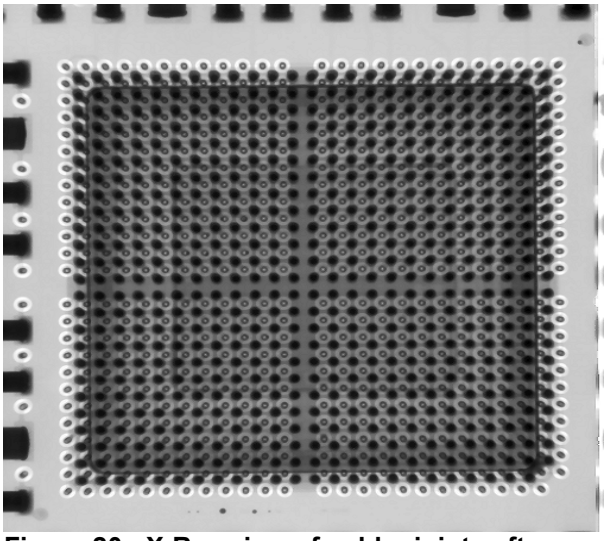
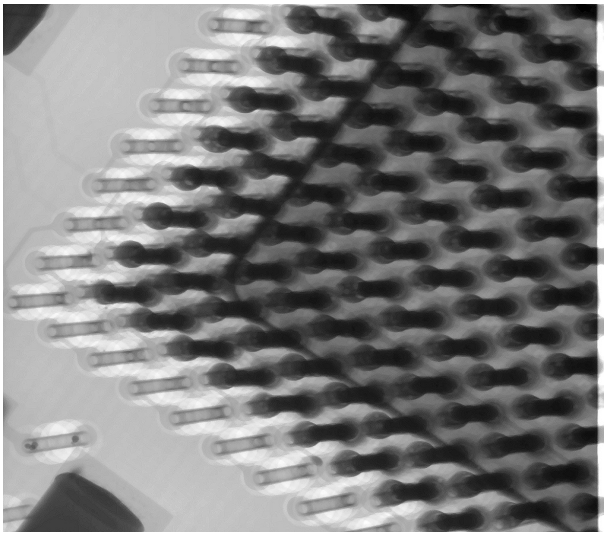
Figure 20 - X-Ray view of solder joints after rework

Figure 21 - Tilted X-Ray view of solder joints after rework

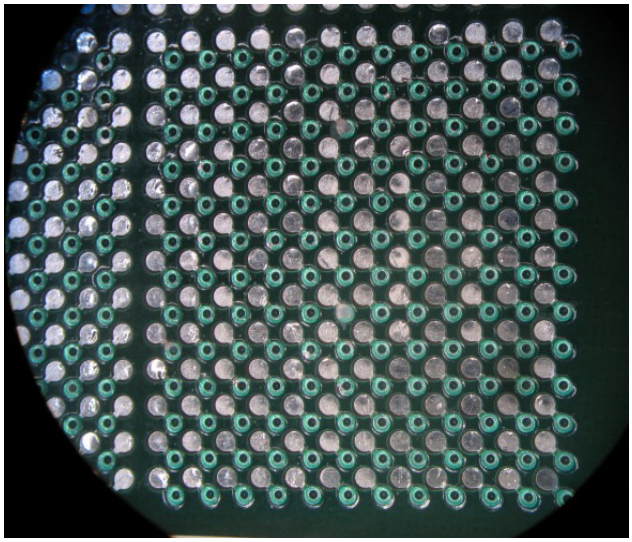
Another test sample was prepared and soldered on the vapor phase soldering machine, but was not conformal coated. The CGA was removed using the rework station. The clean-up of the pads took the same technician less than 2 hours to complete. The pad area after rework looked pristine. See Figure 22. There was no damage to the pads or to the solder mask. The new CGA package was placed and soldered using the rework system. The daisy chains were all determined to be 100% connected by the resistance measurements.

Figure 22 - Non Conformal Coated Board pads after removal of CGA and Clean-up of Columns

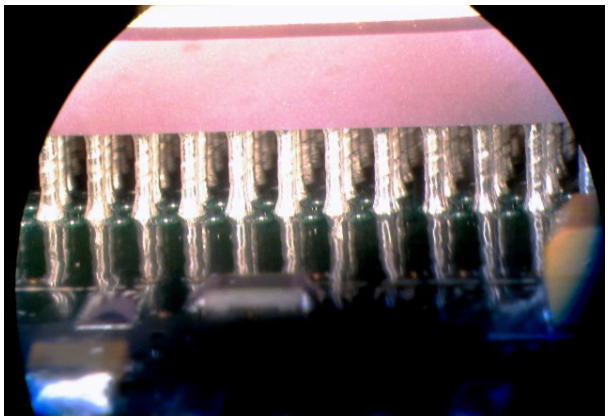
Figure 23

In Figure 23, shown are the Close up view of Solder joints generated by rework process.

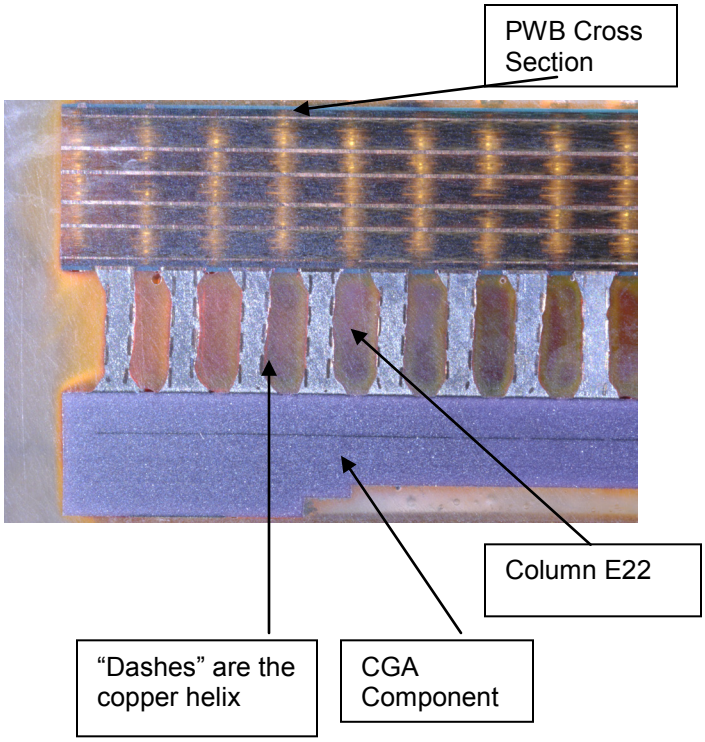
A failure of S/N 013-2 was initially detected after 169 Cycles by the continuous monitoring instrumentation. The failure was in chain 1 of the five chains instrumented on each CGA. At 207 cycles manual resistance measurements showed that the circuit had a resistance of 118 ohms. As the measurements were being taken, it was noticed that the resistance of this chain reduced to 9 ohms indicating that the high resistance circuit had sensitivity to movement. (This is consistent with a cracked solder joint). The chain resistance was 2.89 ohms at the beginning of the test sequence which is representative of all chain 1's on all samples.

The test was terminated after 328 cycles with the other chains intact. The measured resistance of the failed string at that time was 64K ohms in contrast to the 3 ohms that is the normal value. Through resistance measurements, the column associated with pin E22 was suspected. Microsectioning was performed by Section 514 Failure Analysis Lab. The photo in Figure 28 labeled "Suspected Column" shows the column E22. The solder fillets appear to be good and are similar to columns adjacent to it. SEM analysis was also performed and no cracks or any anomalies were detected. In fact all solder joints that were inspected were of high quality. The second photo (Figure 29) shows the via associated with the column E22. All vias inspected on the board and on the test coupon provided with the board are intact and are of high quality. No definitive cause of the failure was found, but all evidence would lead one to believe that the solder process was not at fault. The early failure (169 cycles), when all other boards went through many more cycles with no failures, indicates an infant mortality of the part.

Figure 24 - Suspected Column

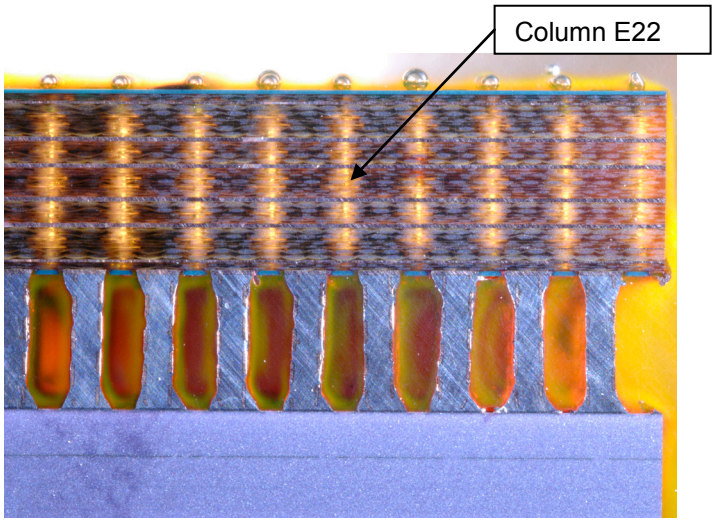
Figure 25 - Suspected Via
