Reliability of High I/O High Density CCGA Interconnect Electronic Packages under Extreme Thermal Environments

Rajeshuni Ramesham Ph.D.
Office of Safety and Mission Success
Reliability Engineering and Mission Environmental Assurance Office
Jet Propulsion Laboratory-NASA, California Institute of Technology
Pasadena, CA 91109
Tel: *818 354 7190;* ***e-mail:*** *rajeshuni.ramesham@jpl.nasa.gov*

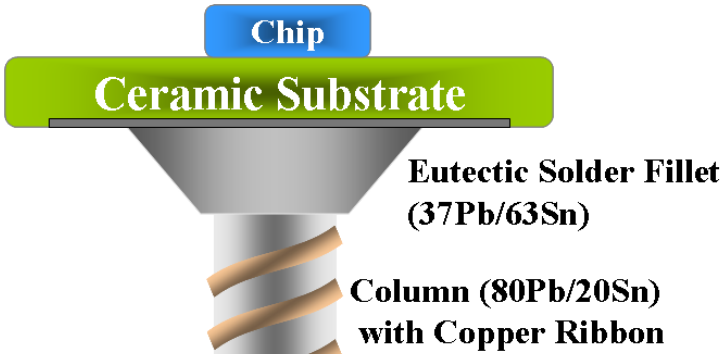
electrochemical corrosion. Any thermal co-efficient of expansion (TCE) mismatches between the board material and column, column and ceramic substrate causes shear displacement at each solder joint interconnect, which may lead to low-cycle thermal fatigue failure during thermal or power cycling. Reliability may be significantly increased by matching/tailoring the TCE of the substrate material, ceramic material, and the columns materials. The key contributing factors to solder joint fatigue failure are interdiffusion at the ceramic/solder and printed wiring board/solder interfaces, the solder material, dimensions of the contact area, and finally the environment where they are going to be used. Figure 1 shows the schematic of the 80%Pb/20%Sn column with copper spiral configuration in a given CCGA package.

Figure 1: Schematic of a Column in a CCGA Package

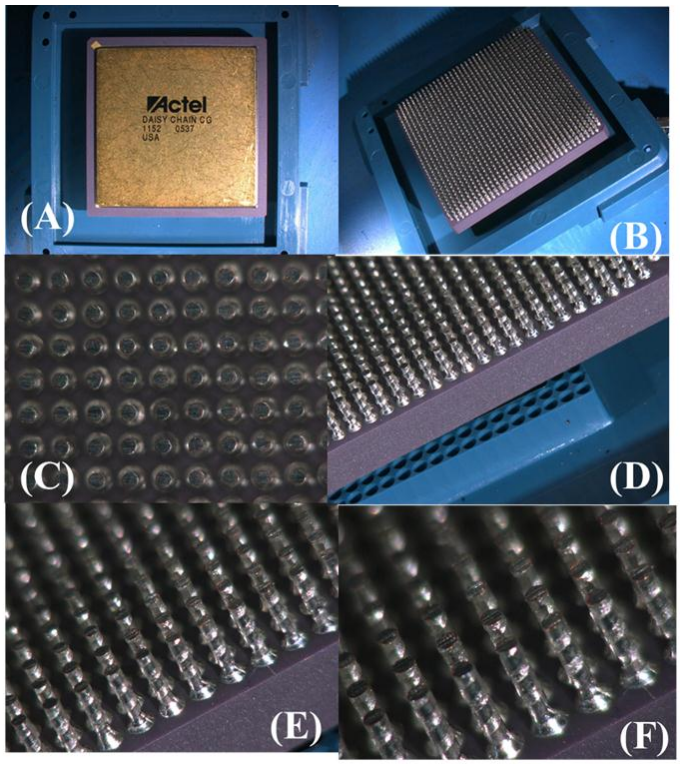
The boards were manufactured using a similar process reported by Mehta and Bodie in refs. [3,4]. They have used a processes that was implemented to qualify CCGA package assemblies using printed wiring boards (PWB), daisy chain CCGA packages for JPL/NASA projects. Figure 2 and 3 show the microscopic images photographs of the as received CCGA 1152 and CCGA 1272 packages prior to reflow at various magnifications. Complete CCGA array package has also been shown in the figure 2 and 3 (33 mm x 33 mm). Copper spiral can be seen around the column interconnect material in figures 2 and 3. Using of copper spiral around the column materials would increase the integrity of the column interconnect during the solder reflow process at higher temperature. Copper melting point is significantly higher than the column material. Figure 4 shows the reflow profile that was used to reflow CCGA 1152 and CCGA 1272 packages. Figures 5 show the digital photographs of the CCGA packages (1152 and 1272) after they have been reflowed over the polyimide PWB board. Figure 6 and 7 show the non-destructive x-ray images of the CCGA packages after solder reflow. There were no shorts or over flow of solder materials that can affect the CCGA packages and their reliability. It is clear from the x-ray images that there were no shorts in the packages.

Figure 2: Microscopic images of Actel CCGA 1152 package

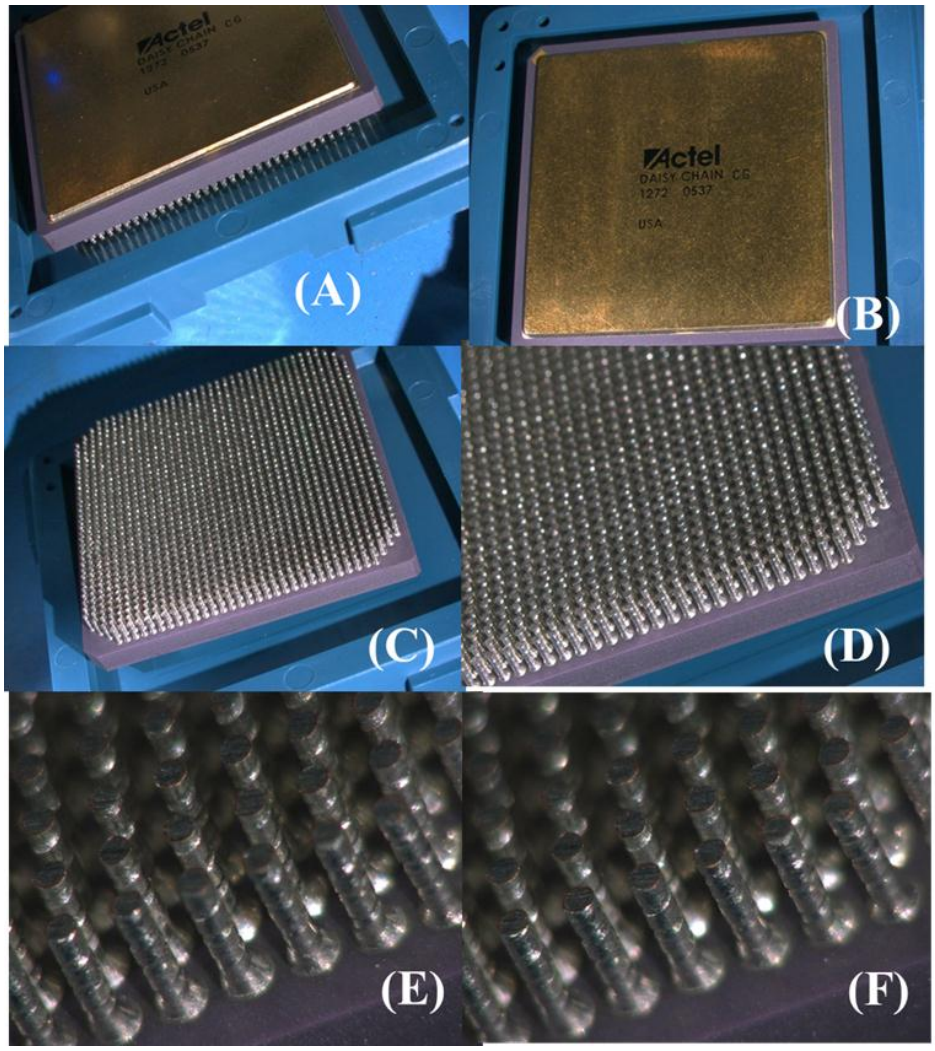
Figure 3: Microscopic images of Actel CCGA 1272 package

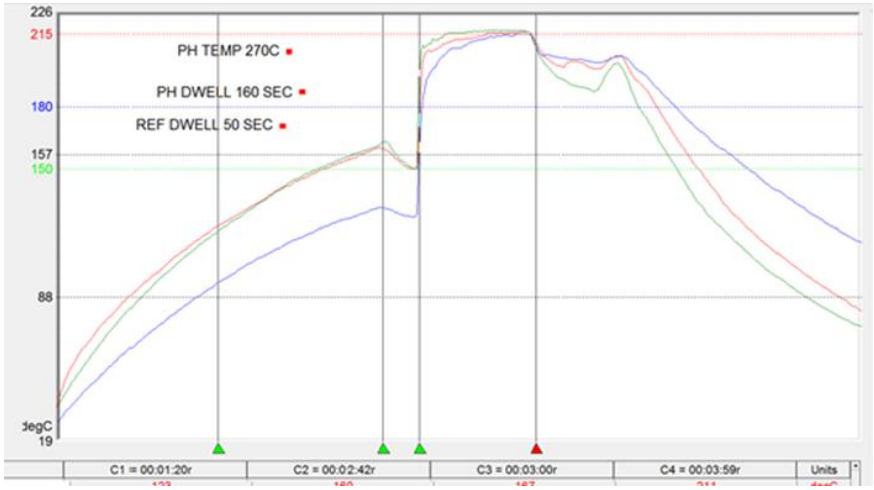
Figure 4: Reflow profile that was used to reflow CCGA1152 and CCGA1272 packages.

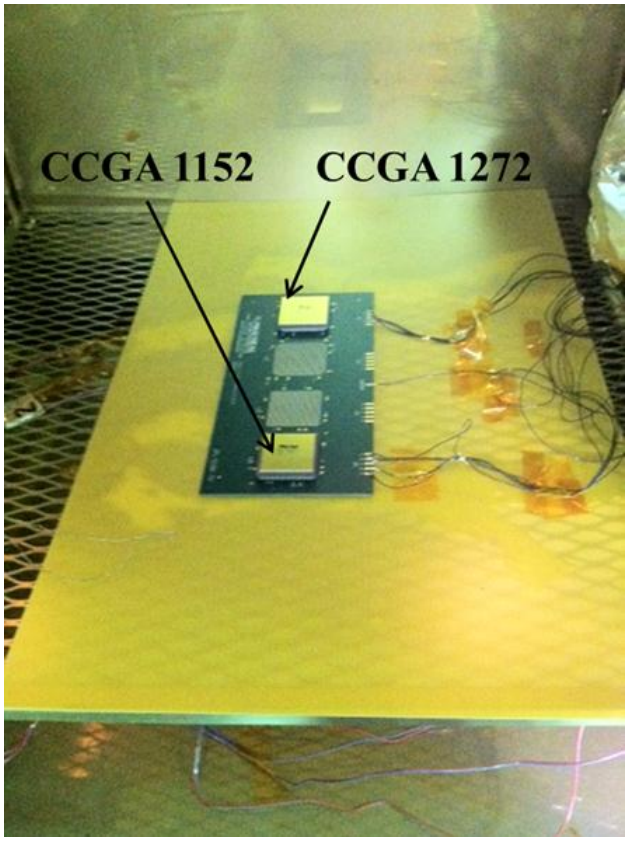
Figure 5: Optical photograph of the test board assembled with CCGA1152 and CCGA1272 packages

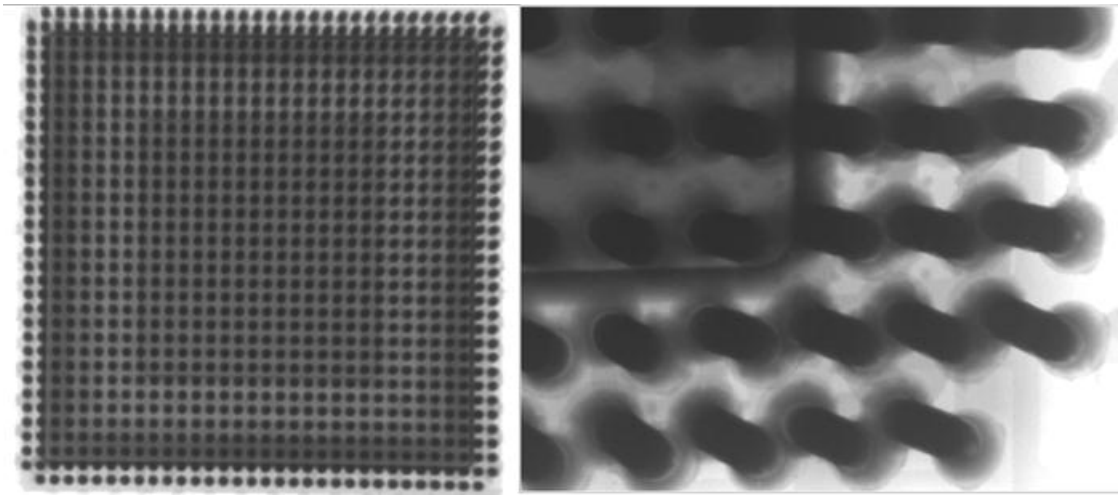
Figure 6: X-ray imaging of the CCGA 1152 assembled board prior to thermal cycling

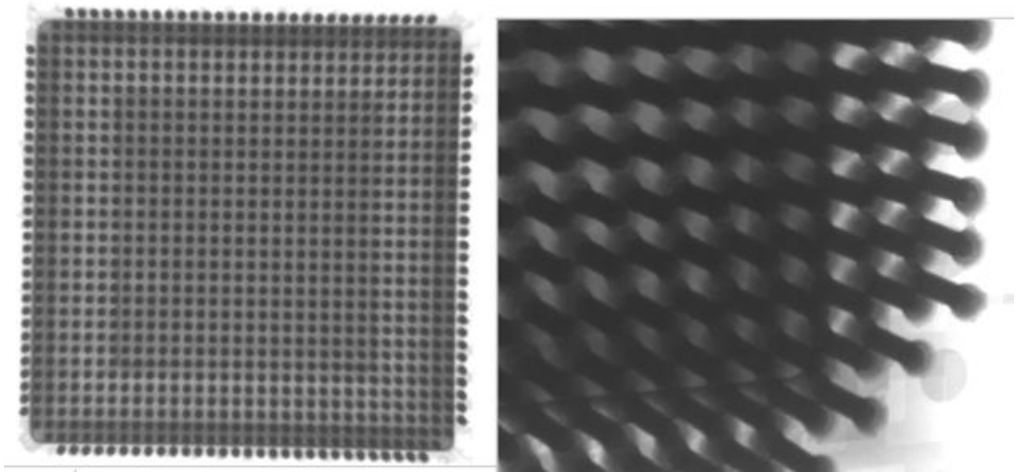
Figure 7: X-ray imaging of the CCGA 1272 assembled board prior to thermal cycling

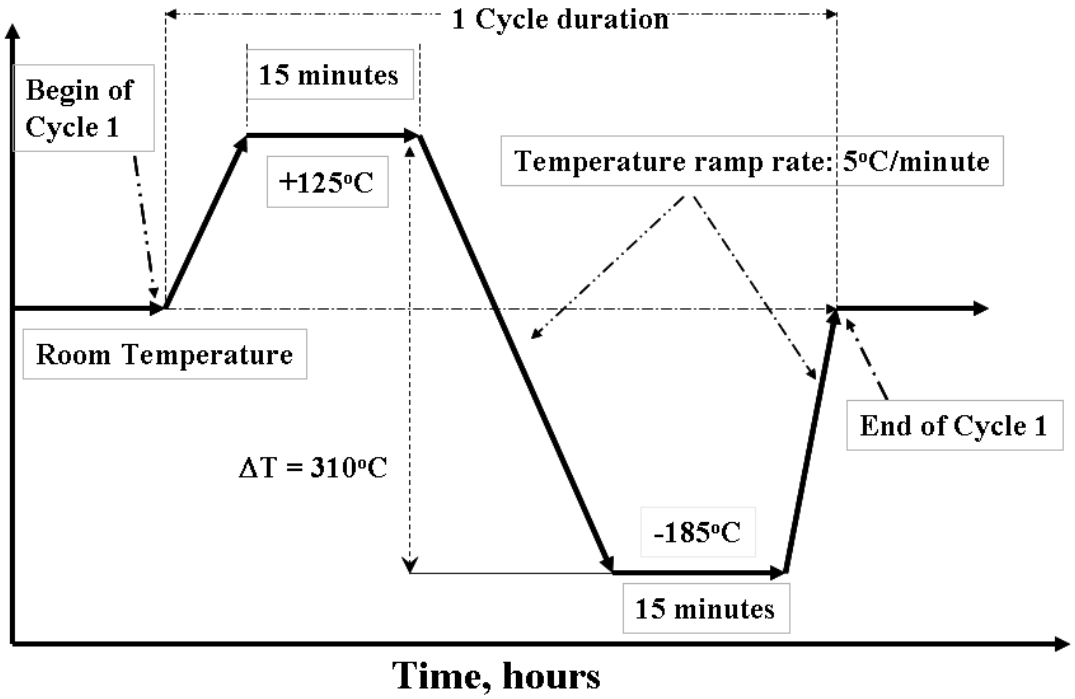
Figure 8 shows the thermal cycling temperature profile employed in this experimental study to perform the cycling of the daisy chained CCGA interconnect polyimide test boards. The low temperature of -185°C and high temperature of +125°C were used in this study. The temperature ramp rate was 5°C/min and dwell time was 15 minutes on hot and cold temperature during the thermal cycling.

Figure 8: Extreme Temperature Thermal Cycling Profile used in this study

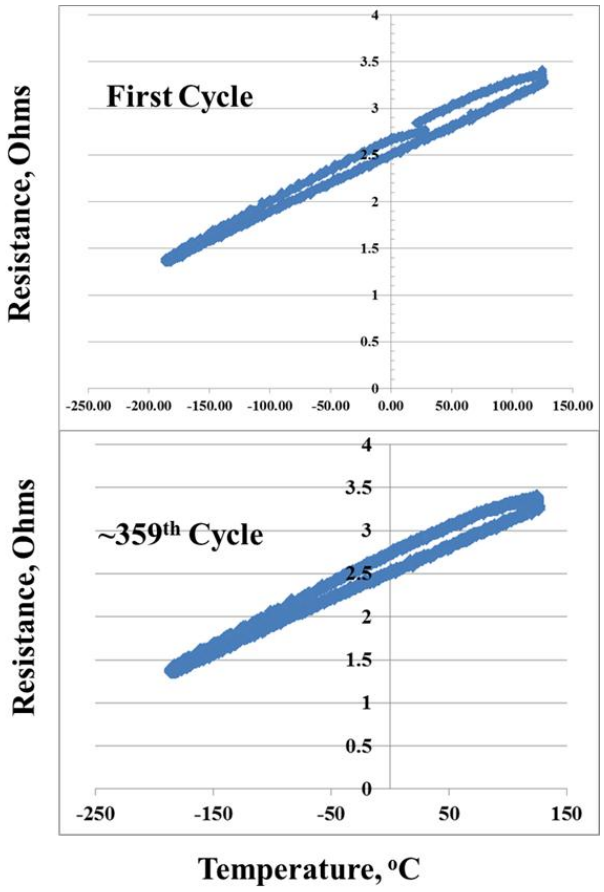
study. Figure 9 and 10 shows the daisy chain resistance of the same daisy chain as a function of temperatures at various stages of the thermal cycling such as first cycles, 359th thermal cycle and 596th thermal cycle. Resistance of the solder joint increases as the temperature increases and resistance decreased as the temperature decreases. Figure 11 and 12 shows the resistance of solder joints of all the daisy chains as a function of thermal cycles at first cycle, 359th cycle and 596th cycle. There was no change in resistance of all of the daisy chains even until 596th cycle and the test is still continuing. Most of the solder joints have been functioning normally electrically. The CCGA solder joints are robust electrically for 596 thermal cycles. There were no intermittent failures were observed even until 596th thermal cycle.

Figure 9: Resistance of one daisy chain during the first cycle and also during the 359th cycle.

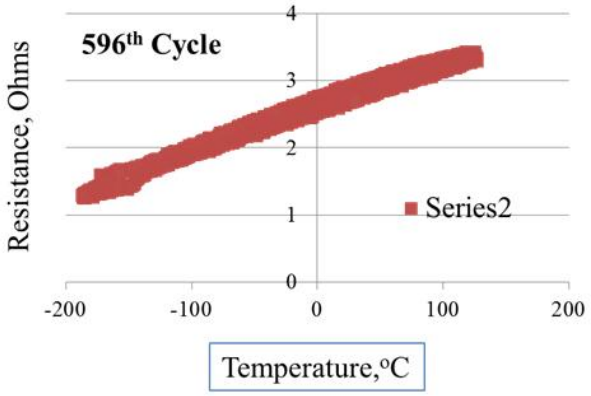
Figure 10: Resistance of one daisy chain during the 596th cycle.

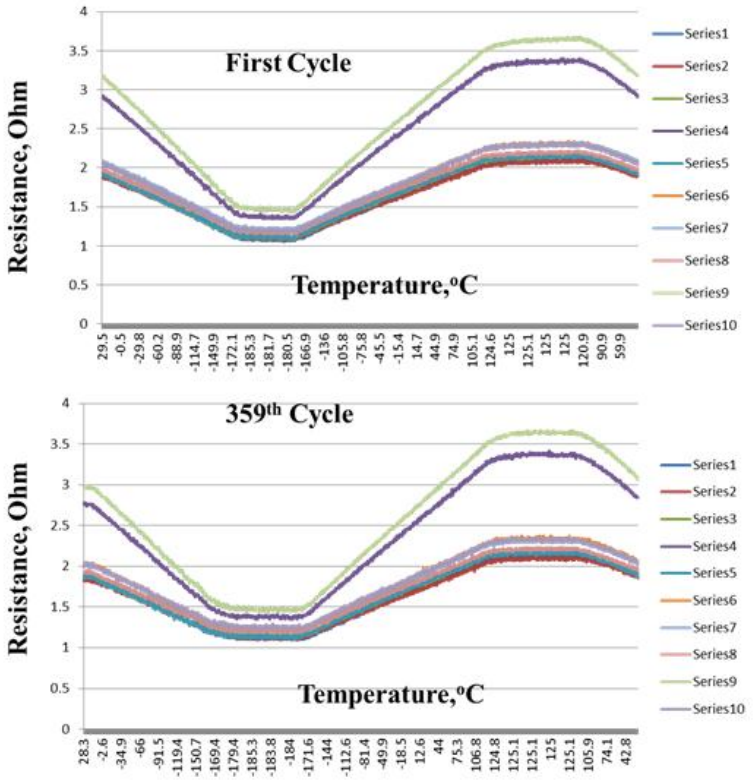
Figure 11: Resistance of ten daisy chains collected during the first cycle and also during the 359th cycle.

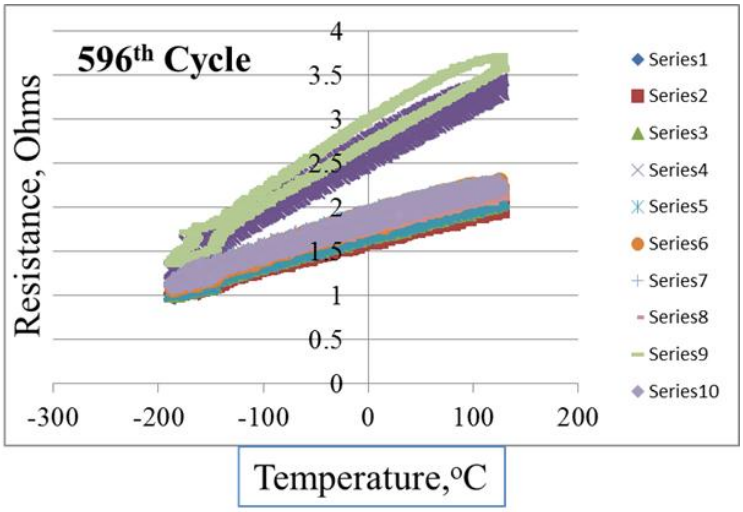
Figure 12: Resistance of all daisy chains during the 596th cycle.

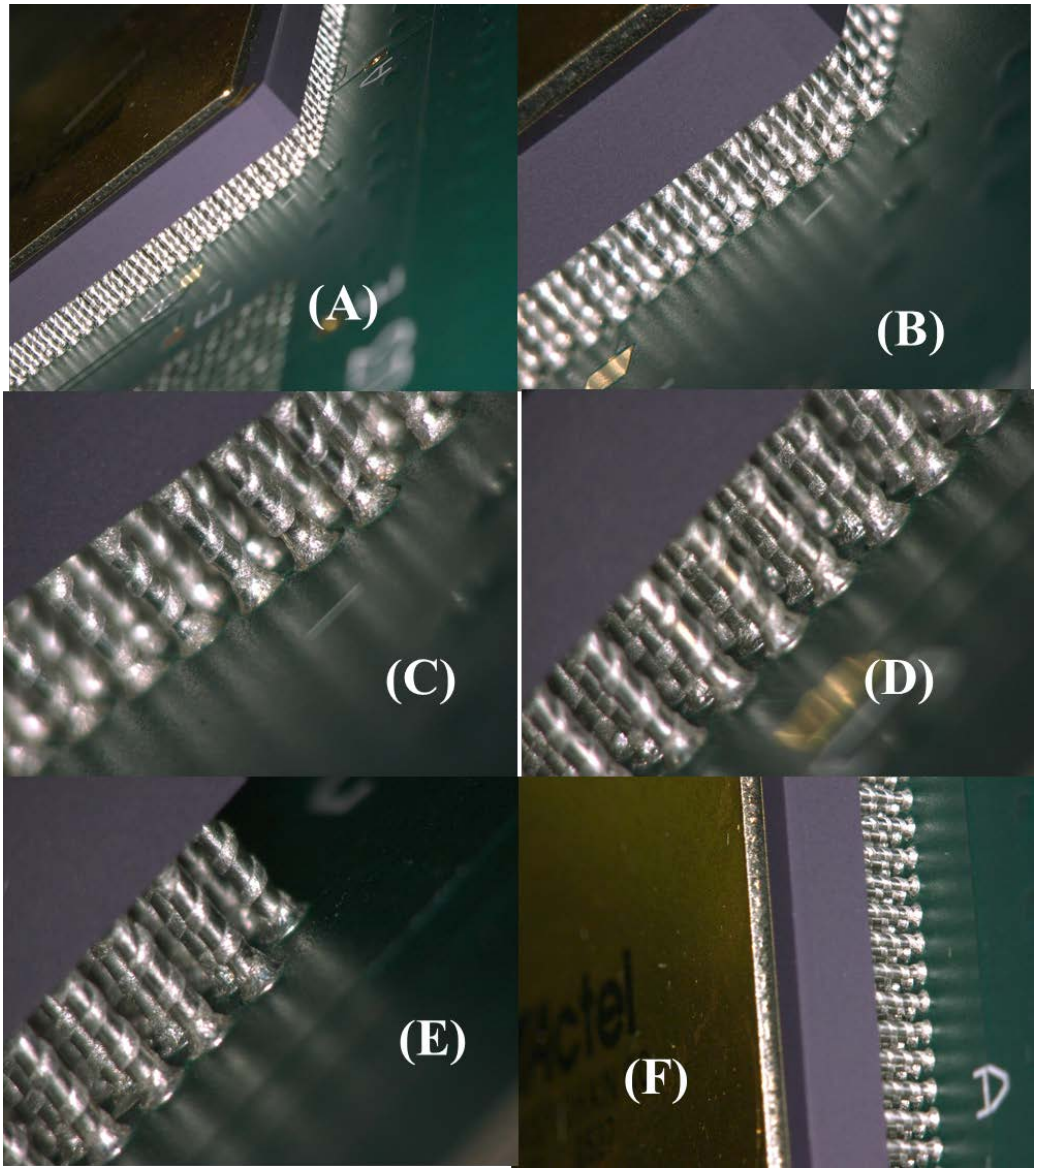
The CCGA test articles were inspected prior to thermal cycling and later subjected to thermal cycling. The CCGA packages were inspected after 258 and 596 thermal cycles. However, the daisy chains were monitored continuously during the thermal cycling from the beginning of the test. Figure 13 and 14 show the microscopic images of the CCGA1152 and CCGA1272 packages. There was no change in visual appearance of the solder joints. It indicates that the CCGA1152 and 1272 have survived for 258 extreme temperature thermal cycles. Solder joint fatigue started showing up in CCGA1152 package over CCGA1272 under extreme temperature thermal cycling from -185°C to +125°C. The ΔT of this test was 310°C which is significantly higher than military applications (-65°C to 125°C) and NASA thermal cycles (ΔT = 155°C, Temperature range: -55°C to 100°C). Figure 15 shows the microscopic images of the CCGAs that were inspected after 596 thermal cycles. Several micrographs show that the significant damage of solder joints particularly notably at the corners of the CCGA 1152 package as shown in figures 14 and 15. Some of the columns are about to dislodge from their original solder joint position. The fatigue has occurred at the column and board interface and also at the column and ceramic interface per figures 14 and 15. Figures 16 show the higher magnification of the solder joints of CCGA 1272 packages. Figures 16 show no fatigue indications yet with CCGA1272 packages even after 596 thermal cycles.

Figure 13: Microscopic images of the Actel CCGA 1152 package after 258 thermal cycles from -185°C to 125°C

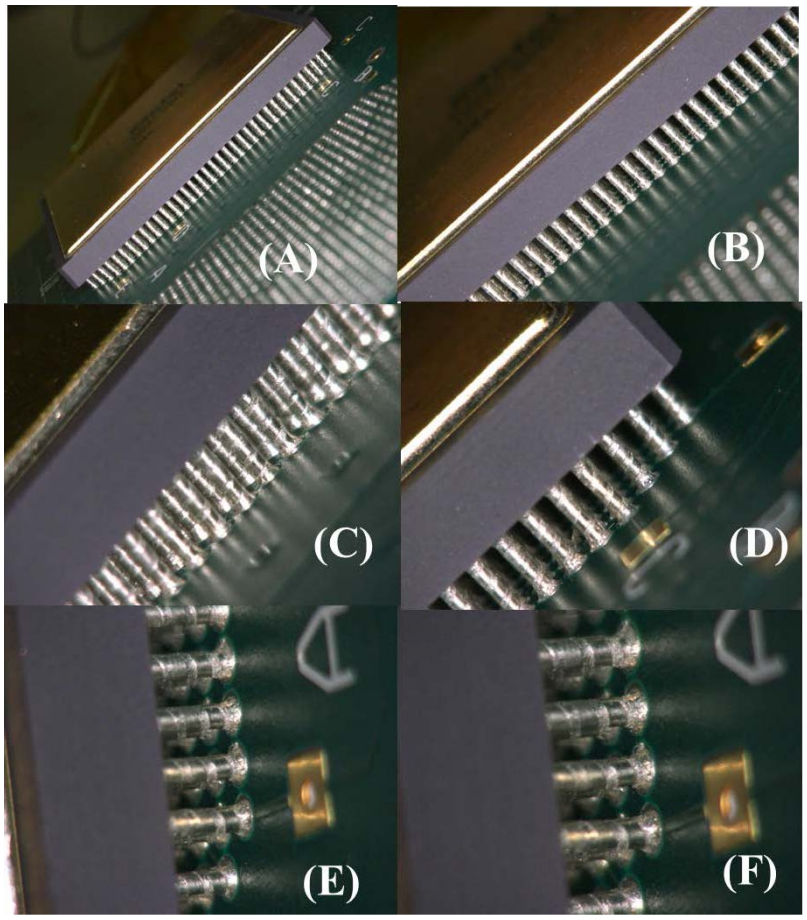
Figure 14: Microscopic images of the Actel CCGA 1272 package after 258 thermal cycles from -185°C to 125°C

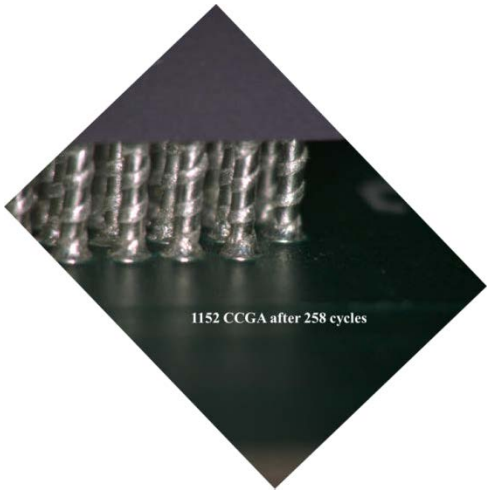
Figure 15: Microscopic image of the column which are slightly bent due to thermal cycling. (CCGA1152) for 258 cycles

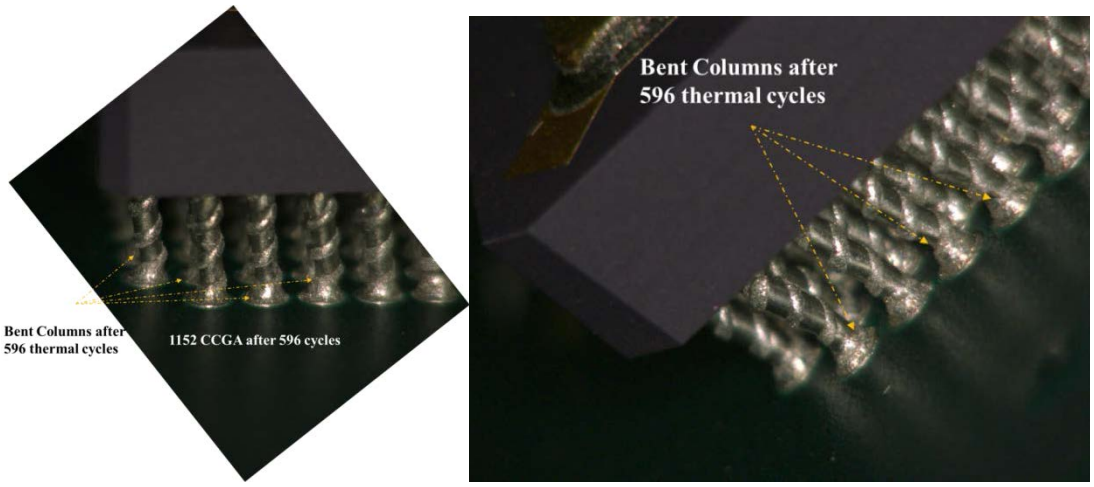
Figure 16: Microscopic image of the column which have been significantly bent due to thermal cycling. (CCGA1152) for 596 cycles

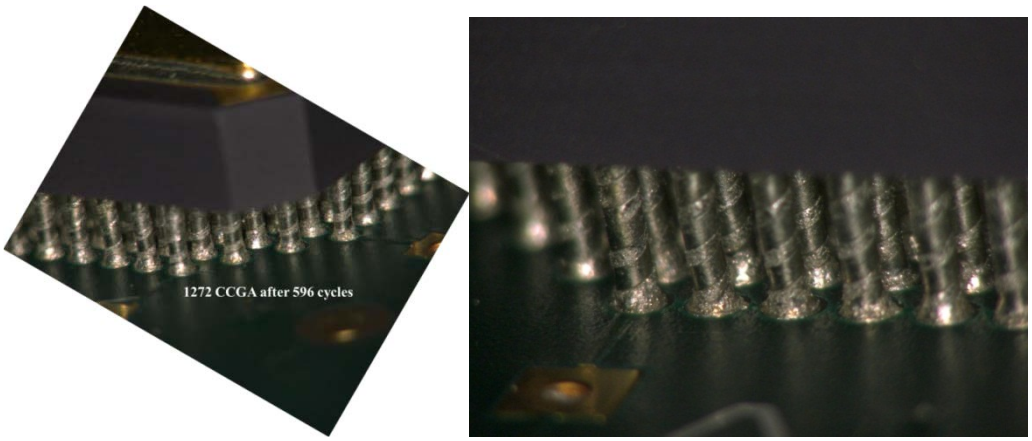
Figure 17: Microscopic images of the column which have not been bent due to thermal cycling (CCGA 1272) for 596 cycles
