Single-event Effect Report for EPC Series eGaN FETs: Comparison of EPC1000 and EPC2000 series devices for destructive SEE

Leif Scheick
Jet Propulsion Laboratory
Pasadena, California

JPL Publication 14-4 01/14

NASA Electronic Parts and Packaging (NEPP) Program
Office of Safety and Mission Assurance

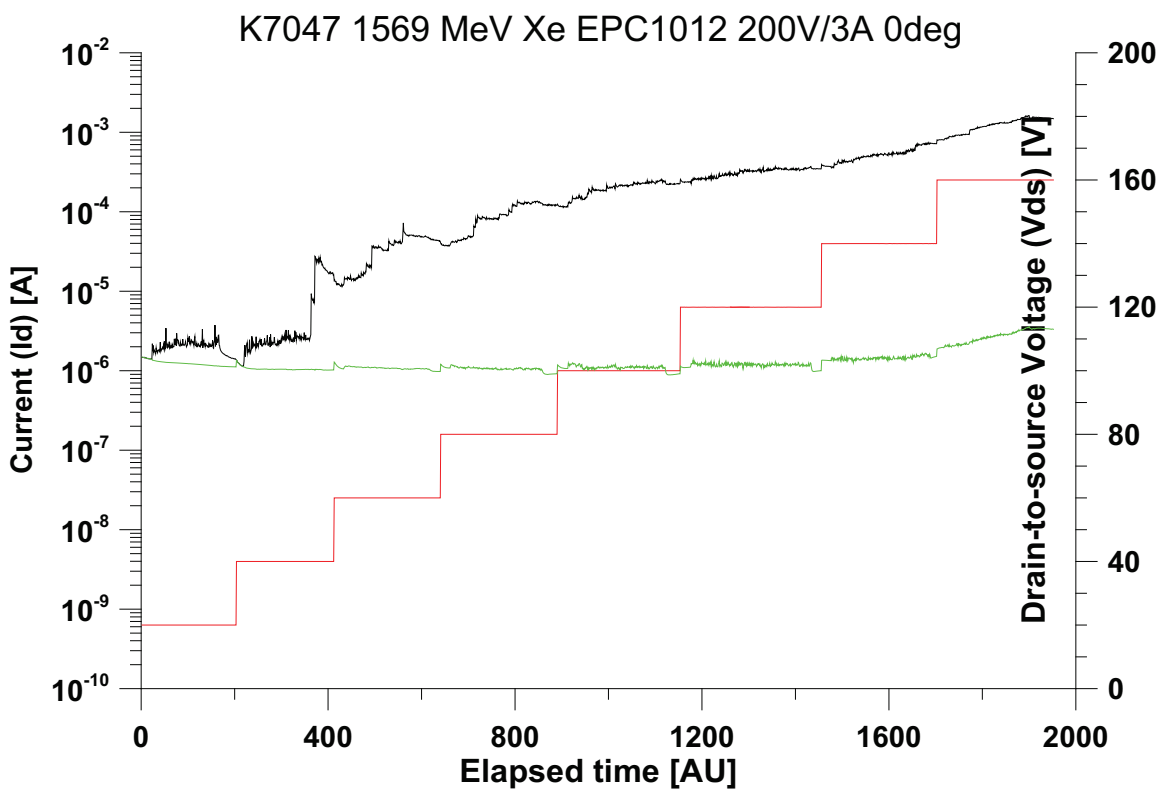
Figures 7.0-1 thru 7.0-6 present the results of SEE testing at various angles for the EPC2012 and EPC1012. In all figures, green is gate current, red is V_{ds}, black is drain current. The EPC1012 is a 200 V part suspected to be worst case. Gen1 has SEE onset at 40 V (20% of rated voltage) and Gen 2 has SEE onset at 80 V (40% of rated voltage). 60 degree tilt angle irradiation shown less sensitivity to small break. But the SEE – SEDR and SET – seen at higher voltages are more pronounced. TRIM calculation showed ion Bragg peak at or beyond the active region. Figures 7.0-7 and 7.0-8 show the transfer curve for an EPC1012 and EPC2012, respectively, after similar heavy ion irradiations. Figure 7.0-9 shows the comparison in the doping of the substrate of the EPC1012 and ECP2012. The lower doping in the EPC1012 (Gen1) results in more charge collection and therefore more field distortion under the 2DEG. This would seem to be the cause of the lower V_{see} in Gen1 parts. At least three devices were tested in all conditions and Table 7.0-1 shows the lowest V_{see} of all tests. Some part-to-part variance was observed in V_{see}, but was generally within the steps size of 20 V. EPC parts with 40 V ratings were also tested, but all showed no SEE effects for any condition.

Figure 7.0-1. Heavy ion response of the EPC1012 at normal incidence. Ion flux was 2E4 cm^{-2}-s^{-1}.

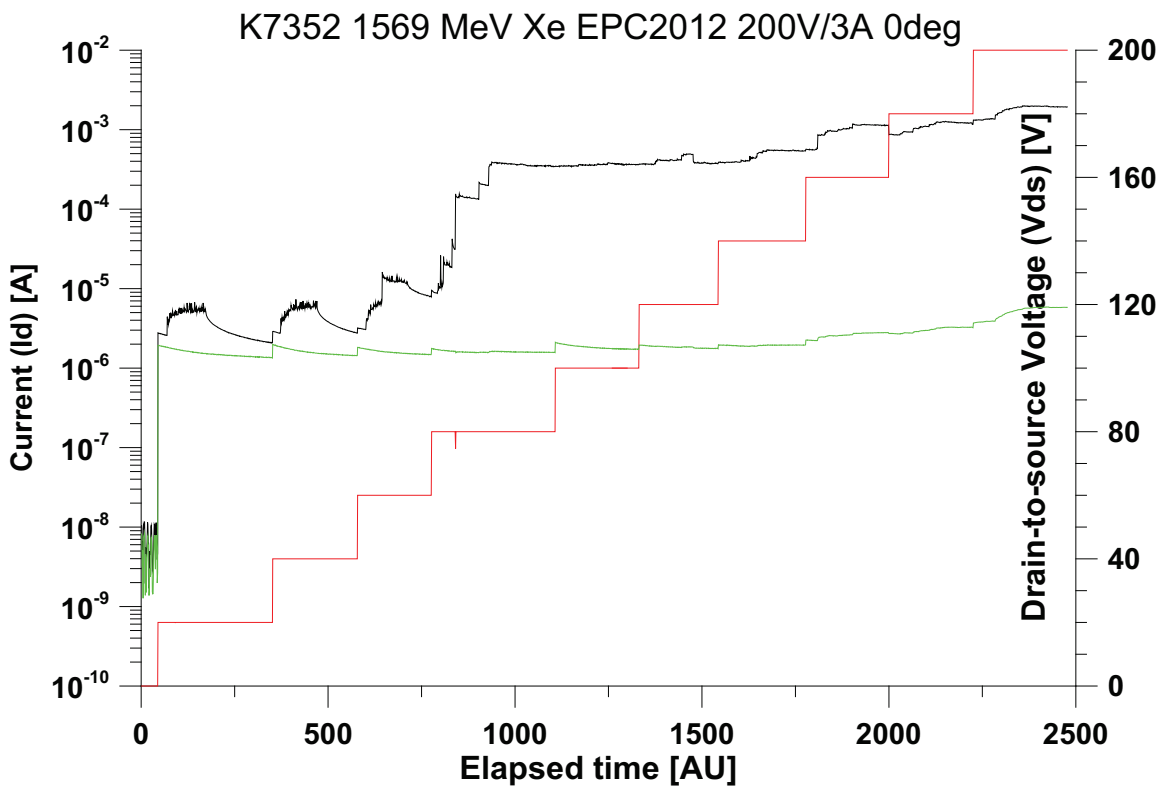
Figure 7.0-2. Heavy ion response of the EPC2012 at normal incidence. Ion flux was 2E4 cm^{-2}-s^{-1}.

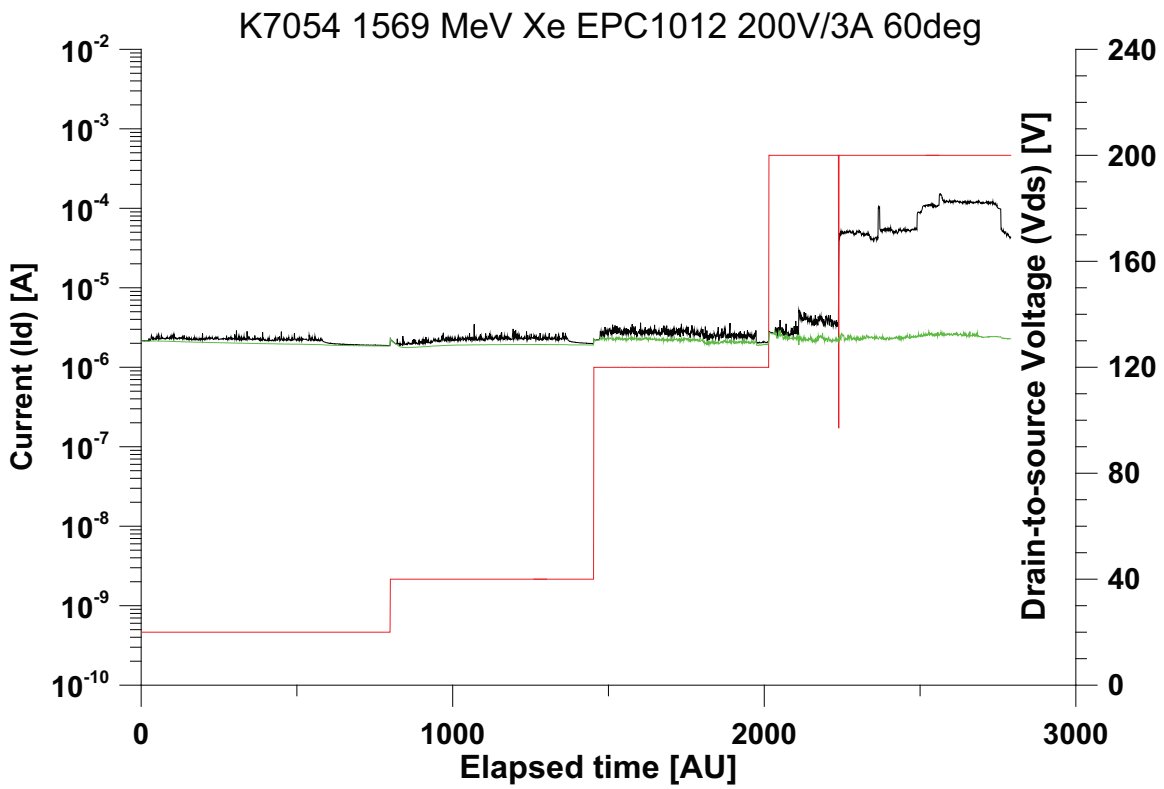
Figure 7.0-3. Heavy ion response of the EPC2012 at 60 degree tilt. Ion flux was 2E4 cm^{-2}-s^{-1}.

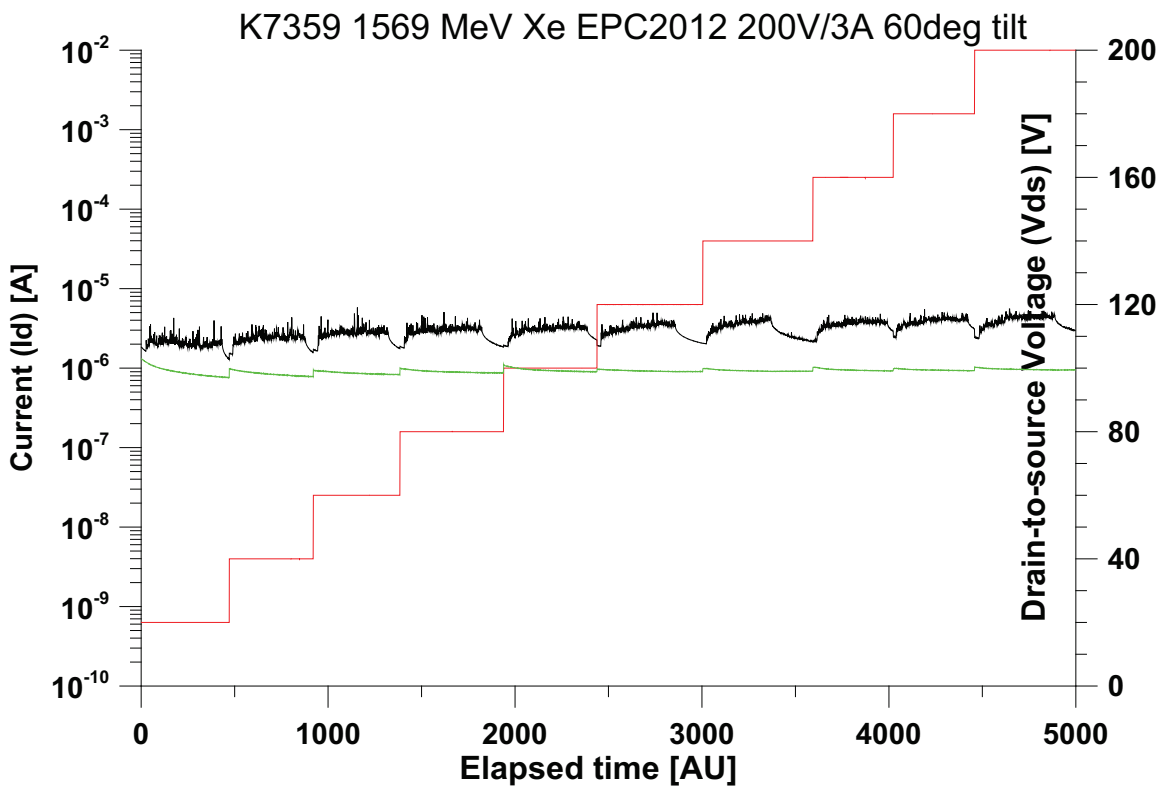
Figure 7.0-4. Heavy ion response of the EPC2012 at 60 degree tilt. Ion flux was 2E4 cm^{-2}-s^{-1}.

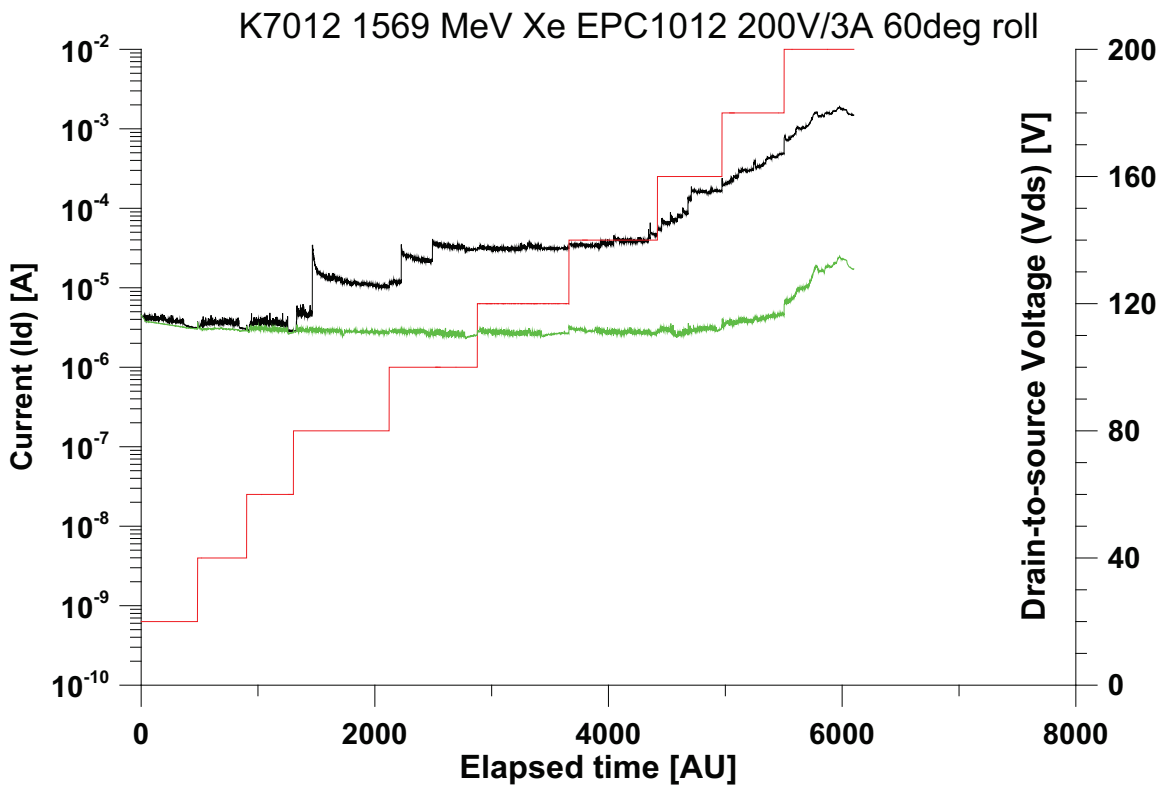
Figure 7.0-5. Heavy ion response of the EPC2012 at 60 degree roll. Ion flux was 2E4 cm^{-2}-s^{-1}.

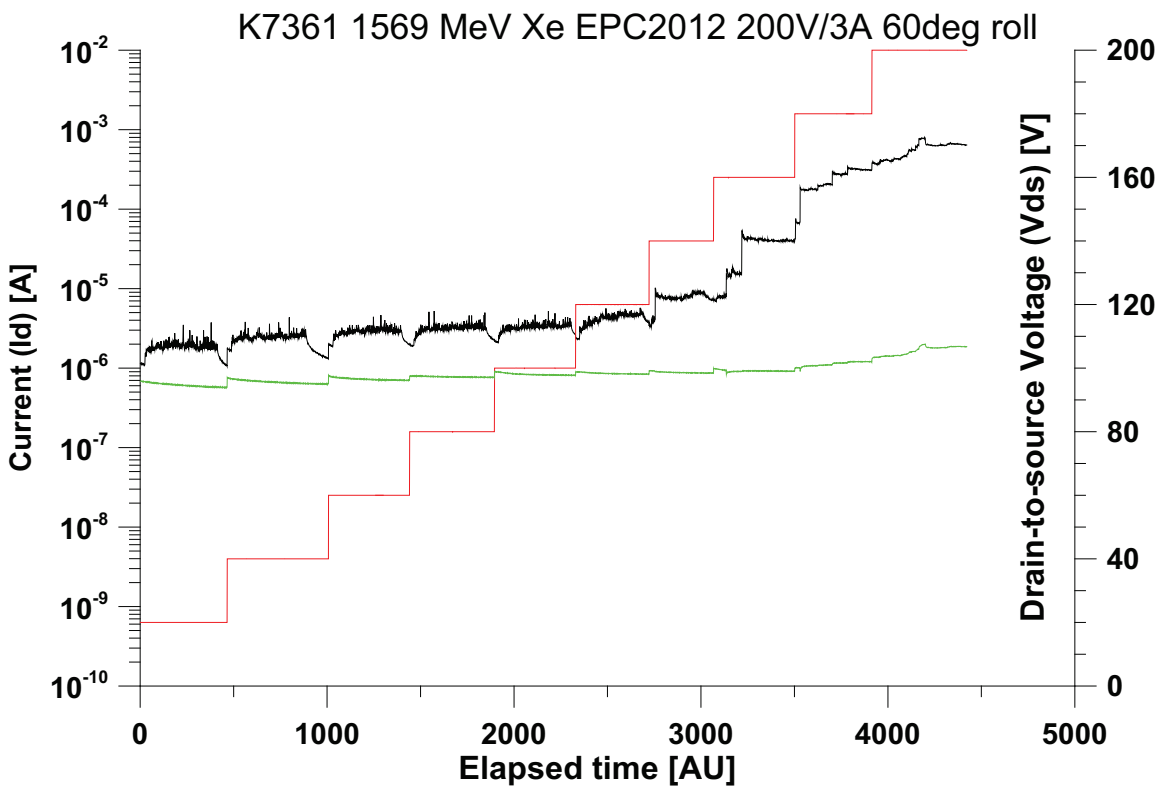
Figure 7.0-6. Heavy ion response of the EPC2012 at 60 degree roll. Ion flux was 2E4 cm^{-2}-s^{-1}.

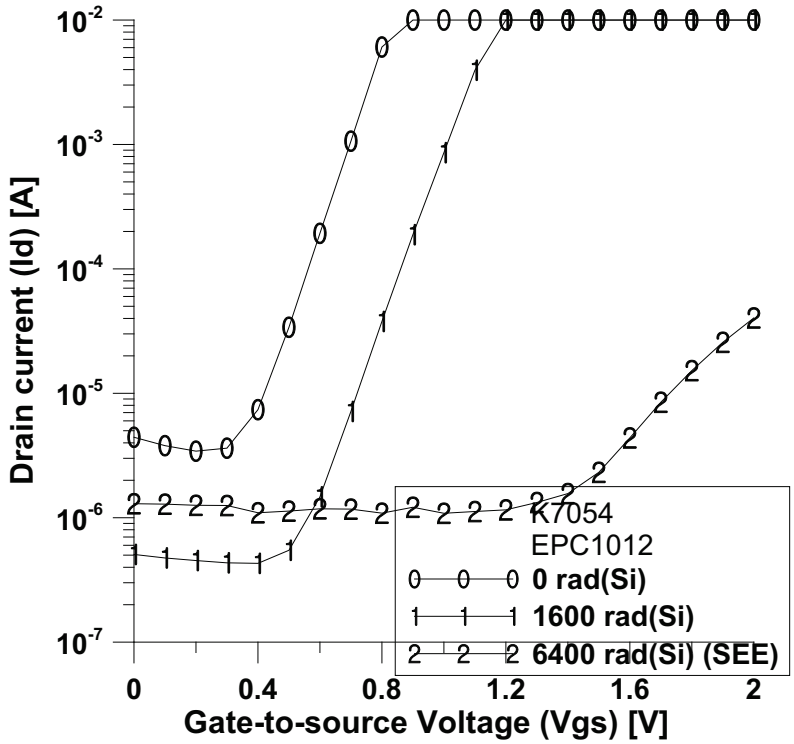
Figure 7.0-7. I-V curve after several heavy ion irradiations for an EPC1012.

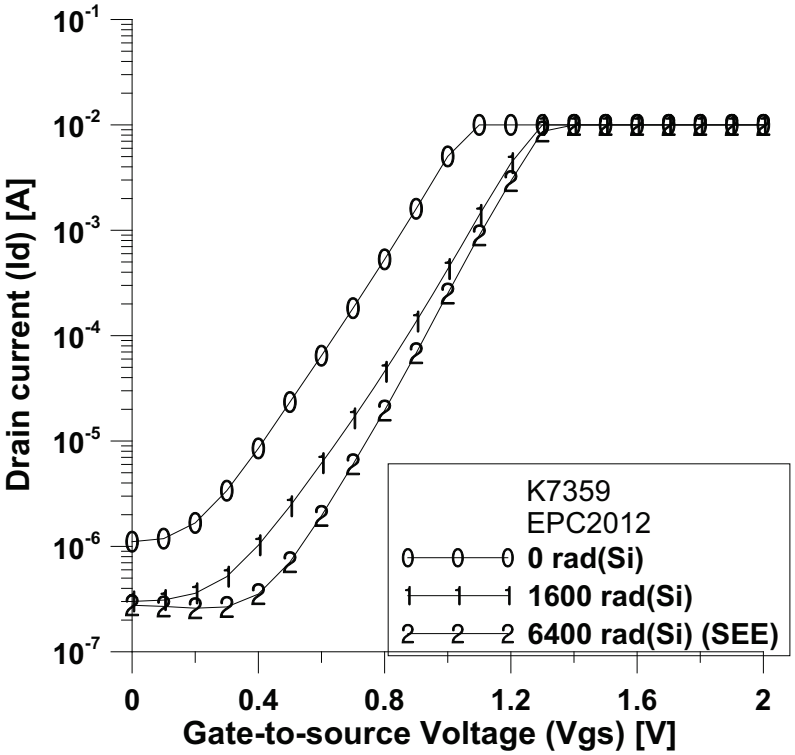
Figure 7.0-8. I-V curve after several heavy ion irradiations for an EPC2012.

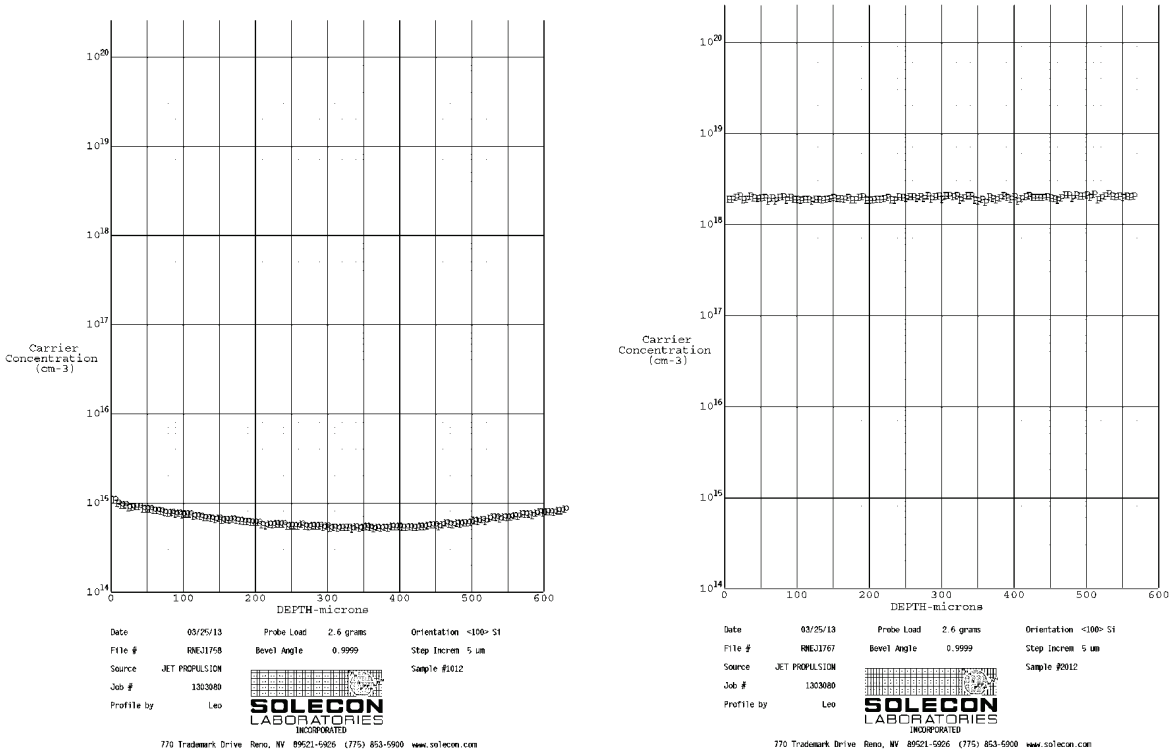
Figure 7.0-9. Spreading resistance results for the EPC1012 (left) and EPC2012 (right).
