Destructive Single-Events and Latchup inRadiation-Hardened Switching Regulators

Abstract

Single-event destructive behavior and latchup has been observed in two separate radiation-hardened switching regulators. We discuss the test conditions and observed results.

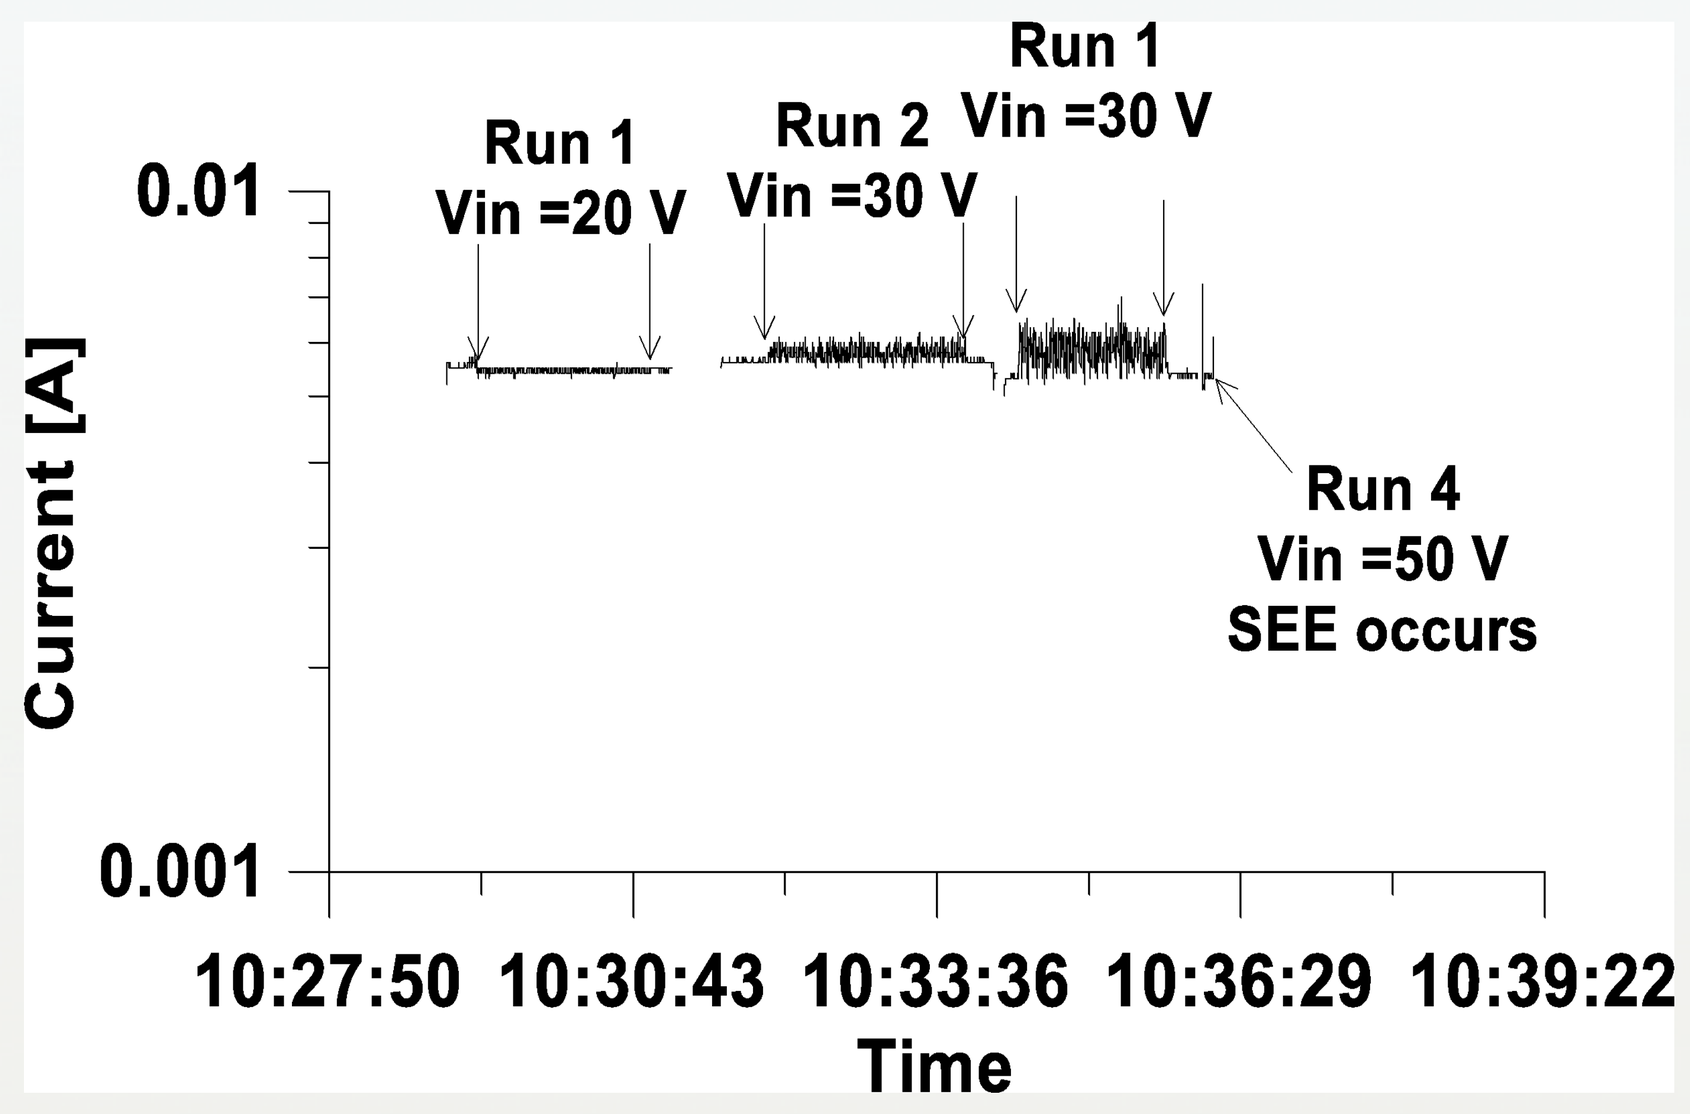
Destructive SEE were observed when the input voltage is greater than 40V. A typical test run is shown in Fig. 4 where V_{IN} is increased while monitoring device current and V_{OUT}. The device exhibited destructive SEE when V_{IN} was at 50V. The quantity V_{SEE} was defined as the average for the last pass and failure voltage for the device, or 45V for Fig. 4. The error bars are one-half of the difference; therefore, it is 5V for Fig. 4. Later runs were done with smaller voltage steps to determine V_{SEE} more precisely. V_{SEE} is plotted as a function of LET in Fig. 6 for the parts tested, and the cross-section is plotted as a function of LET in Fig. 6. Fig. 7 presents pictures of the die showing the failure region. Both the V_{IN} and local ground wire were blown off the die.

Fig. 4 A typical test run showing the determination of the V_{SEE} value for a device. V_{SEE} is 45V with error bars of 5V for this specific run. Later runs were done with smaller voltage steps to determine V_{SEE} more precisely.

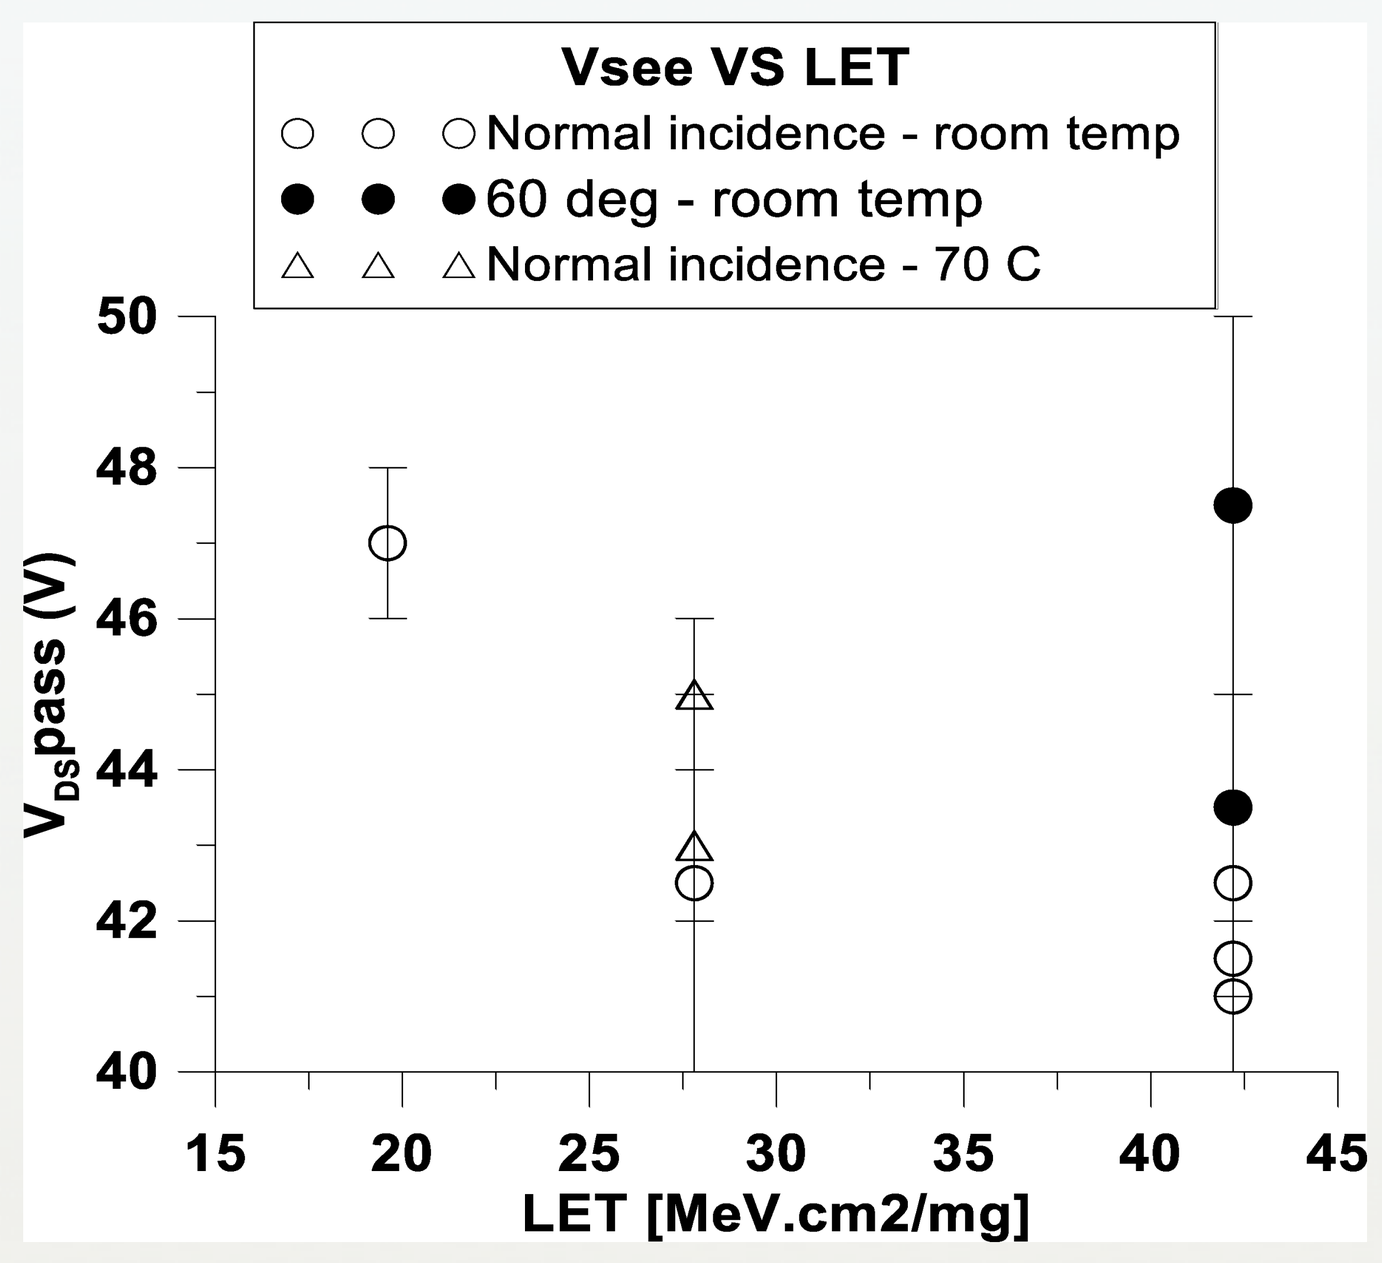
Fig. 5 V_{SEE} as a function of LET for various testing configurations.

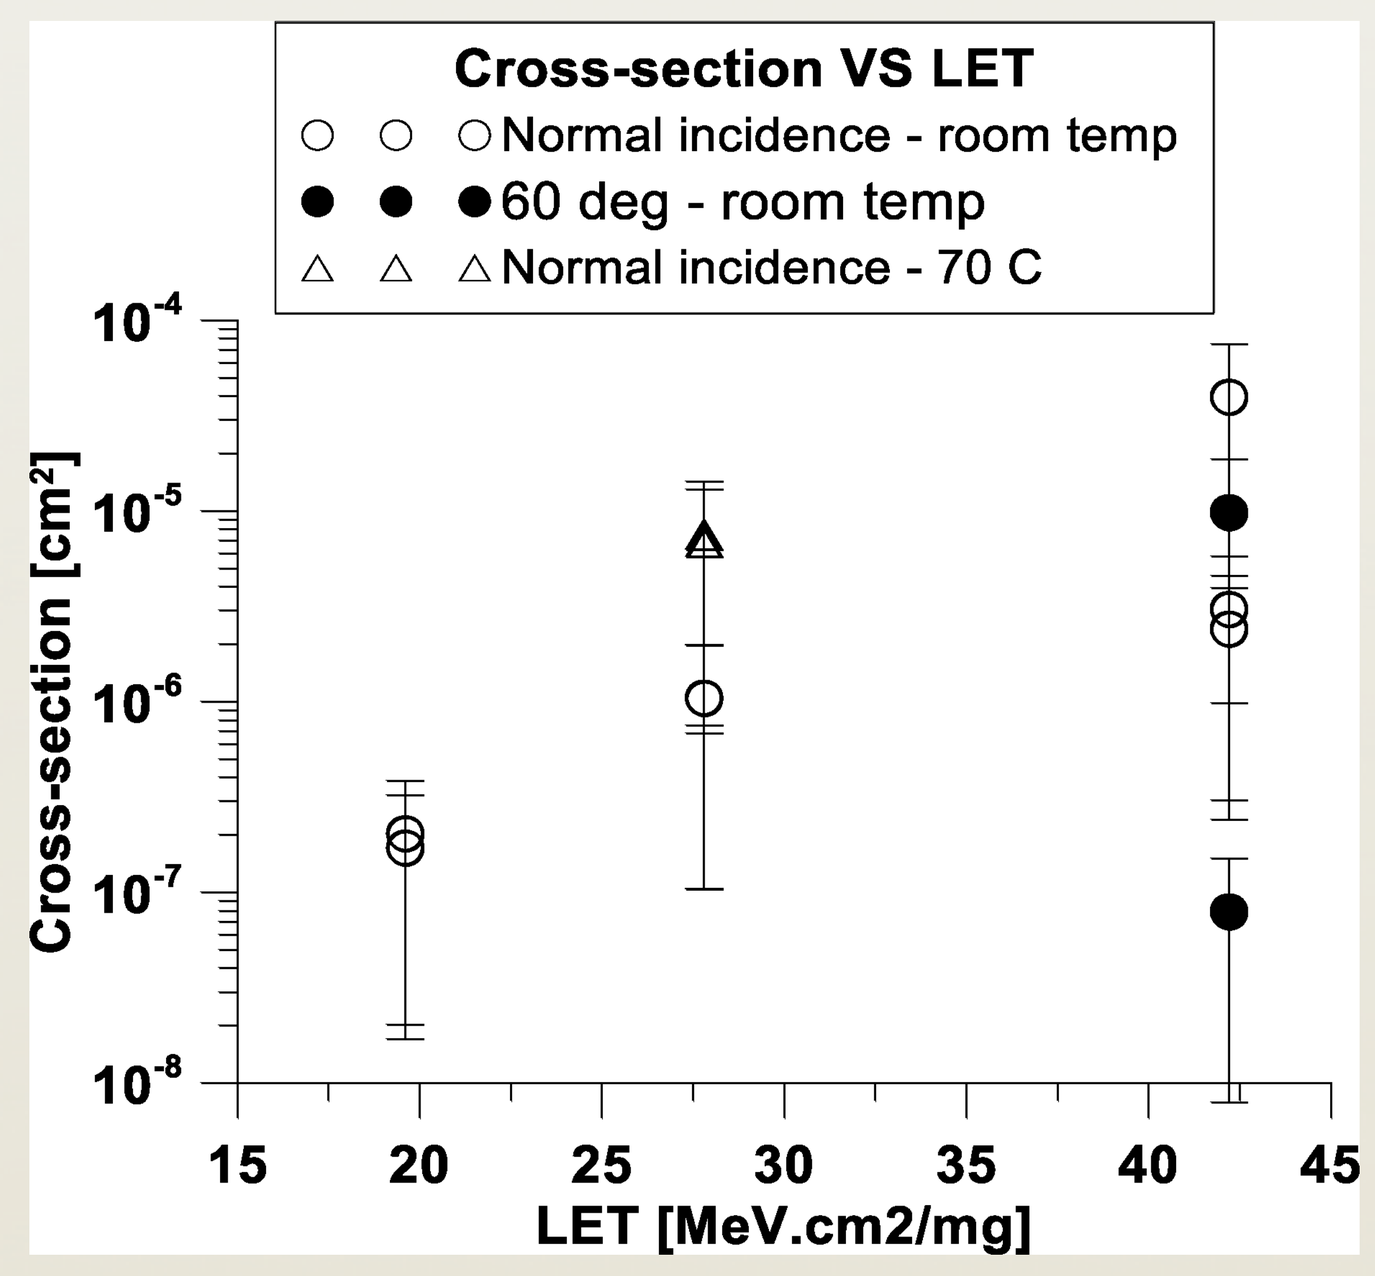
The results of the testing are shown in Table III. The destructive SEE may be described as Single Event Dielectric Rupture (SEDR) since it is a hard error that causes micro-damage in the device; however, we are making no claims to the specific mechanism. The potential SEDR was observed above 41V. Voltage cross-section did improve with elevated temperature and angle. The device is immune to SEL and SEU up to 77 MeV-cm^2/mg.

Fig. 6 Cross-section as a function of LET for various testing configurations.

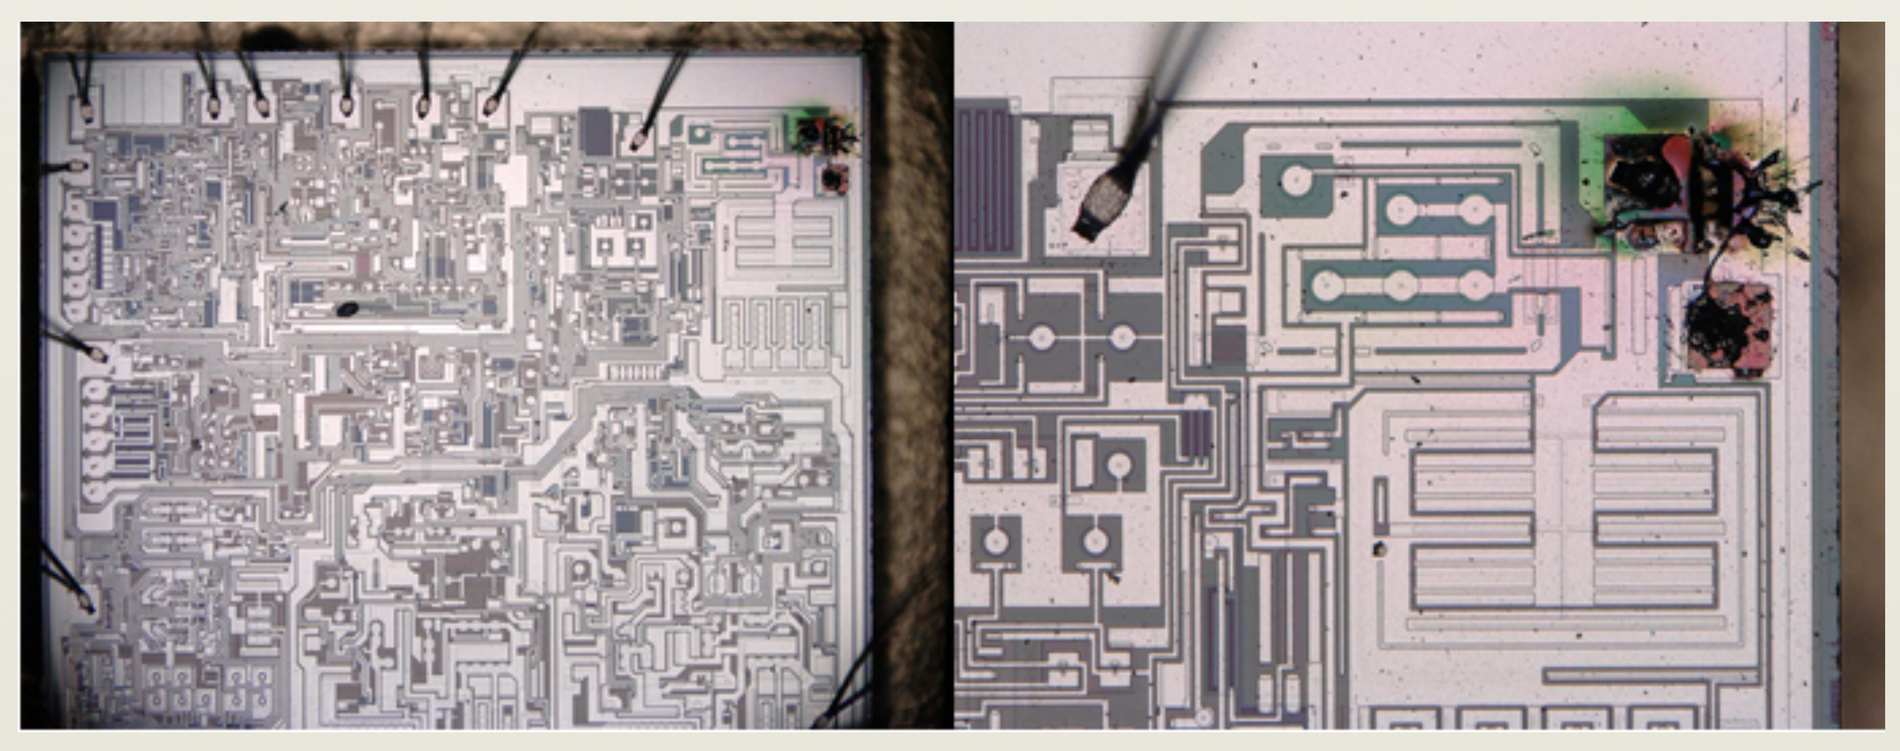
Fig. 7 Photomicrographs of a RH3845 that exhibited destructive SEE.

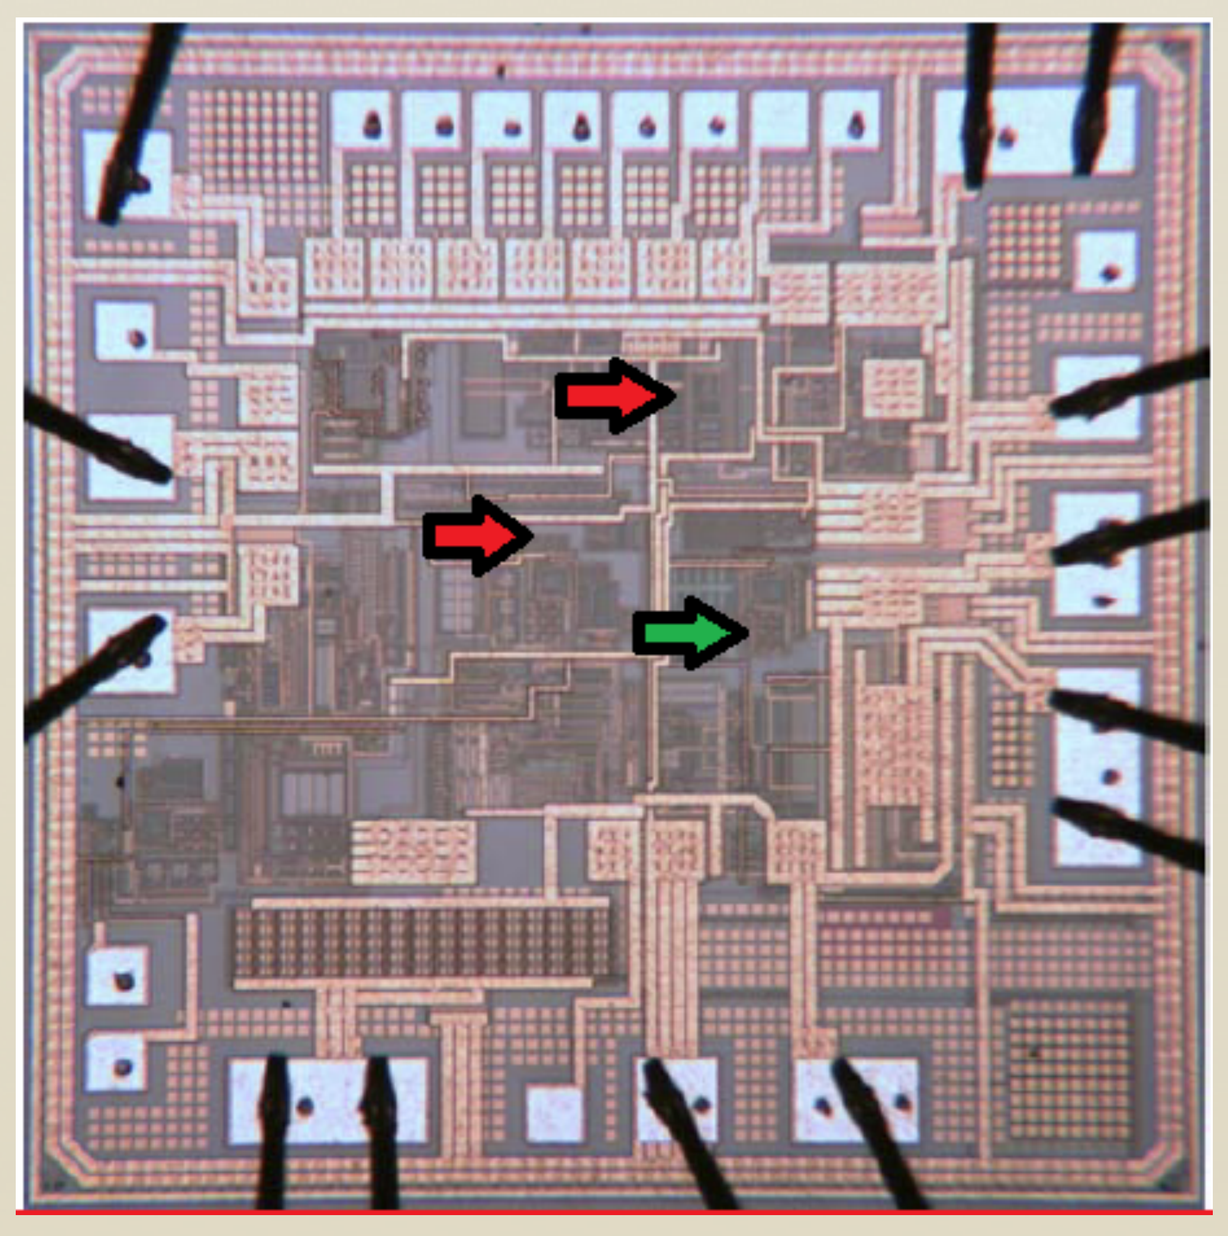
The test conditions were replicated on the laser system. With V_{DD} biased to 14.7V and temperature set to 125°C, the two sites exhibited the same current latch event. Those locations are shown on the die micrograph in Fig. 9 (red arrows). Once we induced the high-current event, the second location where the high-current event was cleared was discovered and shown in Fig. 8 as well (green arrow) [8].

Fig. 8 Photomicrograph of the entire ISL78843 die with latchup sites (red arrows) and the latchup clear site (green arrow) marked [8]. Die photo released with explicit permission from Intersil Corporation.

We verified with Intersil that the locations we identified leading to the latchup events under laser exposure consist of an abutment of NMOS and PMOS devices. These structures provide the classic NPNP SCR construction for CMOS circuits that can lead to latchup. The ion or laser triggers the SCR which then latches ON and leads to the excess current condition. The recover location (green square and dots) is the under-voltage circuit for the voltage supply to those latching structures. Intersil asserts that the recovery event is the interruption of the voltage supply to the latched structures. Thus, the event at the recovery location simulates a power-down situation at the latching locations and leads to recovery [9].
