SMT SOLDER JOINT RELIABILITY/WORKMANSHIP ENVIRONMENTAL
TEST RESULTS CORRELATION FOR LCC ASSEMBLIES

Reza Ghaffarian, Ph.D.
Jet Propulsion Laboratory
California Institute of Technology
Pasadena, CA

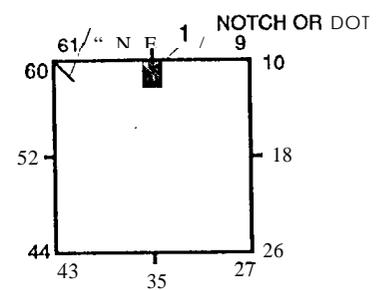
FIGURE 4. SEM Photos of Crack Propagation for 68-Pin Leadless Chip Carrier

At JPL, the conventional pass/fail criterion relies on visual inspection at 10x to 50x magnifications. For leaded parts, once cracking is observed, more than an one order of magnitude additional cycles are required before the failure. For leadless assemblies this is not the case. The cracks usually initiate inside the joint, at the corner underneath the part, and propagate outward. Figure 4 illustrates SEM photos of a corner solder joint of a 68-pin LCC assembly from initial to final failure showing damage propagation with cycles. For this particular test assembly, cracks were not observed until 47 cycles. Complete cracking and failure occurred after 71 cycles.

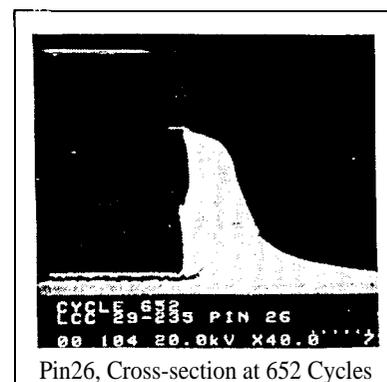
FIGURE 5. Plot of Ranking Solder Joint Damage Levels by Visual Inspection. SEM and Cross-sectional Photos for solder joints with different damage levels

Figures 5 illustrates the use of this type of plot for the 28-pin LCC assembly with the 29-235 serial number. This sample failed after 652 thermal cycles as detected by the Anatech[®]. The X and Y axes depict the pin locations of the part. The Z (vertical) axis depicts a qualitative relative value assigned to various levels of stress, from 1 (no visible damage) through 9 (100% feature length crack, dark bars

The solder joints at one side of the assembly received considerably more damage than did the opposite side. Apparent damages also increase as moving away from center and are maximum at the corner solder joints. The results confirm the assumption generally made in theoretical modeling that the corner joints with the maximum Distance from Neutral Point (DNP), should typically fail first

Visual inspection results need to be verified by SEM and cross-sectional microscopy in order to gain confidence in data for analysis and crack propagation mapping. For comparison, SEM and cross-sectional micrographs for the selective leads with increasing damage levels are also shown (Figure 5). It appears that even though inspector does not access to the inner of solder joints that crack initiates, if they are trained, they will possess ability to provide inspection results that correlate well with cross-sectional micrograph results. To be effective in Qualification Inspection, the QA inspector need to be trained in inspection procedures and to be provided with a well categorized list of observable damages and correlation to inner solder joint characteristics and relationship to life cycles.
