SDRAM SEFI on the Juno and MSL Projects

Steven M. Guertin, Farokh Irom, Greg Allen,
and Douglas Sheldon

Jet Propulsion Laboratory / California Institute of Technology
Pasadena, CA

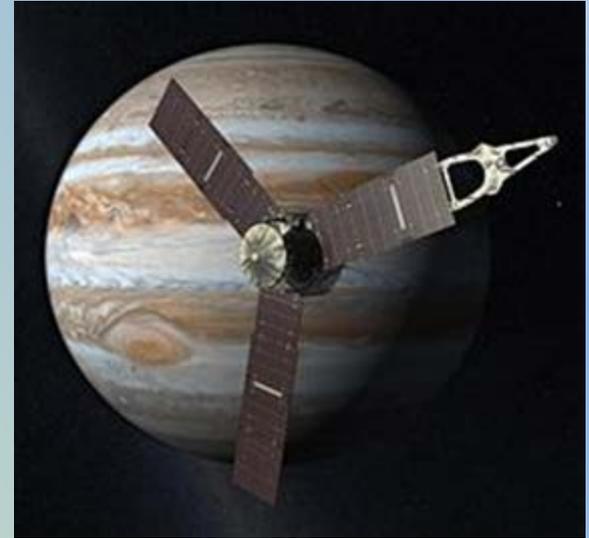
- The Juno spacecraft was launched on August 5, 2011 and will arrive at Jupiter July 4, 2016
- Juno has a Data, Telemetry, and Command Interface (DTCI) card that has EDS5104 memory
 - Juno has 80 devices for 4GB of memory + EDAC
 - DTCI has experience 5 SEFIs during flight (about 1/3 months)
- Juno SEFIs:

Error Type	Bits	Bank	Row Range	Column Formula	#MBEs	Changing Address Bits	
						#	Affected Bits
Band_Type	X,_,_,X	1	0x1000-0x13ff	(0x24,0xa4)x(0x200N)	2681	14	R0-R9, C5, C9, C11, C12
Band_Type	X,_,_,X	3	0x1000-0x13ff	(0x01,0x41)x(0x200N)	4349	14	R0-R9, C6, C9, C11, C12
Band_Type	_,X,X,_	2	0x800-0xbff	(0x20)x(0x200N)	3057	13	R0-R9, , C9, C11, C12
Band_Type	Unknown	3	0x1800-0x1bff	(0xe)x(0x200N)	4082	13	R0-R9, , C9, C11, C12

- Effort to understand events on MSL and Juno have indicated a high likelihood SEFIs come from the “Latch Array”.
 - Reloading the mode register fixes them, indicating a temporary remapping
 - Laser testing by Bougerol et. al. (2010) suggests fuse latch upsets result in addressing errors
- MSL does not have a mechanism to periodically reload the mode register
- This suggests that without mode register reload the memory may not be functional
