Final Dawn Reaction Control System (RCS) Propulsion System In-Flight Characterization

Todd J. Barber[1], Barry Nakazono[2], and Masashi Mizukami[3]
Jet Propulsion Laboratory, California Institute of Technology, Pasadena, CA, 91109

The Dawn spacecraft concluded eleven years of operations on 31-Oct-2018, upon depletion of its hydrazine supply in Ceres orbit during the second extended mission. Dawn's Reaction Control System performed admirably during this lengthy campaign, including years of unanticipated and novel operation given Reaction Wheel Assembly failures during flight. New and modified modes of thruster operations were implemented during the mission. Pressure transducer drift was negligible, consumable limits were generally not exceeded (except for minor violations in Reaction Control System thruster cycles), and thruster performance was nominal throughout this long interplanetary journey. Tank models of hydrazine remaining mass were consistent with depletion within uncertainties, although thruster consumption-based models ended up being conservative by 15%. Unexpectedly, apparent nitrogen permeation through the hydrazine tank elastomer diaphragm allowed hydrazine in the li

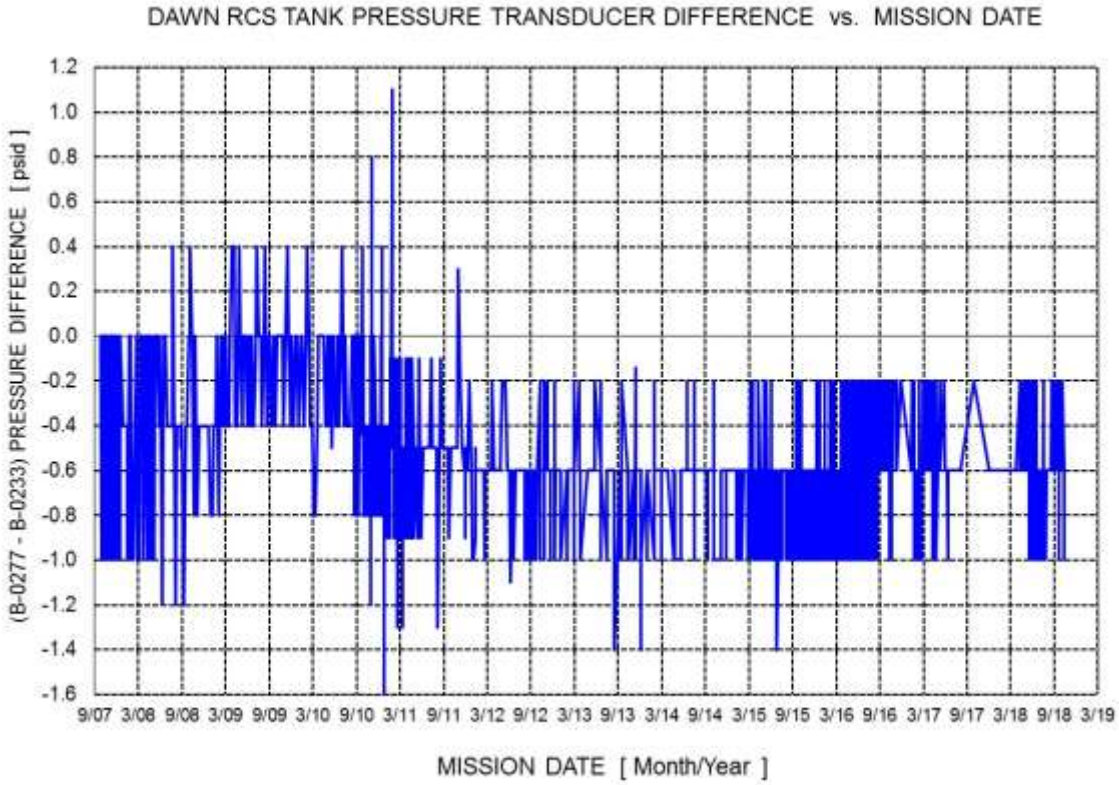
Figure 4: Dawn RCS Tank Outlet Pressure Relative Transducer Drift vs. Mission Time

Figure 4 represents the difference of two Dawn RCS tank outlet pressure measurements, telemetry channel B-0277 minus telemetry channel B-0233, as a function of mission time between launch (27-Sep-2007) and the end of mission (31-Oct-2018). In Figure 1, these two pressure sensors may be found between the N_2H_4 tank outlet and the system filter upstream of the branch tee. The difference between these two pressure values was nearly flat vs. time, suggesting Dawn RCS pressure transducers did not drift much at all, even after eleven years.

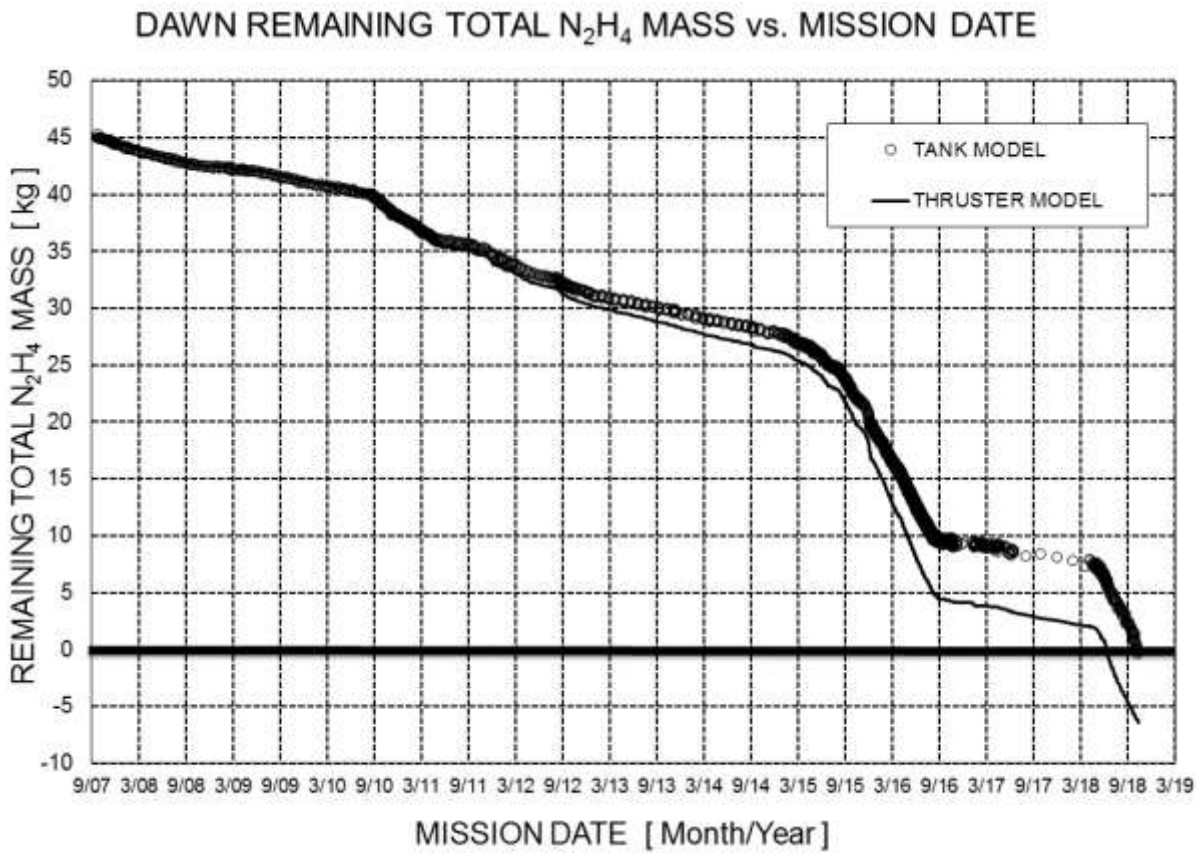
Figure 5: Dawn RCS Remaining Hydrazine Mass vs. Mission Time (Thruster Consumption vs. Tank Models)

The hydrazine mass remaining between launch and end of mission is displayed below in Figure 5. There are two methods that can be used to estimate spacecraft hydrazine mass remaining. First, a hydrazine consumption model was used to attempt to "bean-count" every drop of hydrazine leaving the spacecraft. This model was of limited use due to the inaccuracies in the pulse-mode consumption model for the thruster, but over short time scales, it was the only way to effectively estimate hydrazine usage for a given propulsive event. For every JPL mission flying this class of thrusters, hydrazine usage has been overpredicted using consumption modeling, which is thankfully in the conservative direction with respect to propellant depletion. An alternative method is to simply calculate the hydrazine mass remaining from telemetered values of tank pressure and temperature using a thermodynamic model (and a known quantity of loaded pressurant gas). This method should offer the greatest accuracy over the long term, as long as pressure transducers are not drifting (as was verified above). The data of Figure 5 were generated using the original pre-launch thruster consumption or "throughput" model with one minor post-launch modification in 2011 to force the consumption and tank models to agree (note well: this correction is within the noise on the scale of the entire mission), along with the thermodynamic or "tank" model.[3] Nearly 3000 hydrazine-consuming events were tabulated over the eleven-year Dawn mission, leading to the fine detail evident in the data of Figure 5.

As anticipated, the consumption model consistently overpredicted hydrazine usage vs. the tank model, over the entire mission. By the end of mission, the original throughput model suggested 45.3 – (-6.8) = 52.1 kg of fuel was expended, or 52.1/45.3 = 115% of the total launch load including unusable hydrazine. However, the more believable tank model indicated only 45.3 - 0 = 45.3 kg of hydrazine was used, or 45.3/45.3 = 100% of the launch load. Equivalently, it appears the original consumption model overpredicted hydrazine usage by (115/100 – 1) =

15% vs. the tank model. This discrepancy is actually very typical; some JPL missions had pulse-mode consumption errors above 30% vs. tank models (e.g., Deep Space One). Cassini MR-103 consumption models also overpredicted hydrazine consumption by almost precisely 15%, albeit for MR-103H thrusters instead of MR-103G thrusters.[5] Consumption modeling errors for very small pulses can be rather sizable, so 15% agreement between the two curves in Figure 5 is actually not too bad at all.

It is clear from Figure 5 that Dawn hydrazine usage was not linear vs. mission time. Specifically, during periods of ion thrusting, pitch and yaw control were provided by IPS thruster gimballing, so this reduced hydrazine usage. Even the failure of RWA #3 in August of 2012 did not adversely affect hydrazine usage too much, since this was near the beginning of the orbit transfer to Ceres. It is also evident from Figure 5 and Table 2 that Ceres mapping orbits, particularly HAMO and LAMO, were periods of heavy fuel usage. Without the use of hybrid mode during this portion of the mission (e.g., if another RWA had failed), it may well have been difficult to complete all mission objectives. Thankfully, post-LAMO orbits before the final orbit were sufficiently far from Ceres that RCS operations were feasible. It is clear, though, how rapidly hydrazine was used in the final XM07 orbit, during the last four to five months of the mission.

One of the most gratifying observations from Figure 5 is just how well the tank model matched flight data at the end of mission. In particular, the tank model essentially showed zero remaining hydrazine mass at the point when independent evidence suggested the diaphragm had bottomed out in the propellant tank. This will be discussed in further detail below in Section VI.

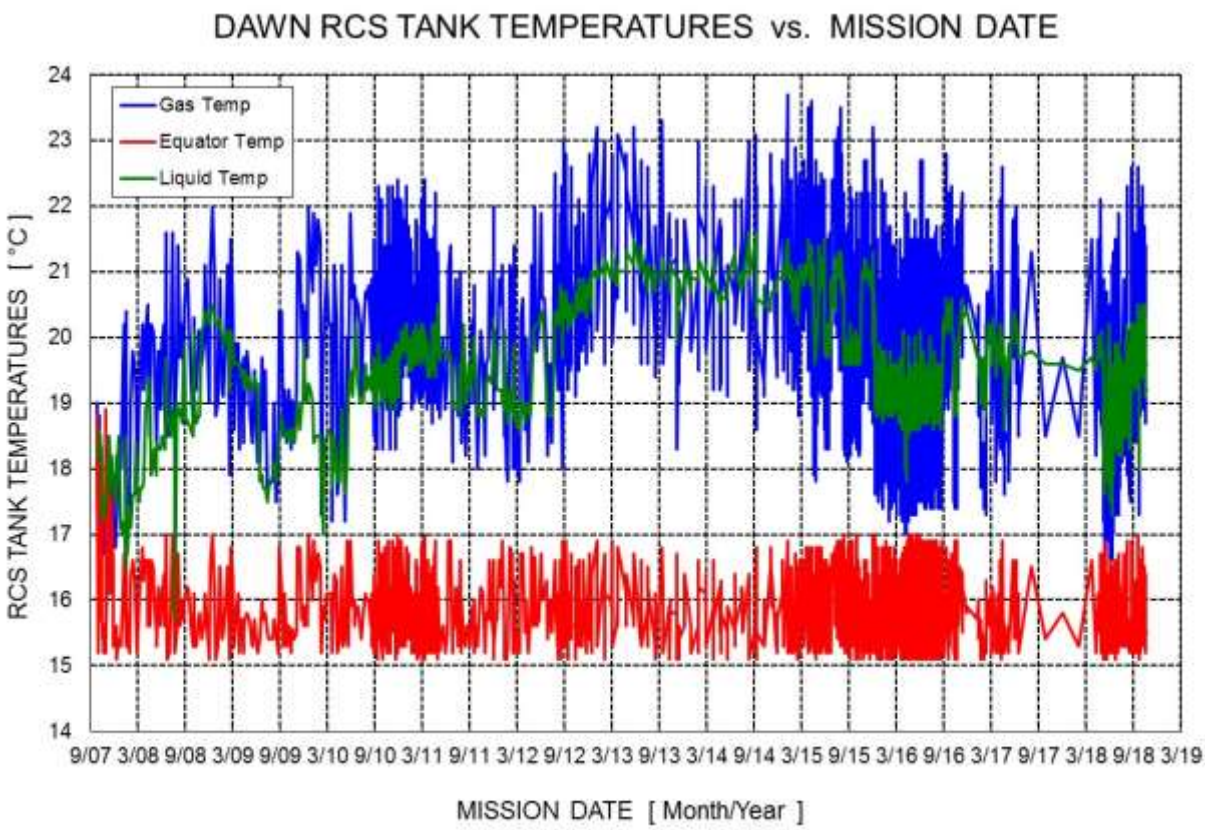
Figure 6: Dawn RCS Tank Temperature vs. Mission Time

Figure 6 below displays the time history of the Dawn RCS tank temperatures. Except for the first few months in flight, the tank equator structure temperature was software controlled over a quite narrow temperature range of 15-17°C, while gas and liquid temperatures were always warmer and more variable, typically spanning a range of 17-24°C. Note also larger fluctuations in temperature for the gas side vs. the liquid side, as expected given its lower thermal inertia.

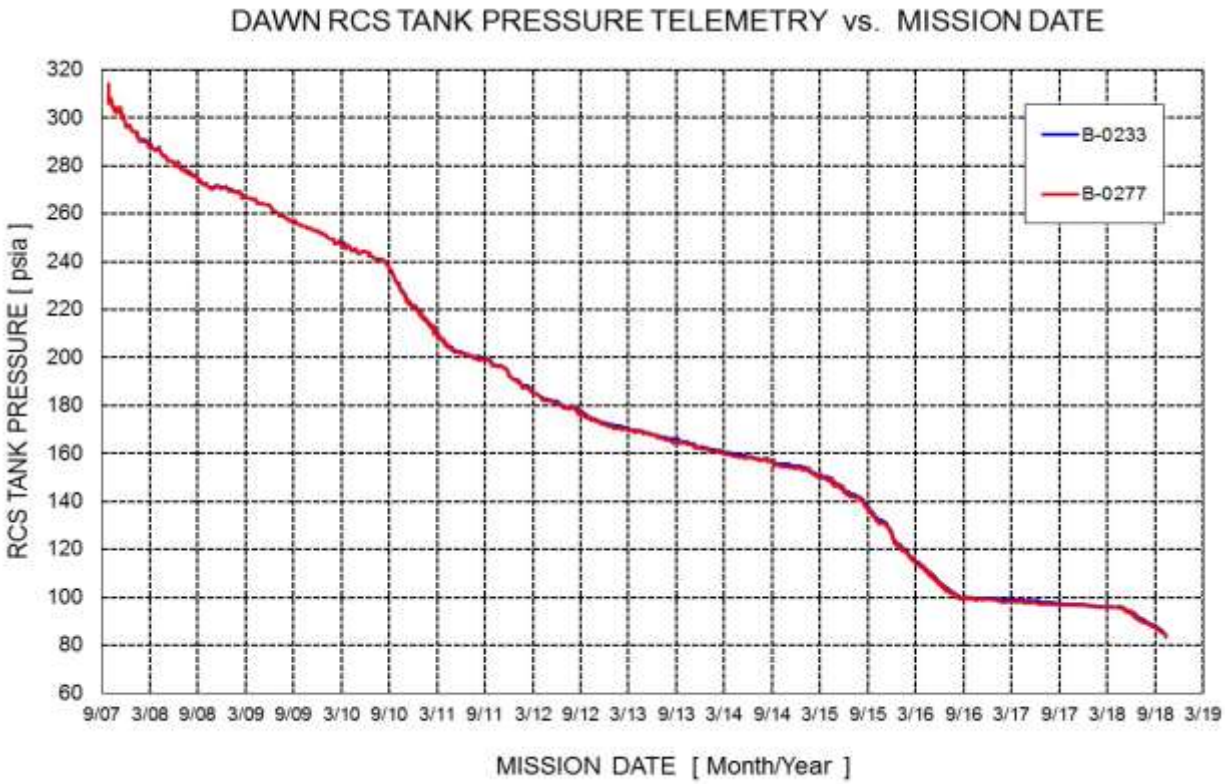
Figure 7: Dawn RCS N_2H_4 Tank Pressure vs. Mission Time

Figure 7 presents hydrazine tank outlet pressure over the entire mission, a classic blowdown pressure curve. Note well the measured values from both pressure transducers at the propellant tank outlet (B-0233 and B-0277) agree incredibly well, particularly on this expanded vertical scale (their difference was plotted in Figure 4). The as-flown range for Dawn hydrazine tank pressure was 84-314 psia, securely within the thruster inlet pressure allowable firing range of 70-420 psia. Upon tank depletion, additional thruster firings took place a very low inlet pressures (14-84 psia), though apparently with minimal issues, given the ability of the spacecraft to continue executing its science mission during this time. Line pressure following tank depletion is not shown in Figure 7, so that the data of Figure 7 may be a true representation of tank pressure only over the mission. Line pressures during the final weeks of the mission will be discussed below, in the context of hydrazine exhaustion.

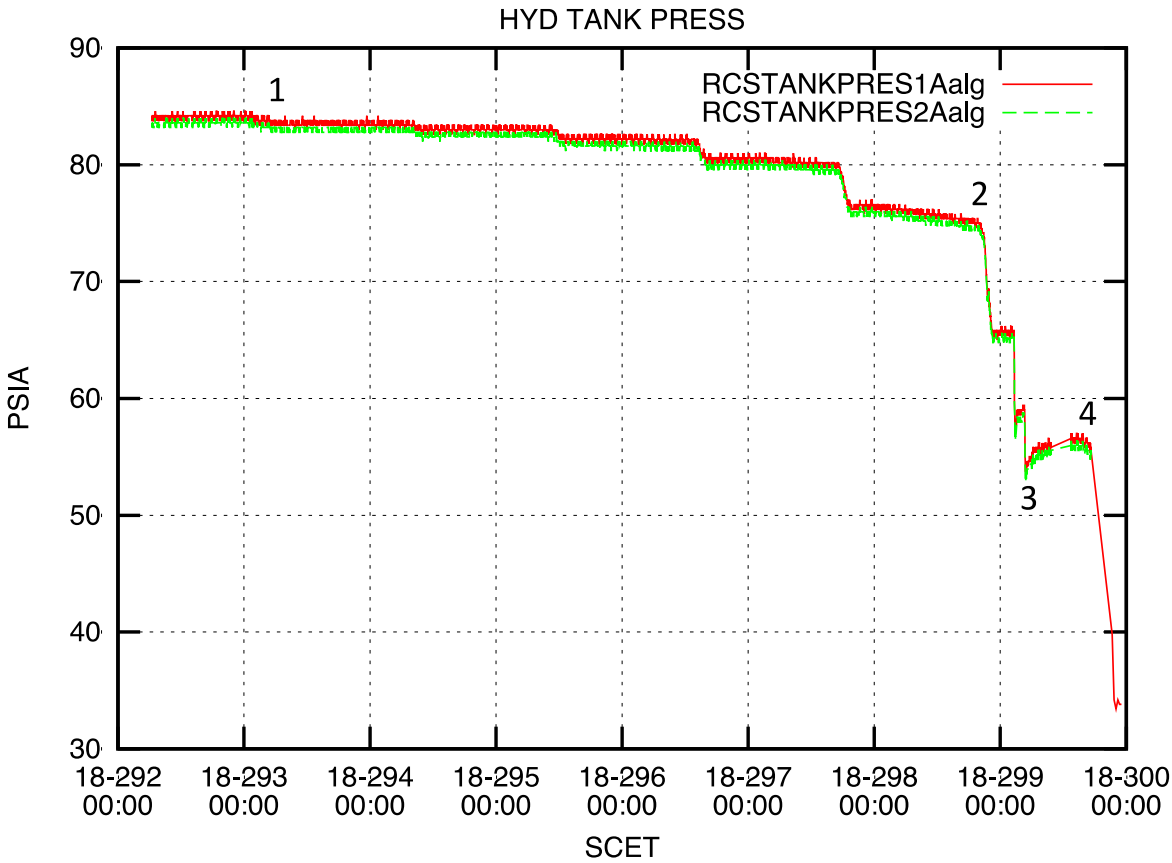
Figure 8: Dawn RCS Tank Pressure during Tank Depletion (2018/292-300 SCET UTC)

Figure 8 displays RCS tank outlet pressure vs. time just before the end of mission in 2018. Flag 1 on the plot is where the tank diaphragm was expected to bottom out, at a tank pressure of 83-84 psia. Between Flag 1 and 2, hydrazine was being delivered at increasing pressure differential as the diaphragm squeezed the last amount of propellant out of the tank. About 250 grams of hydrazine were used during this period of 5.5 days. This represents 0.4% of the tank capacity, which is consistent with the tank specification minimum expulsion efficiency of 99% and a measured expulsion efficiency of 99.9% during ground testing.

Between Flag 2 and 3 the spacecraft used about 42 grams of propellant during a periapsis pass, followed by 15 grams expelled in a spacecraft turn. These propellant consumption estimates are based on multiplying the thruster model prediction by 0.85. This correction factor is the difference between end-of-life thruster model consumption and the likely much more accurate tank model, as explored above in Section IV.

The model assumes that propellant can be delivered normally up to the point where the maximum amount has been squeezed out of the tank (Flag 2). Thruster commands after that point will result in the line pressure drastically dropping. This results in the nitrogen pressurant gas in hydrazine coming out of solution. Nitrogen is about fifty times more soluble than helium in hydrazine, and this results in gas bubbles being generated throughout the wetted lines. These bubbles can then merge to create larger gas bubbles that stand across the tube cross-sectional area, and this gas pressure allows continued thruster operation.

After periods of thruster usage, the line pressure dropped to 54 psia and the pressure slowly recovered 2.0 psi over nine hours. This is surmised to be due to leakage of nitrogen across the diaphragm, driven by a pressure differential of 84 psia tank pressure to 54 psia line pressure.

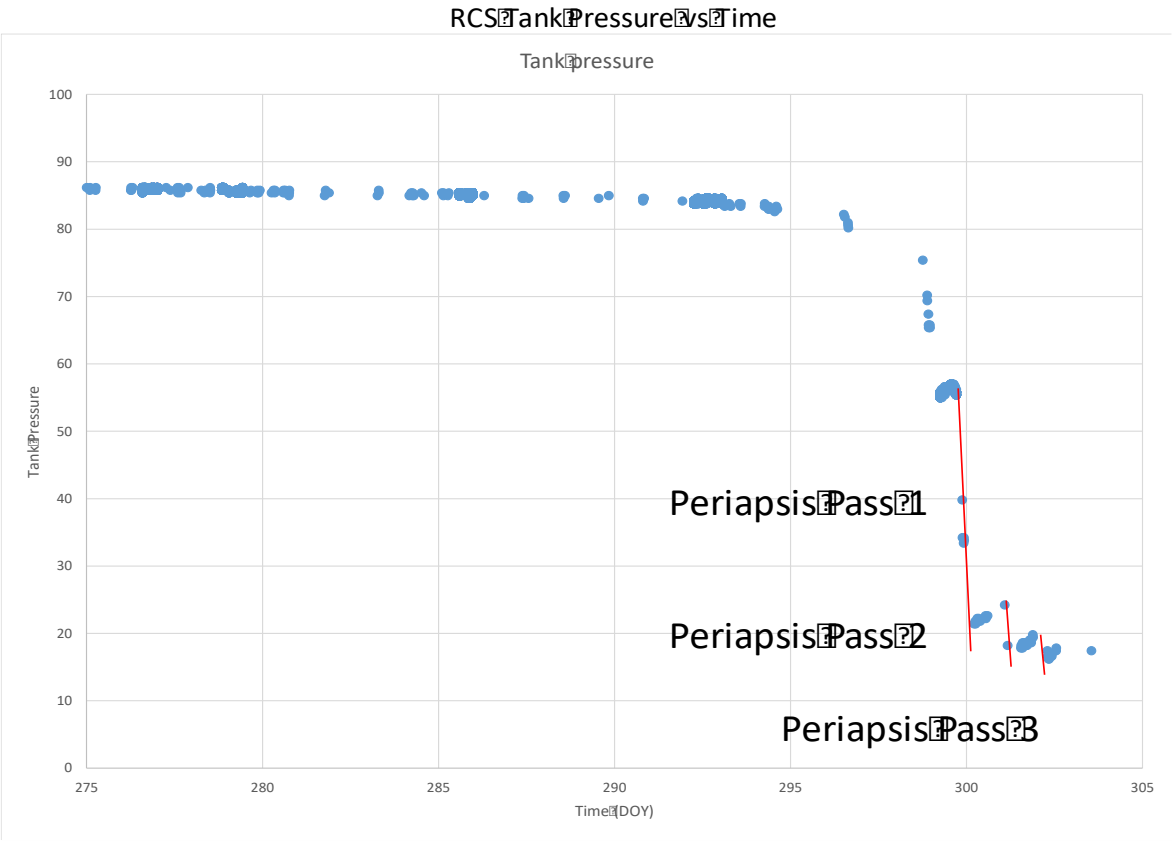
Figure 9: Dawn RCS Line Pressure between Tank Depletion and End of Mission (Actual vs. Model)

Figure 9 offers a direct comparison between the flight telemetry data (in blue) and the line repressurization model (in red). For a simple model, the agreement between the two curves is quite good, suggesting the actual physics of hydrazine line depletion have been captured well for Dawn. Most gratifyingly, this unexpected bonus extended the mission an extra one to two weeks. Since each periapsis pass every 27 hours offered additional unique science, this was most appreciated by the Dawn science teams.

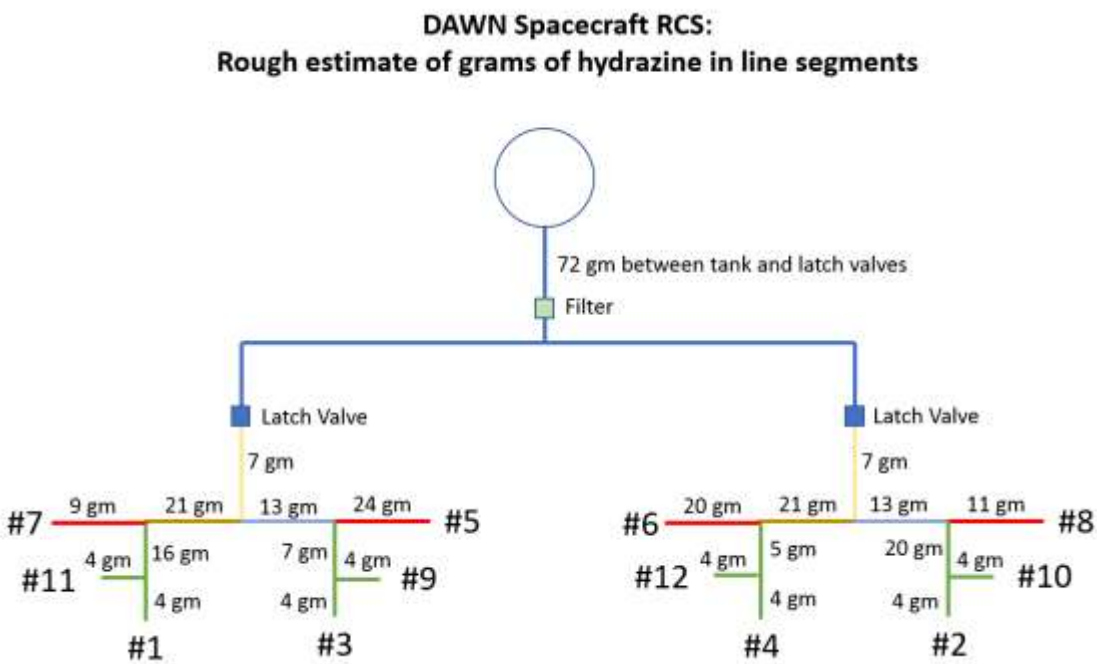
Figure 10: Dawn RCS Rough Estimate of Hydrazine Mass in Line Segments below Tank

Figure 10 shows a rough estimate of the propellant mass in the Dawn RCS line sections. This is a coarse estimate based on the Hydrazine Tank Assembly drawing. However, even this relatively crude accounting provides reasonable estimates of propellant available from the lines, and it shows a rough match to actual depletion.
