Special Edition: Because electronic parts packaging is frequently discussed on Domestic and International NEPAG telecons, we bring you this article by JPL's Phil Zulueta.

Inspection of Area Array Package Interconnections

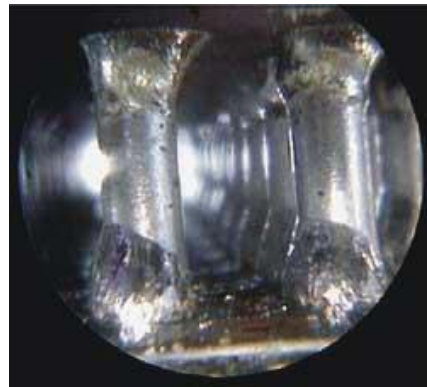
Endoscope image of CGA Interconnects (Courtesy Advanced Packaging)

This inspection can be accomplished with either an optical endoscope (a fiber-optic tube) or a rotating prism system attached to a viewing device.

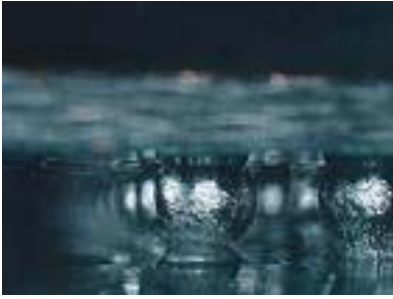
Rotating Prism image of BGA interconnects (Courtesy Hirox)

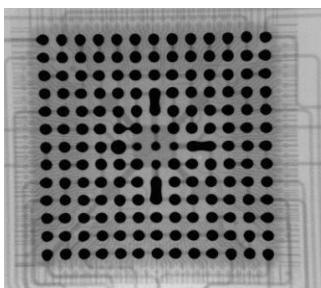
2D X-ray of a BGA on a PCB shows solder bridges, excess solder and insufficient solder reflow defects. (Courtesy FeinFocus)

2D X-ray, providing a top-down image of the board or package area being viewed, or more advanced systems offering the ability to examine samples for defects at oblique angles, can distinguish a variety of solder defects such as voids, shorts, excess solder or insufficient solder reflow.

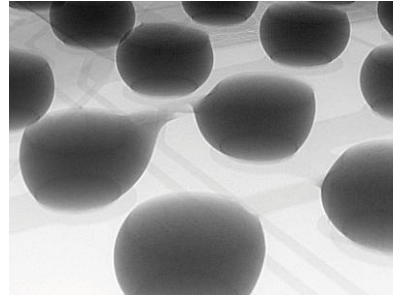
Oblique 2D X-ray view of BGA (Courtesy Xylon)

In this case, oblique angle imaging can reduce this problem, depending on the complexity of the assembly inspected. Overall, 2D X-ray inspection of area array interconnects is a quick, economical inspection method, but also has its limitations.

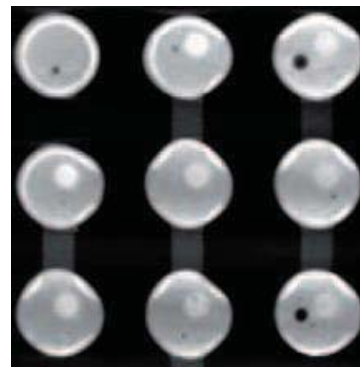
Solder voids (Courtesy Xylon)

It is well-known that voids in area array interconnections, either in the ball or column, or at the interfaces between these and the package or board, reduce the thermal fatigue life thus compromising part reliability.

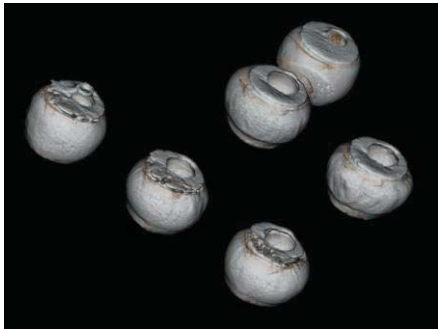
3D view of BGA balls with voiding close to pad and small fractures (Courtesy Xylon)

For example, solder balls on the underside of BGAs can be viewed from all sides, and defects such as insufficiently wetted or cracked balls can be easily identified.

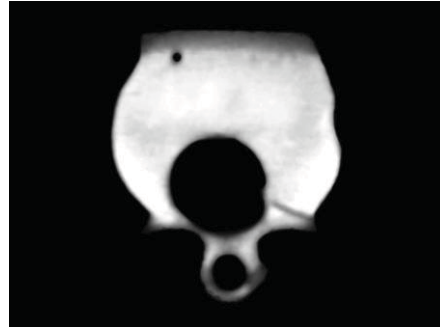
3D slice of single BGA ball with μ -via showing micro-crack and various voids (Courtesy Xylon)

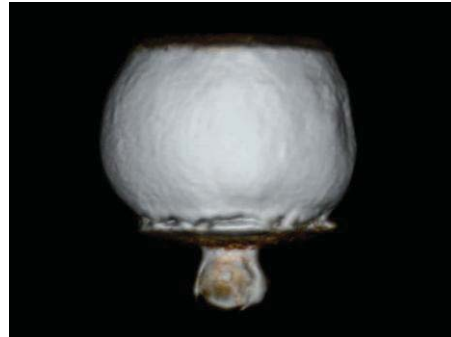
3D view of single BGA ball with μ -via (Courtesy Xylon)
