Applied Space Environments Conference 2019

Bit Errors Induced by Internal Electrostatic Discharge on SpaceWire

James Chinn, Wousik Kim, David Keller, Sergeh Vartanian, Eduardo Martin, Dennis Thorbourn

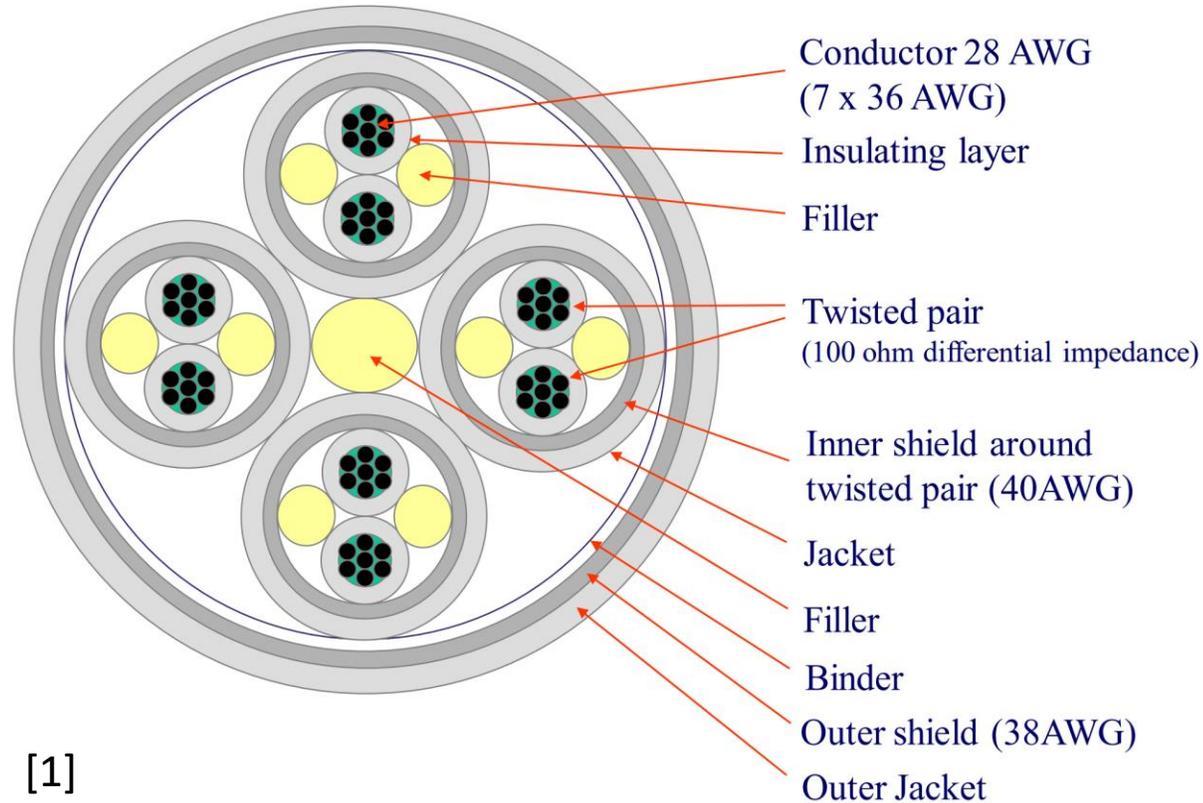
Gore SpaceWire Cable

Wire insulation and binder material is ePTFE, the filler material is PTFE, the twisted pair jacket material is fluoroplastic, and the bundle jacket material is ETFE.

Additional Cu tape overwrap using 50% overlap results in HBM Class 1A discharges or better from cable.

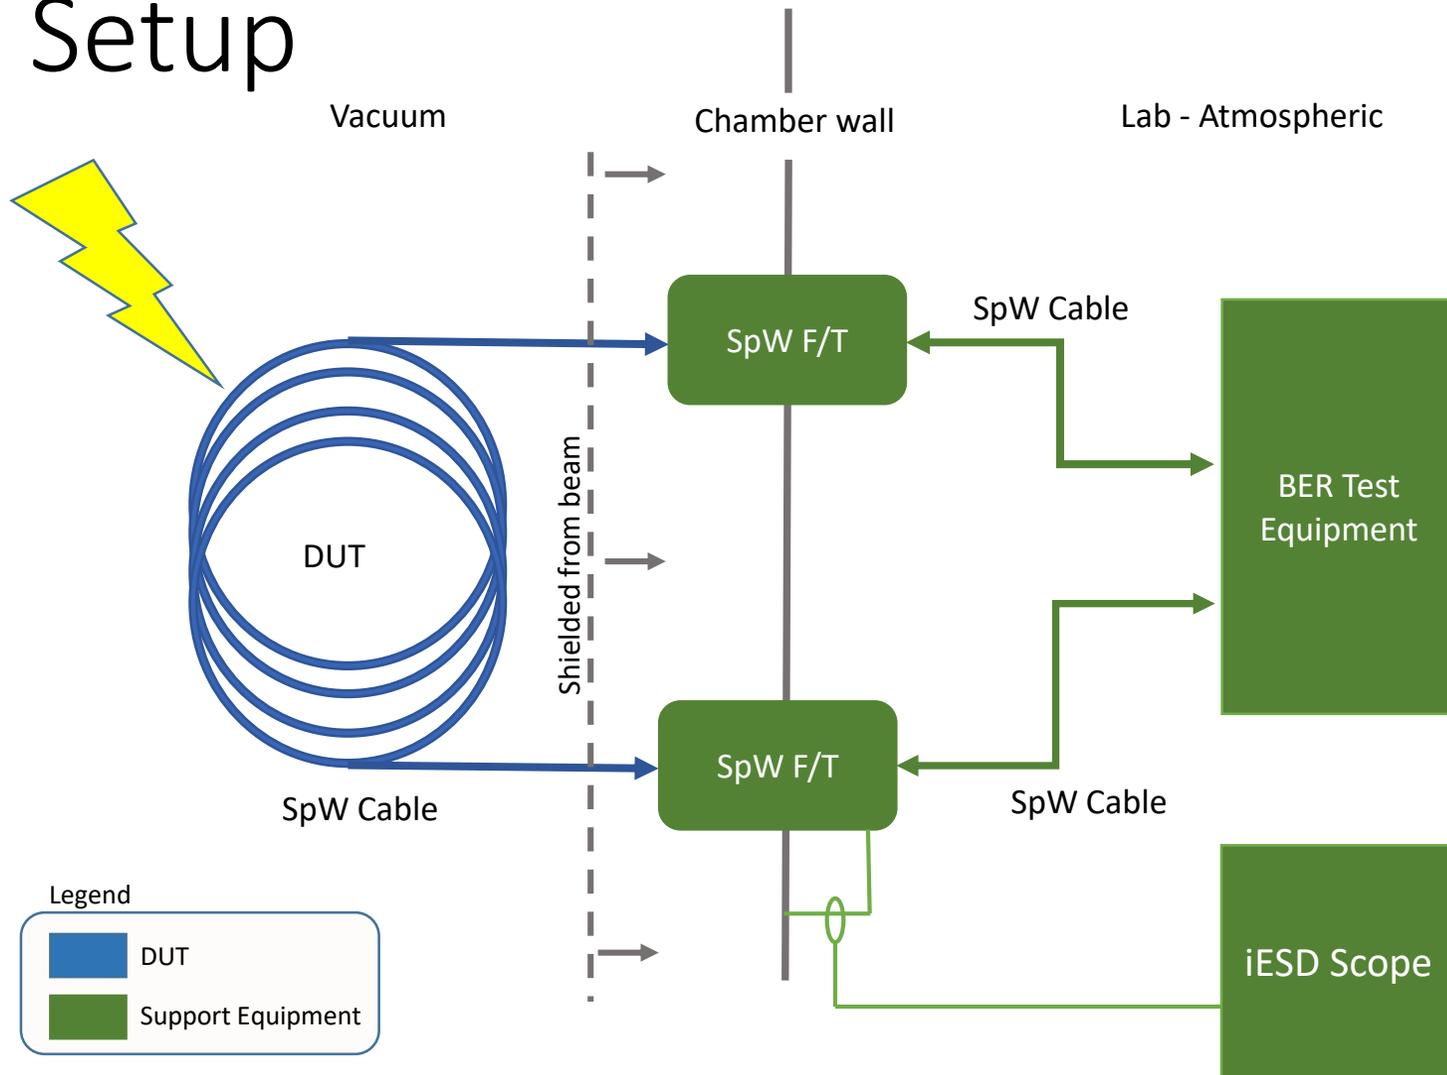
Test Setup

Two current probes at each feedthrough (only one pictured). Measuring current in TP shields (combined) and in bundle shield to ground.

- The number of discharges (and hence, number of errors) increases with the length of the cable exposed to the beam. This test campaign exposed 12.5 feet of cable to the beam, which is approximately the longest length expected to be used during flight. Total cable length is 25 feet (including unexposed cable and cable outside the chamber).
- The number and magnitude of discharges typically increase as temperature decreases. $-75\text{ }^{\circ}\text{C}$ is the lowest expected operating temperature for Spacewire. As recommended in the ERD, we tested at $15\text{ }^{\circ}\text{C}$ lower than this temperature ($-90\text{ }^{\circ}\text{C}$).
- All the TP shields were tied together and the current from them to ground was monitored. The current from the harness shield to ground was also monitored. Both ends of the cable were monitored for a total of 4 channels.

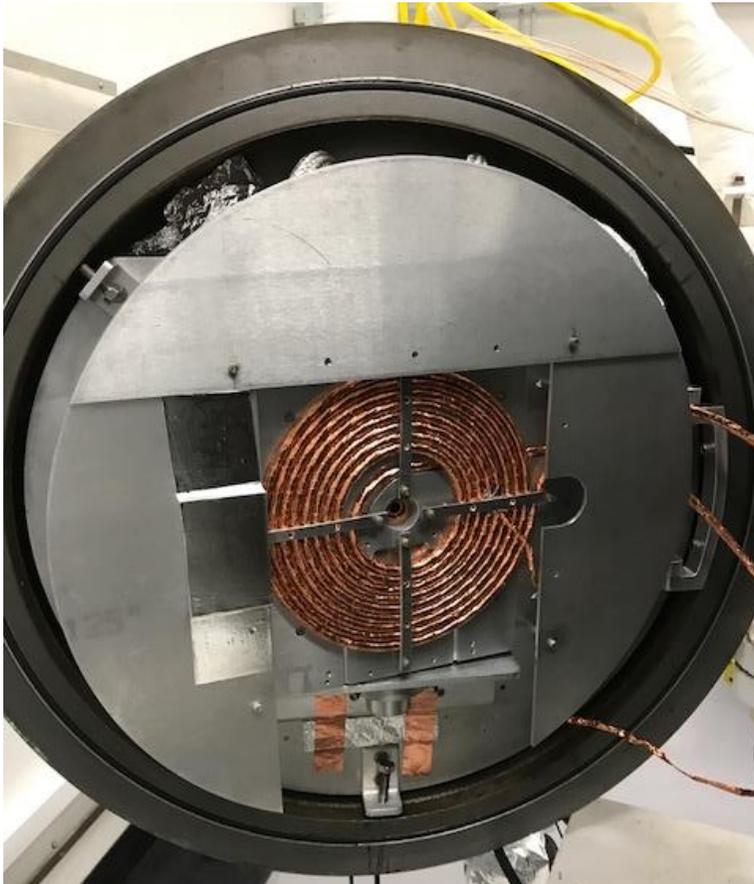
DUT in chamber with shielding

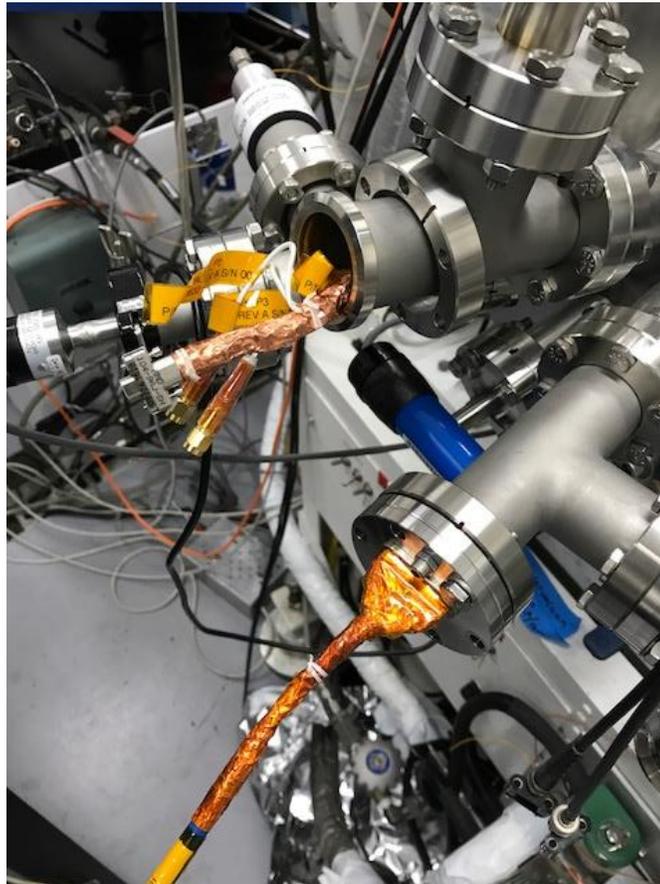
Feedthrough

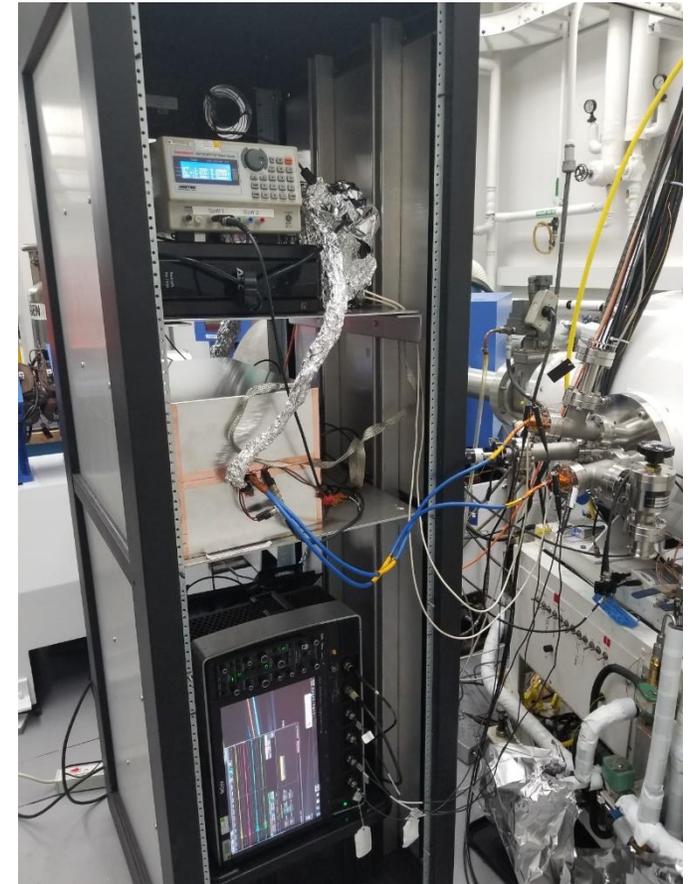
BER Tester & iESD Scope

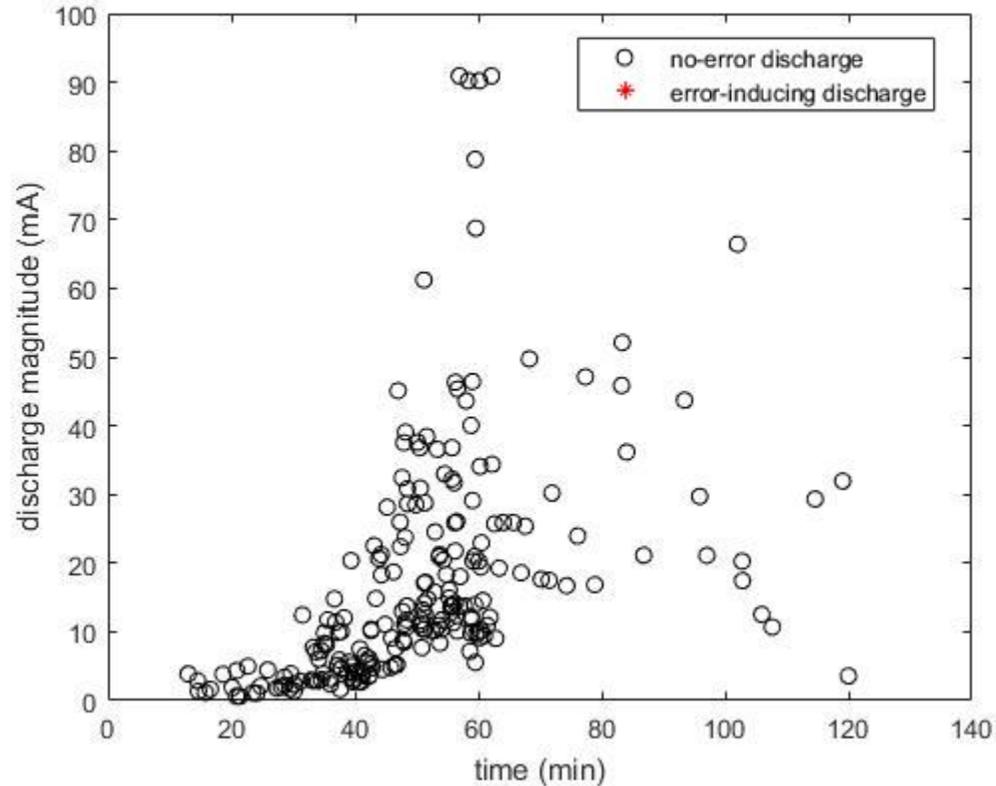
01/30/18

The purpose of this test was to check that the error-monitoring system and discharge-monitoring system were working and could communicate.

This test wasn't intended to evaluate the BER due to iESD. Nevertheless, the sample received the total flyby flux without any errors (at room temperature).

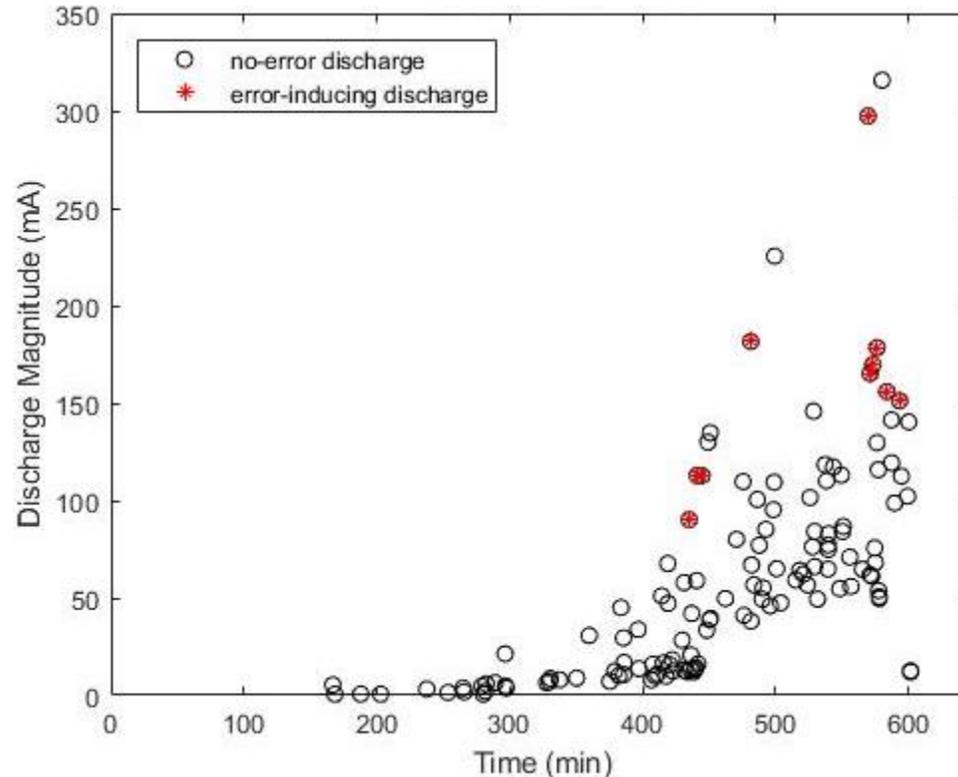
02/28/18

This was the baseline test: nominal beam conditions (4x accelerated flux compared to the expected environment flux for ¼ of the duration) and maximum bit rate of 200 Mbps.

10 bit errors were observed during the 10-hour test. Because the flux is accelerated by 4x, the 10-hour test represents the entire 40-hour iESD flyby environment. Therefore, we expect 10 bit errors during the flyby.

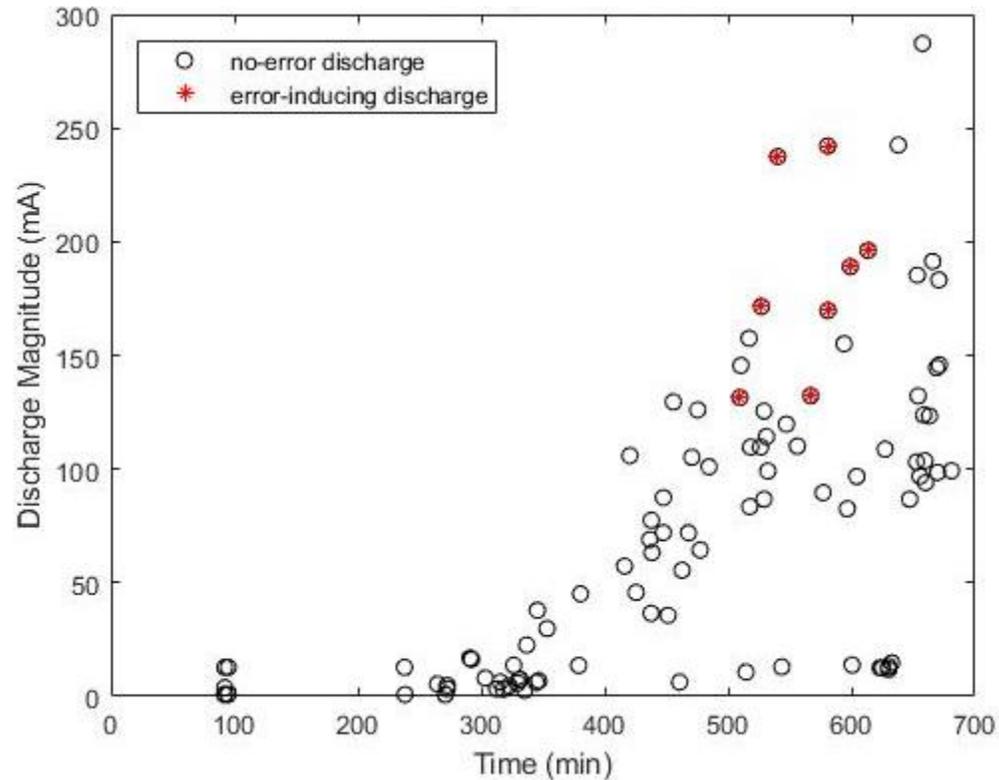
03/13/18

The purpose of this test was to check the performance at a lower bit rate.

The performance was similar to that at 200 Mbps. 8 bit errors were observed during the equivalent flyby environment exposure.

*extra time added because beam was brought down a few times. Total exposure time still 10 hrs.

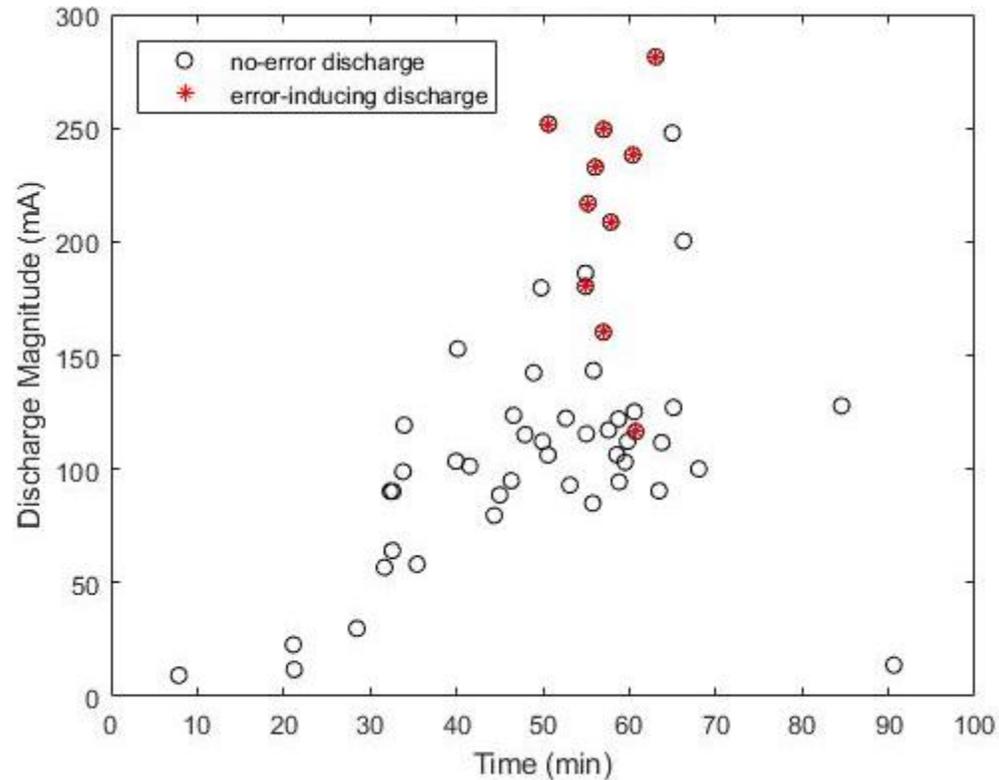
The purpose of this test was to check whether the lack of bit errors during the 01/30/18 test was due to the accelerated flux condition or the higher temperature.

The performance was similar to the previous tests at -90 °C. The discharge magnitudes were higher than the 01/30/18 room temperature test and there were more errors. This indicates that the lower temperature was the cause of the errors, not the lower flux rate. 11 bit errors were observed during the equivalent flyby environment exposure.

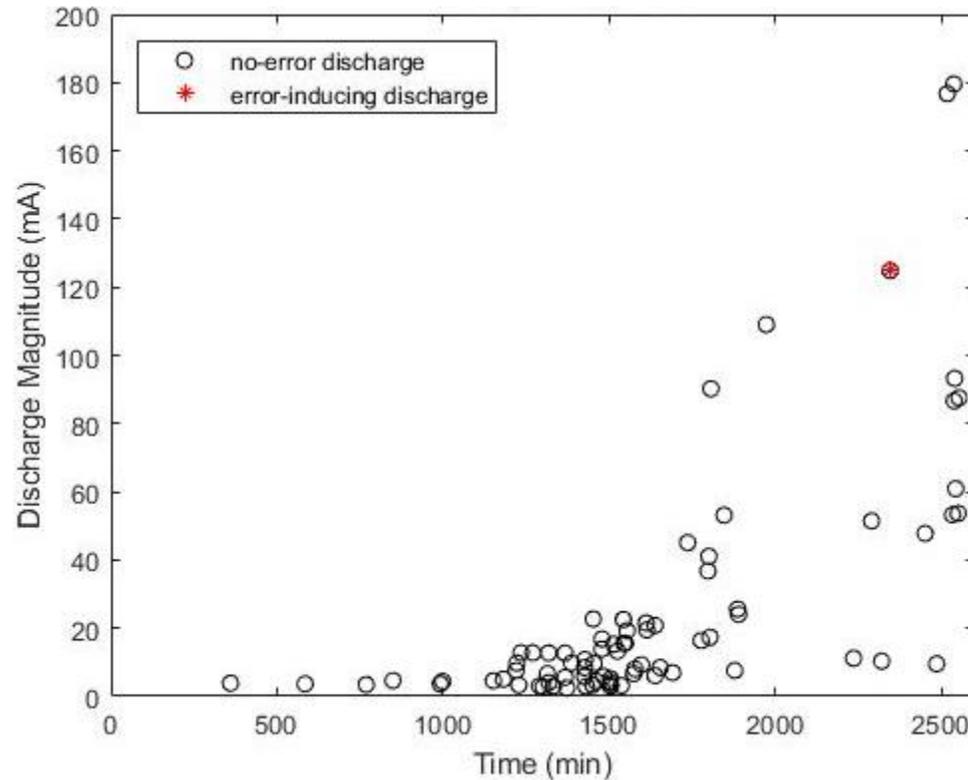
The purpose of this test was to check the performance at the actual expected flux (1x condition), bit rate, and temperature.

At the lower flux, the magnitudes of discharges were ~30% less than the 4x condition. 1 bit error was observed during the equivalent flyby environment exposure.

*extra time added because beam was brought down a few times. Total exposure time still 40 hrs.

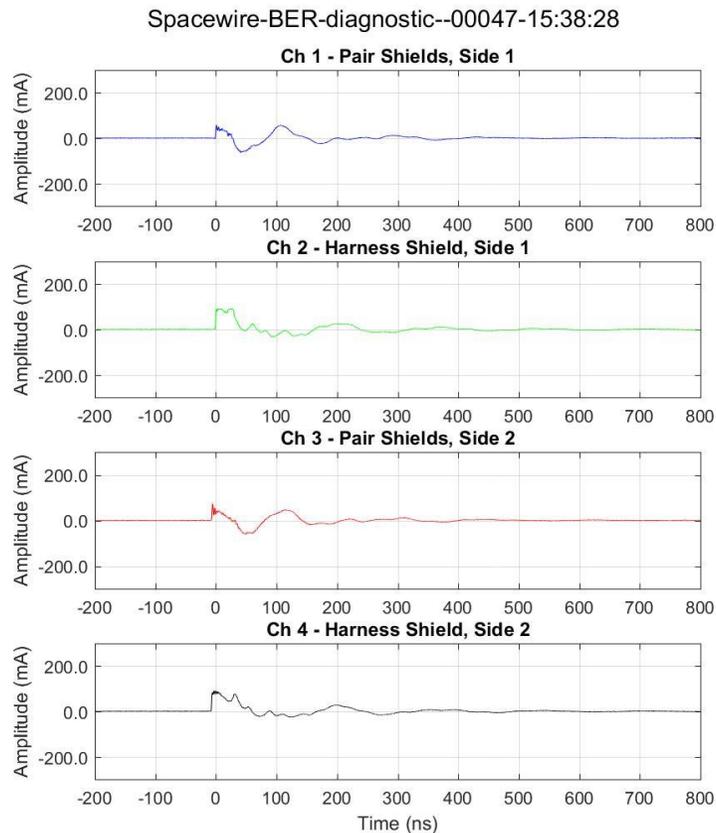
Caused Error

Looking at the discharge profiles, there is nothing that stands out to indicate why the left discharge pulse caused an error and the right discharge pulse did not. In general, there is no clear feature that reliably predicts what discharge pulses caused errors. Some speculation includes:

- Some discharge pulses may have been more common mode than others of similar magnitude. SpaceWire uses low voltage differential signaling and is more robust to common mode (~ 1.2 V) than it is to differential mode (~ 0.4 V).
