# SEE and TID of Emerging Non-Volatile Memories

D.N.Nguyen and L.S. Scheick

Jet Propulsion Laboratory  
California Institute of Technology  
Pasadena, California

**Abstract** – We report on the SEE and TID tests of higher density flash memories. Stand-by currents and full functional tests were used to characterize the response of radiation effects. Both normal and irregular SEFI were observed indicating upsets from complex control circuitry. TID results are compared with tests from previous generations.

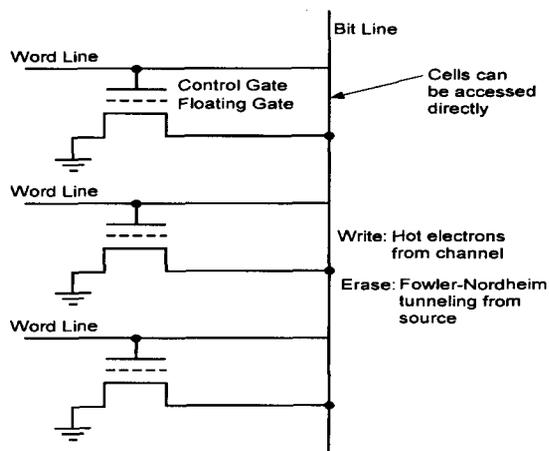
Figure 1: the NOR flash memory architecture

There are two types of flash architecture: NOR and NAND. While both architectures have the same basic storage element (consisting of a control gate stacked over an insulating oxide known as a floating gate, a source, and a drain), it is the interconnection of these memory cells that distinguishes the structure. The NOR cell architecture is shown in Figure 1 and in the NOR flash memory array, the bit line logic goes to "0" if any of the memory cell transistors is "ON".

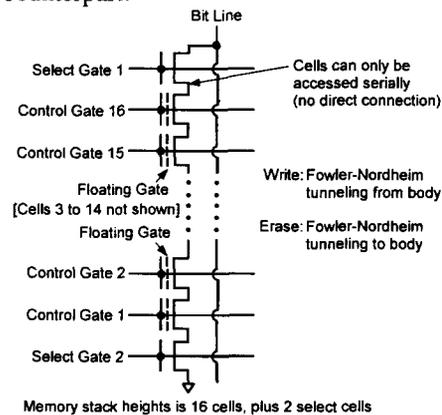
Figure 2: the NAND flash memory architecture

The NAND cell structure is shown in Figure 2 and in the NAND flash memory array, the bit line logic goes to "0" if all of the memory cell transistors are "ON". Both architectures require charge pump circuits in order to provide the high internal voltages that are needed for erase and write operations.

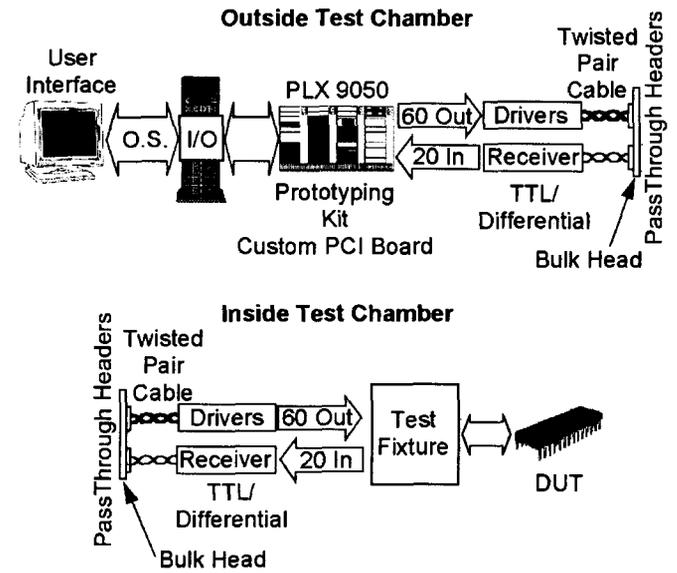
**Figure 3: SEE Test Setup**

The test equipment was comprised of two PCs, a power supply, and a FPGA-based test board. One PC controlled a HP6629A power supply. This allowed precision voltage control and latch-up detection and protection since the PC had millisecond control over the operation of the power supply. A second, dedicated PC controlled the test circuit board designed specifically to read errors and write commands/test patterns to the DUTs. Parts were programmed with a pseudo-random pattern to mimic real data. The algorithm generates a reproducible sequence of binary states. Two patterns are used to complement each other and to ensure that all bit locations are changed states. The address of any failure and the value at that address were recorded in a file for each run. The number of address and bit failures also was recorded in a separate log file. A depiction of the setup used is shown in Figure 3.

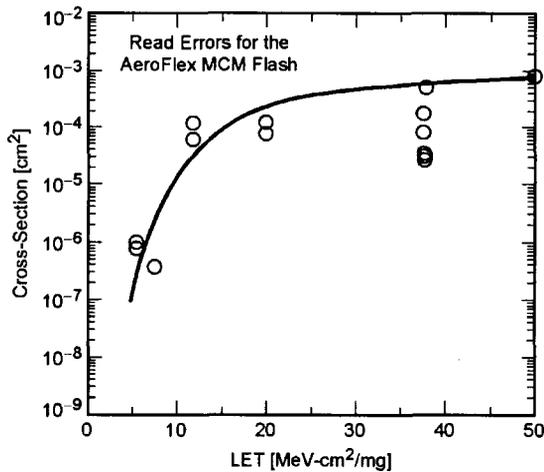
**Figure 4: Cross-section of the dynamic read upsets (AeroFlex MCM)**

Three AeroFlex MCM parts were tested with negligible variation among them. Figures 4, 5, and 6 are statistically fit using a model by Edmonds [3]. Three operational modes were tested during irradiation: read, write and erase. Static read (post-irradiation) test is also conducted. Figure 4 shows the test results of the dynamic read errors. SEFI happens occasionally with the sudden increase of device supply current. Restarting the read function or cycling power reset SEFI errors. No hard errors or bit erasures were seen in  $10^{11}$  particles per centimeter.

Test results for the read-upsets of the SanDisk devices were very similar to the test results observed during the read mode of the AeroFlex MCM components. However, SEFI post-read lockup never occurred for SanDisk parts. Figure 8 displays the SEE read upsets of SanDisk components. Based on Figure 4 and Figure 8, the cross-section of read-upsets of the SanDisk was qualitative similar to those of AeroFlex MCM parts.

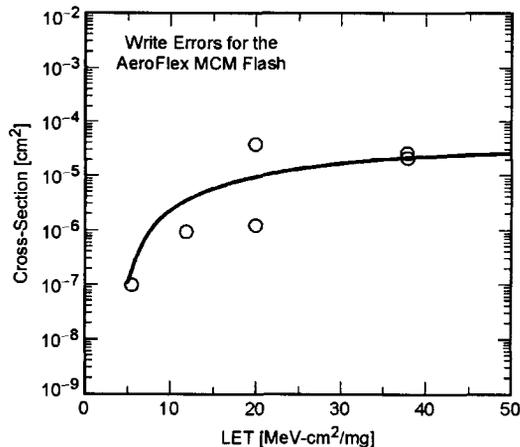
**Figure 5: Cross-section of write-upsets (AeroFlex MCM)**

Figure 5 illustrates test results of write errors. This occurs due to state machine being upset resulting in the changing of the address it was reading for validation from the address that was being written. Block-erase errors are similar to write errors since the erase operation is aborted before completion. Figure 6 shows the results of the test of the block-erase mode of all three DUTs.

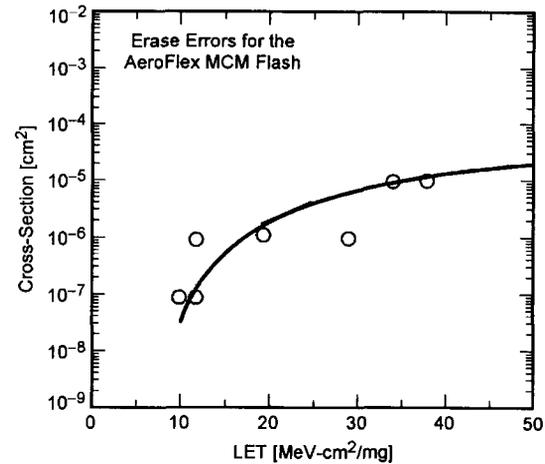
**Figure 6: Cross-section of erase upsets (AeroFlex MCM)**

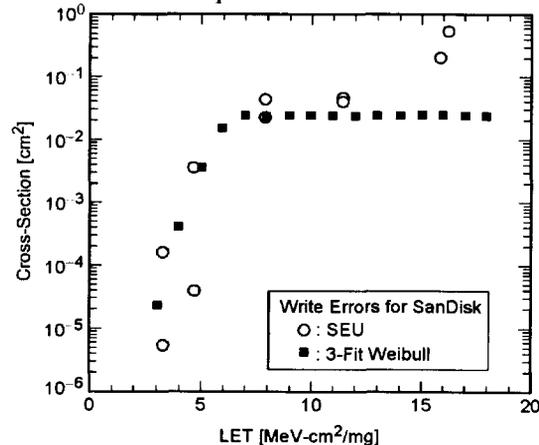
**Figure 7: Cross-section of write-upsets (SanDisk)**

One permanent bad block was observed after the lockup produced by a SEFI write upset. Figure 7 shows the cross-section of write upsets in SanDisk parts. Most SanDisk SEFI errors are write errors and similar to the AeroFlex SEFI lockups, they can be recovered with either power cycling or erase/write/read sequences.

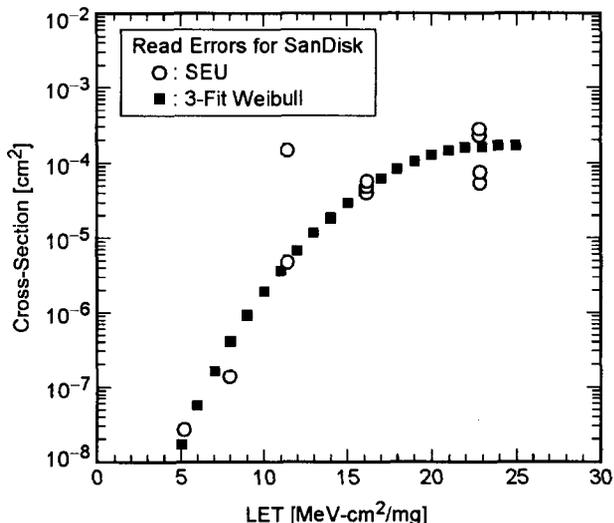
Figure 8: Cross-section of read upsets (SanDisk)

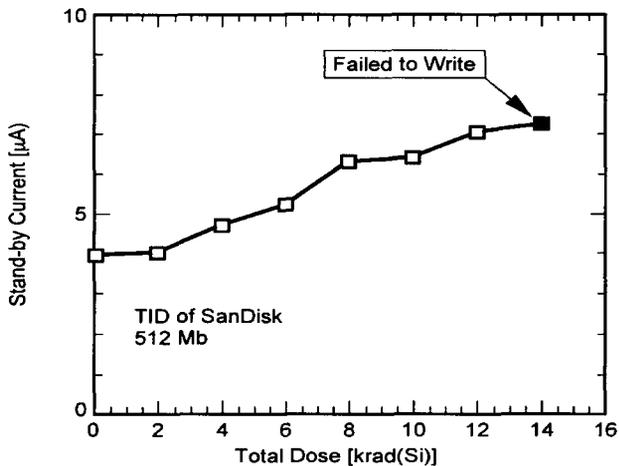
Figure 9: Total dose test results for the SanDisk 512Mb flash devices evaluated in full functional mode

The measured stand-by currents for SanDisk parts show no significant increase, a change of 3.26µA. The stand-by current of SanDisk devices went up to 7.22 µA at 14 krad(Si) at which functional failures occurred. Devices could be erased after 14 krad(Si). But the complement pattern could not be written to the DUTs and there were 5 million-bit read errors after 14 krad(Si). After 24 hours anneal at 3.3 volts and 25 degree C, one SanDisk part could be re-programmed. Previous generations of flash memory devices failed to erase at a lower level, around 8 krad(Si) with full functional tests including the erase/write/read sequence and could not recover

after 24 hours annealing [4]. Figure 9 displays the TID response of SanDisk parts.

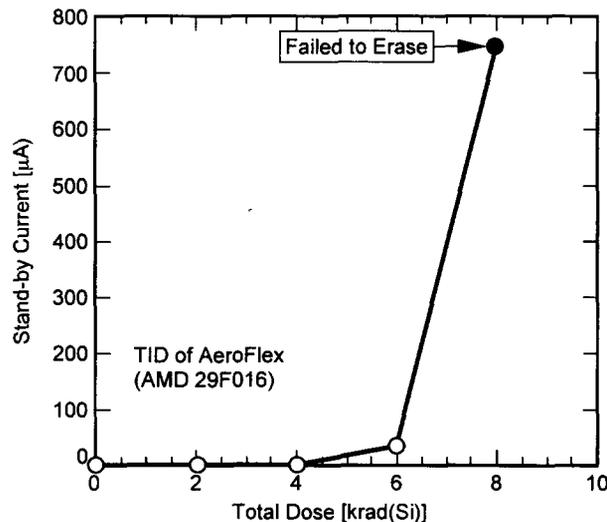
Figure 10: Total dose test results for AeroFlex MCM

The AeroFlex, two AMD29F016B parts, was evaluated in the similar setup as described in the previous paragraph. The AMD parts failed to erase after 8 krad(Si). The stand-by current went from less than 1 µA at the start of the test to 744 µA at 8 krad(Si). This implied that the oxide thickness of AeroFlex die is higher than those of the SanDisk devices. Figure 10 shows the total dose test results for the AeroFlex parts.
