# **V-Band Separation Shock Characteristics**

Kurng Y. Chang  
Jet Propulsion Laboratory, California Institute of Technology  
4800 Oak Grove Dr., MS 157-410, Pasadena, CA 91109-8099, USA  
Phone: 01 818 354 8565, fax: 01 818 393 1156

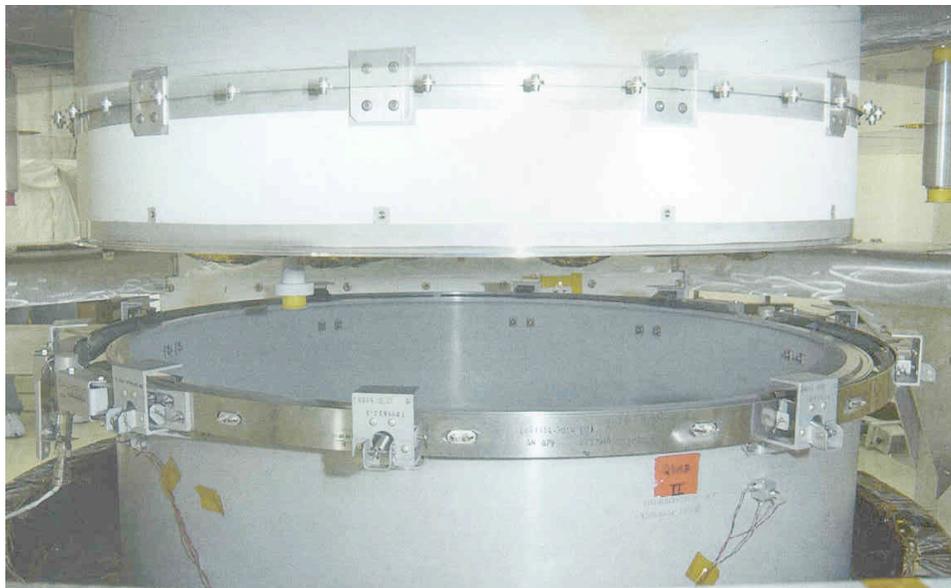
Figure 1. MER V-Band Assembly after Separation

V-band is a ring-shaped tension clamp. V-band assemblies come in a variety of styles, using sheet metal V-band clamps, sheet metal V-band flanges or machined flanges. A typical V-band used in the Mars Exploration Rover (MER) program is shown in Figure 1. Generally, the separation band system used in the aerospace industry consists of three main parts: an upper ring, a launch vehicle adapter including lower ring, and a clamp band. The upper attachment ring is installed on the bottom of the spacecraft adapter permanently and serves as the upper surface of interface plane. On the top of the launch payload adapter, the lower ring is installed and serves as the lower surface of interface plane. The clamp band is manufactured in two identical halves and connected together at their ends by pyrotechnic lock devices. In addition, four (4) or six (6) catchers dependent on the ring diameter size are fixed to the payload adapter's ring, to guide, catch and park the band within the allowed volume after band released. The clamp band has a peripheral length shorter than that of the upper ring and the launch vehicle adapter; therefore the clamp band can only be installed in tension. A release mechanism containing pyrotechnic devices is used to release the band.

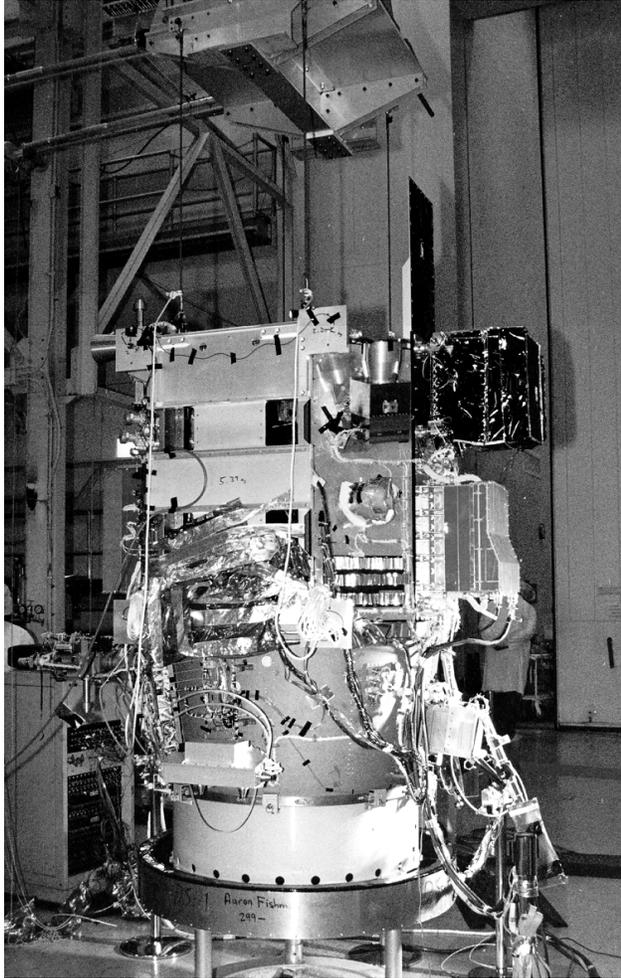
Figure 2. DS1 Spacecraft Configuration for V-Band Separation Test

Separation tests of V-band release conducted in this study include three JPL spacecrafts which all use the Delta II 37-inch diameter V-band clamp assembly to induce separation of payload attachment. The 1<sup>st</sup> test article was the Deep Space (DS) 1 flight spacecraft with a 3712C test Payload Attachment Fitting (PAF). The DS1 test configuration before the V-band clamp separation is illustrated in Figure 2. The spacecraft was suspended by a bridge crane. A PAF catcher was placed on the floor below the test article with approximately 2 inches clearance between the top of the catcher and the bottom surface of the test PAF. The PAF catcher was used to catch and to gradually absorb all the energy of the falling test PAF (after separation) without allowing a hard impact. Three repeat firings were performed for determining possible flight-to-flight variation (Reference 1). The 2<sup>nd</sup> and 3<sup>rd</sup> test articles were the MER flight spacecrafts attached with the same test PAF. Their test configuration for the V-band clamp separation is presented in Figure 3. Both MER spacecrafts were tested in the same configuration with the spacecraft supported by the cruise stage support ring on the back shell assembly cart standoff (References 2 and 3). One firing was carried out for each spacecraft. The PAF catcher was placed on the floor below the test article to catch and to gradually absorb all of the energy of the falling test PAF.

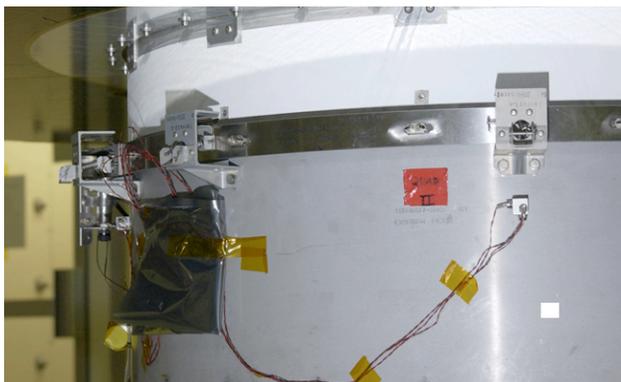
Figure 4. Shock Response Accelerometer Locations for MER#2 V-Band Separation Test (Response Accelerometers Mounted above V-Band in MER#1 Launch Separation Test)

Figure 8 shows the shock spectrum levels measured on the test PAF during the MER#2 V-band separation. Two (2) sets of tri-axial accelerometers were used to measure the shock responses in the MER separation tests; one was mounted at the location just below the bolt cutter and near the spacecraft/PAF interface, and a secondary one was mounted at 90 degrees apart below the V-band catcher. The actual measurement locations can be seen in Figure 1 and Figure 4. As shown in Figure 8, the measured shock levels due to the MER spacecraft separation at most frequency regions are slightly below the Boeing imposed shock requirements. Since one firing was performed, no statistical variation could be estimated to obtain the maximum expected flight shock level. Nevertheless, no flight equipment is located on the PAF; the results shown here are only used as a reference base to characterize the source shock levels of the V-band separation.

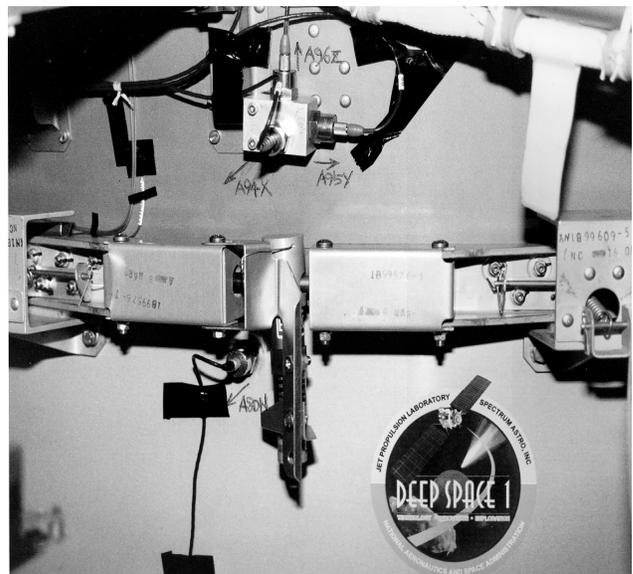
Figure 5. Accelerometer Locations for Shock Measurements in DS1 V-Band Separation Test

Figure 7 shows the shock response spectra measured on the test PAF near the bolt cutter during the second and the third of the DS1 spacecraft test firings. (No measured data was obtained for the first firing.) The accelerometer located below the V-band right next to the bolt cutter is illustrated in Figure 5. The test measurements along with the maximum expected interface shock environment as specified in the Boeing document (Reference 4) are plotted in the same figure for comparison. The test data was observed to be quite repeatable during the two firings and are virtually identical to the maximum shock environment provided by Boeing.

Two sets of tri-axial accelerometers at two locations, 90 degrees apart, were used to measure the shock environment on the spacecraft near the spacecraft/test PAF interface in both DS1 and MER#1 tests. Their respective locations are illustrated in Figure 5 and Figure 6 for the DS1 separation test. The shock levels measured at the DS1 magnetometer and DCIU equipment rails near the spacecraft interface for all firings are plotted in Figure 9. The shock response spectra measured tri-axially at these two locations are independent of measurement direction and similar in response levels. Figure 10 again shows the shock spectrum levels measured at two locations on the spacecraft interface during the MER#1 separation test. The maximum expected spacecraft interface shock environment as specified by Boeing (Reference 4) are also plotted in the same figure for comparison. As shown in these two figures, the maximum measured shock levels due to the V-band separation at most frequency regions can be enveloped by a level which is at least 10 to 12 dB (or 4 times) less than the Boeing imposed shock requirements.

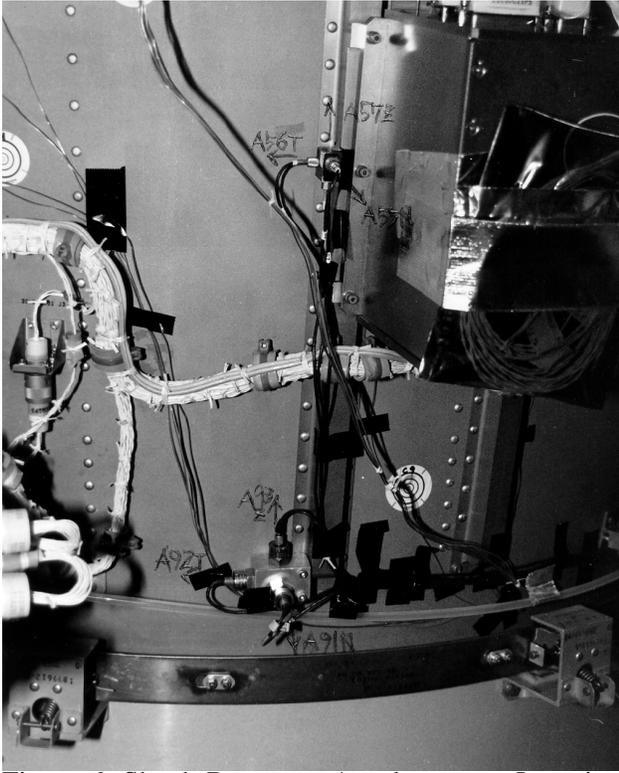
Figure 6. Shock Response Accelerometer Locations for DS1 V-Band Separation Test

Two sets of tri-axial accelerometers mounted at two locations, less than 12 inches away, were used to compare the shock environment at equipment locations. Their respective locations are illustrated in Figure 6. Figure 11 shows the z-axis SRS levels measured at these two locations of the DCIU equipment rail for all three DS1 separation firings. The shock response spectra measured tri-axially are independent of measurement direction and similar in response level. As illustrated in the plot, only small variations in shock level for all frequencies in all three firings are observed at each measurement location, except at low frequencies where larger variations are due to instrumentation dynamic range restrictions for the first test firing. However, significant shock attenuation was observed in the frequency range from 400 Hz to 4000 Hz between two measurement locations. The reduction at the DCIU equipment in the same frequency range even reaches a factor of 4 to 5 times less than the spacecraft interface shock input, which is unexpected for a linear shock source of a circular band: distance usually does not produce significant shock reduction or virtually no decay over short distance on a cylinder-type structure. This result is inconsistent with the expectation that the release of tension in restraining band is a direct contributor to the high frequency shock at the spacecraft interface.

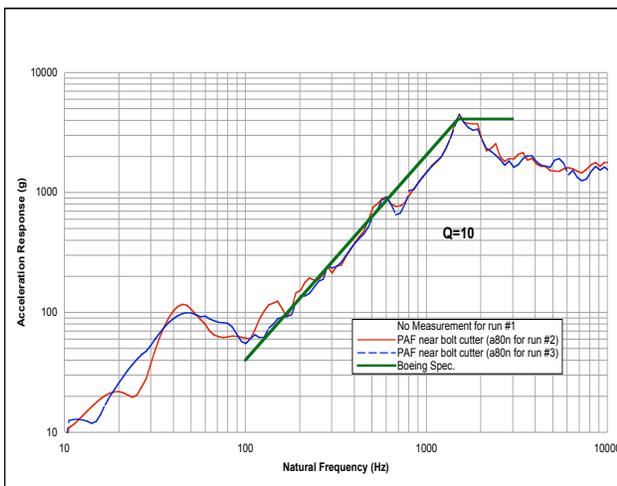
Figure 7. Shock Environment Measured at Test PAF from DS1 V-Band Separation Tests

Figure 12 presents the shock waveform measured at the test PAF from DS1 Run# 2 and 3 test firings. Their corresponding SRS values are plotted in Figure 7. Figure 13 presents the shock transients in the radial direction at two different locations measured at the test PAF during MER#2 test firing. These measurements are the highest recordings in all three orthogonal axes. The intensity of the shock pulse as well as the waveform and duration for all four measurements are similar to each other. However, the pulse duration is close to 100 msec, which is much longer than the near-field shock generated from a pyrotechnic device (typically less than 10 msec). The shock levels measured at the PAF are as predicted and the shock character is also as expected, which is primarily due to the rapid release of the stored strain energy from the preload tension of the restraining band acting along a line of contact between the band and the lower adapter ring being separated.

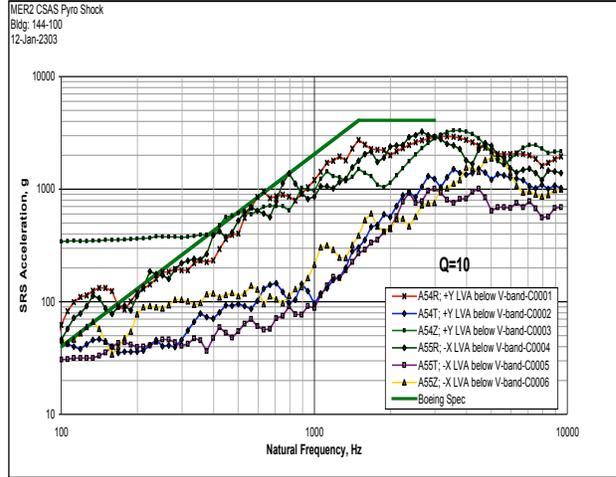
Figure 8. Shock Environment Measured at Test PAF from MER#2 Spacecraft Separation Test

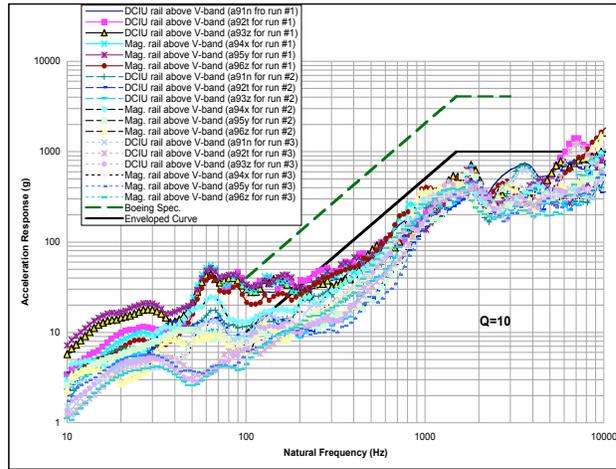
Figure 9. DS1 Spacecraft Interface Shock Environment from V-band Separation

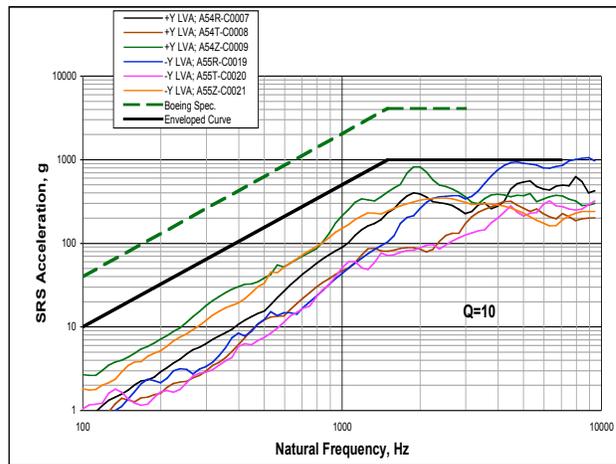
Figure 10. MER#1 Spacecraft Interface Shock Environment from V-band Separation

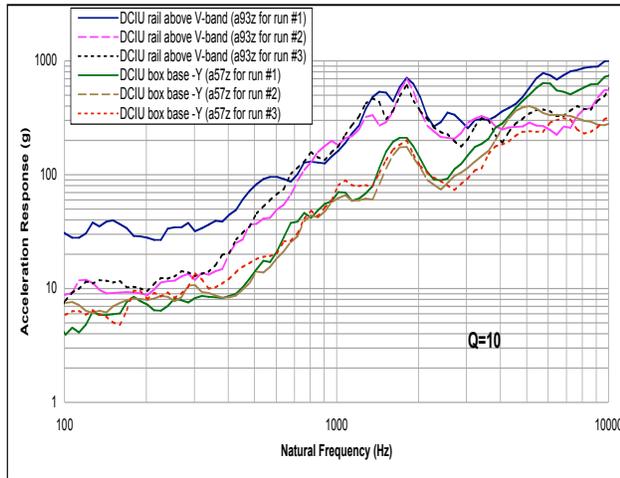
Figure 11. Comparison of Shock Environment Measured at Short Distance from V-band

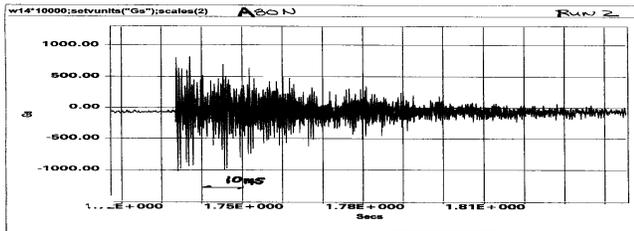
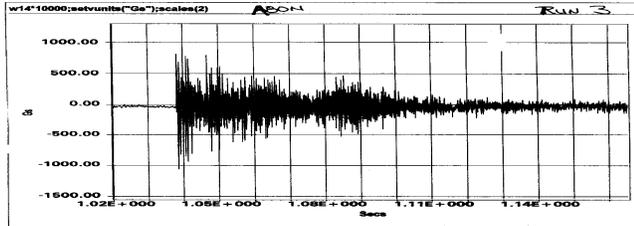
Figure 12. Shock Measurements at PAF below V-Band from DS1 Separation Firings

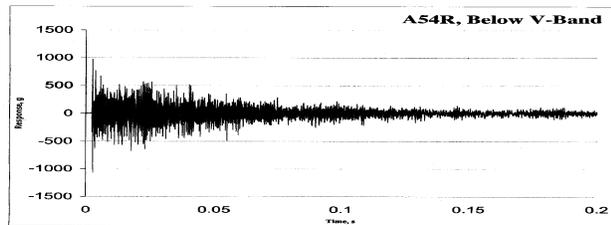
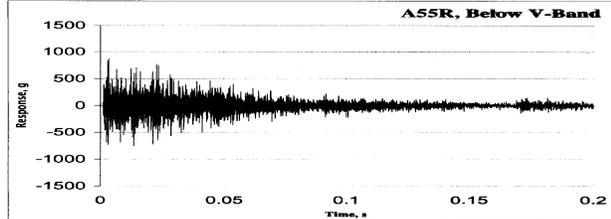
Figure 13. Shock Measurements at Two Different Locations on PAF from MER#2 Test

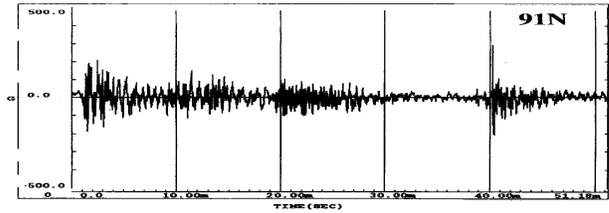
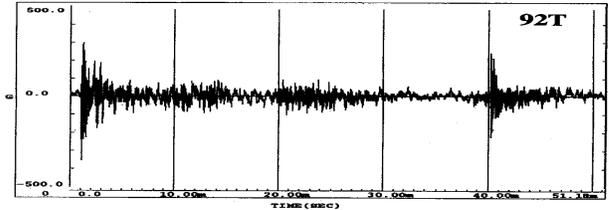
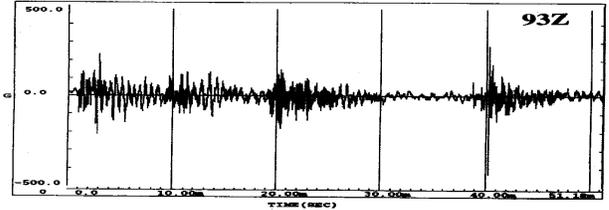
Figure 14a. Typical shock Measurements near Spacecraft Interface from DS1 Separation

Figures 14a and 14b present typical shock measurements near the DS1 spacecraft interface. Figure 15 shows the shock measurements at two immediate locations near the MER#1 spacecraft interface. Multiple shock pulses were observed at the spacecraft interface during spacecraft separation from the V-band. This result is contrary to expectation. This phenomenon can only be explained that repeated impacts were occurring rather than the waveform being generated from a single band shock or line source during separation. The character may be attributed to the high-speed contacts between the clamp band, the band's catchers and the spacecraft attachment ring after separation. This result was also noticed from the review of high-speed video films recorded during each separation test.

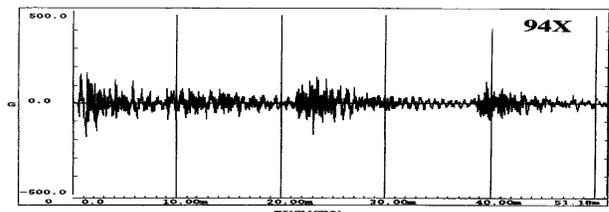
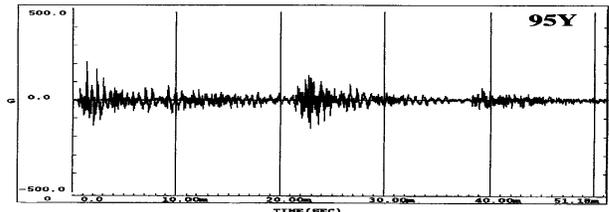
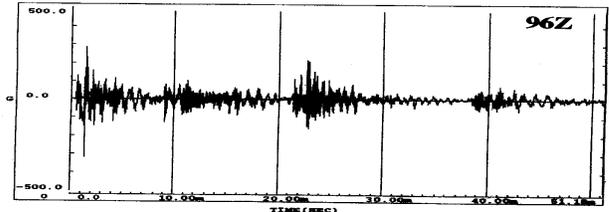
Figure 14b. Typical shock Measurements near Spacecraft Interface from DS1 Separation

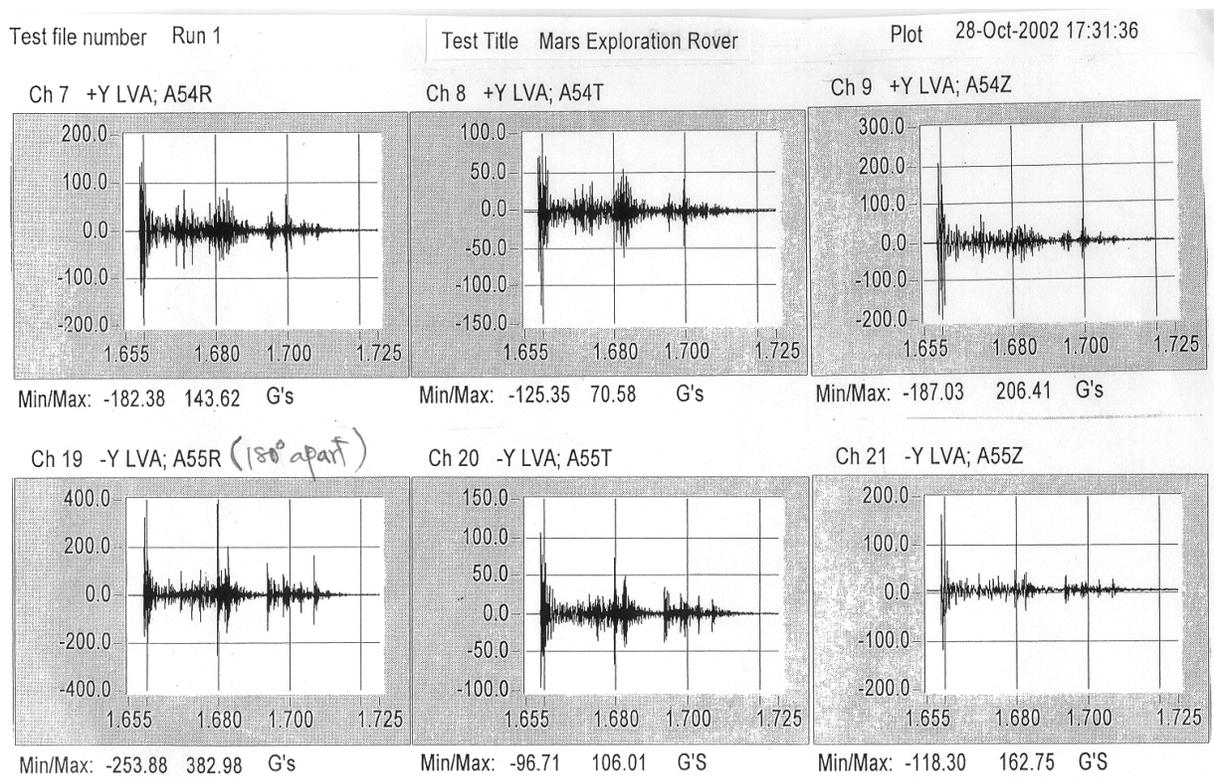
Figure 15. Shock Measurements at Immediate Vicinity of Spacecraft Interface from MER#1 Separation Test

- Multiple shock pulses were observed at the spacecraft interface during the spacecraft separation from the V-band. This character may be attributed to high-speed impacts between the V-band and the spacecraft attachment after separation. This result was also noticed from the high-speed video film. It is concluded that the rapid release of the band's strain energy is not a direct contributor to the high frequency shock at the spacecraft side of the interface. Shock levels will be attenuated much quicker with distance since this source is a point contact shock rather than a linear distributed source as previously assumed.
